SITE INSPECTION REPORT

Site Name: Buffalo Business Park

Site Number: V00663

Inspection Date: 2/18/2026

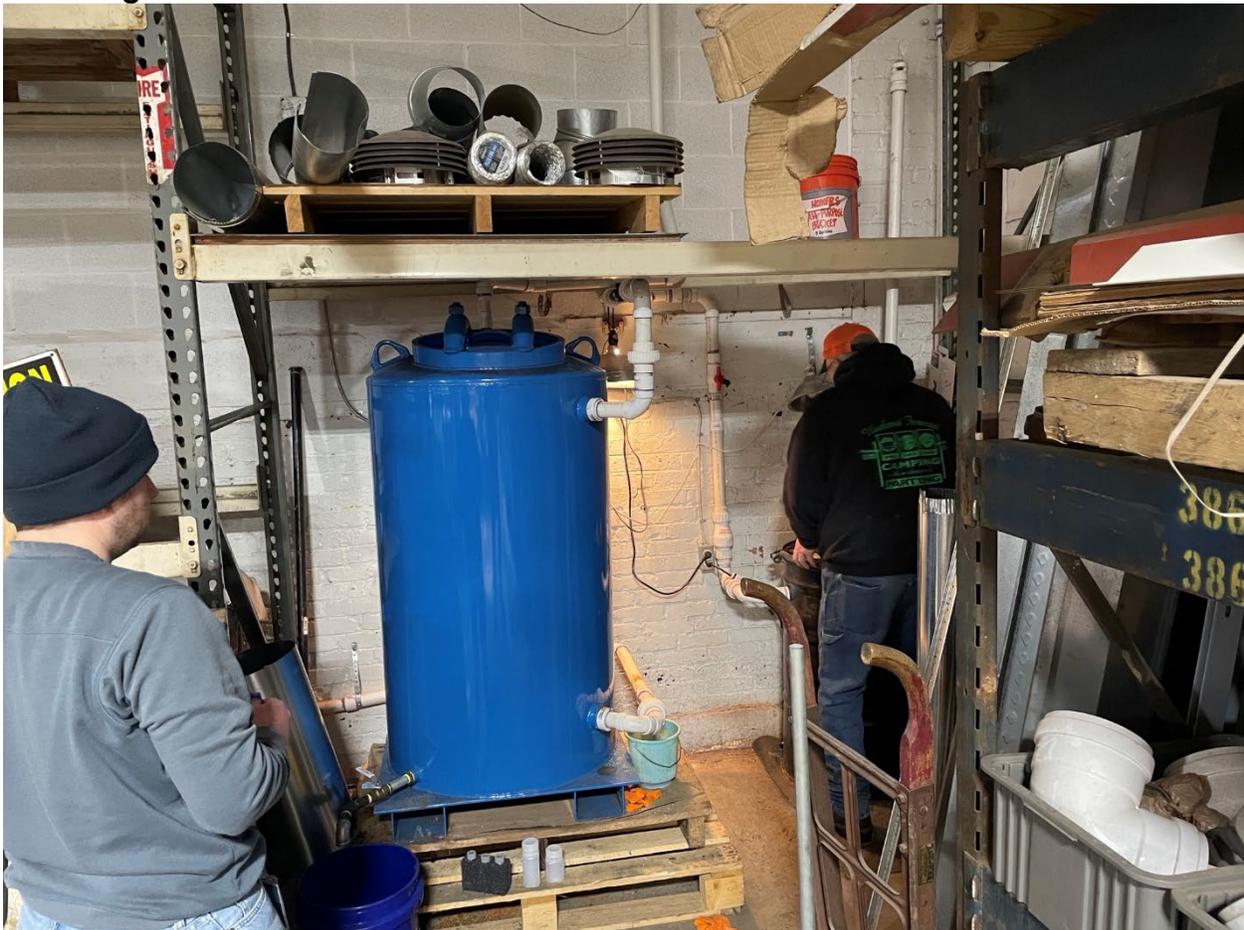
- C&S took treatment system effluent sample. No issues observed with treatment system lines, meters, or granular activated carbon (GAC) tank.

Treatment system/GAC tank.

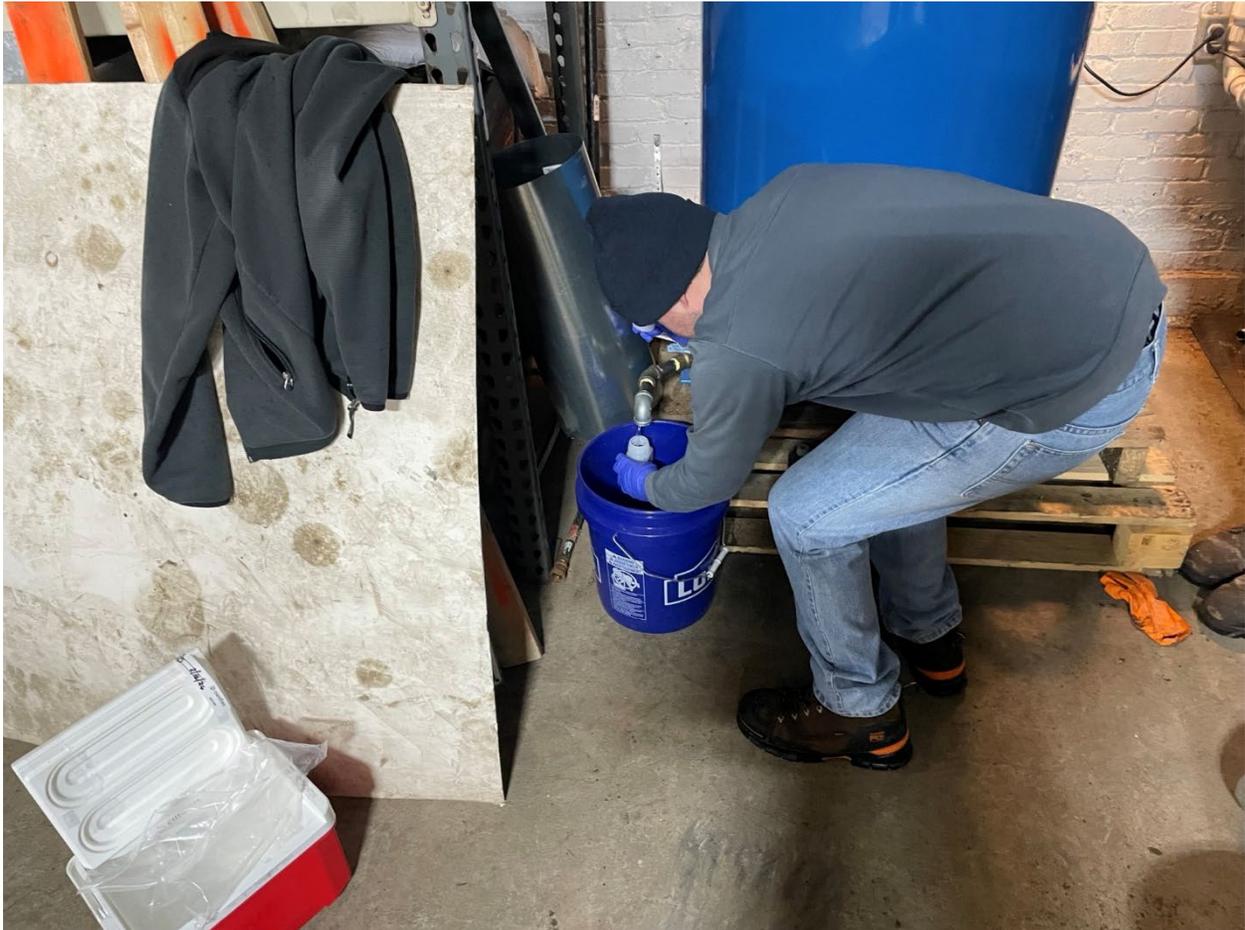
Taking effluent sample.

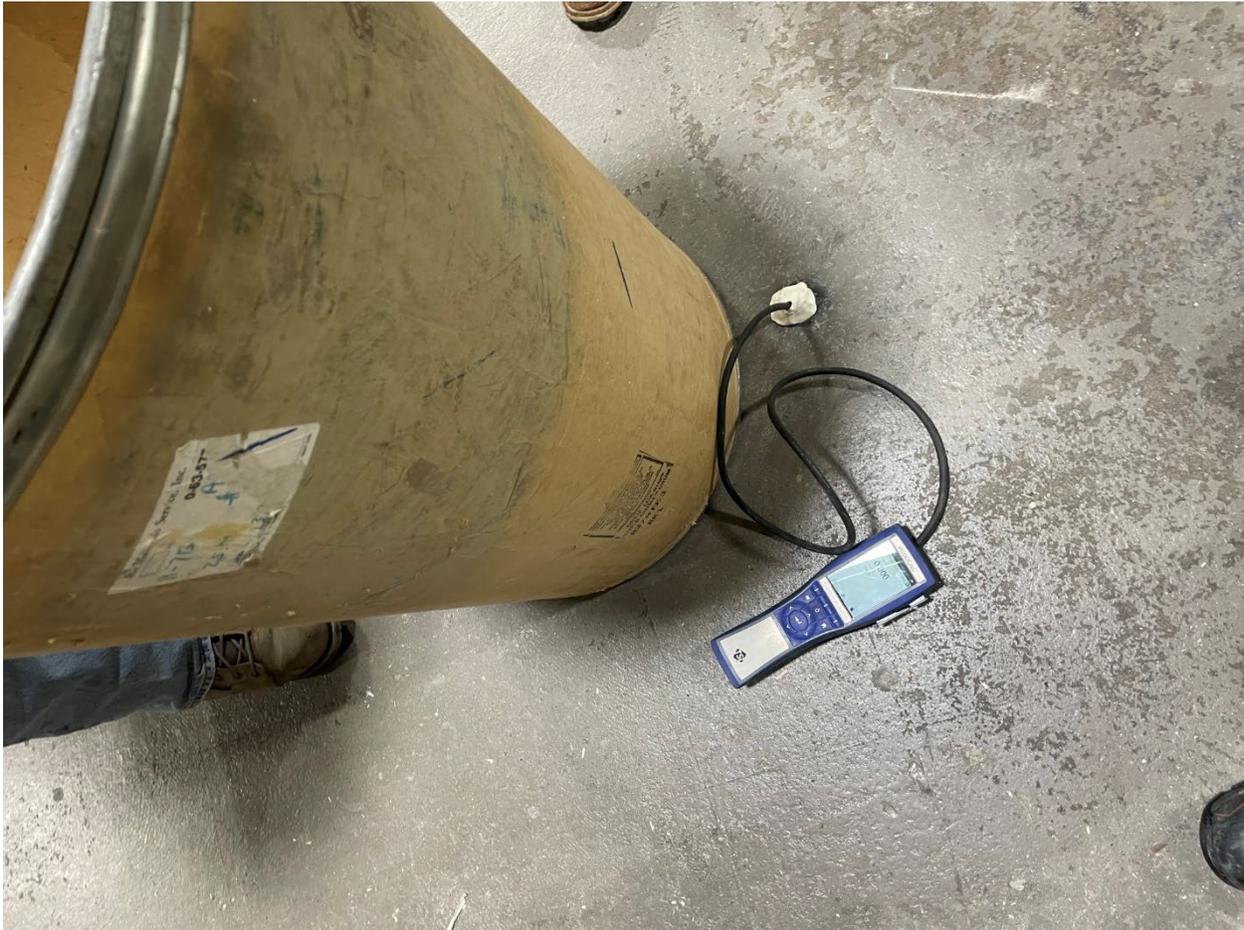
- Pressure field extension testing of the Sub-slab Depressurization System (SSDS) performed by C&S to establish the systems radius of influence. Testing included drilling a hole through slab and taking an air flow reading with manometer to confirm negative pressure/vacuum. Holes were drilled in 1 cardinal direction of each SSDS leg. 3 test points did not achieve vacuum, and this was confirmed with a visual smoke test. Both fans were unplugged to confirm the pressure gauge on the leg dropped and then returned to previous vacuum level once power was restored. Leg 2 remains bent from previous collision with forklift.

Manometer/test hole.

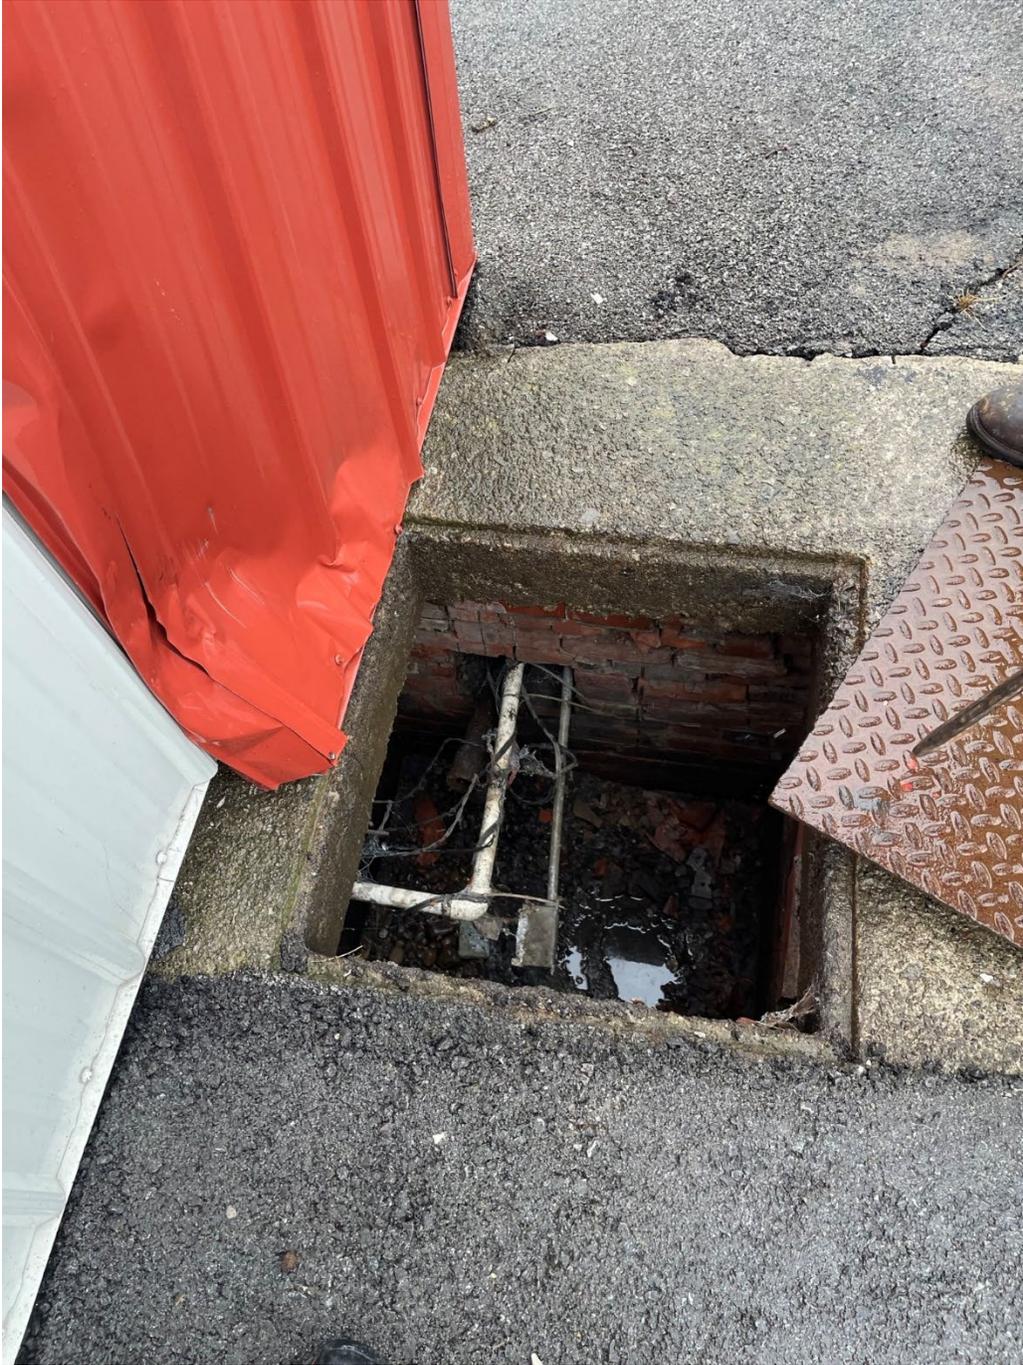
- All pumping well manholes were opened for visual inspection on this date. Nothing unexpected was observed. Pumping well MW-4BR remains connected to temporary power since issues were noted and communicated to NYSDEC by email on 2/5/2026. Per BBP staff power was verified at conduit in corner of building closest to well so it is believed a line may be corroded or pinched. BBP staff are going to cut the pavement up to observe conditions between the wells power line and conduit at corner of building with an electrician onsite to troubleshoot. Well flow meter is also seized, and another one has been ordered per Steve.

Utility vault going into building assumed to power MW-4BR.

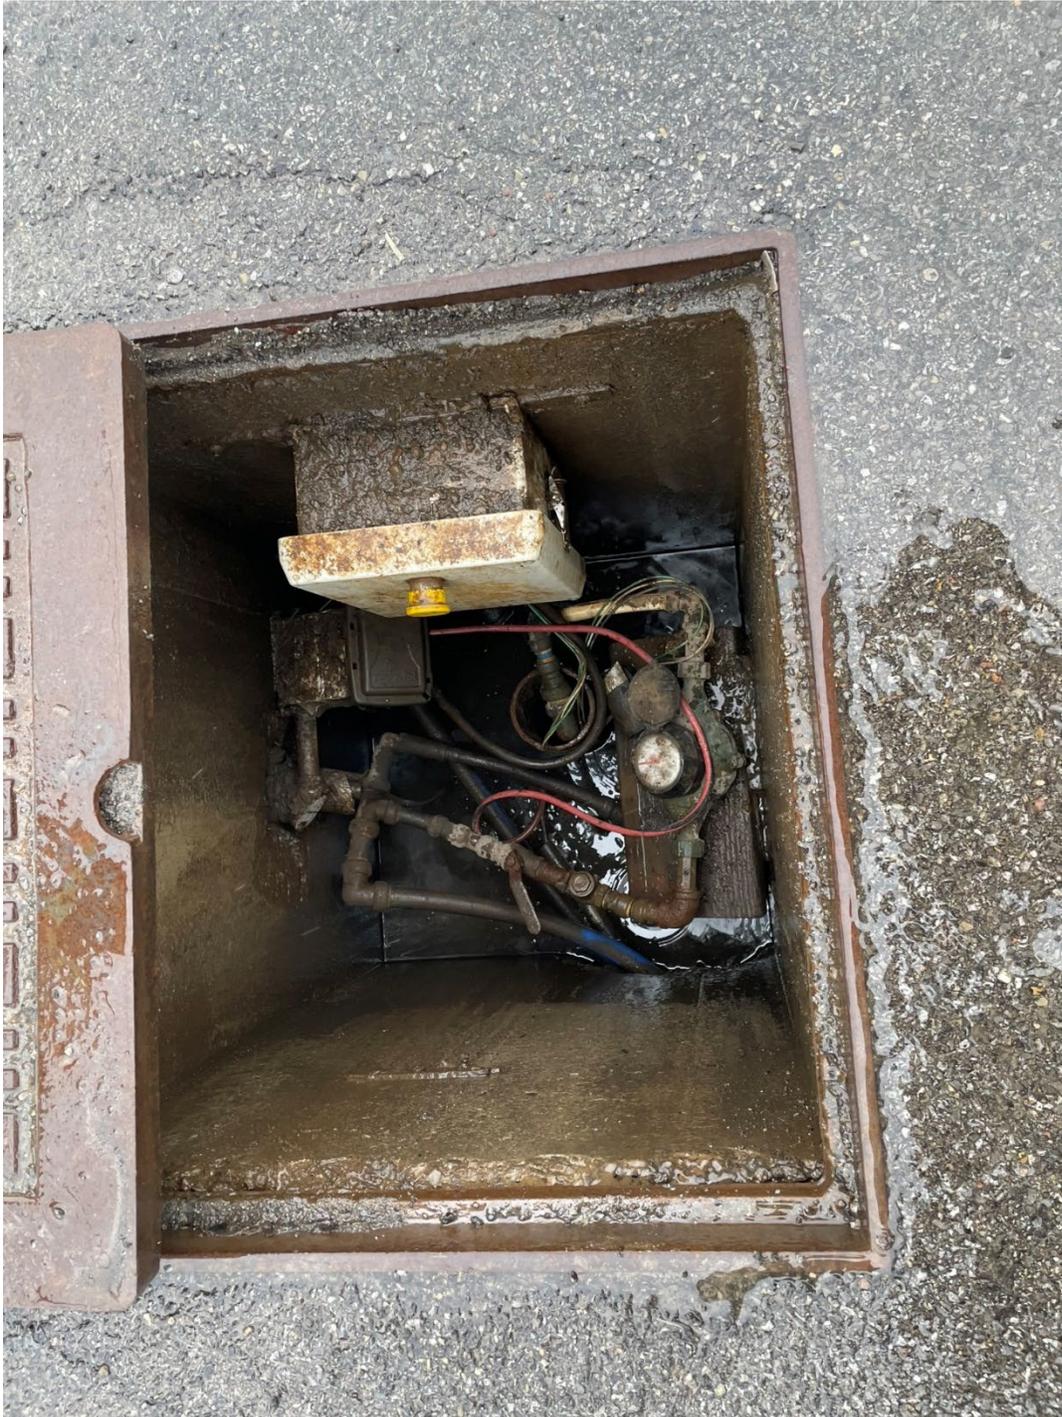
Pumping well with timer box (white/yellow).

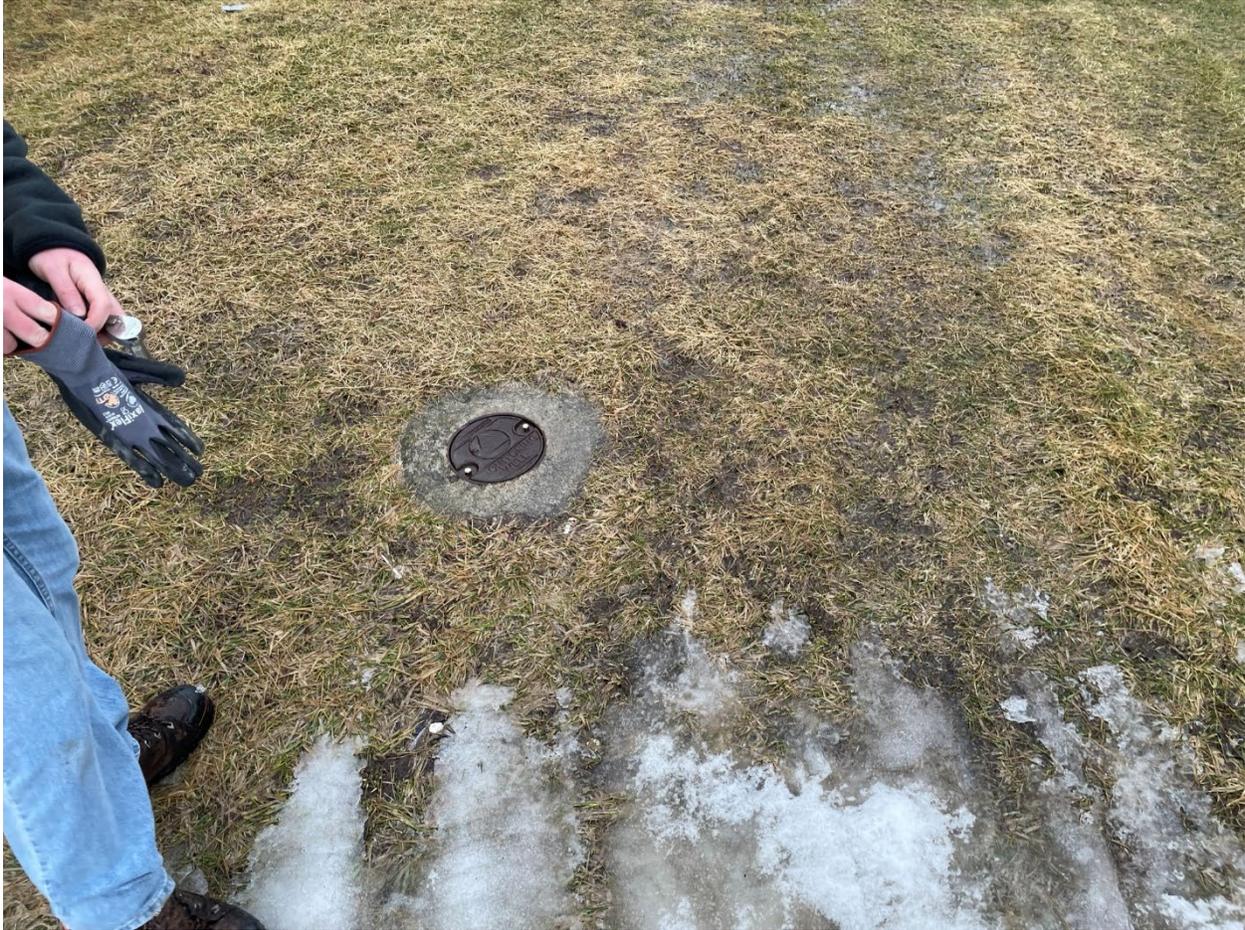
operations. OS-1 was observed to be slightly pitched. No PVC screen was visible. Per C&S, all other wells were to be photographed and documented on this date for required report due next month.

OS-1 on a slight pitch.

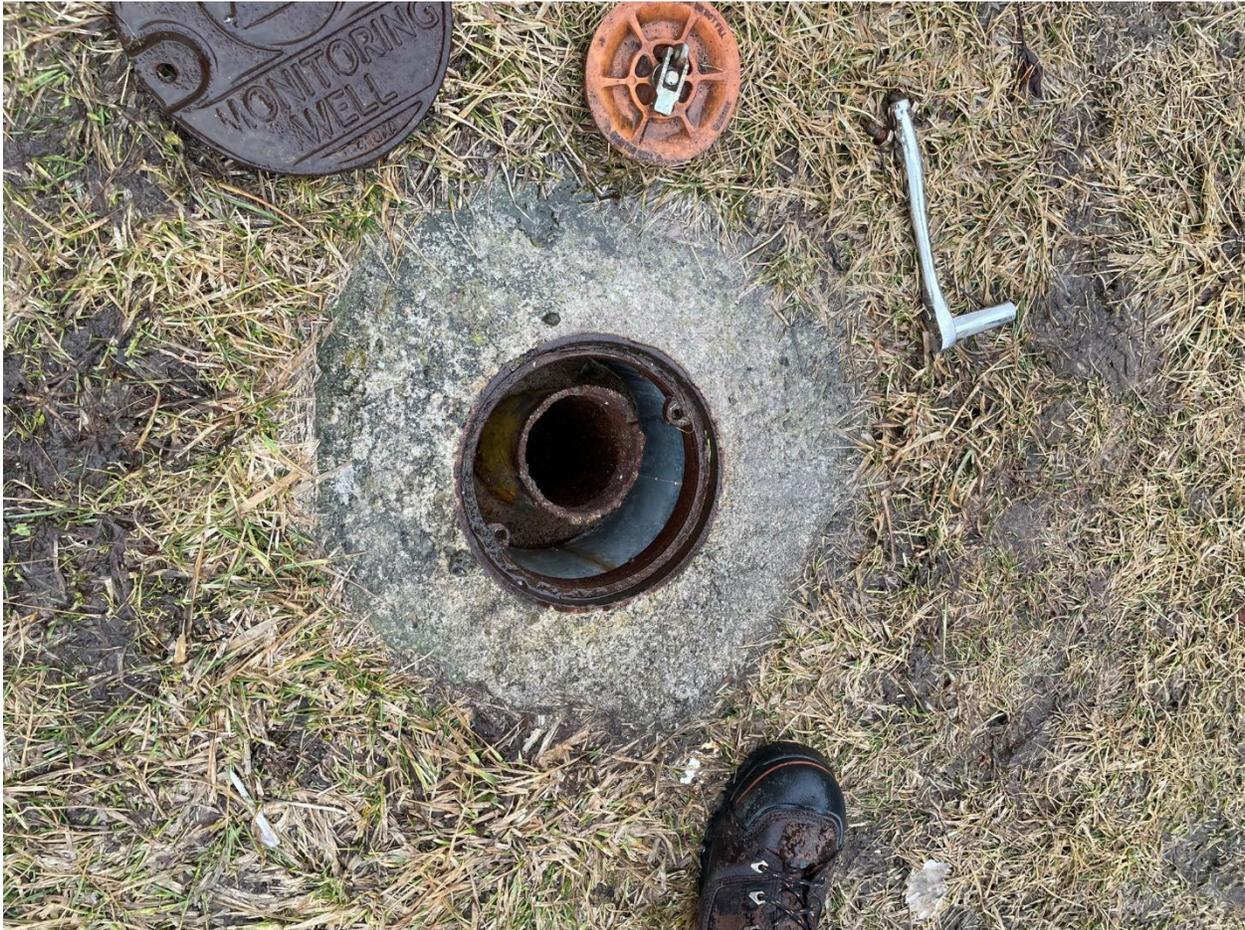
Inside of OS-1. Standing water and no PVC screen observed.
