INSPECTION REPORT

Site Number: V00685

Site Name: Excelsior Steel Ball

Location: 303 Woodward Ave. Tonawanda, N.Y.

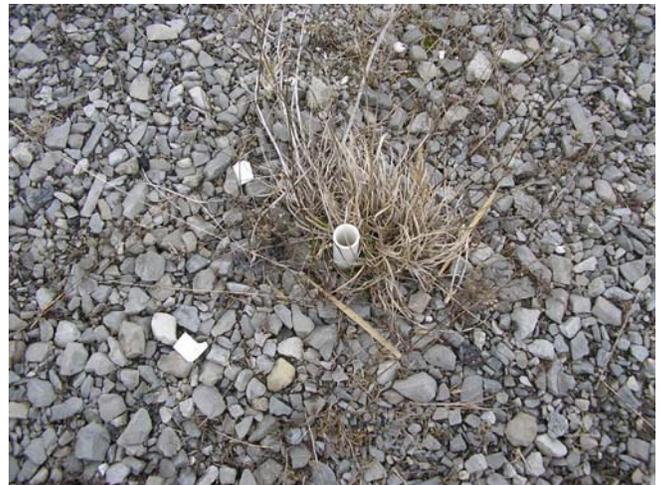
Sheared Micro-Well

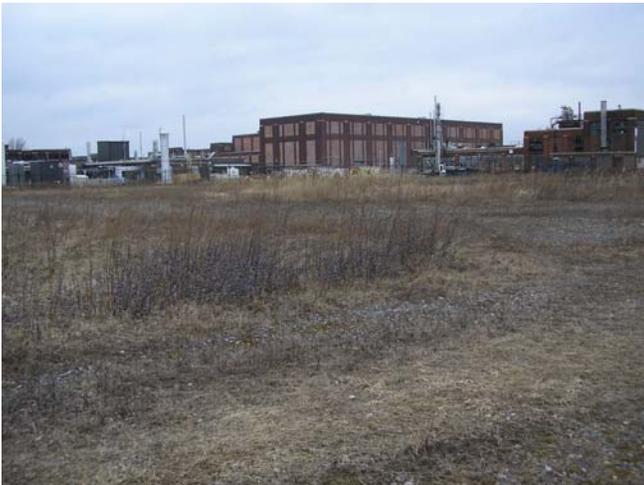
Site When Inspected
