# Remedial Investigation / Interim Remedial Measures / Alternatives Analysis Report

## 402 & 430 Buffalo Avenue Site

August 2015

402 AND 430 BUFFALO AVENUE SITE  
NIAGARA FALLS, NEW YORK  
BCP SITE No. C932164

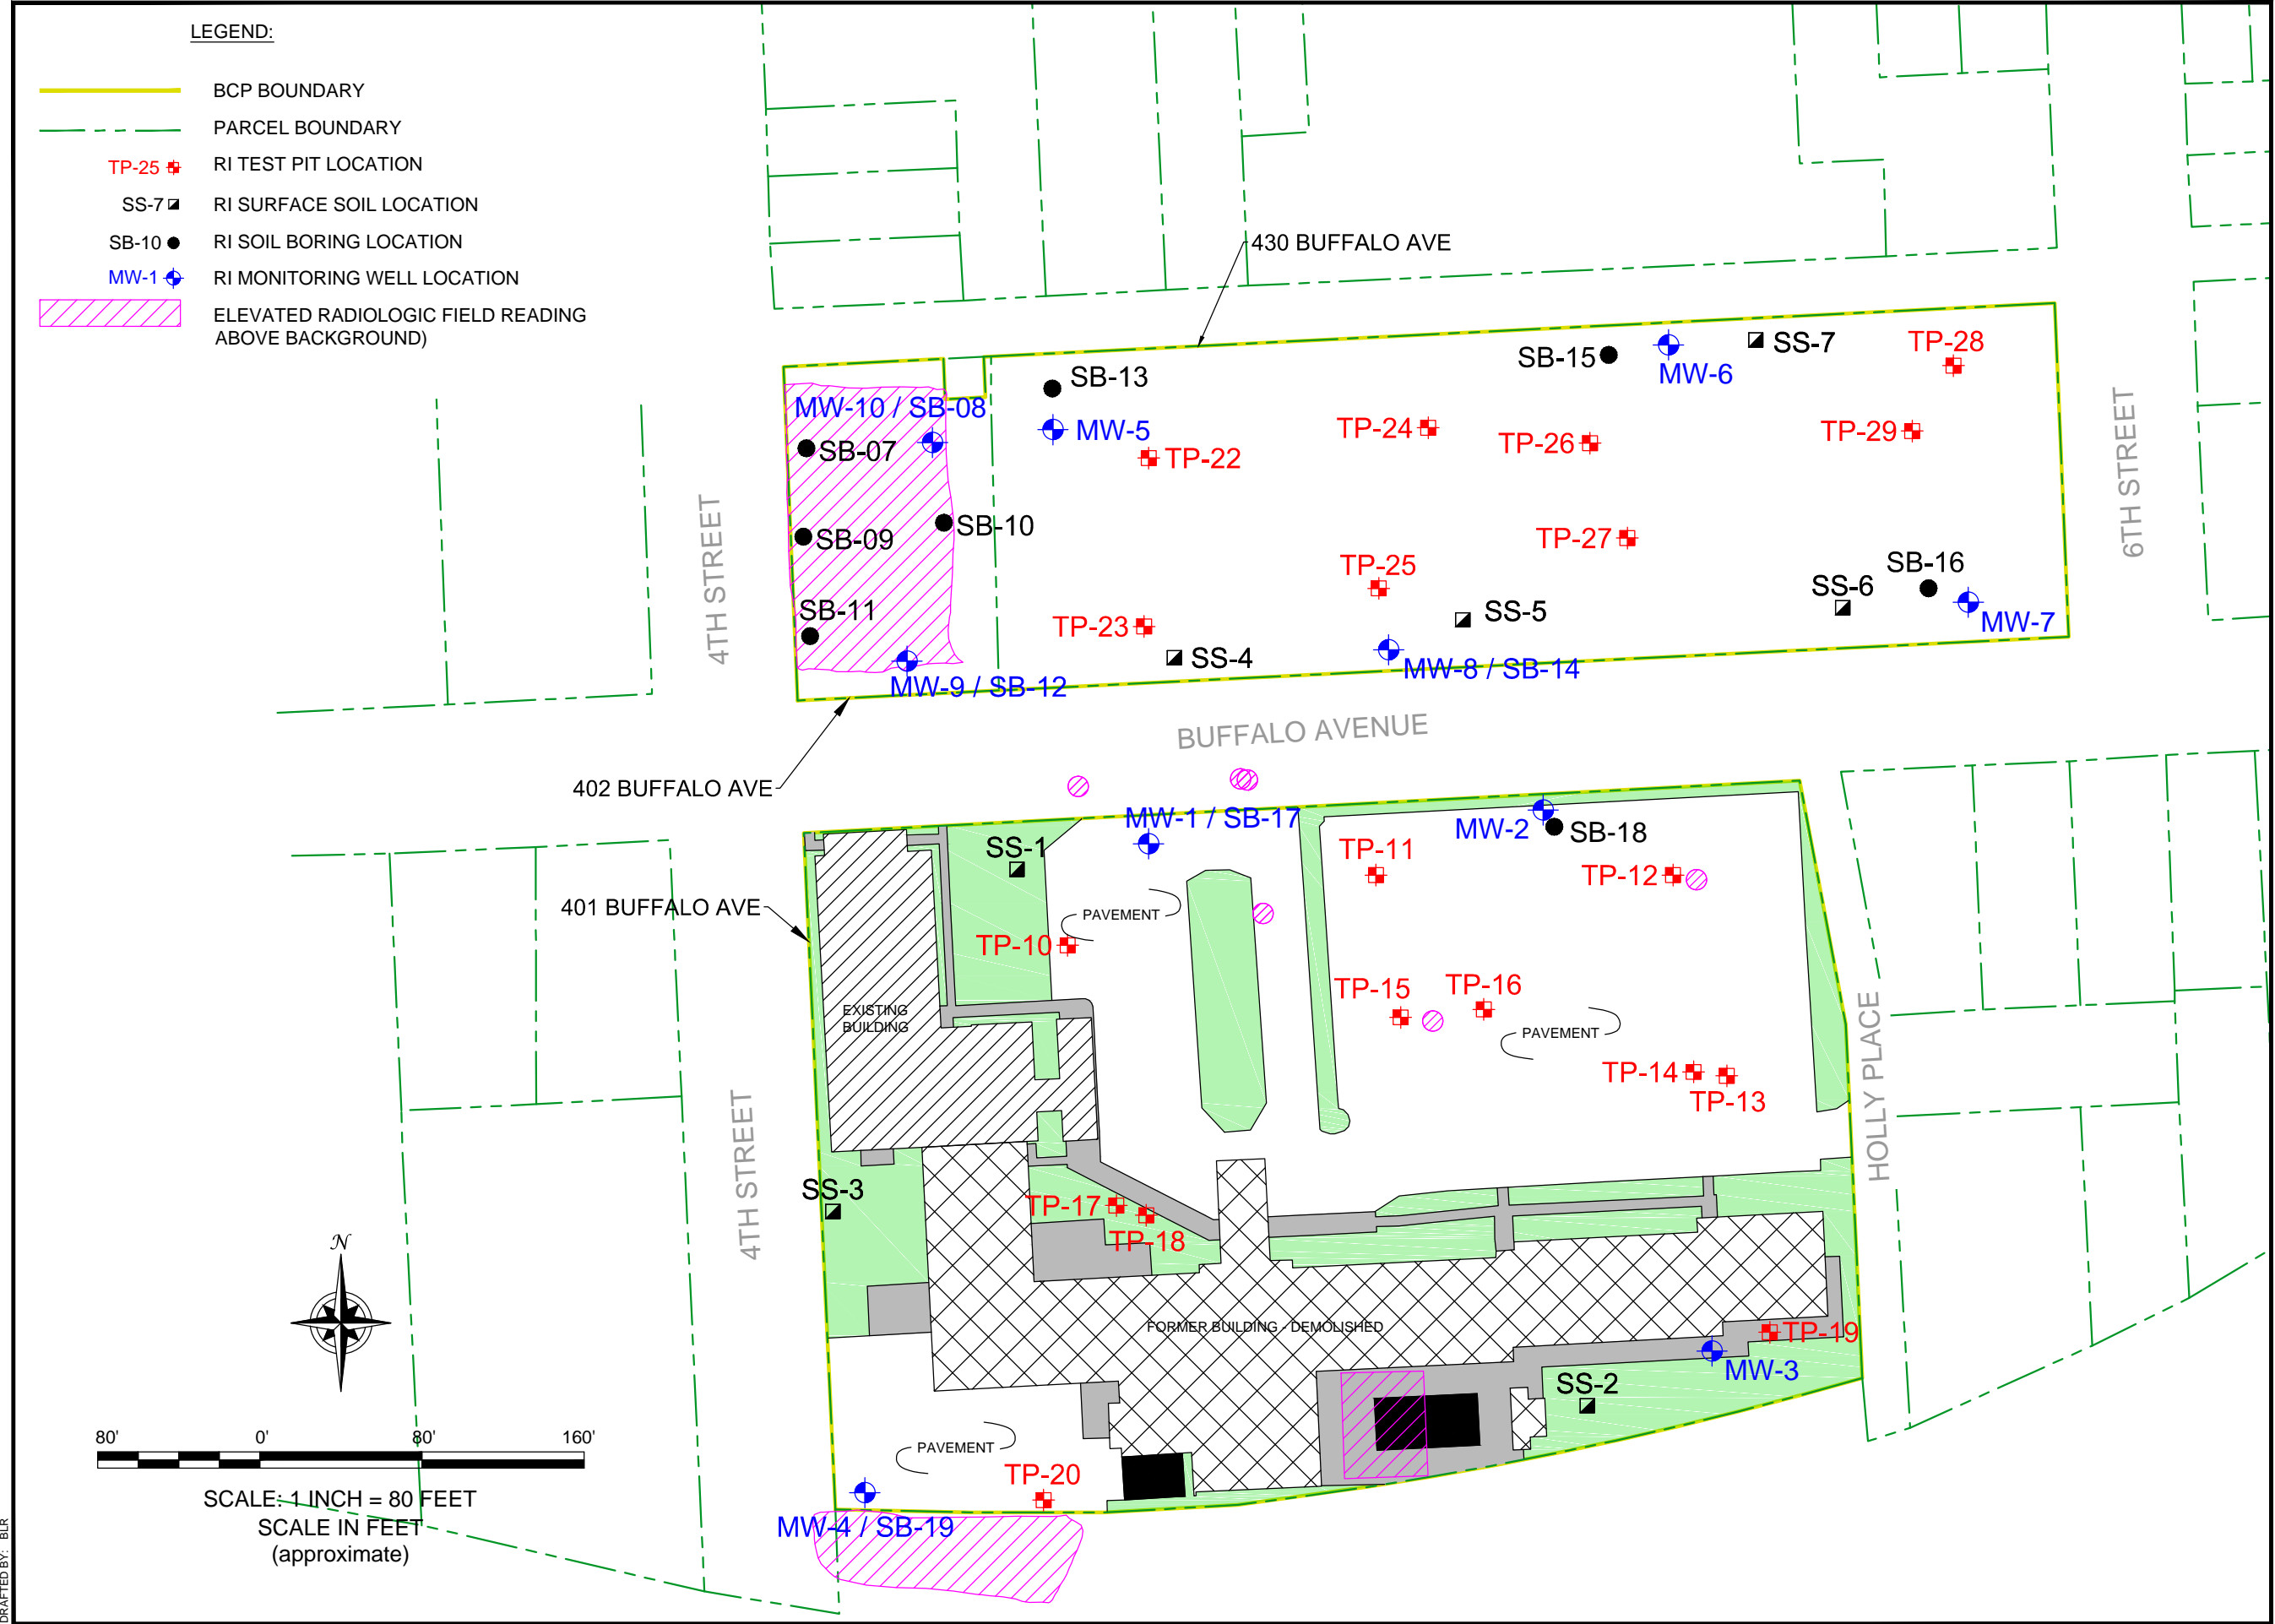
**RI RADIOLOGIC SURVEY RESULTS**

- 402 Buffalo Avenue – an area of approximately 0.25 acre was identified ranging from 20,000-45,000 cpm.
- 430 Buffalo Avenue – a single area in the vicinity of TP-29 (10,000-15,000 cpm). It should be noted that the elevated readings were related to a single slag-rock that was exposed during test pitting activities and GRD took position for future disposal. Post-screening results were 4,000-5,500 cpm.

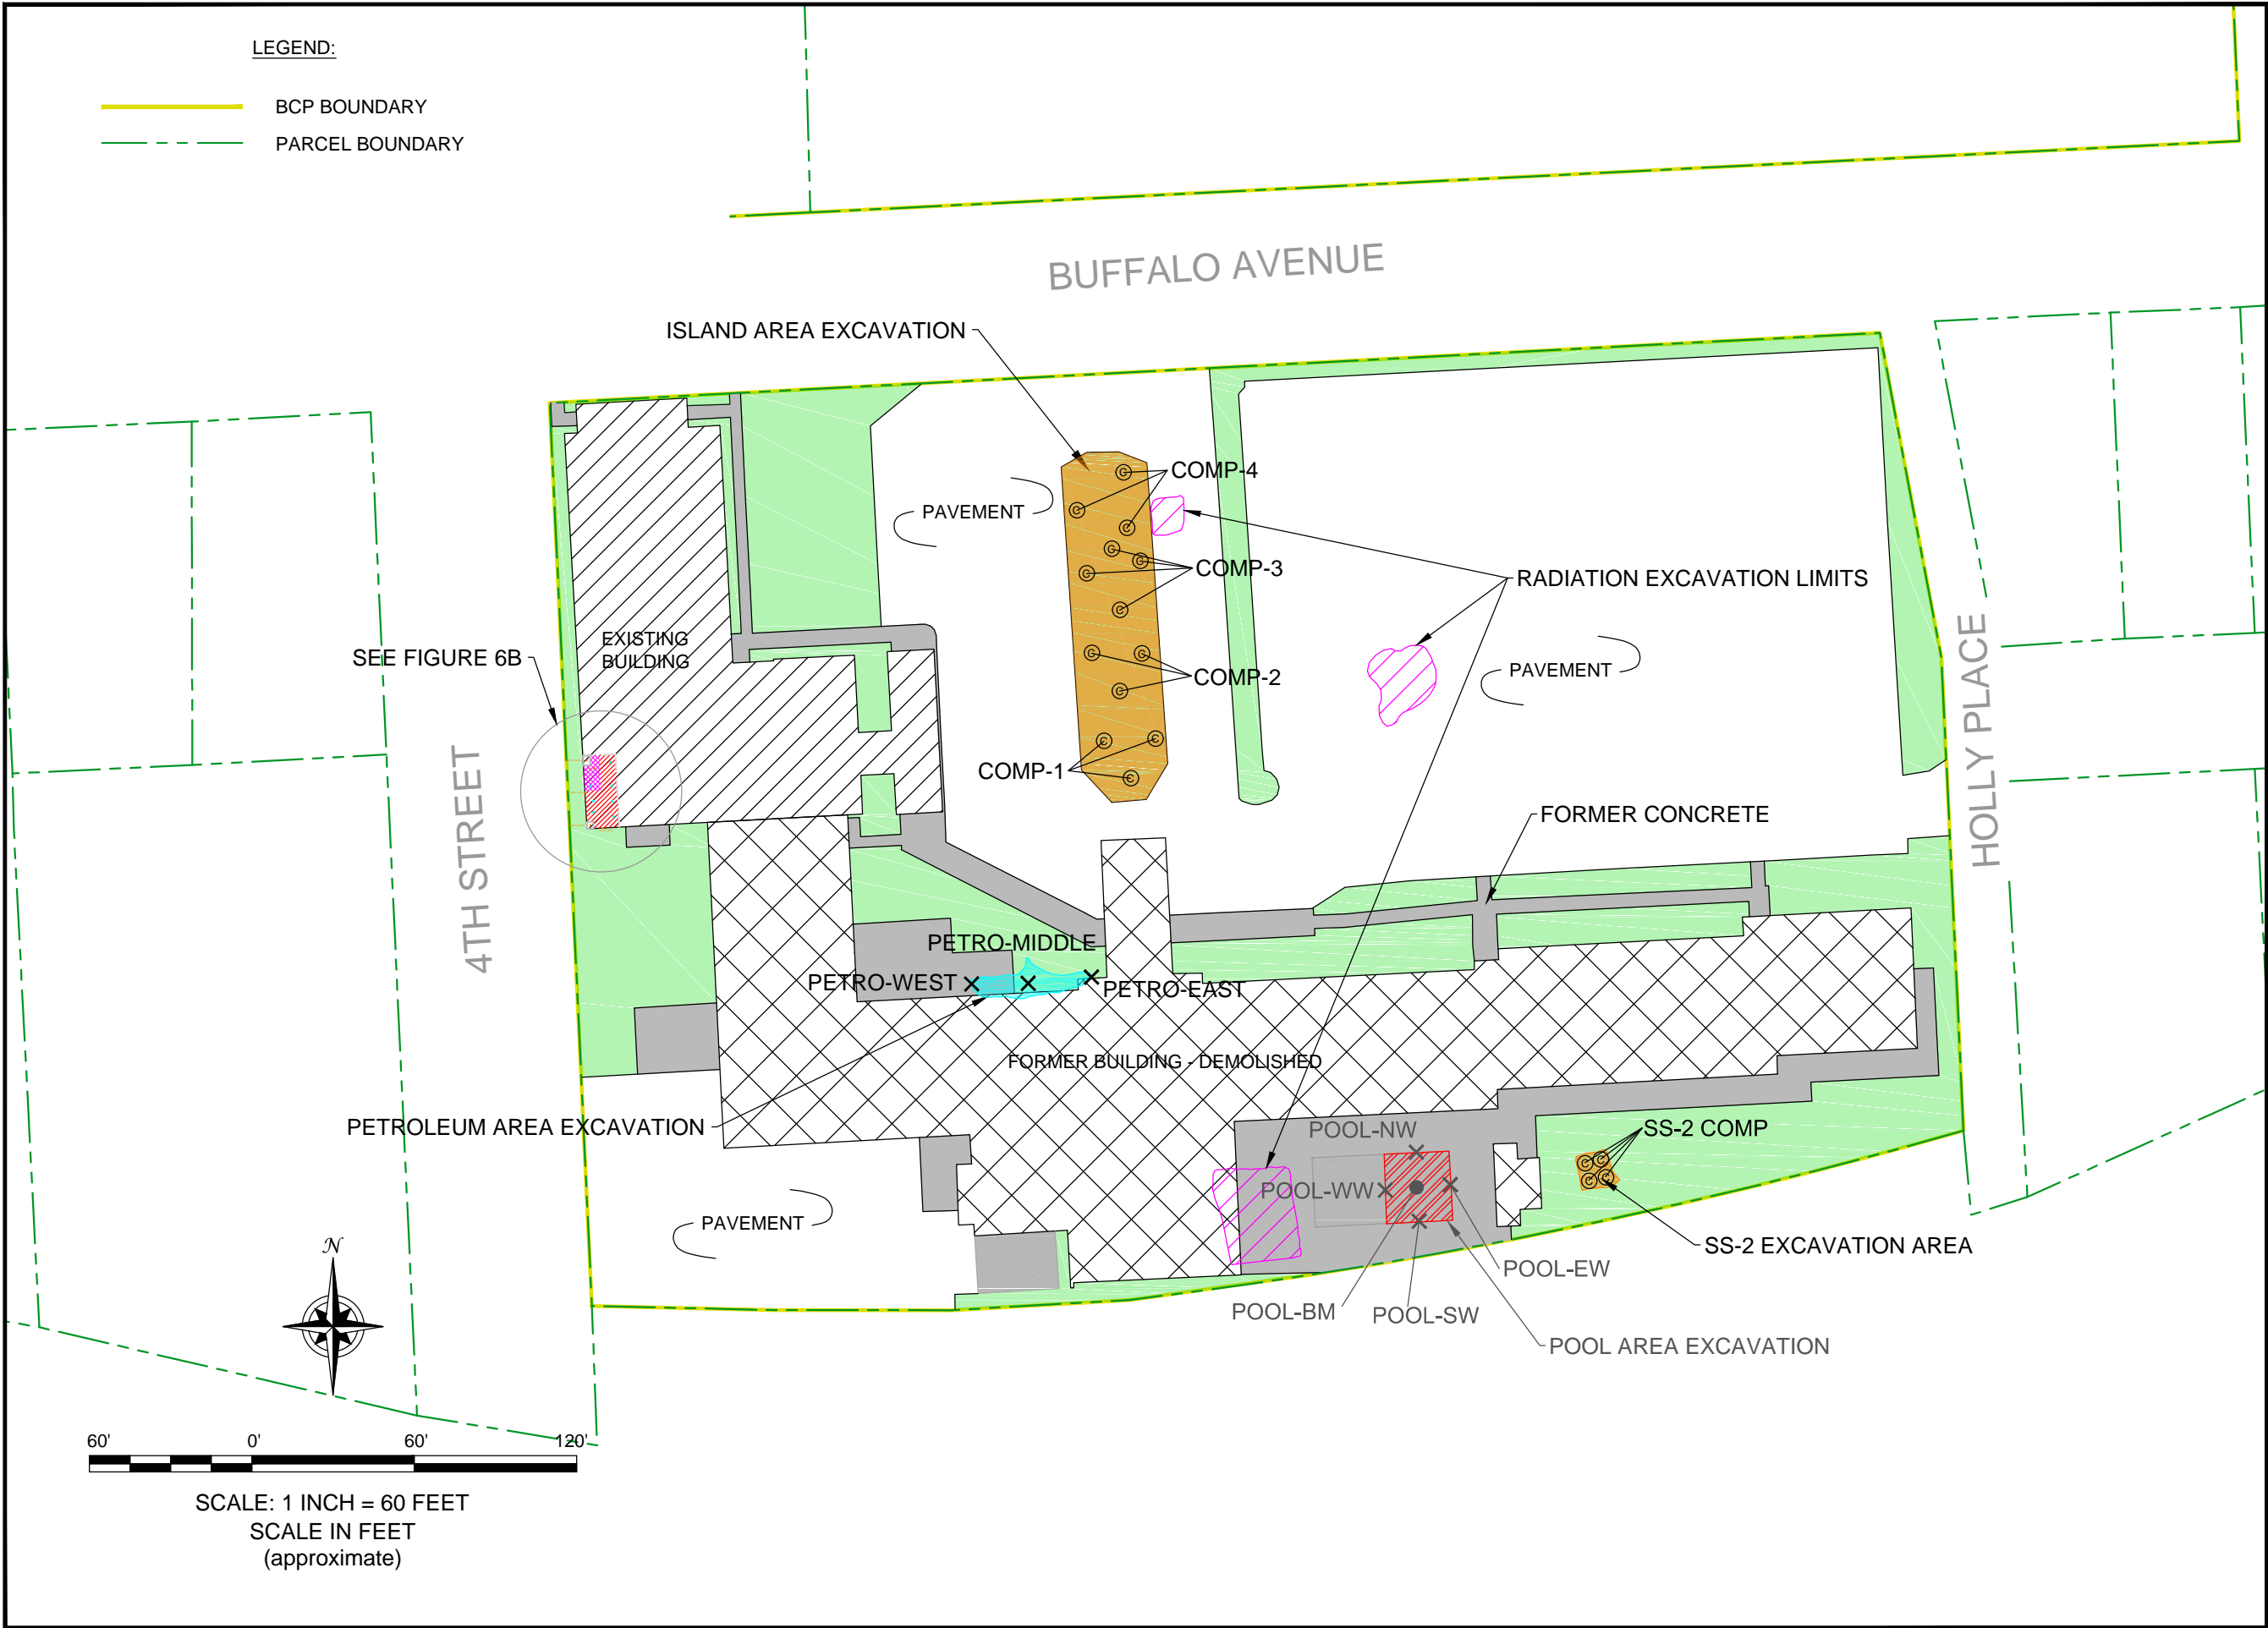
<b>401 BUFFALO AVENUE IRM ACTIVITIES</b>

Based on the RI and historic investigations, soil/fill located on the 401 Buffalo Ave parking lot island was contaminated with PAHs and metals exceeding RRSCOs (see Table 3). Approximately 500 tons of non-hazardous contaminated soil/fill was excavated and direct loaded into trucks for off-site transportation and disposal at Modern Landfill, located in Model City, New York (see Figure 6). Post-excavation samples were collected and all results are below USCOs (see Table 10).

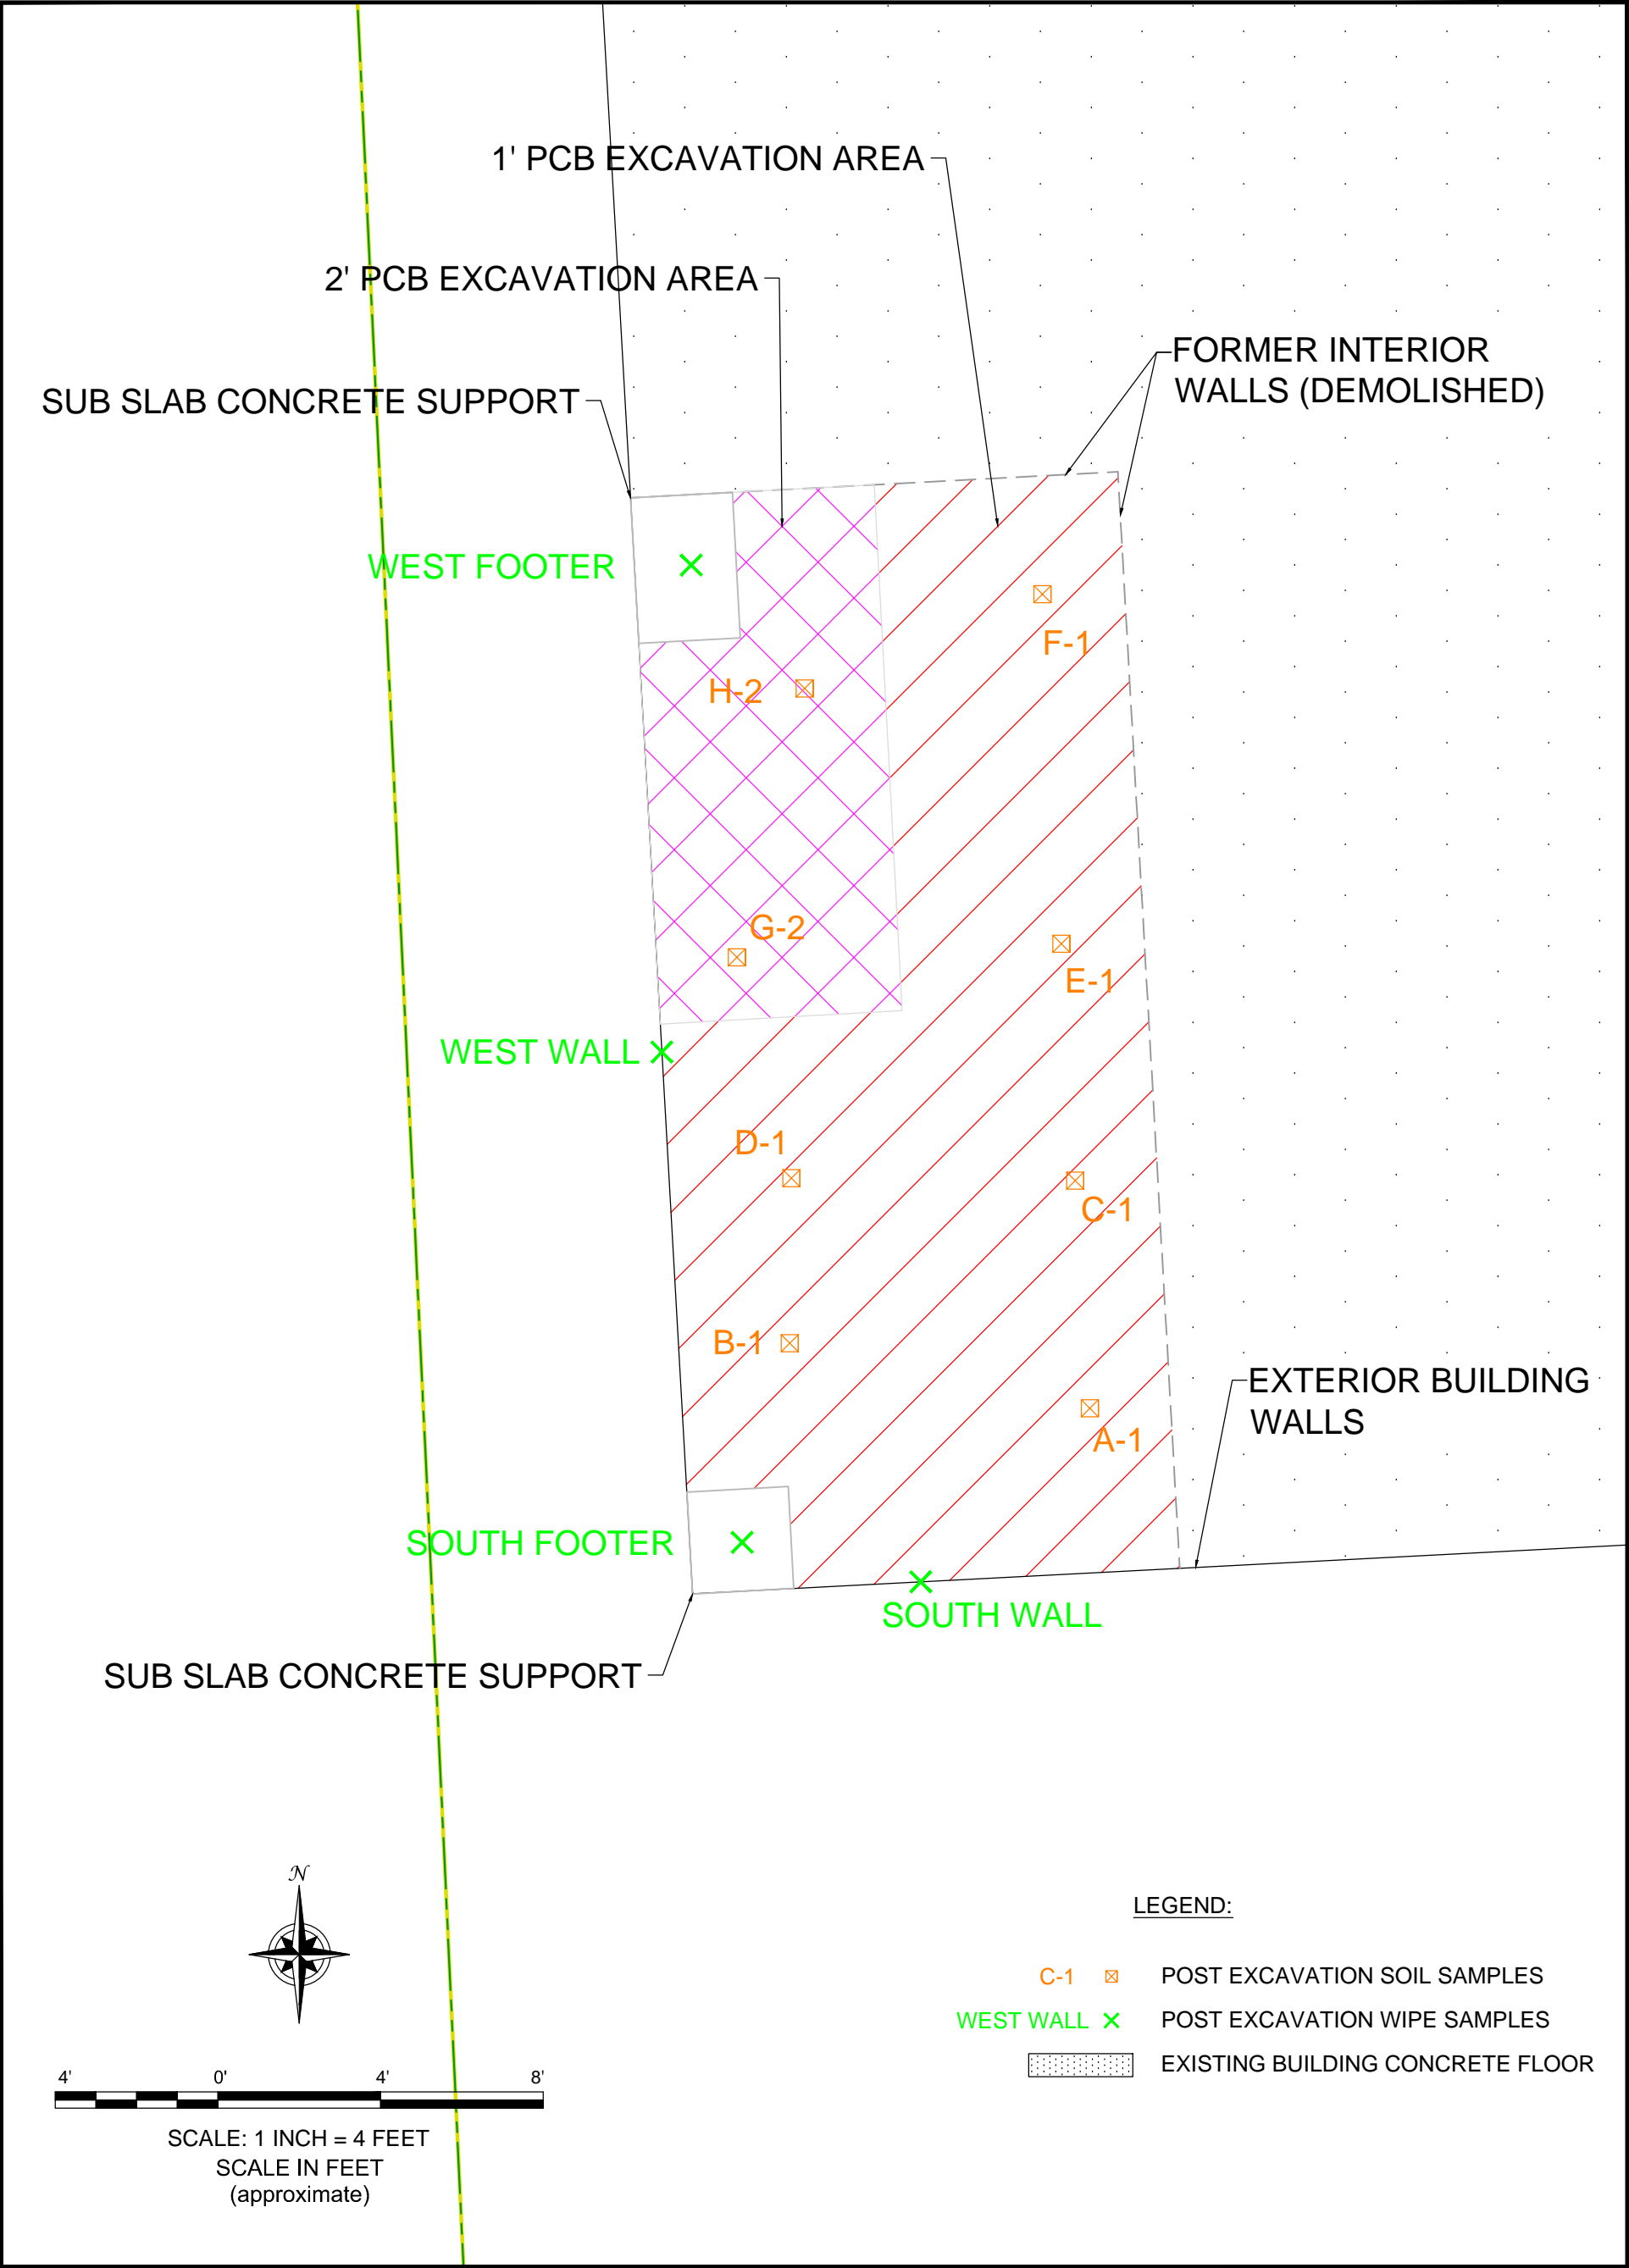
FIGURE 6B	<b>TRANSFORMER ROOM IRM ACTIVITIES</b>

It should be noted that after the discovery of the transformer vandalism the Department was notified and Spill No. 1312160 was opened for the Site. Benchmark-TurnKey personnel placed oil-absorbent pads and booms within the electrical room in an attempt to contain the spill. Given the condition of the building, including asbestos-containing material (ACM), the electrical room was closed, and signs were placed cautioning against entering the room.
