Final Engineering Report

402 & 430 Buffalo Avenue Site
BCP Site No. C932164
Niagara Falls, New York

Revised December 2015

Merani Hospitality, Inc.

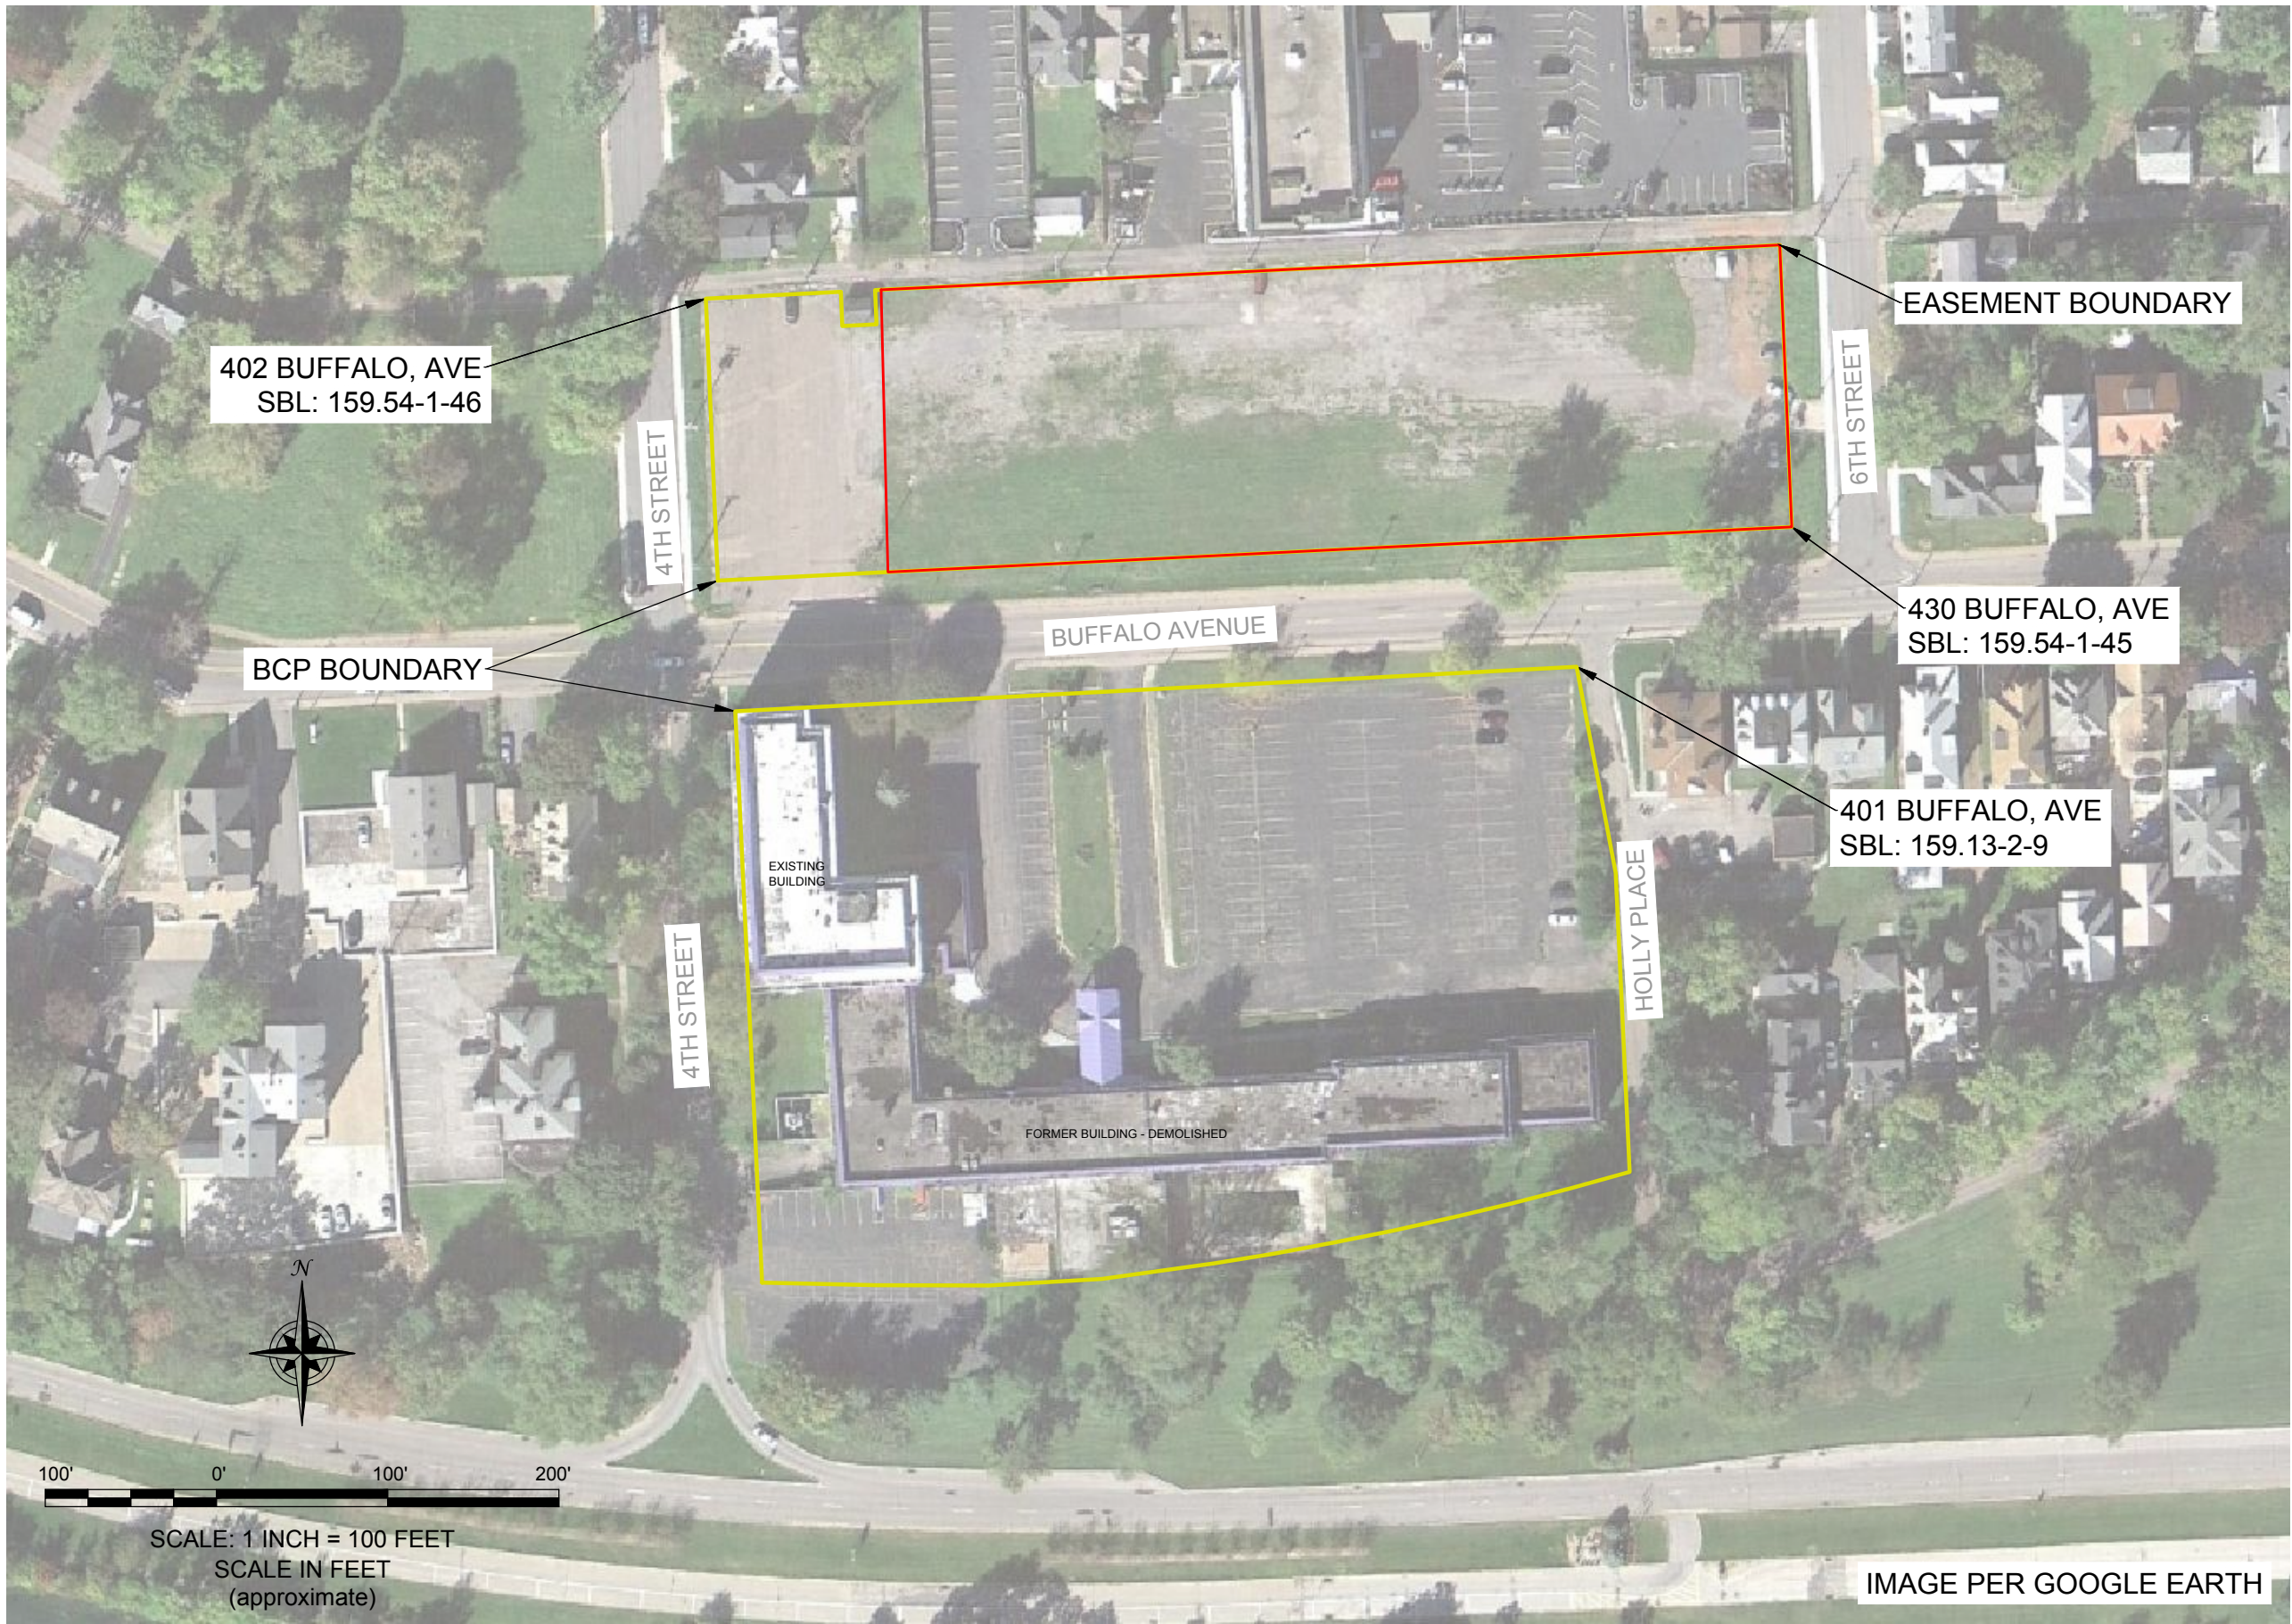
SITE PLAN (AERIAL)

The Site is surrounded by commercial and residential properties to the north, Robert Moses Parkway to the south with the Niagara River beyond, residential properties are located adjacent to the site to the east across Holly Place, and to the west across 4th Street (see Figure 2).

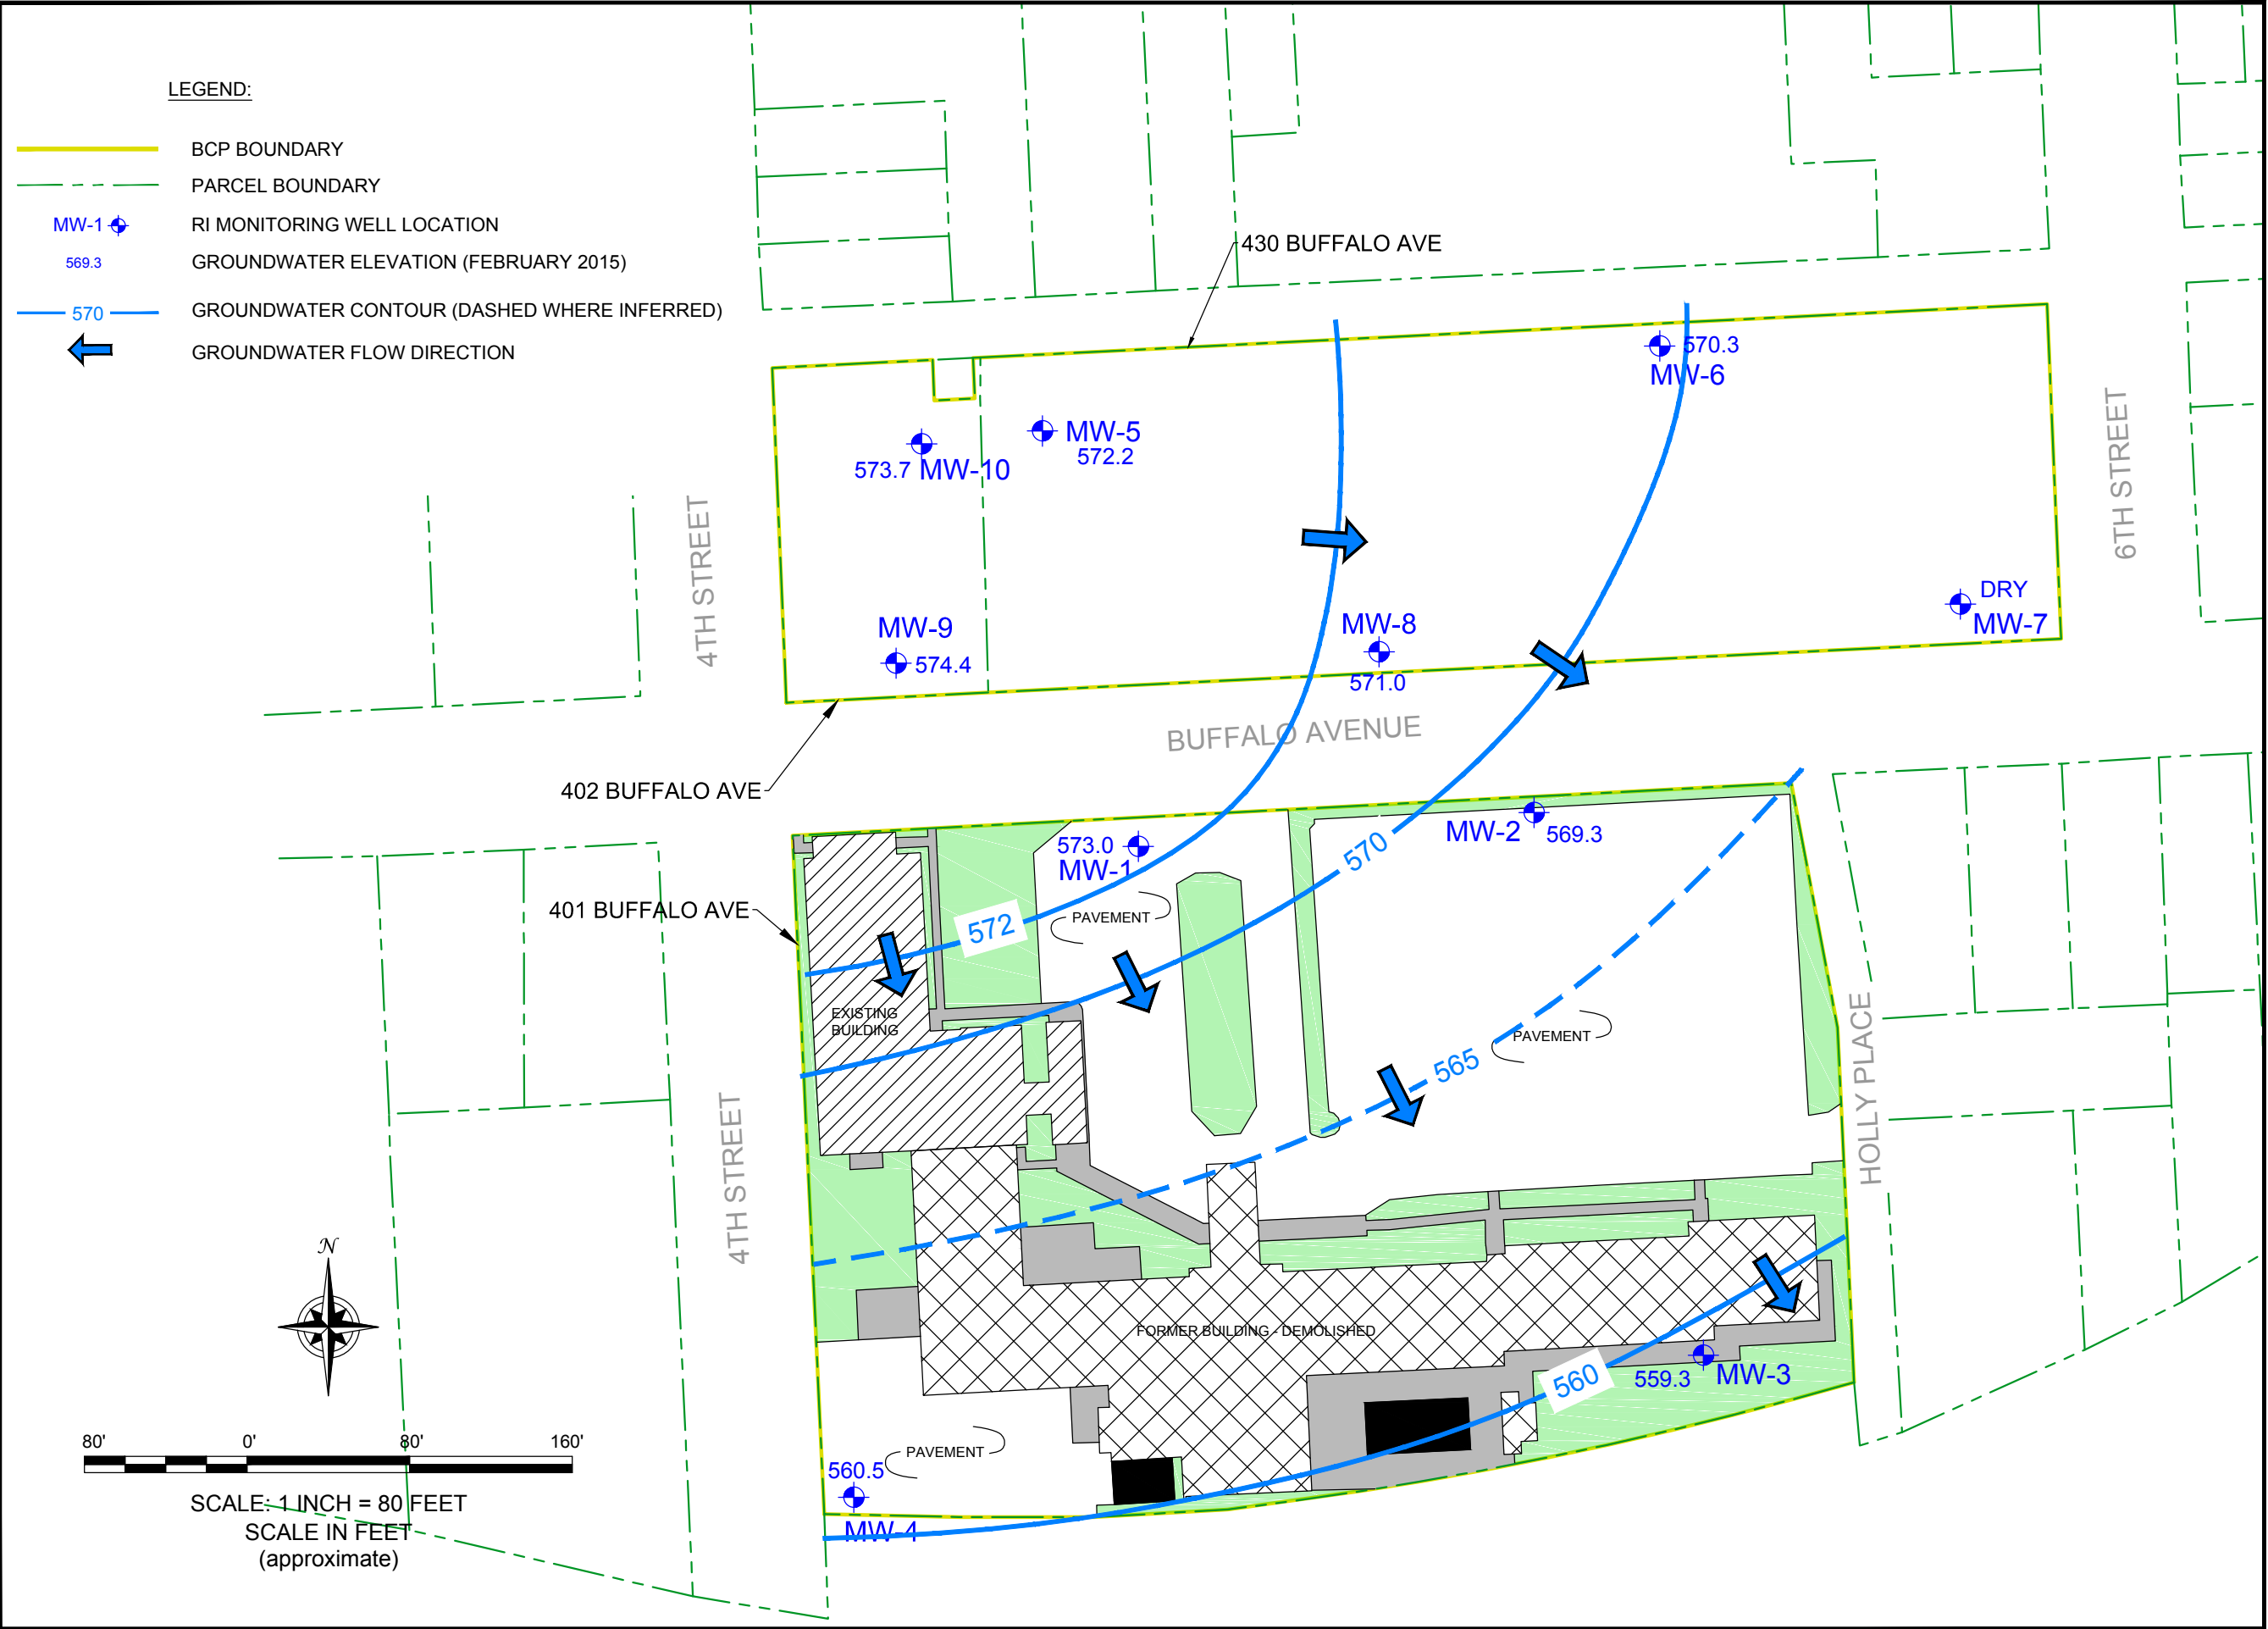
The Site is located approximately 500 feet north of the Niagara River, and less than 0.5-miles from Niagara Falls. Based on the findings of the RI, overburden groundwater was encountered at depths ranging from five (5) to greater than 11 fbgs, with the exception of MW-7 which was dry. The Site hydrogeology is complicated by the presence of municipal subgrade utilities surrounding the Site, particularly along Buffalo Avenue that intersects the Site, and the presence of the elevated Robert Moses Parkway to the south. In general, localized groundwater flow was estimated to flow in a southern direction toward the Niagara River. Figure 3 depicts the estimated overburden groundwater isopotential map based on the water level measurements collected in April 2015.

A total of ten (10) groundwater monitoring wells were installed across the BCP Site (Figure 3).

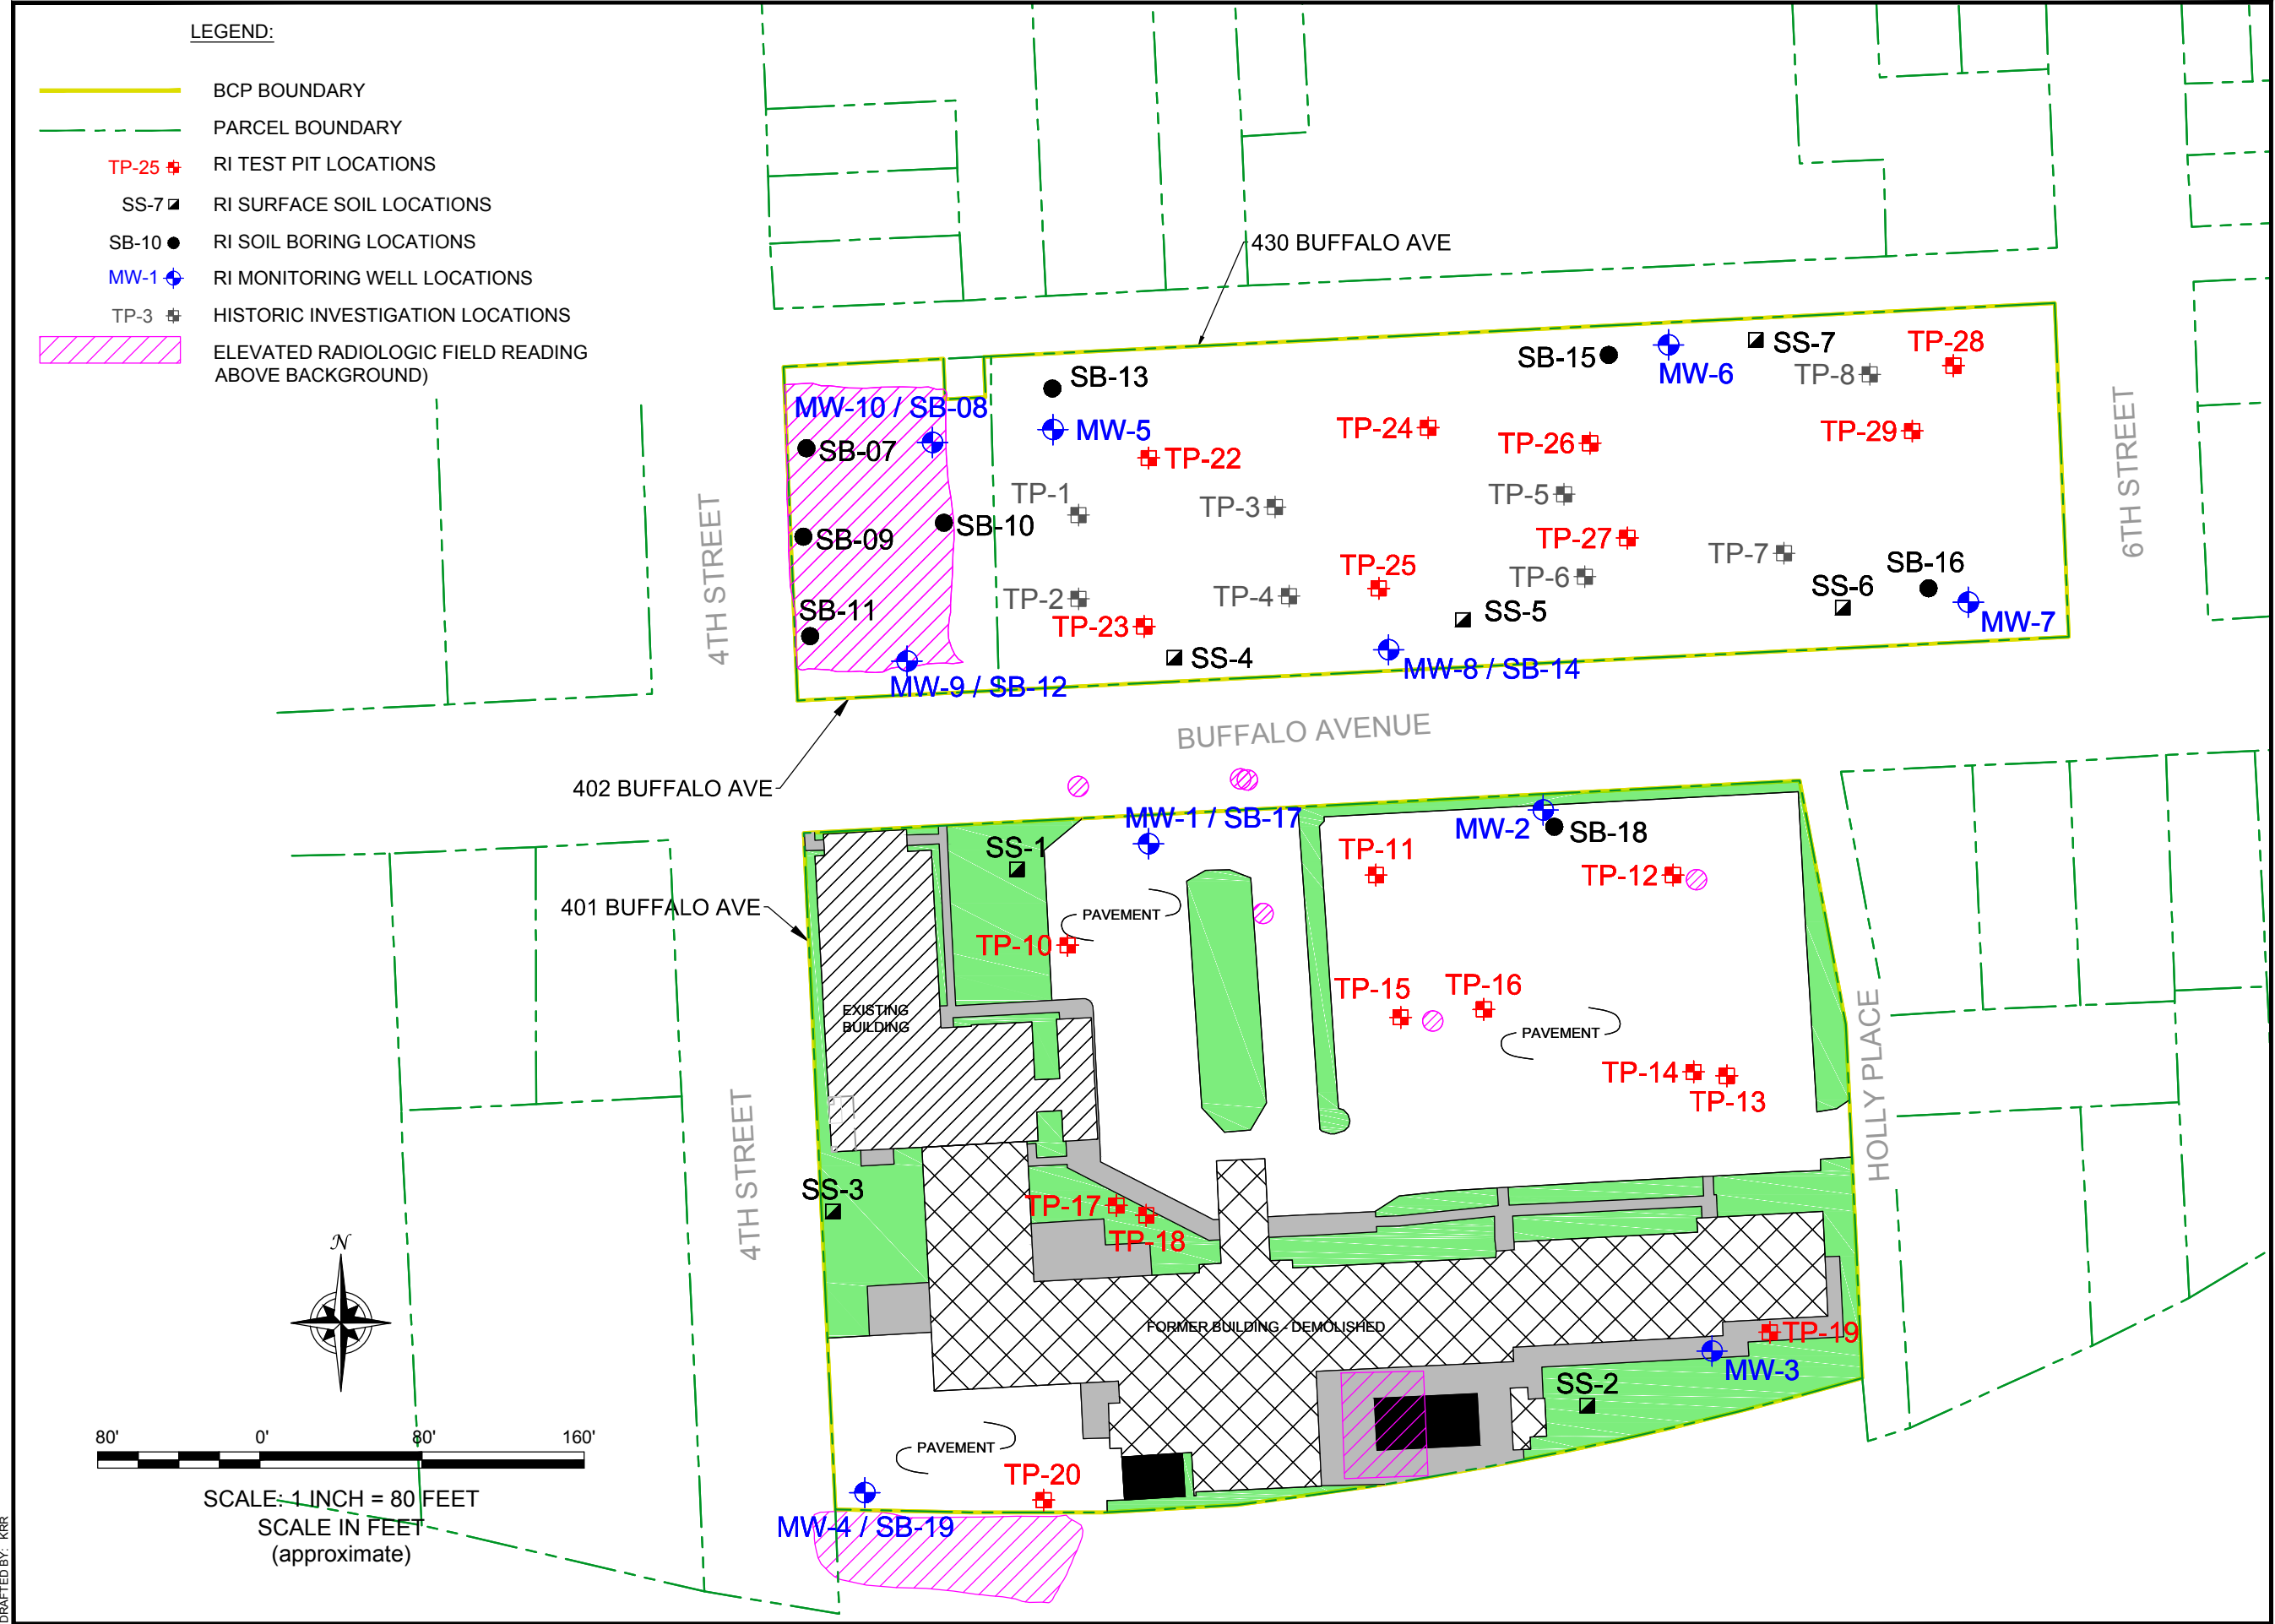
REMEDIAL INVESTIGATION SAMPLE LOCATIONS

An area beneath the asphalt lot on 402 Buffalo Avenue was identified to have elevated readings ranging from 20,000 to 45,000 cpm. Several locations were identified on the 401 Buffalo Avenue parcel to be slightly above background, ranging from 10,000-20,000 cpm, in addition to the previously identified pool area (see Figure 4).

A total of seven (7) surface soil samples, and 32 subsurface soil samples were advanced across the Site (see Figure 4).

- Based on the surface soil data, no SVOCs, PCBs, pesticides or herbicides were detected above Restricted-Residential SCOs (RRSCOs), with the vast majority being reported as non-detect or estimated values by the laboratory. RI results identified only arsenic, slightly above its RRSCO at SS-2.
- Based on the subsurface soil data, no VOCs, PCBs, pesticides or herbicides were detected above Unrestricted Use SCOs (USCOs). Certain PAHs and metals were detected above their respective RRSCOs. Lead was detected above its Industrial Use SCO in TP-3, located on the 430 Buffalo Avenue parcel.
