Interim Remedial Measure Work Plan for the Stormwater Drainage System

Saint-Gobain Performance Plastics Site
1 Liberty Street
Village of Hoosick Falls
Rensselaer County, New York
NYSDEC Site # 442048

SAINT-GOBAIN PERFORMANCE PLASTICS, CORP.
14 McCaffrey Street
Hoosick Falls, New York 12090

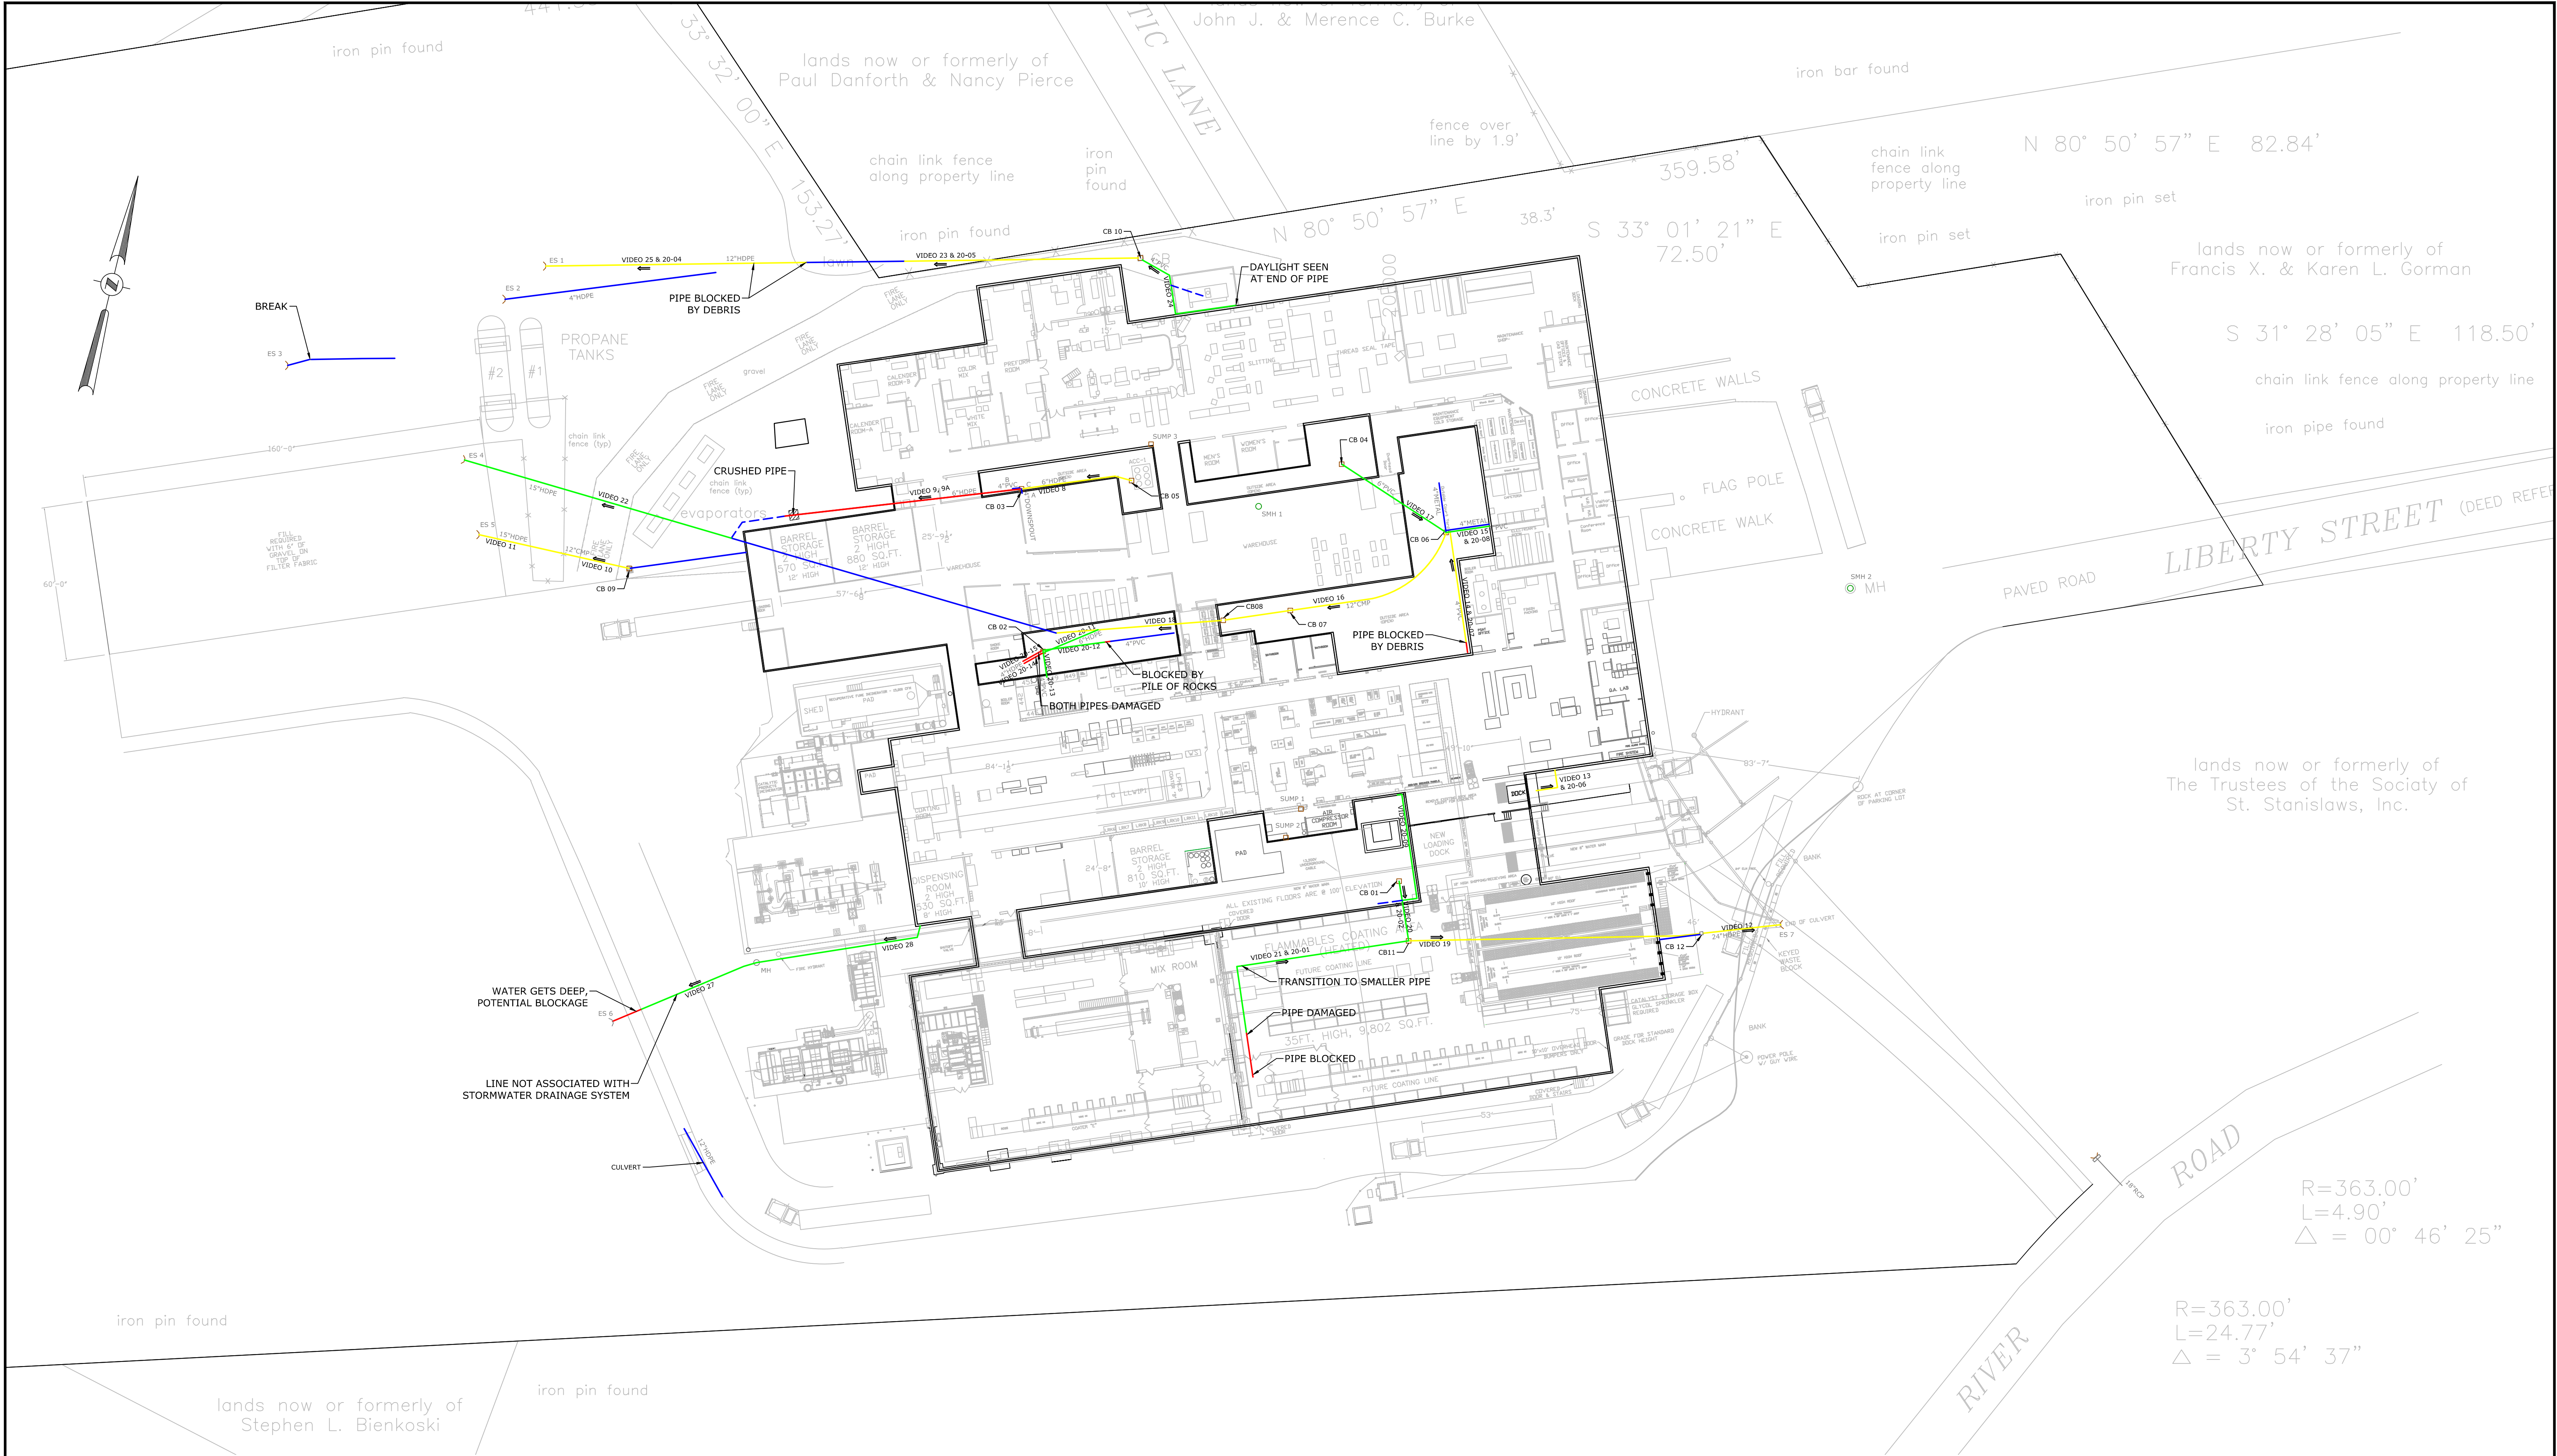
Of the 43 video inspections completed in 2017 and 2020, 27 of the pipes had at least some debris or are of unknown condition. Of those 27 pipes, 12 were either blocked or covered by debris within the pipe and/or the pipe was crushed, limiting the evaluation of the pipe condition without cleaning. Segments of the stormwater drainage system that have not been inspected are identified on Figure 6. The amount of debris was characterized in

Pipe and catch basin conditions as they were recorded during the remedial investigation are shown on Figure 6. Sections of pipe and features where it is already known that the pipe is crushed, collapsed, or otherwise needs repair are identified.

The assessment for damage to the stormwater drainage system will be completed concurrent with cleaning activities. Pipe blockages are present within the building drainage system as shown on Figure 6. It is unknown whether the blockages are a result of solids accumulation or damaged infrastructure.

The building drainage system will be cleaned to the extent feasible. The details of each pipe condition and proposed cleaning are provided in Table 4 and Figure 6. In areas where only a section of a pipe needs to be cleaned, the entire length of the pipe may be cleaned and recorded. A pre-cleaning video inspection will be completed to assess the current condition of the pipe. The pipe will then be cleaned using an industry standard jetting tool to remove accumulation of solids and debris in and on the pipe. Sections of piping not yet evaluated, including those presented in Table 4 where piping is collapsed, disconnected, and possibly cut off from the remaining system, will be discussed and reviewed with the contractor in advance. These sections will be cleaned and treated with caution given the uncertainties regarding their condition. A post-cleaning video inspection will be completed to assess the cleaning efforts. The process by which the piping systems are cleaned will be at the contractor's discretion but will be held to the performance standard as described in Section 3.0.

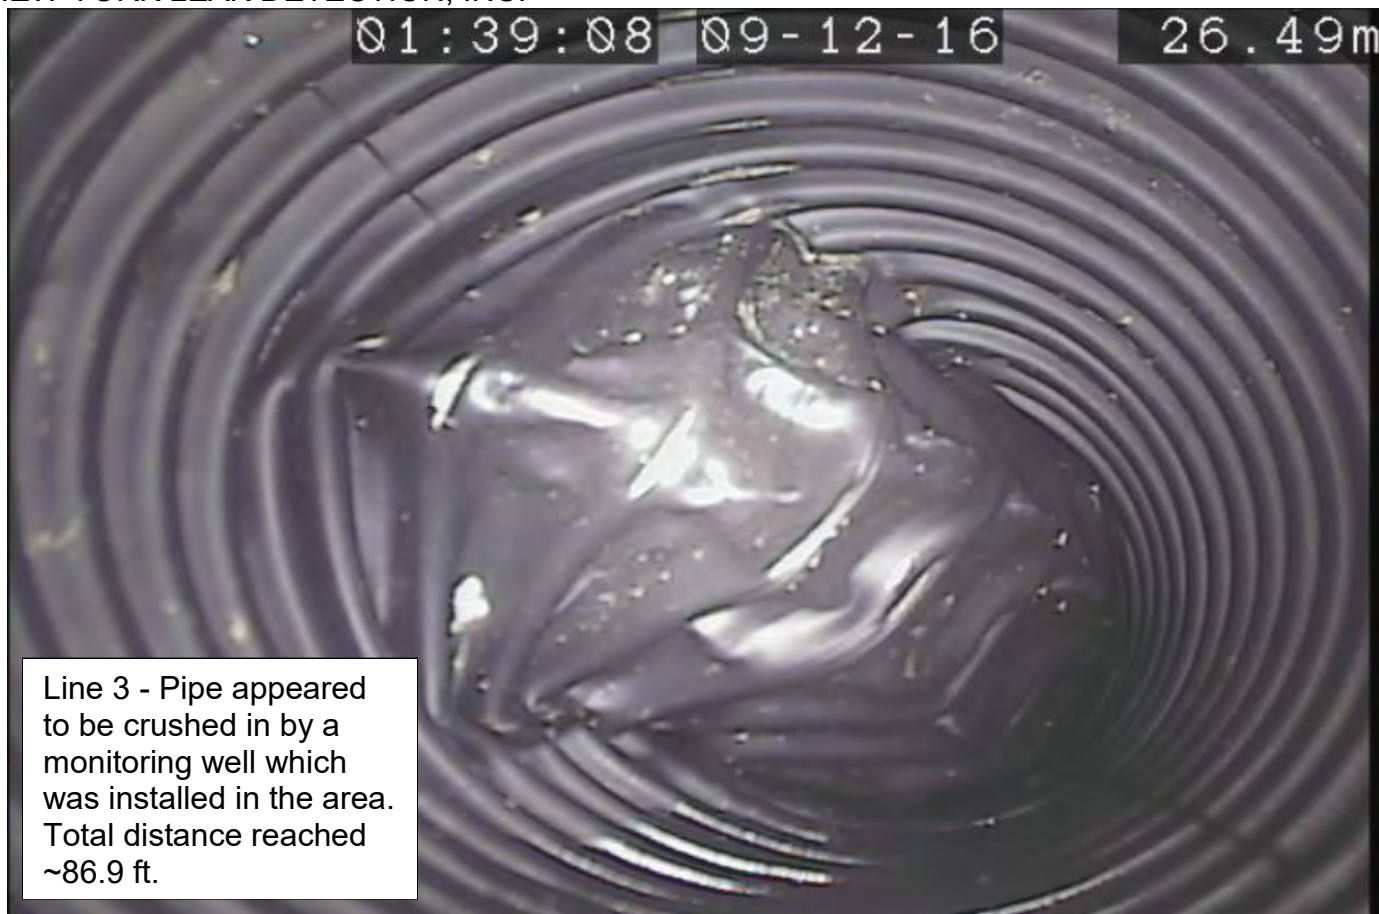
Line 3 - Pipe appeared to be crushed in by a monitoring well which was installed in the area. Total distance reached ~86.9 ft.

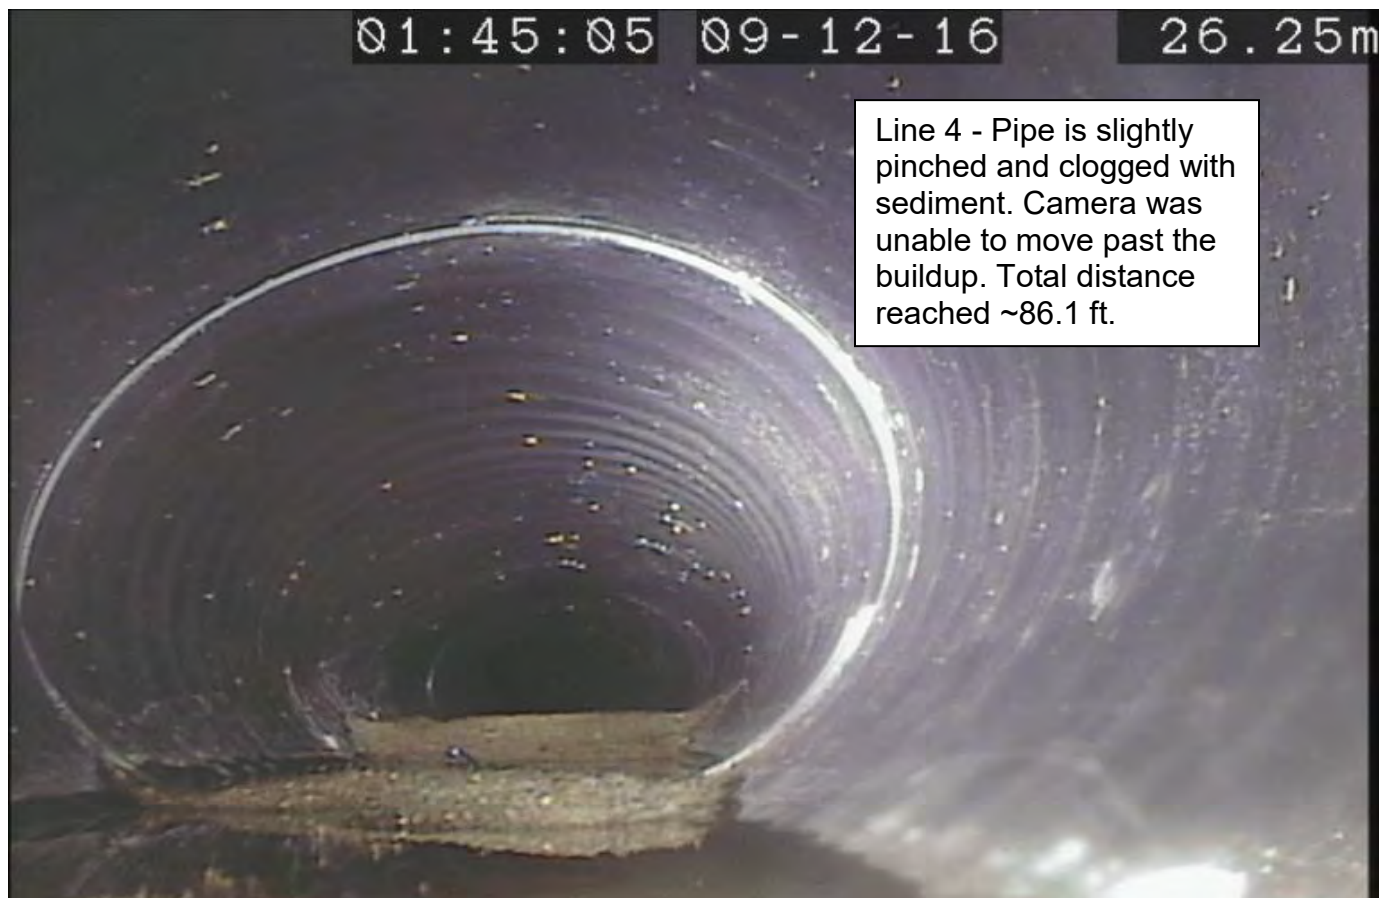
Line 4 - Pipe is slightly pinched and clogged with sediment. Camera was unable to move past the buildup. Total distance reached ~86.1 ft.

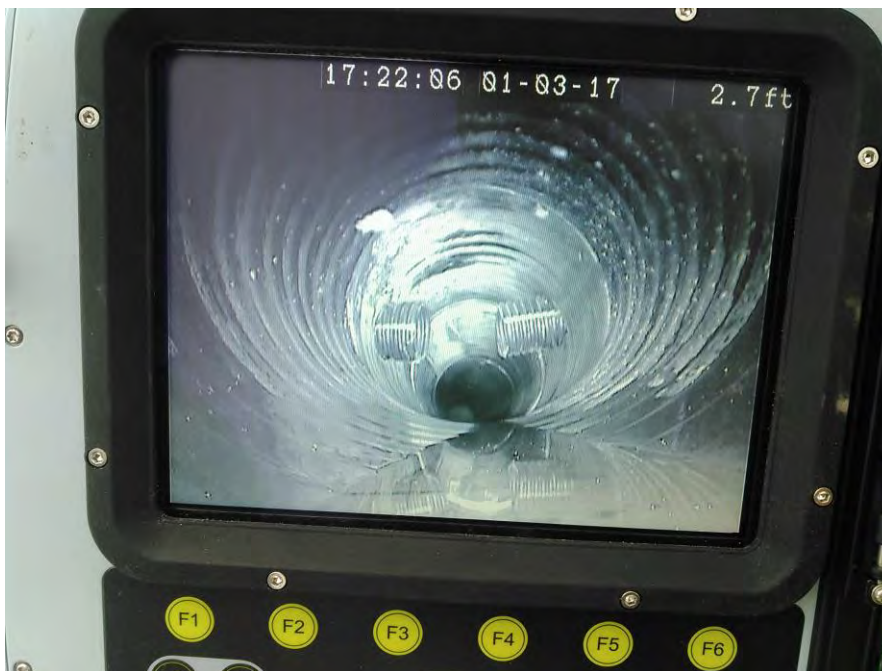
Picture of the 18 inch HDPE drain pipe from the courtyard into the building.

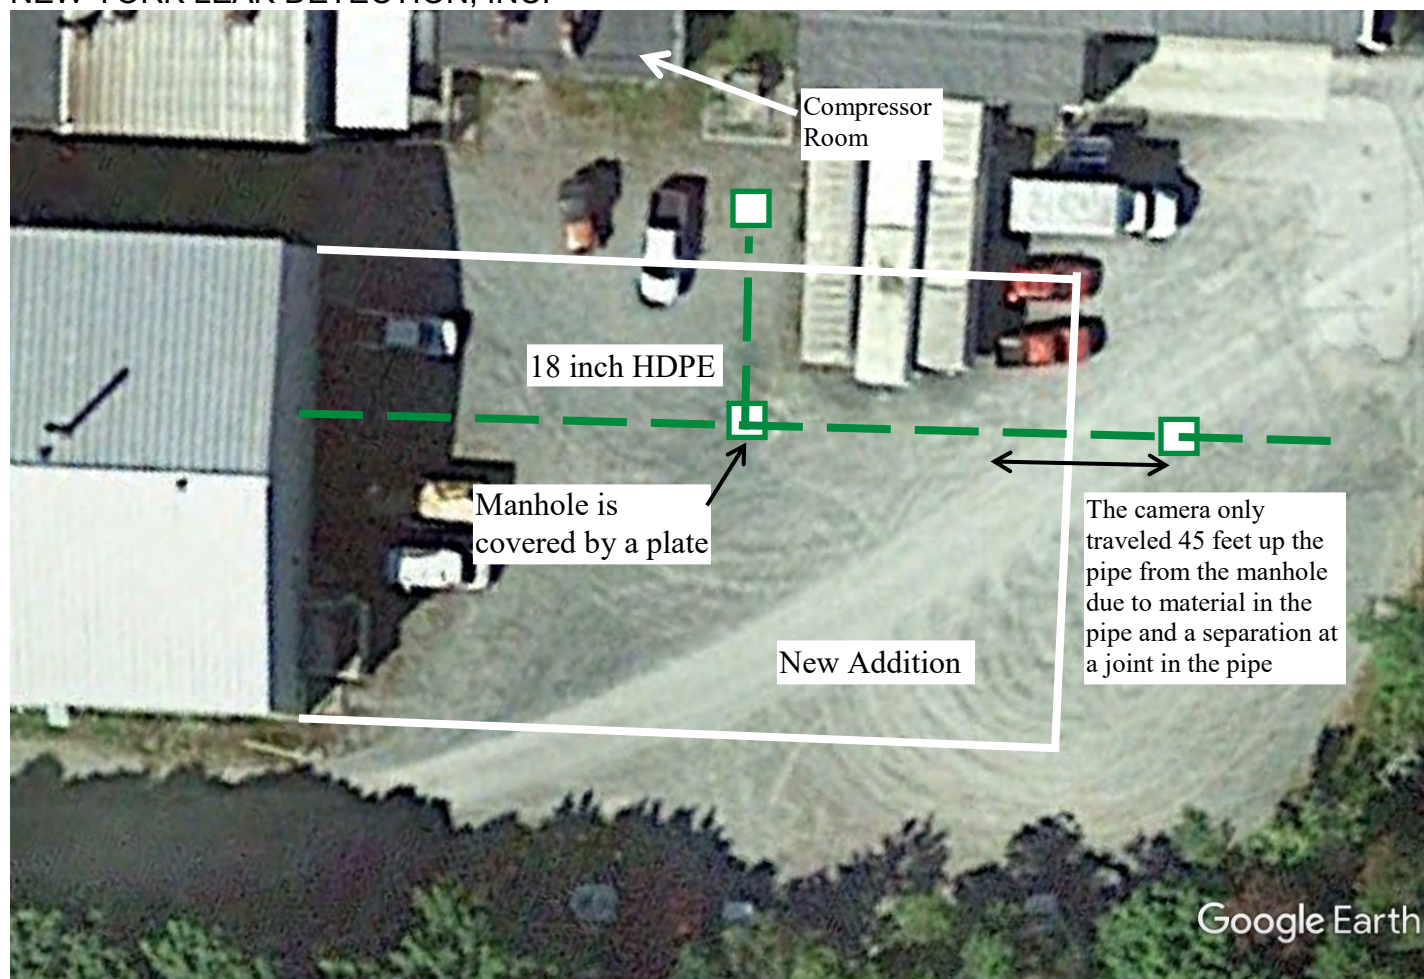
Picture of the 18 inch HDPE drain pipe from the courtyard into the building. Foundation drain pipes are shown entering the pipe.

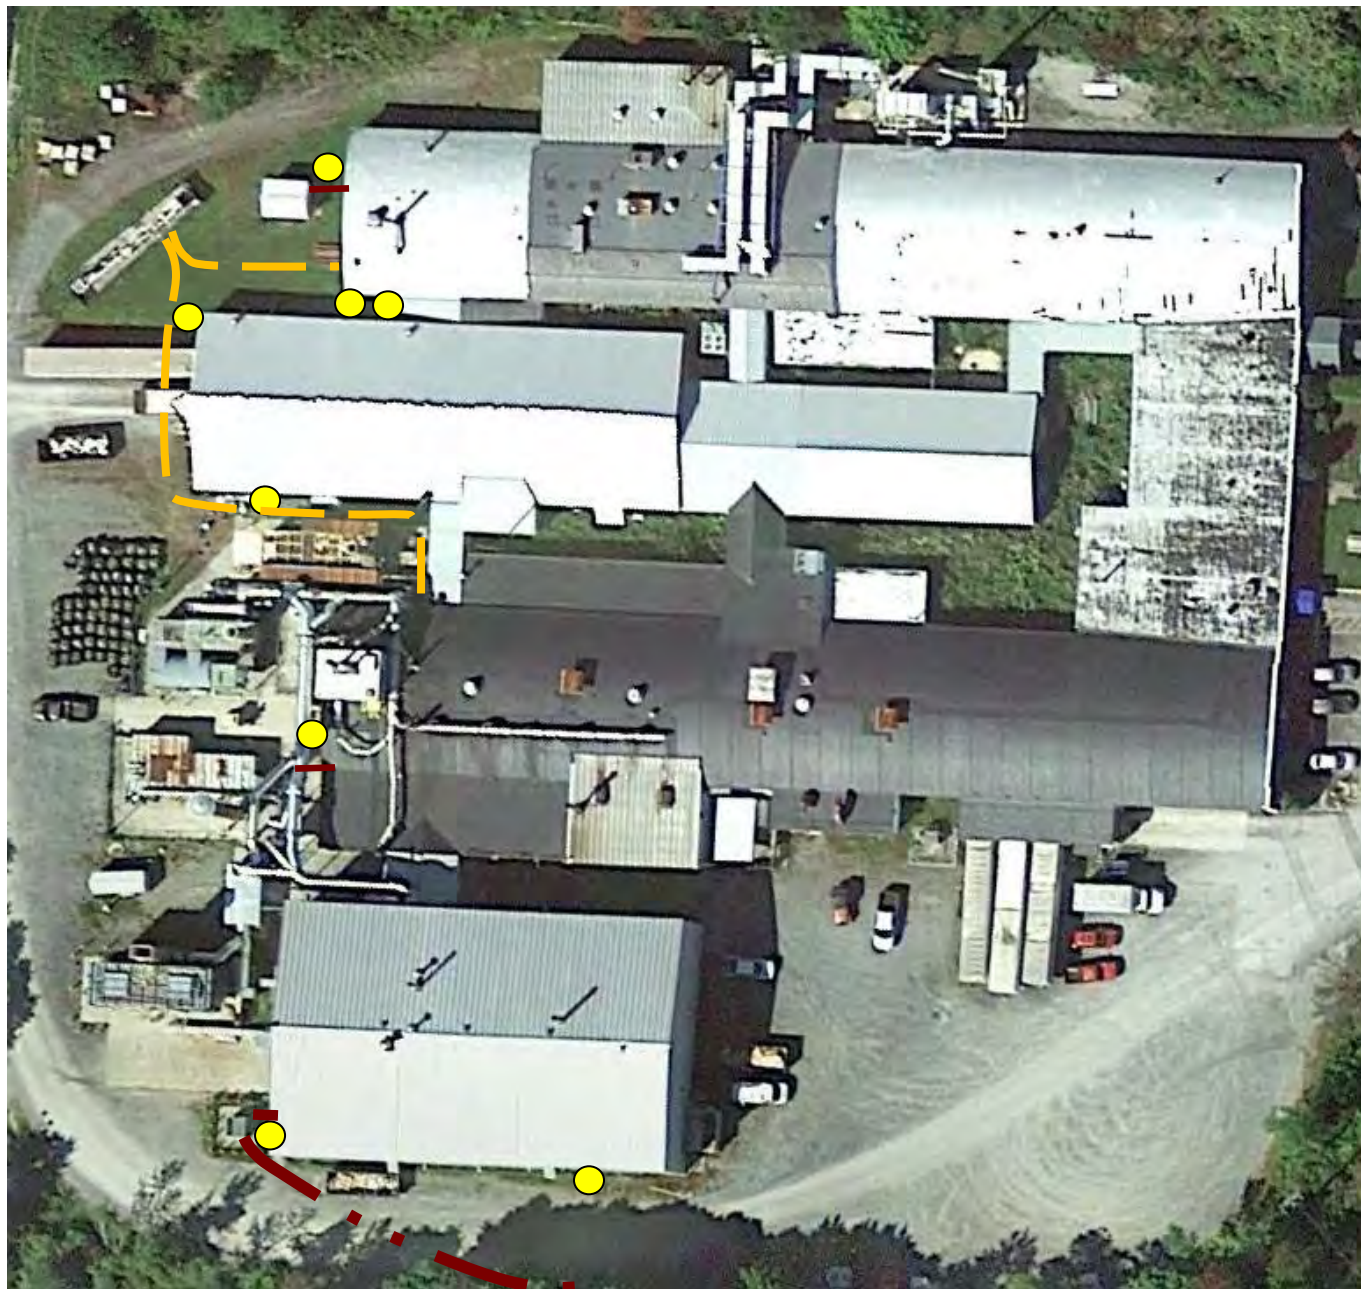
1. The drain pipe in the compressor room appears to be full of the material used to absorb oil.
2. This material in the pipe is saturated with oil.
3. A shop vac using a 1 ½ inch hose might be able to clean the pipe of the material.
4. The GPR imagery for the pipe in the compressor room indicated that it is only in the compressor room and doesn't continue into the manufacturing area.

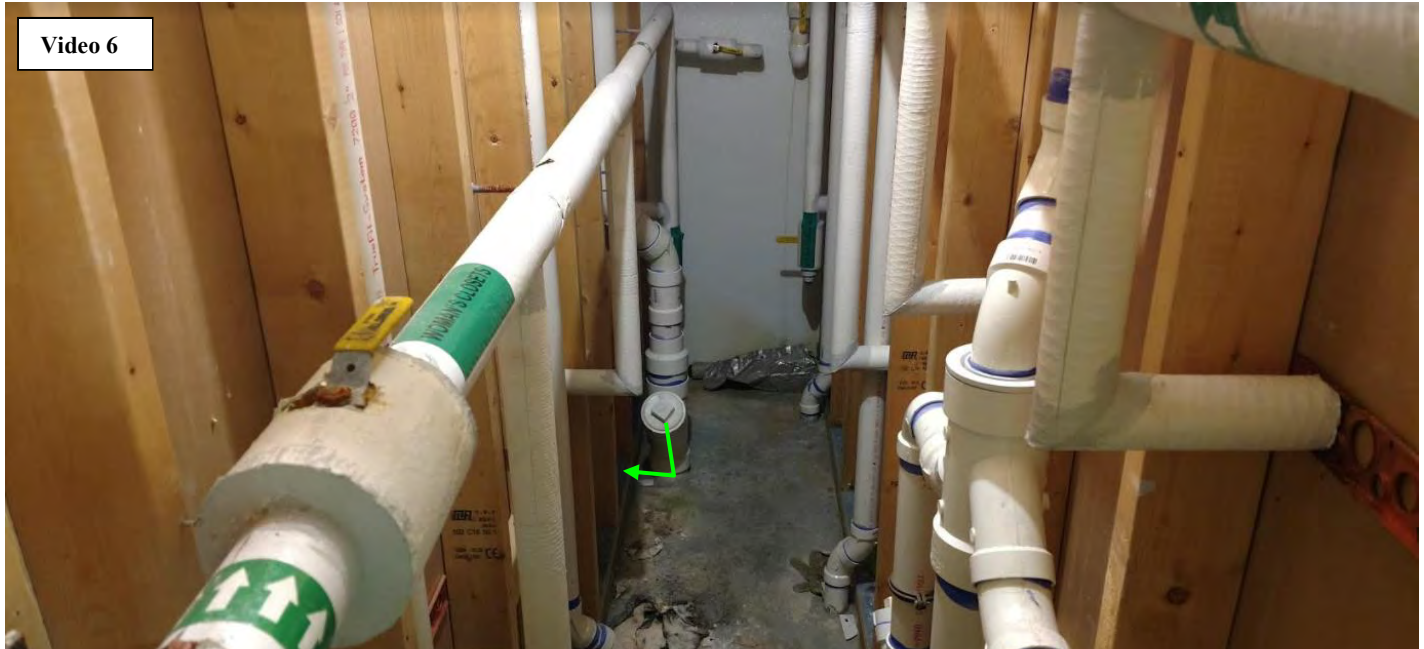
Video 6

Video 6- Sanitary : Was able to record partial run from CO (Pipe 4" – Video Inspection 13 feet long). Pipe runs horizontal and then drops into a vertical before 90's into horizontal. All the bends restricted distance camera could be pushed

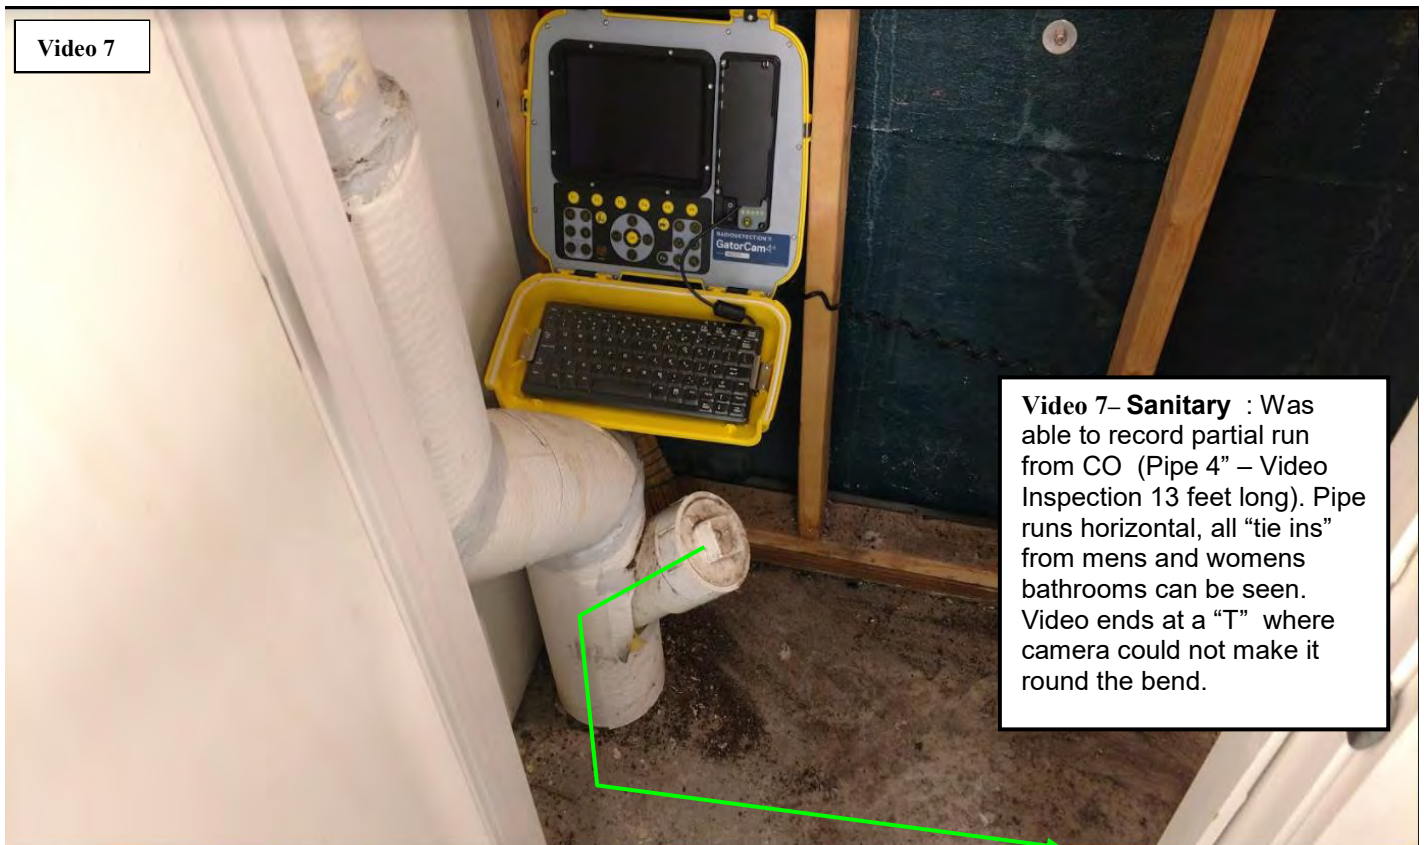
Video 7

Video 7- Sanitary : Was able to record partial run from CO (Pipe 4" – Video Inspection 13 feet long). Pipe runs horizontal, all "tie ins" from mens and womens bathrooms can be seen. Video ends at a "T" where camera could not make it round the bend.

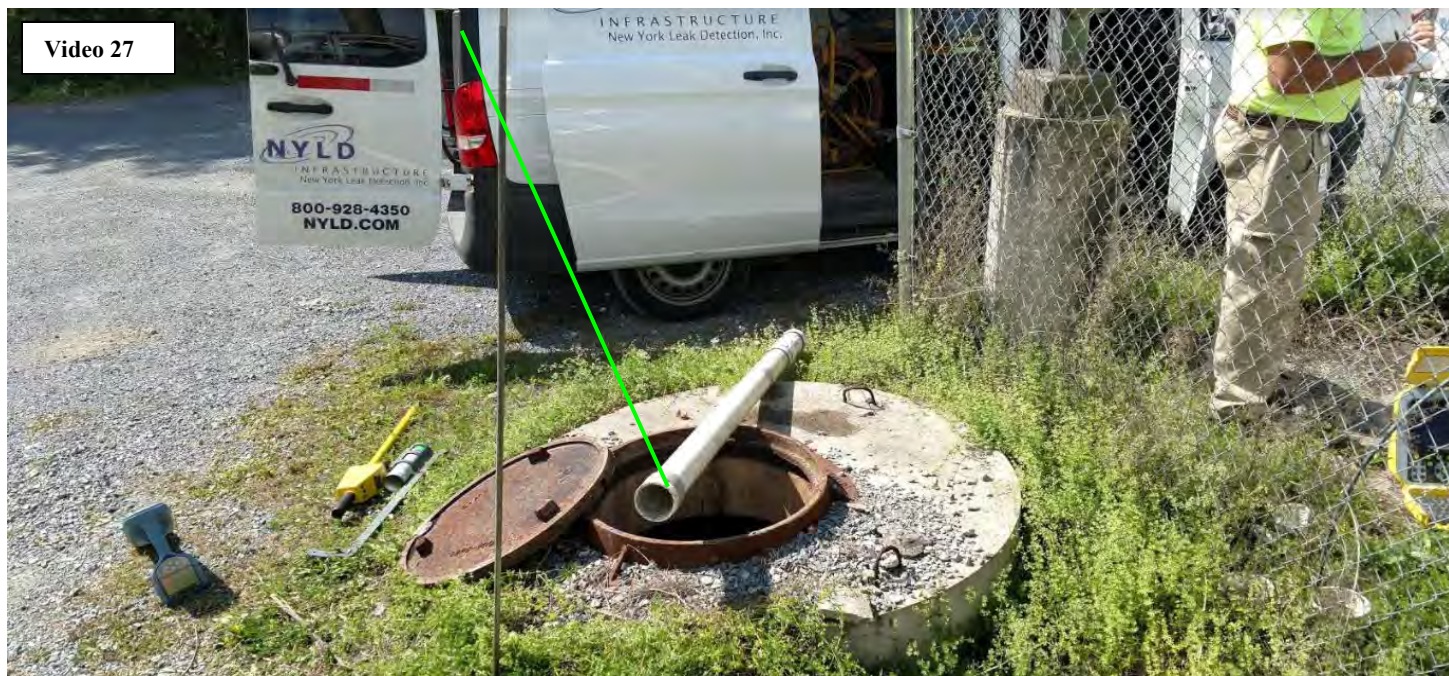
Video 27

Video 27- Storm : Was able to record full run from MH (Pipe 8" – Video Inspection 56 feet long). Pipe was full of debris near end of inspection but full pipe was recorded

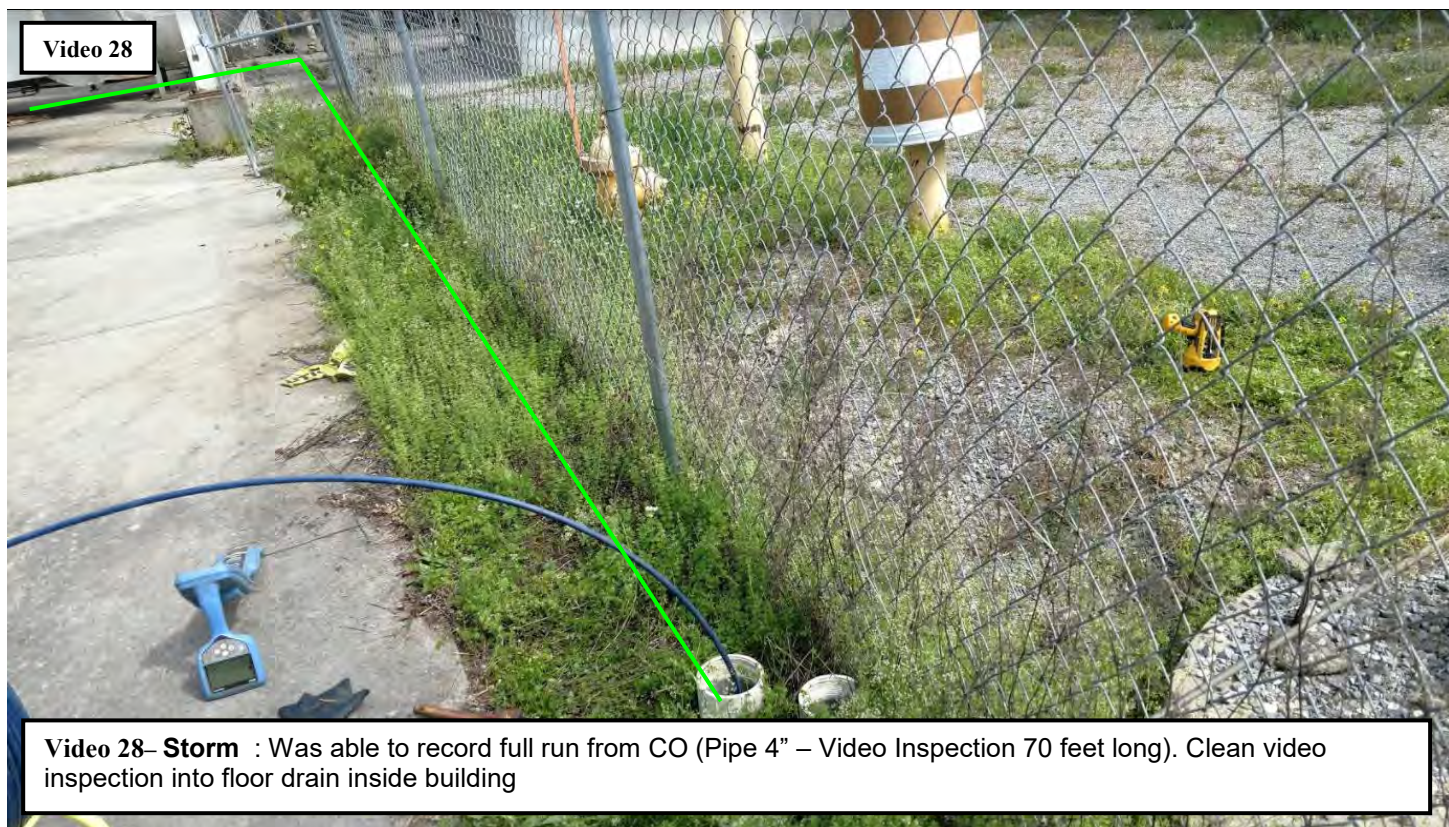
Video 28

Video 28- Storm : Was able to record full run from CO (Pipe 4" – Video Inspection 70 feet long). Clean video inspection into floor drain inside building

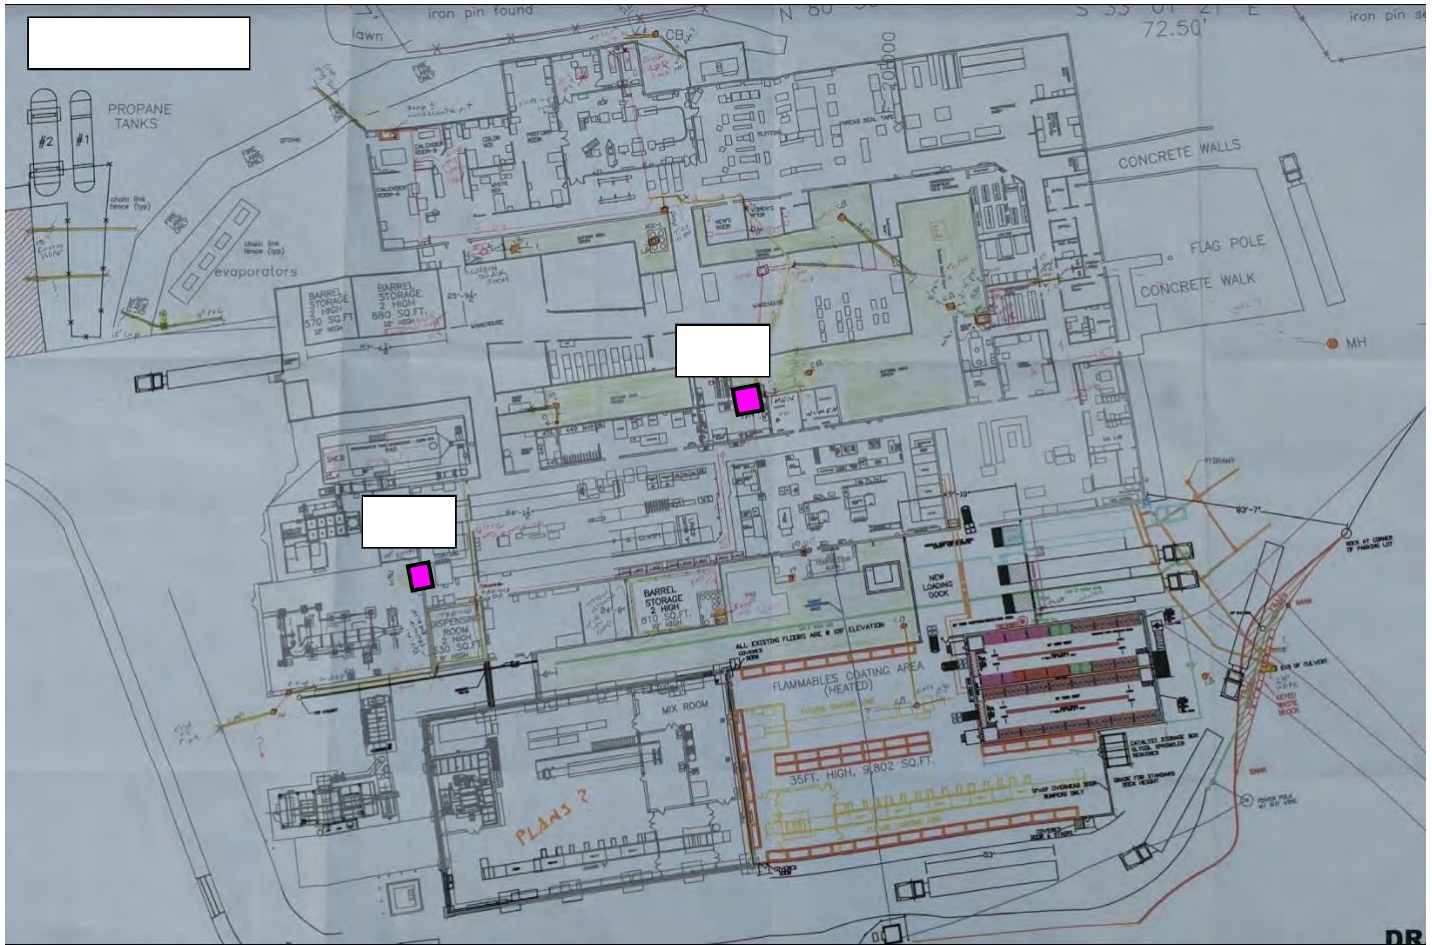
2 pit locations shown above –

Pit 1 : Contains a pipe that heads into the building. Not able to enter pipe due to debris. Vacuming out this pipe may aid in further investigations

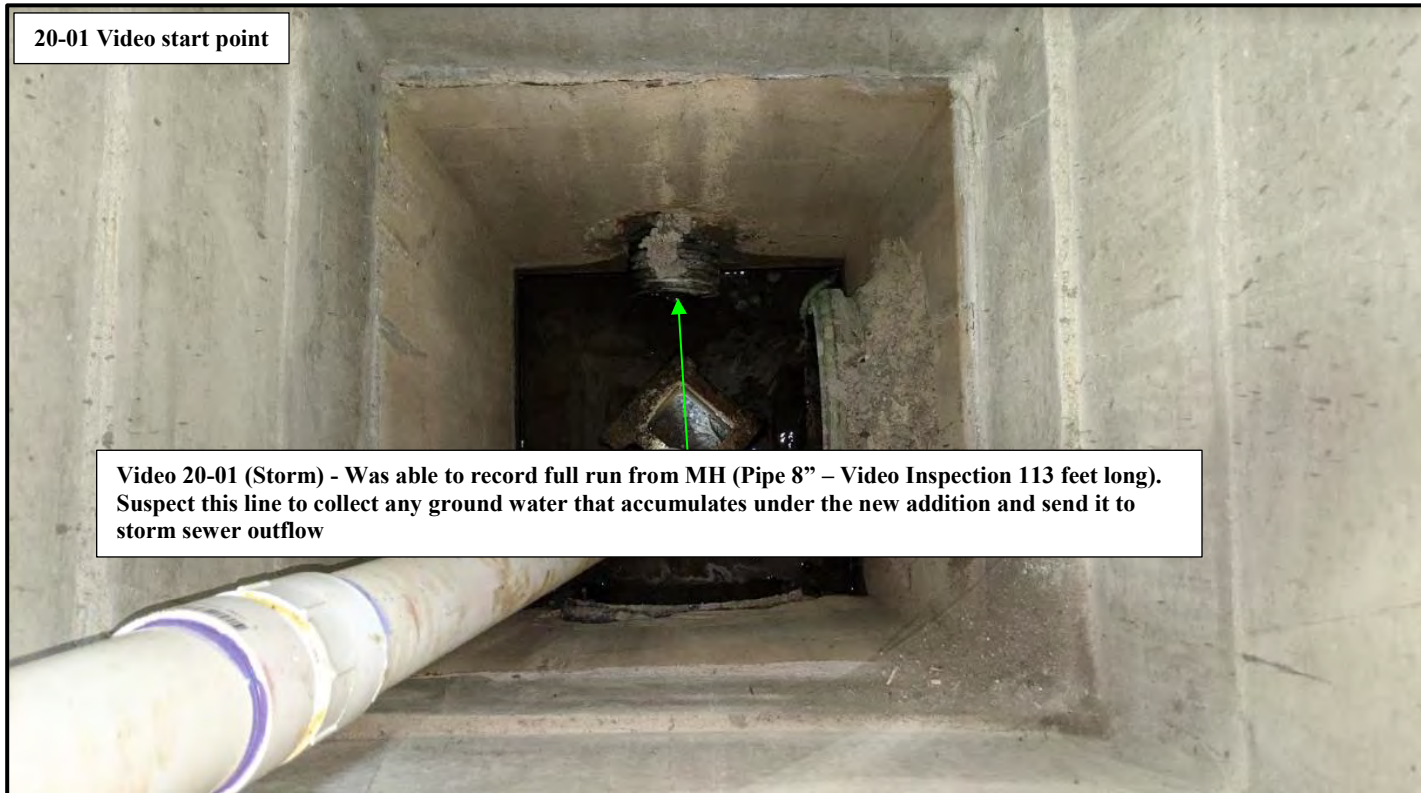
20-01 Video start point

Video 20-01 (Storm) - Was able to record full run from MH (Pipe 8” – Video Inspection 113 feet long). Suspect this line to collect any ground water that accumulates under the new addition and send it to storm sewer outflow

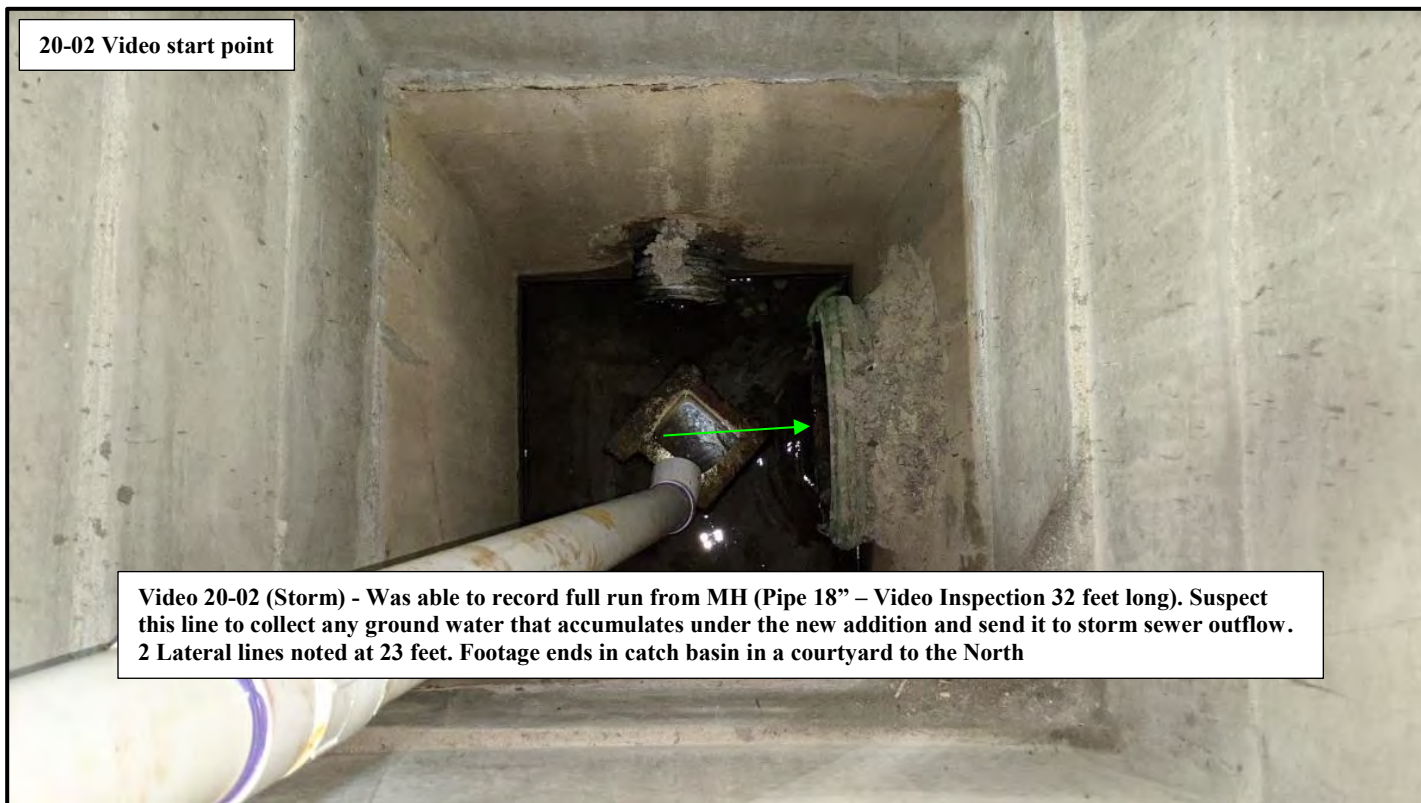
20-02 Video start point

Video 20-02 (Storm) - Was able to record full run from MH (Pipe 18” – Video Inspection 32 feet long). Suspect this line to collect any ground water that accumulates under the new addition and send it to storm sewer outflow. 2 Lateral lines noted at 23 feet. Footage ends in catch basin in a courtyard to the North

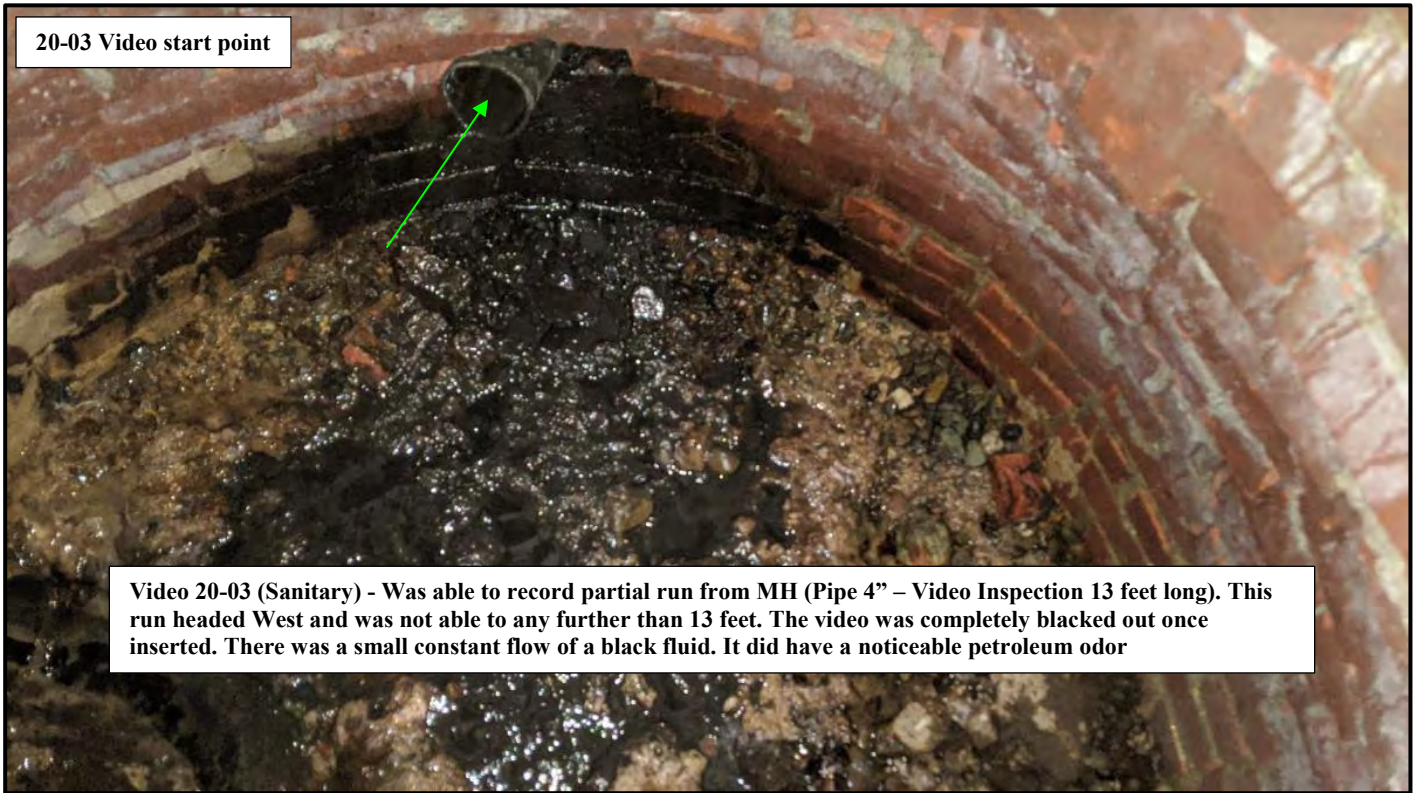
20-03 Video start point

Video 20-03 (Sanitary) - Was able to record partial run from MH (Pipe 4" – Video Inspection 13 feet long). This run headed West and was not able to any further than 13 feet. The video was completely blacked out once inserted. There was a small constant flow of a black fluid. It did have a noticeable petroleum odor

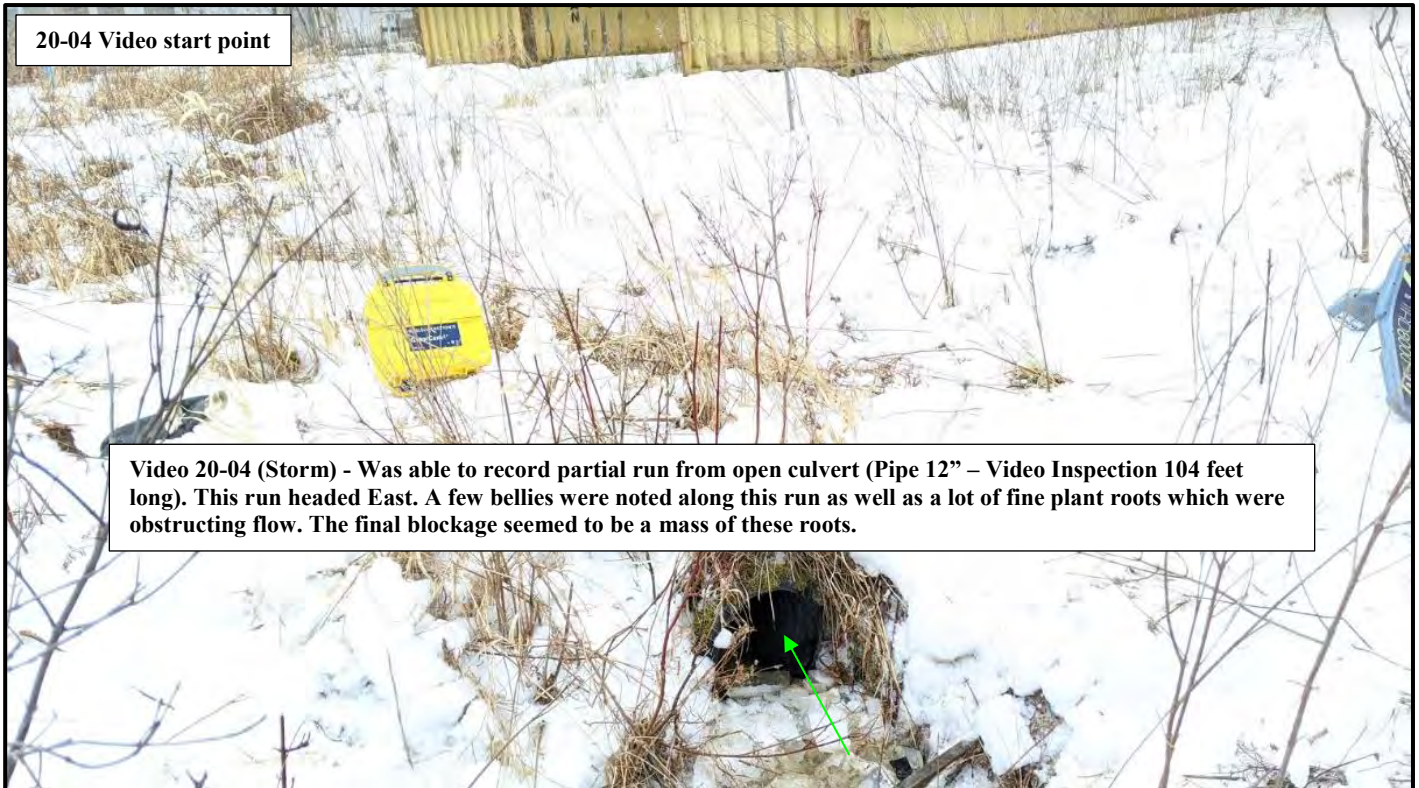
20-04 Video start point

Video 20-04 (Storm) - Was able to record partial run from open culvert (Pipe 12" – Video Inspection 104 feet long). This run headed East. A few bellies were noted along this run as well as a lot of fine plant roots which were obstructing flow. The final blockage seemed to be a mass of these roots.

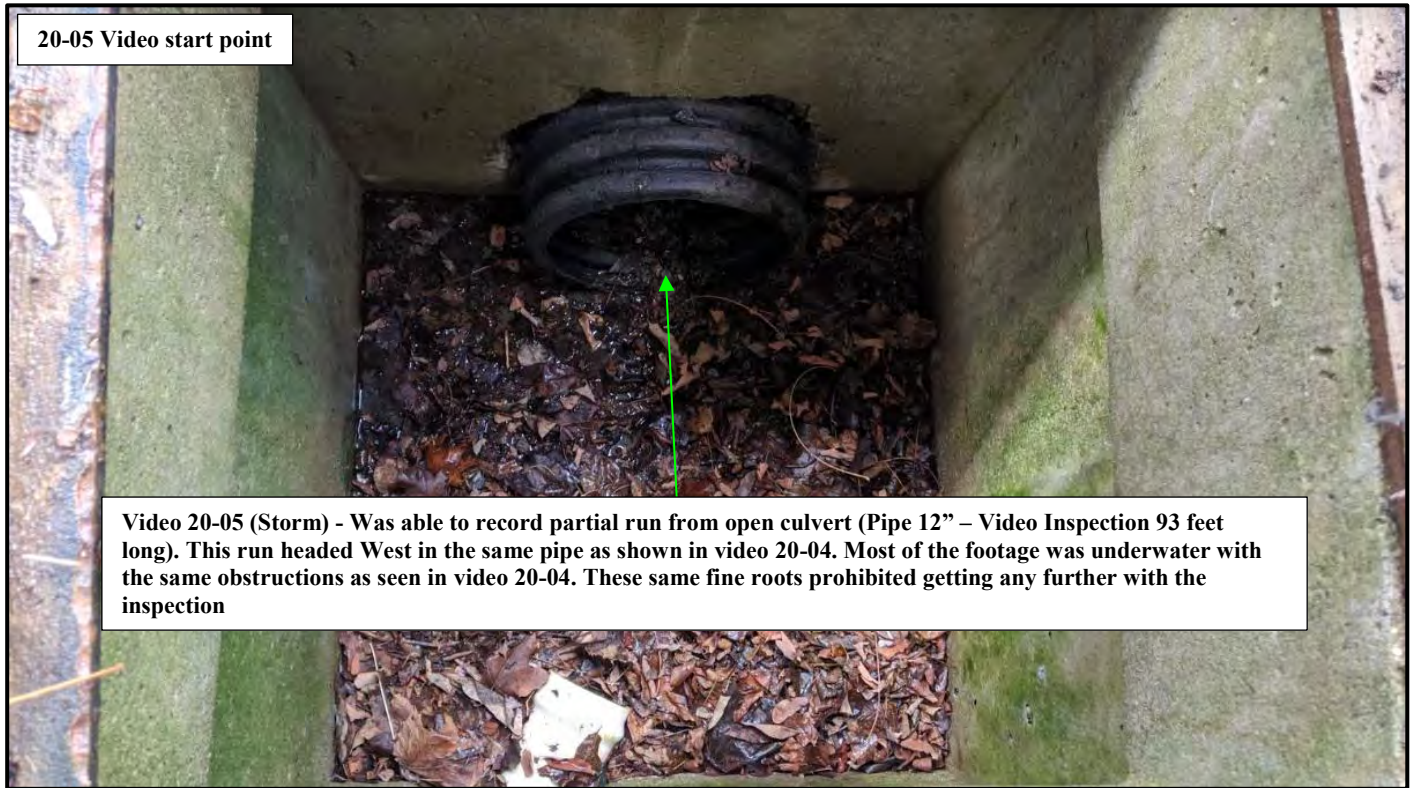
20-05 Video start point

Video 20-05 (Storm) - Was able to record partial run from open culvert (Pipe 12" – Video Inspection 93 feet long). This run headed West in the same pipe as shown in video 20-04. Most of the footage was underwater with the same obstructions as seen in video 20-04. These same fine roots prohibited getting any further with the inspection
