Interim Remedial Measure Work Plan for the Stormwater Drainage System

Saint-Gobain Performance Plastics Site
1 Liberty Street
Village of Hoosick Falls
Rensselaer County, New York
NYSDEC Site # 442048

SAINT-GOBAIN PERFORMANCE PLASTICS, CORP.
14 McCaffrey Street
Hoosick Falls, New York 12090

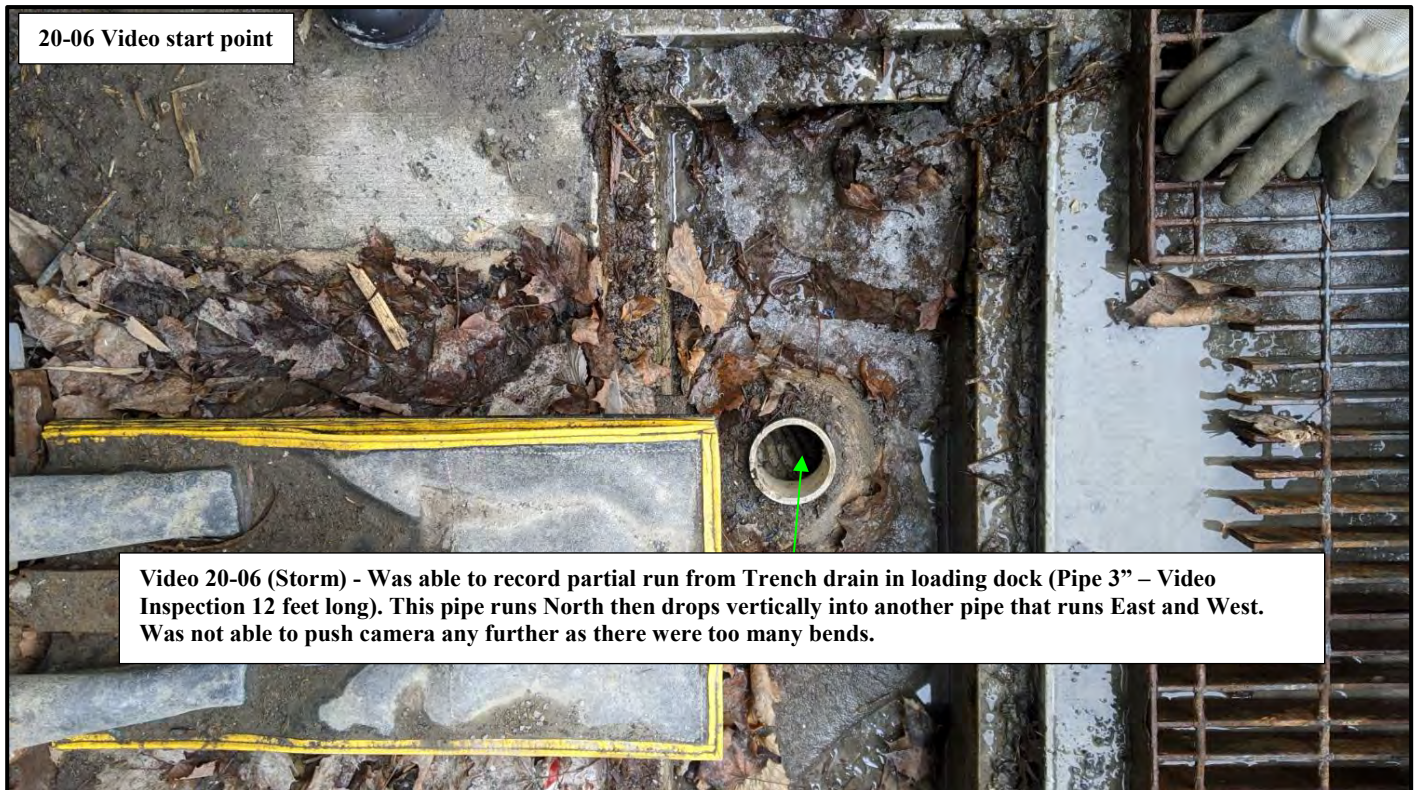
20-06 Video start point

Video 20-06 (Storm) - Was able to record partial run from Trench drain in loading dock (Pipe 3" – Video Inspection 12 feet long). This pipe runs North then drops vertically into another pipe that runs East and West. Was not able to push camera any further as there were too many bends.

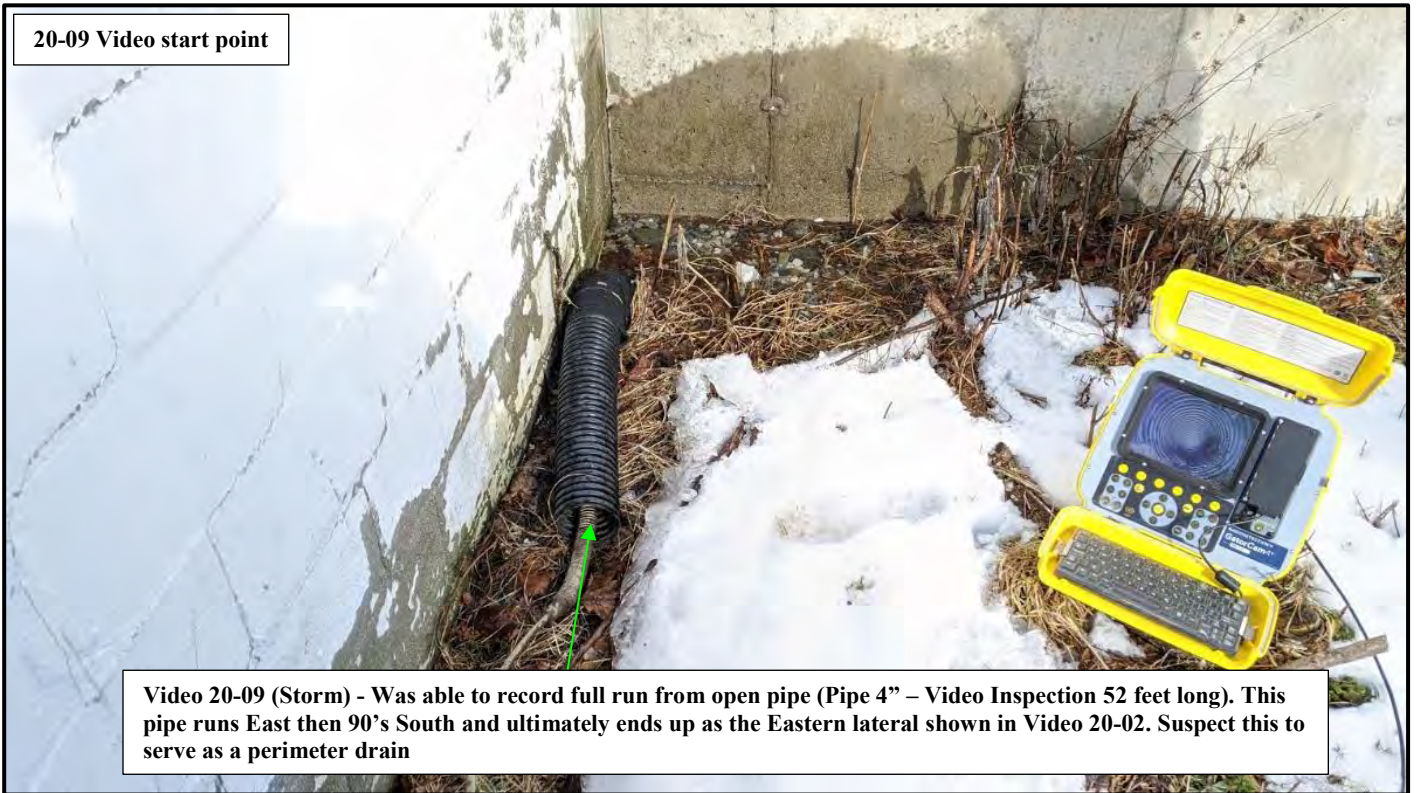
Field Report – Utility Location**20-09 Video start point**

Video 20-09 (Storm) - Was able to record full run from open pipe (Pipe 4" – Video Inspection 52 feet long). This pipe runs East then 90's South and ultimately ends up as the Eastern lateral shown in Video 20-02. Suspect this to serve as a perimeter drain

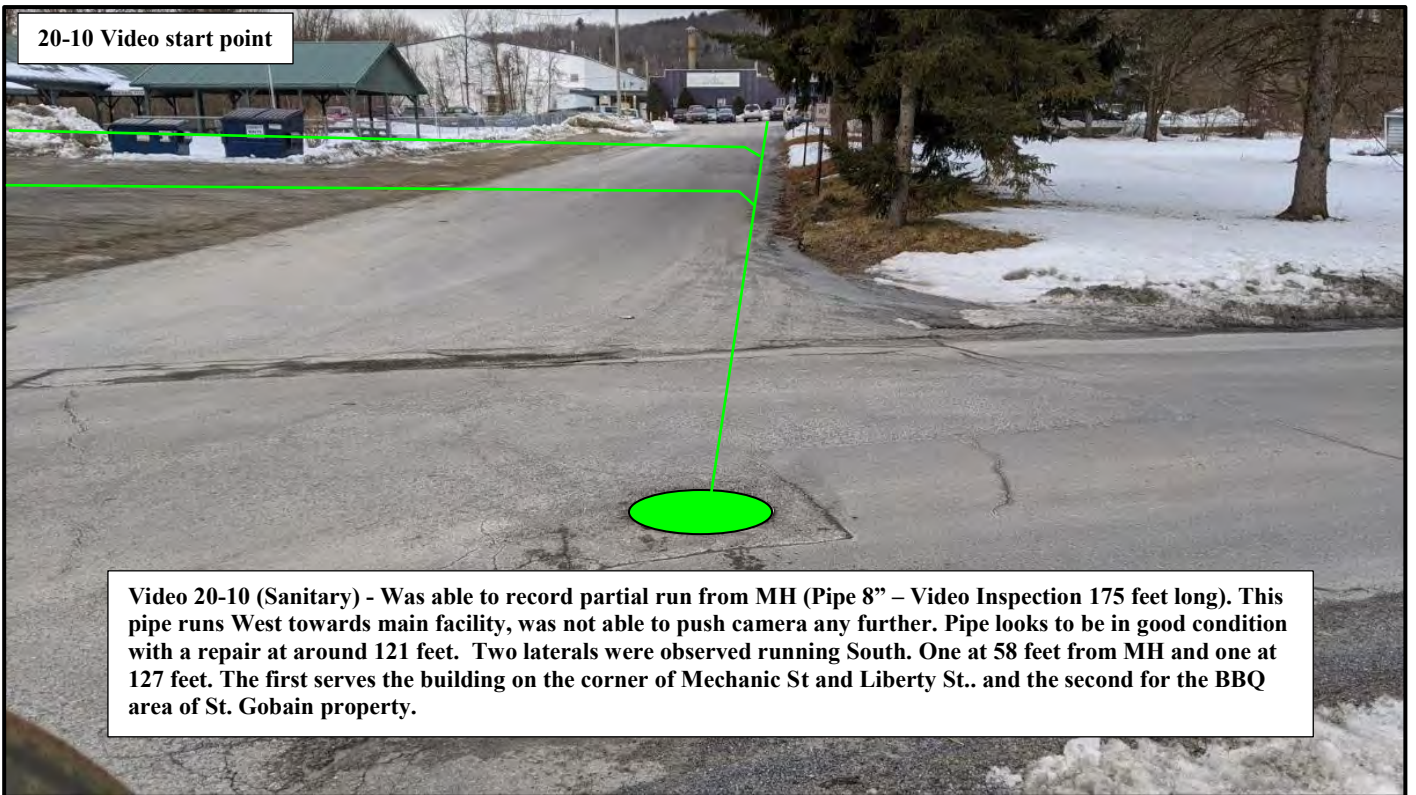
20-10 Video start point

Video 20-10 (Sanitary) - Was able to record partial run from MH (Pipe 8" – Video Inspection 175 feet long). This pipe runs West towards main facility, was not able to push camera any further. Pipe looks to be in good condition with a repair at around 121 feet. Two laterals were observed running South. One at 58 feet from MH and one at 127 feet. The first serves the building on the corner of Mechanic St and Liberty St., and the second for the BBQ area of St. Gobain property.

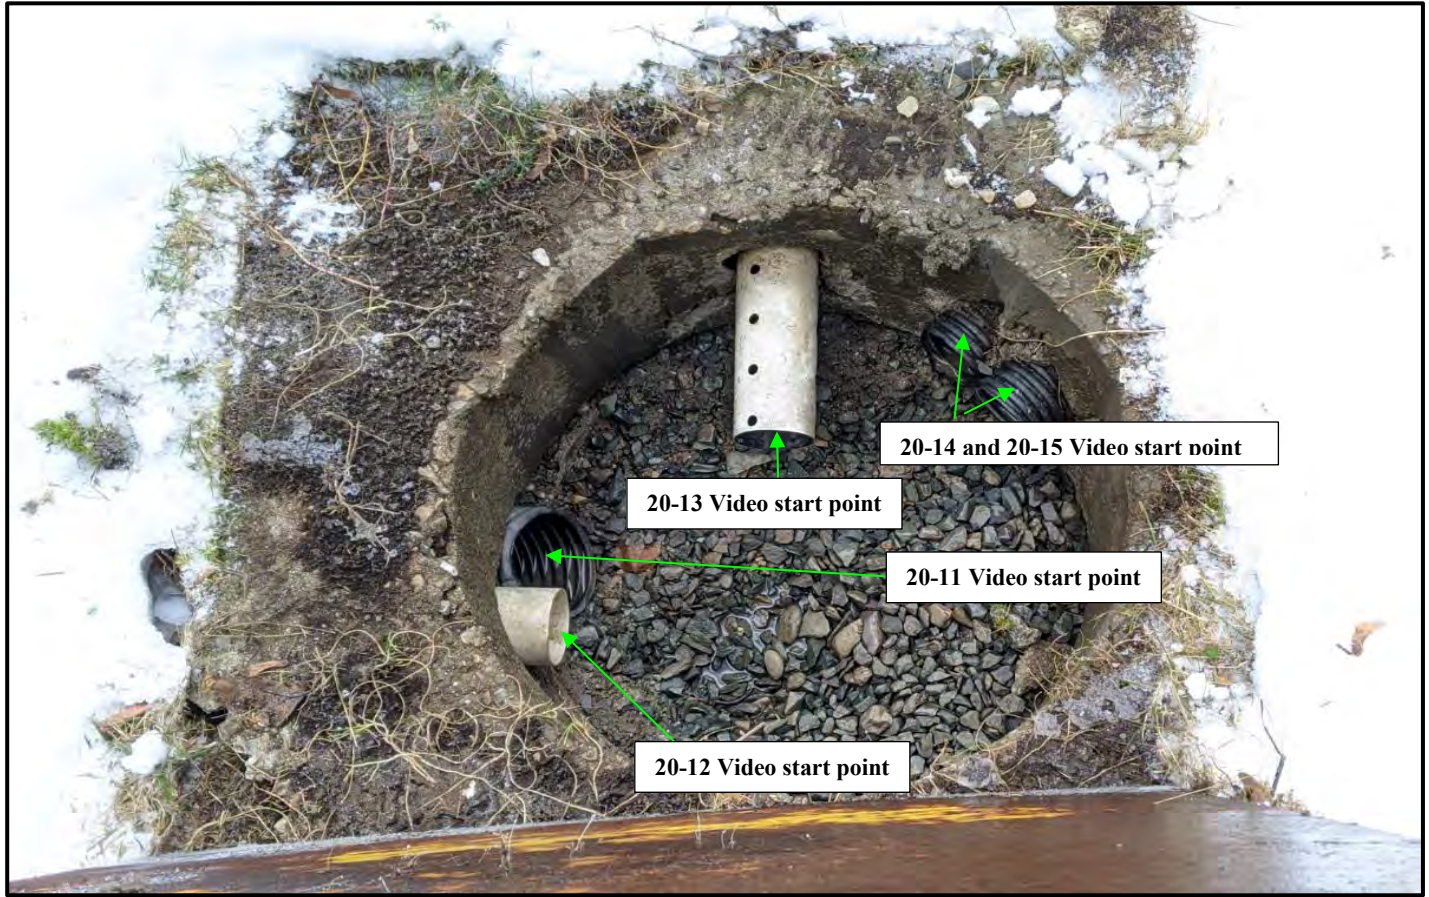
Video 20-11 This video heads East from the start point. At around 25 feet it wyes into the same line that originates from the manhole described in Video 20-08 and 20-07. This pipe looks to be in poor condition with many bellies.

Video 20-12 This video heads East and doesn't make it out of the courtyard due to being blocked with coarse stone. It seems to serve as a perimeter drain due to drainage holes that are obvious in the pipe construction.

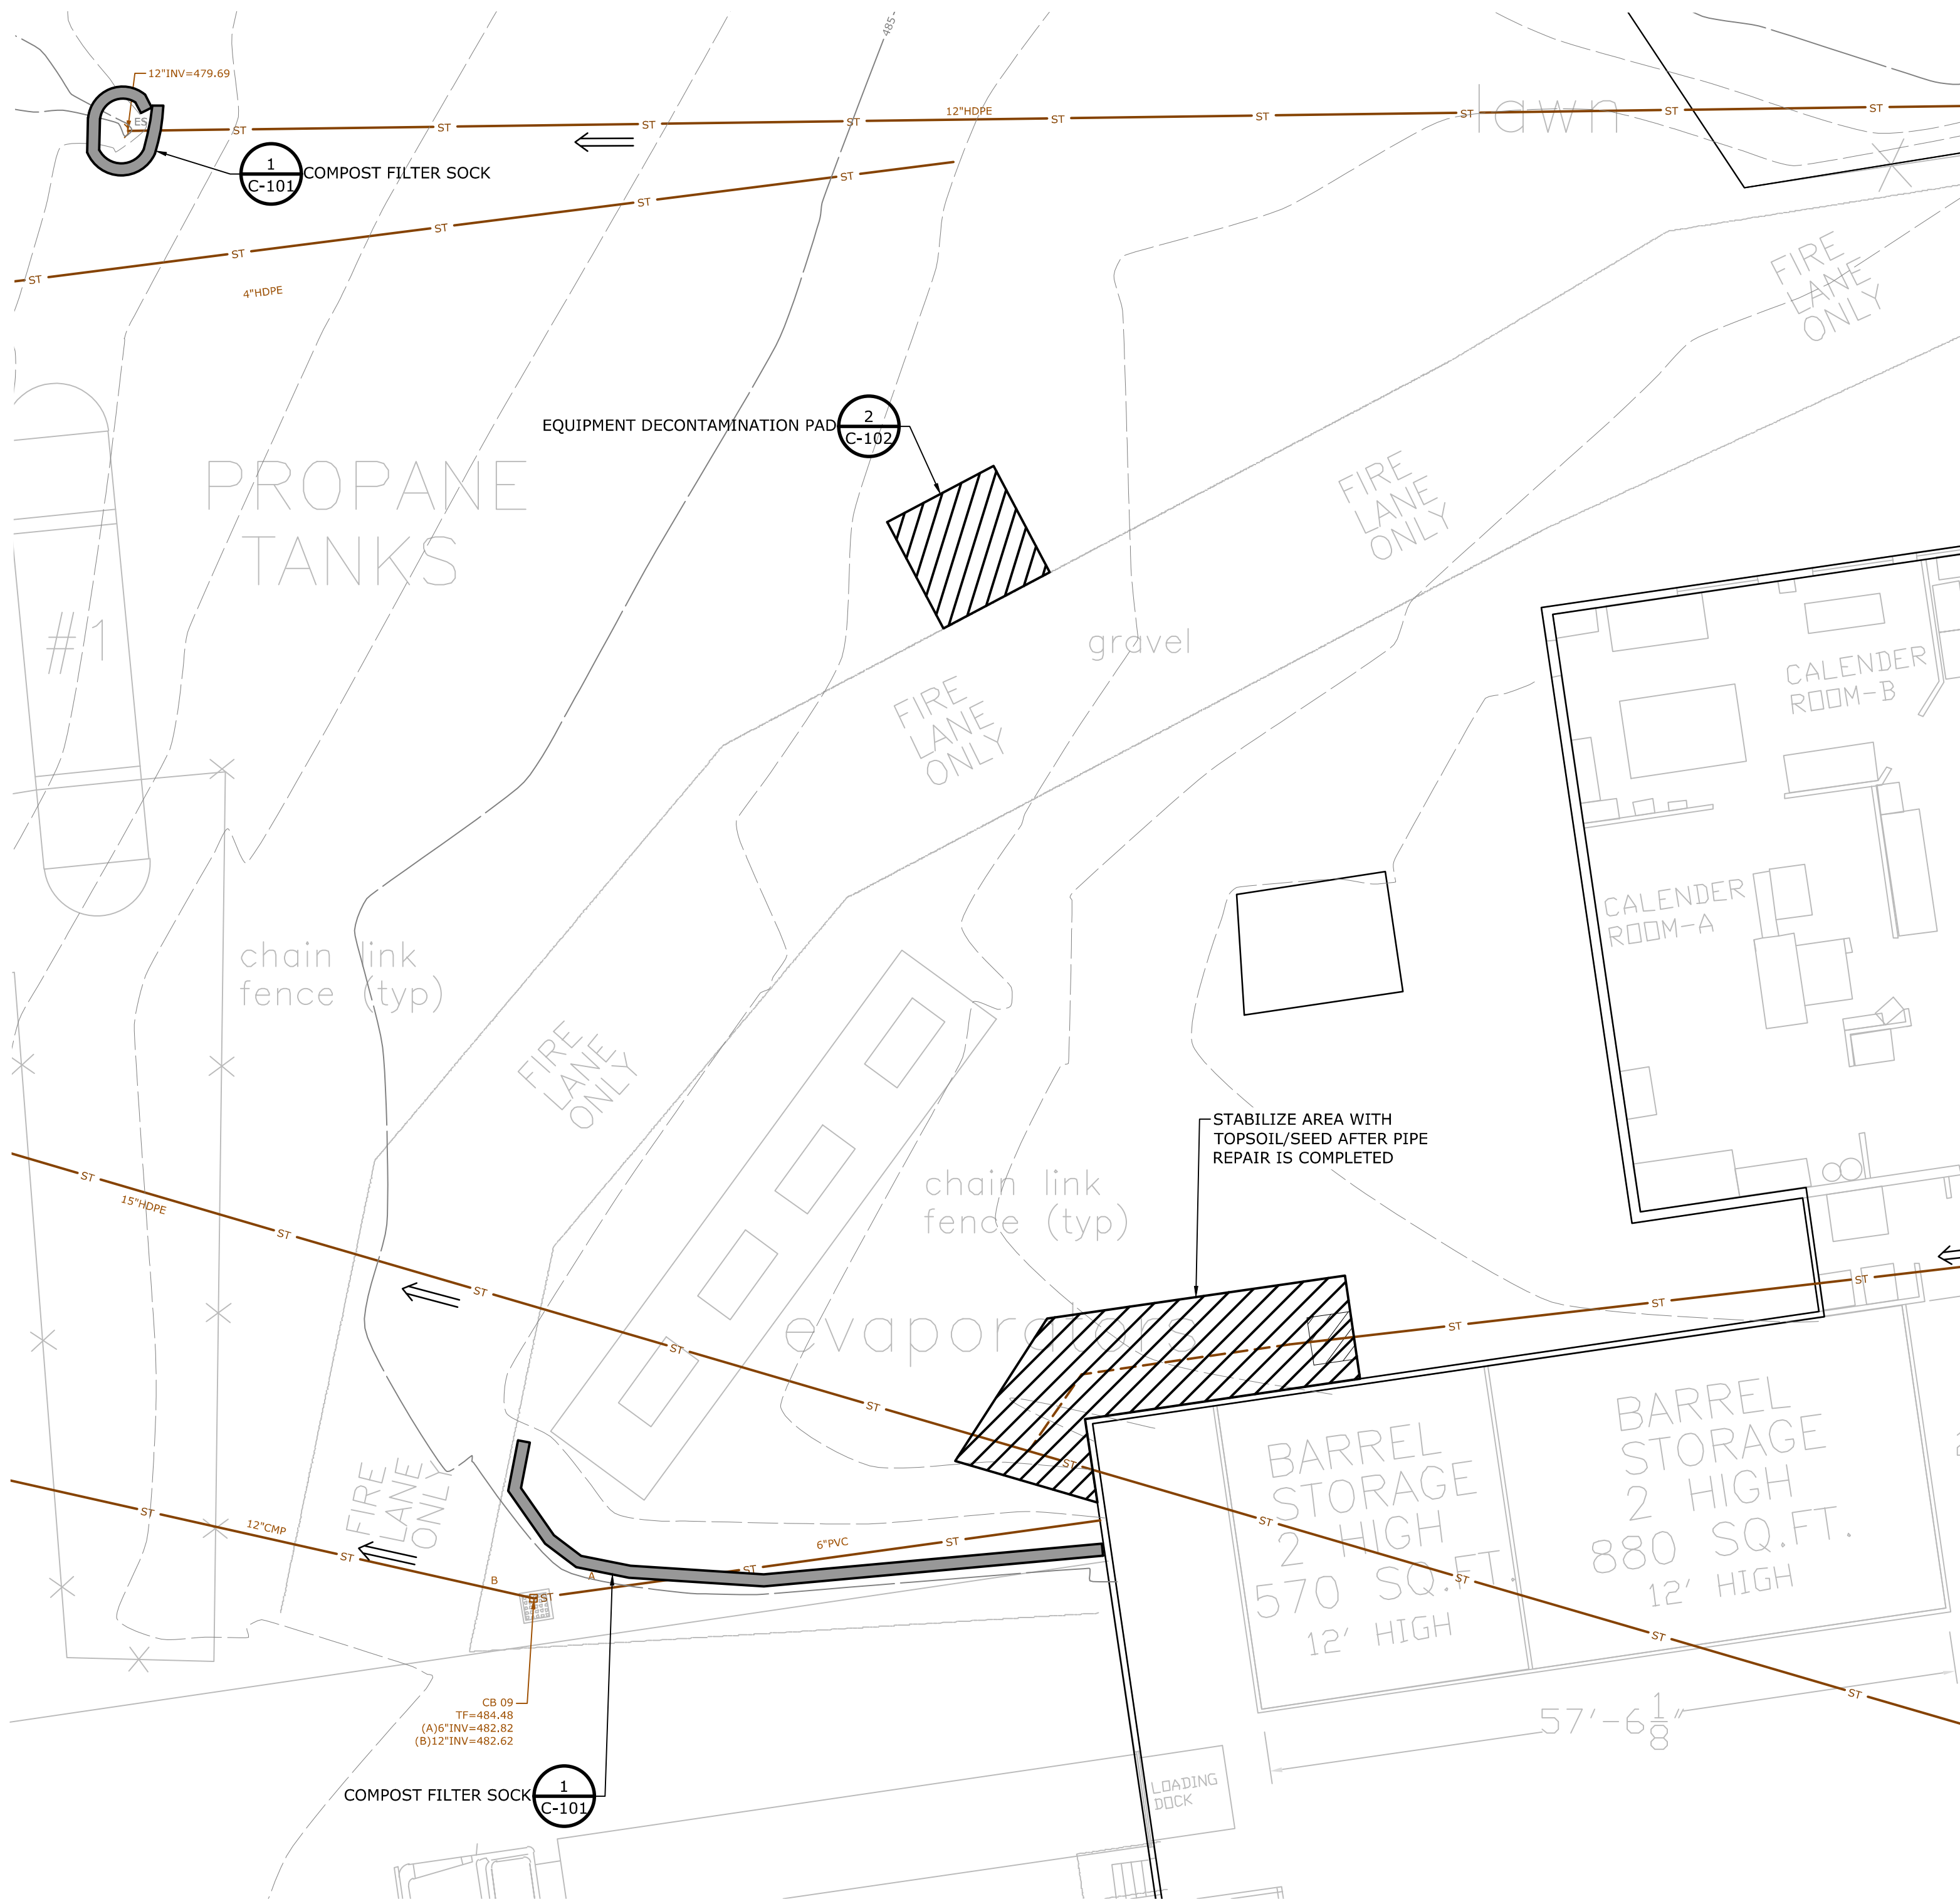
1 SITE PLAN
 C-102 SCALE: 1"=10'
 CROSS REFERENCE: NONE

that will be evaluated and repaired. A section of pipe at the northwest corner of the building has already been identified for repair (Appendix B; Drawing C-102).

After the catch basins and system piping are cleaned, they will be further assessed by visual or video inspections for sections in need of repair, replacement, or lining. Potentially damaged infrastructure identified will be accessed through standard construction techniques for further assessment and repair. Infrastructure in need of repair already identified consists of, for example, catch basins lacking a solid or intact bottom that will be evaluated for installation of a solid bottom and system piping with blockage
