**FORMER SPERRY REMINGTON SITE
(NYSDEC SITE I.D. #808043)**

**REVISED
INTERIM REMEDIAL MEASURE
WORK PLAN**

CITY OF ELMIRA, CHEMUNG COUNTY, NY

7 October 2019

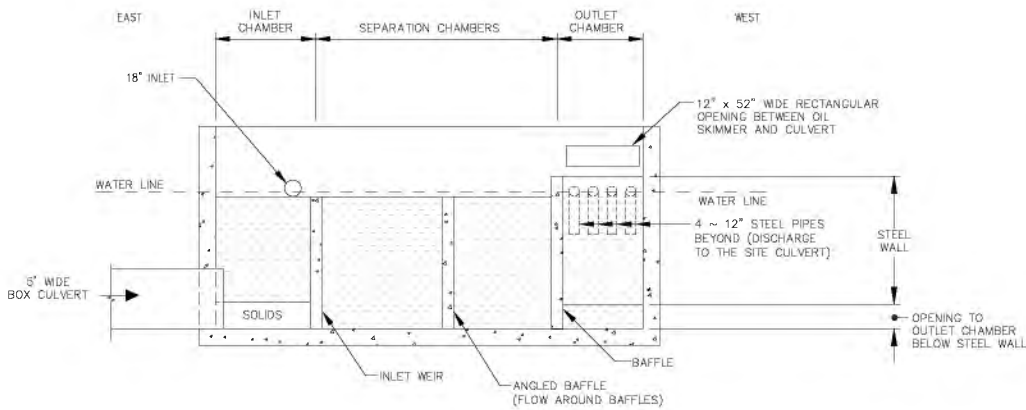
OIL SKIMMER #2	
FORMER SPERRY REMINGTON RAND OUTFALL SITE 1051 SOUTH MAIN STREET ELMIRA, NEW YORK	
Geosyntec consultants COLUMBIA, MARYLAND	DATE: NOVEMBER 2018
	PROJECT NO. MNOB32A
	DOCUMENT NO. MD18229
	FILE NO. 0832f002
	FIGURE NO. 3

Plan and cross-sectional depictions of OS2 are shown on **Figure 3**. The top of OS2 has been observed to be 12 to 36 inches below the ground surface. Observed inlet and outlet connections to OS2 include:

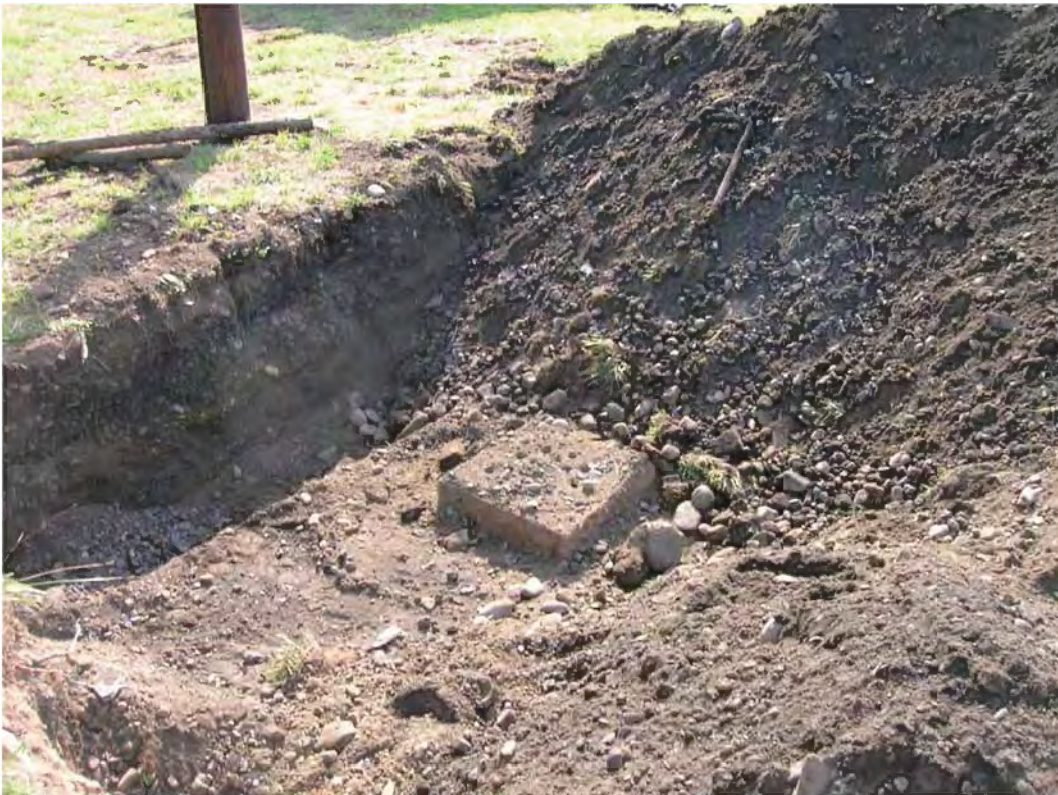
Picture #2- Oil Skimmer manhole uncovered

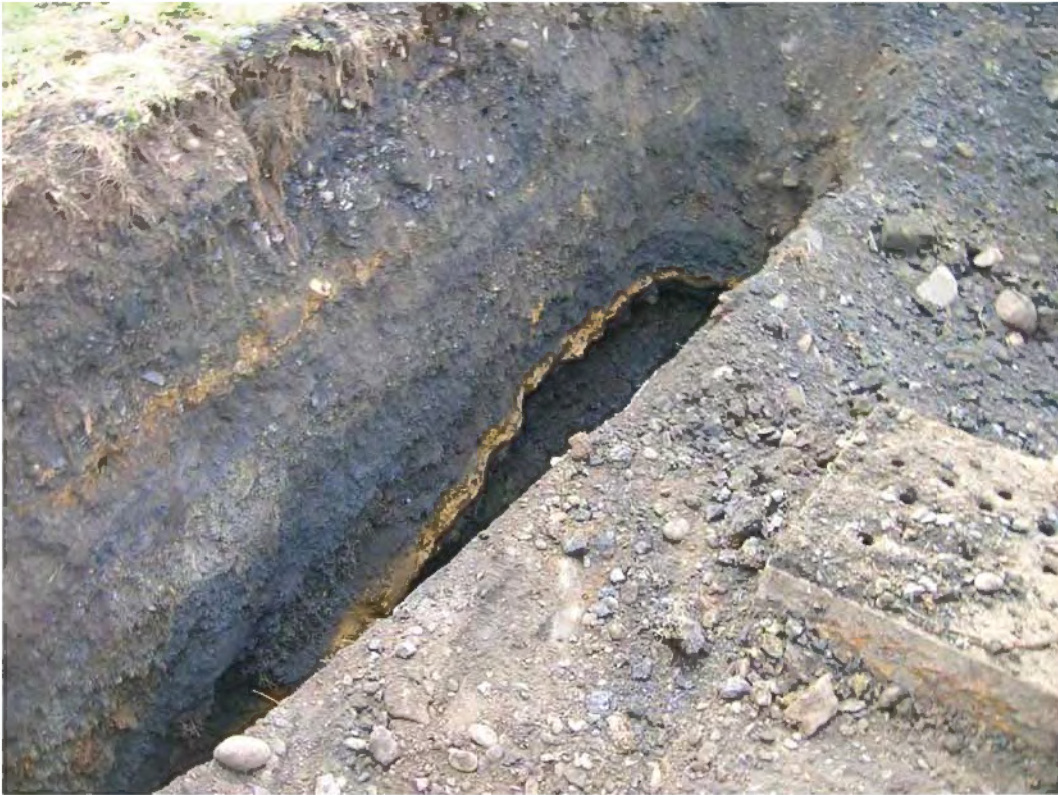
Picture #3- Test Pit #3, next to Oil Skimmer manhole

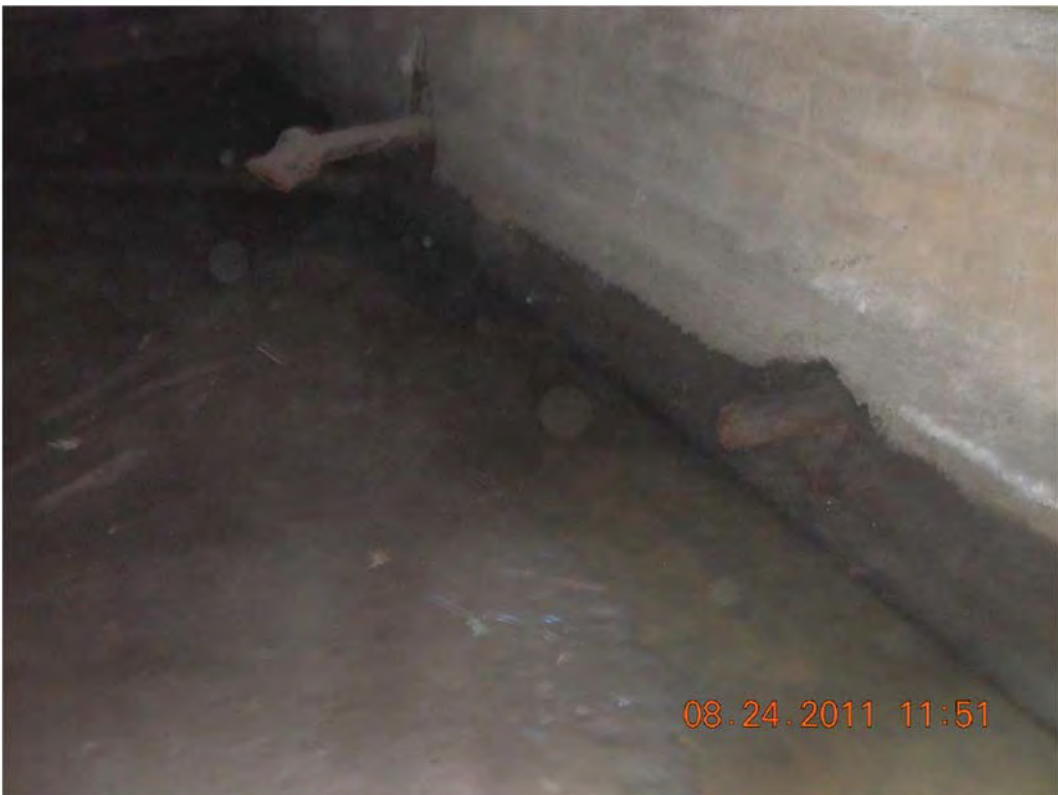
Picture #4- Inside Oil Skimmer from manhole looking NW at pipe penetrations

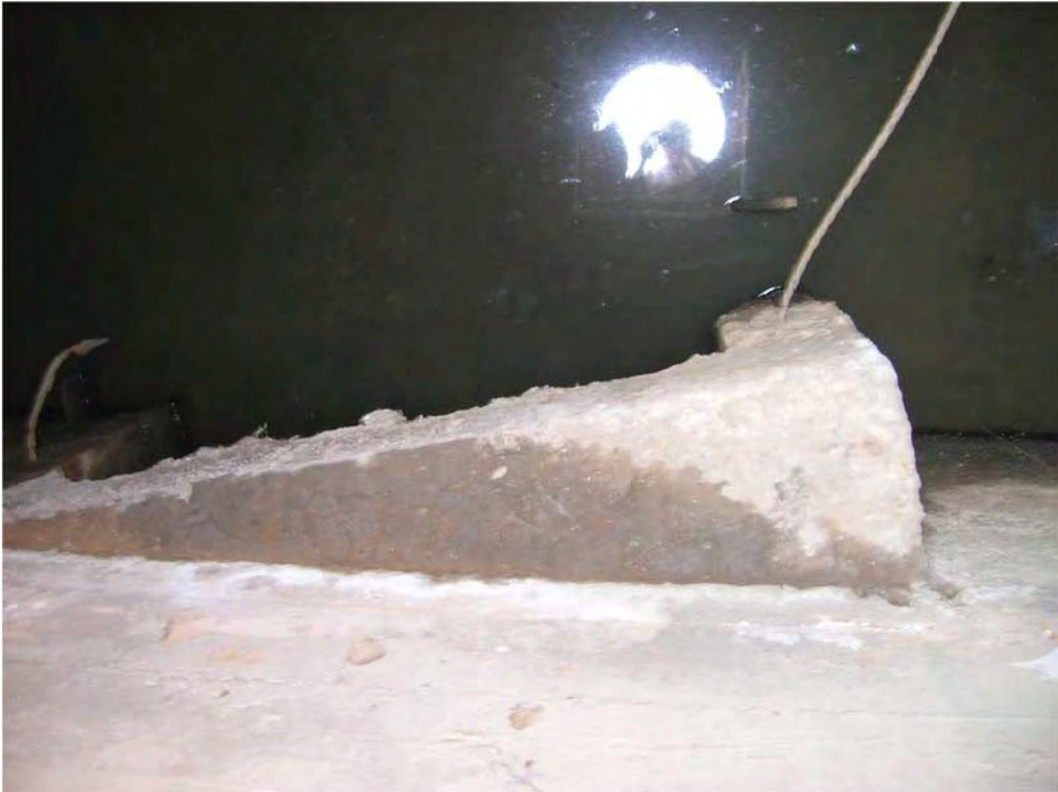
Picture #5- Looking down inside Oil Skimmer at ~5'wide influent culvert from east

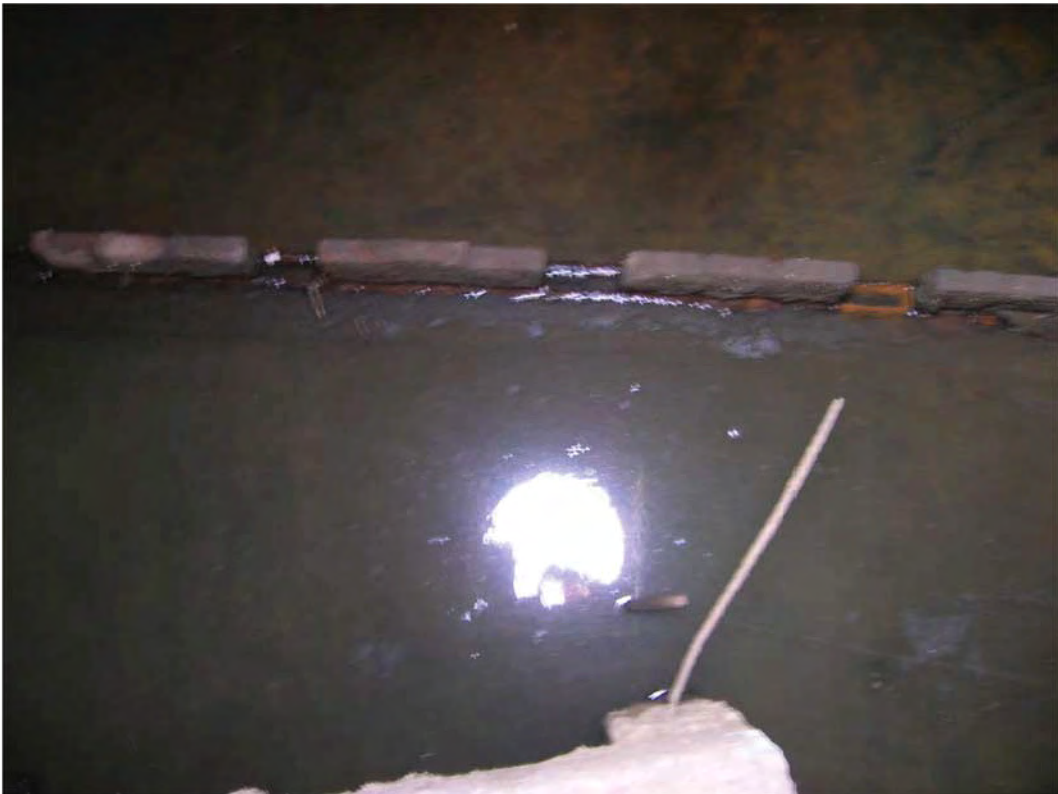
Picture #6- Looking down inside Oil Skimmer at internal baffles

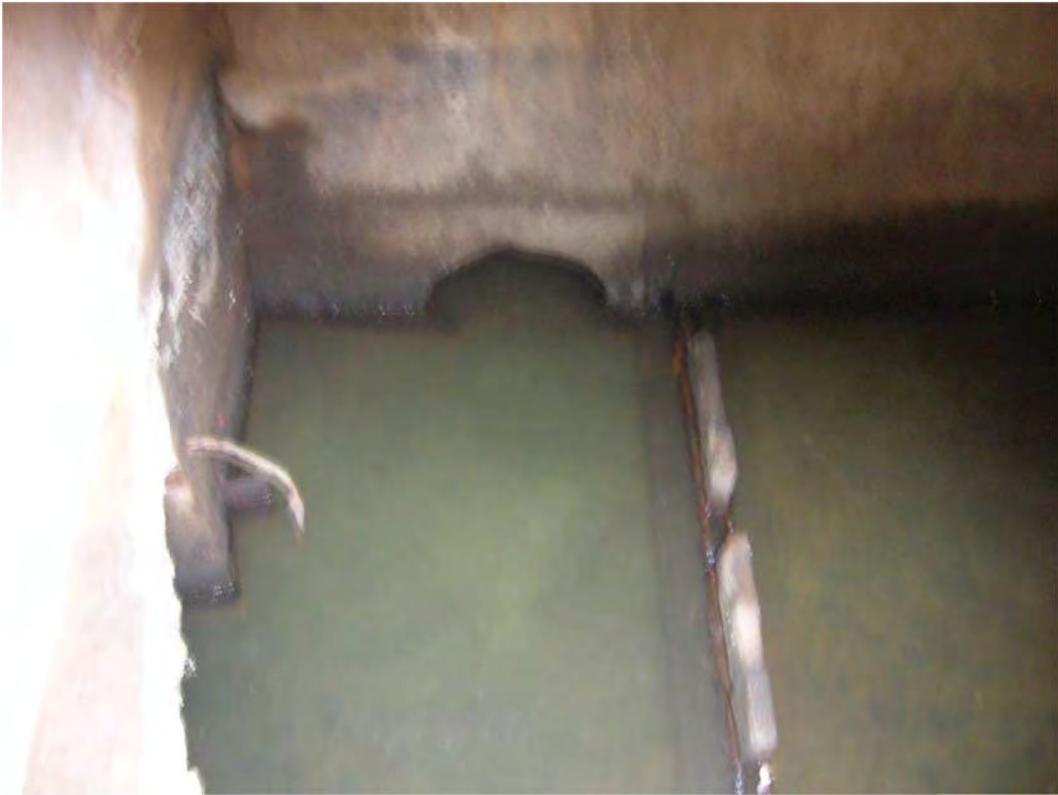
Picture #7- Inside Oil Skimmer looking south at pipe opening to south

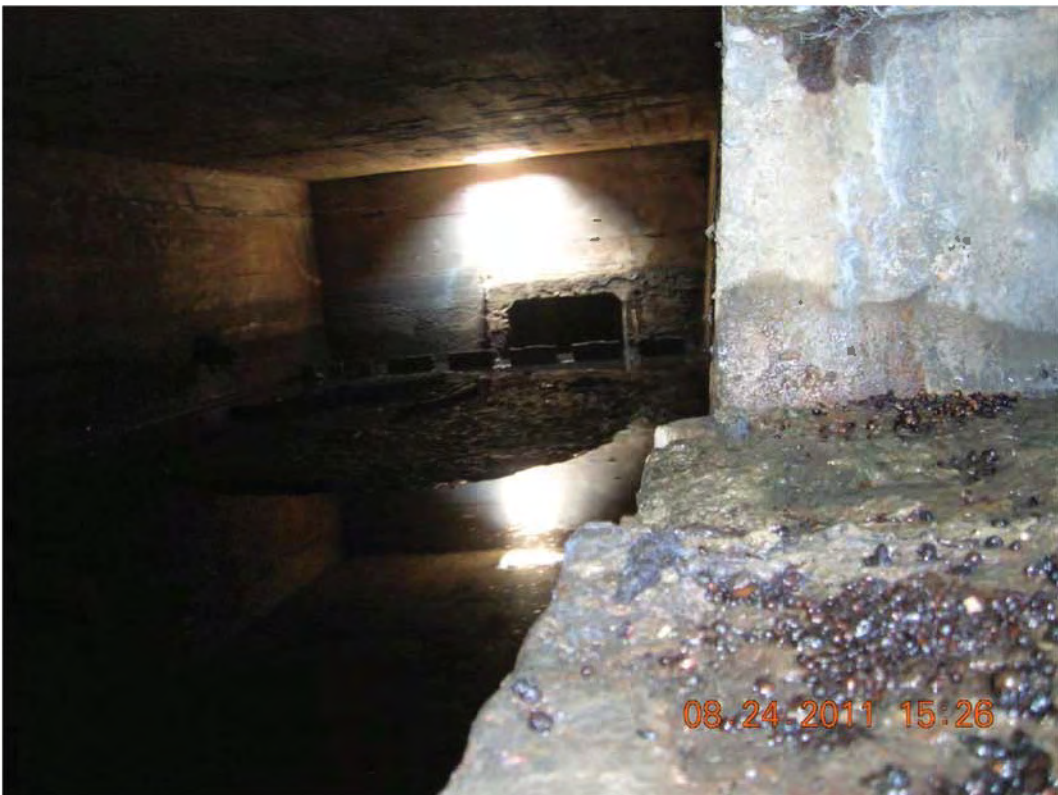
Picture #8- Inside Oil skimmer from Main Site Culvert looking east to ~5' wide culvert

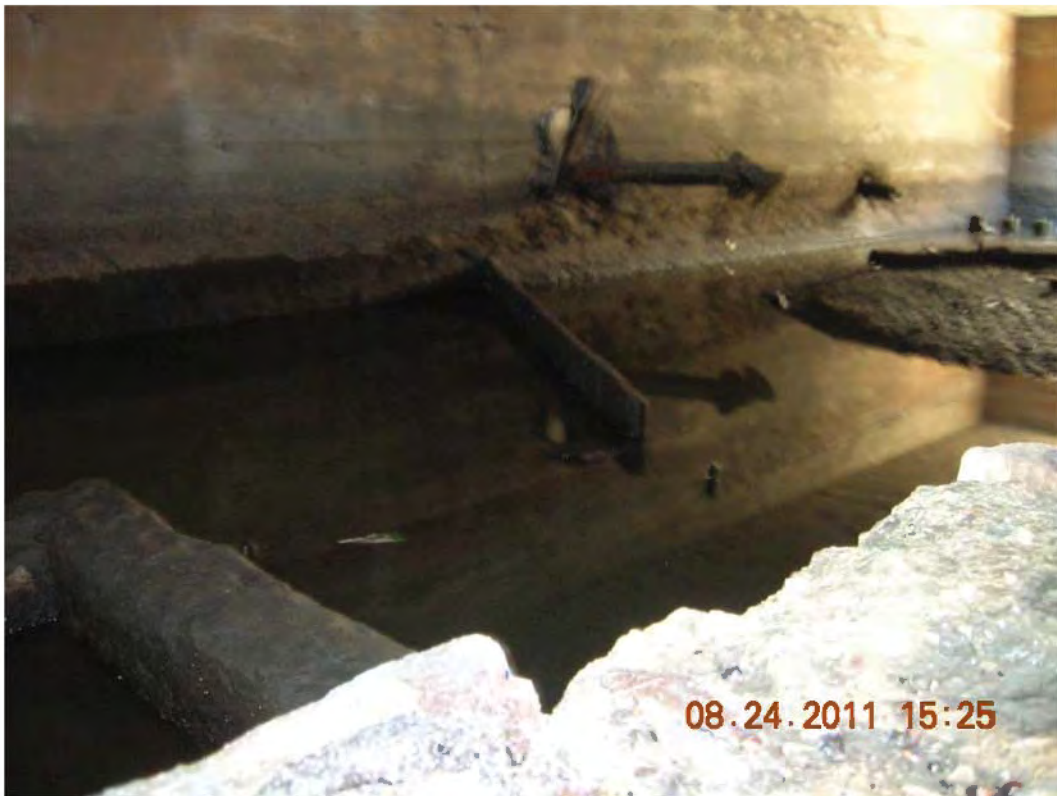
Picture #9- Inside Oil Skimmer looking NW at pipe penetrations and internal baffles

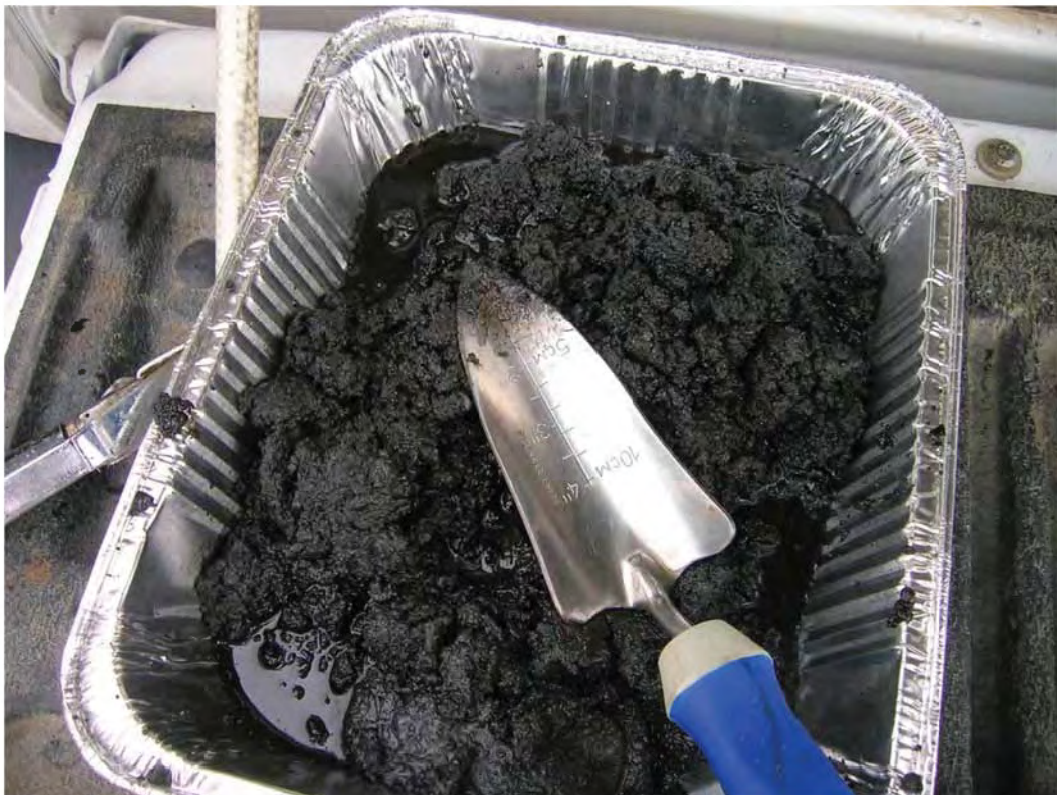
Picture #10- Sediment sample material from Oil Skimmer directly below manhole

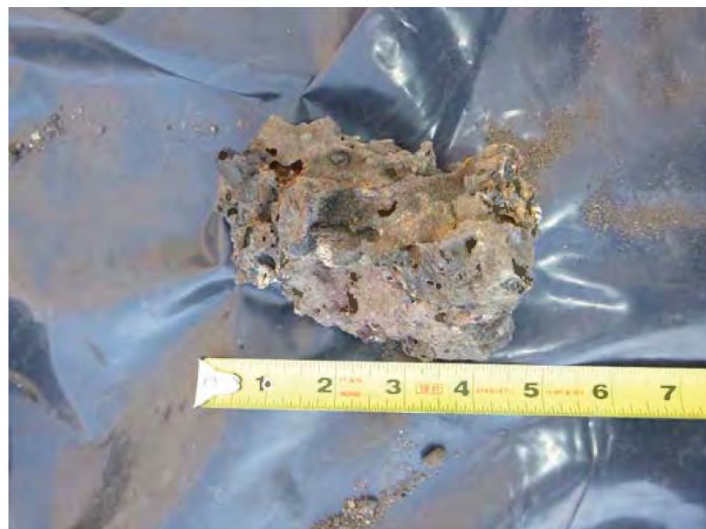
Comments: Slag material found in
TP-2.1 and in other test pits on site.

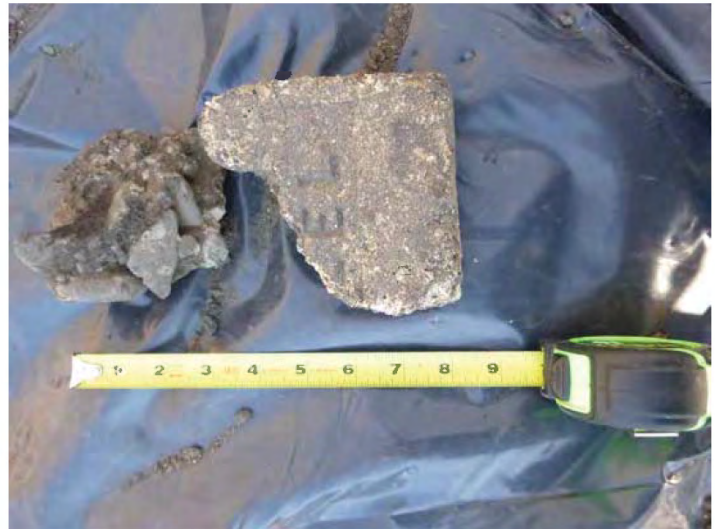
Comments: Sample fill fragments found in TP-2.1 and other soil spoils on site. On the right side is a yellow fragment of brick common in soils found in the Test pit areas 2, 3, and 4.

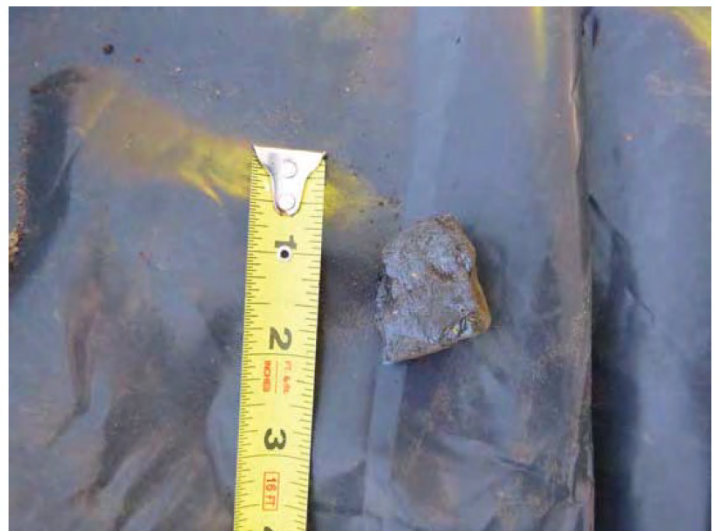
Photograph ID: 4

Comments: A fragment of coal collected from TP-2.1 soil spoils.

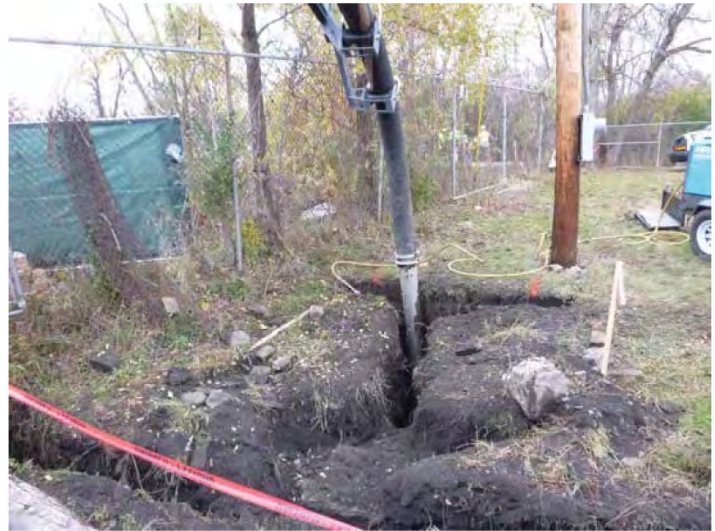
Comments: TP-2.2 investigated the northern and southern edges of OS2, the OS2 manhole, and the 5-ft box culvert headed northeast. Orange paint marks identify the edges of the 5-ft box culvert.

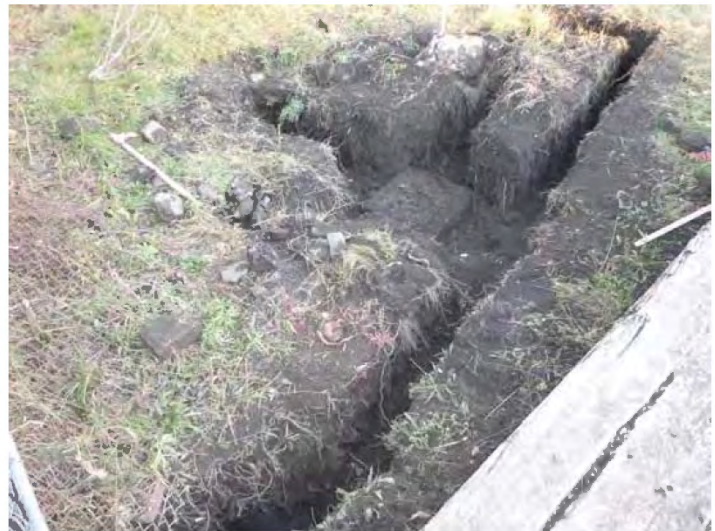
Photograph ID: 6

Comments: The OS-2-man hole was uncovered in TP-2.2 approximately 2 ft bgs.

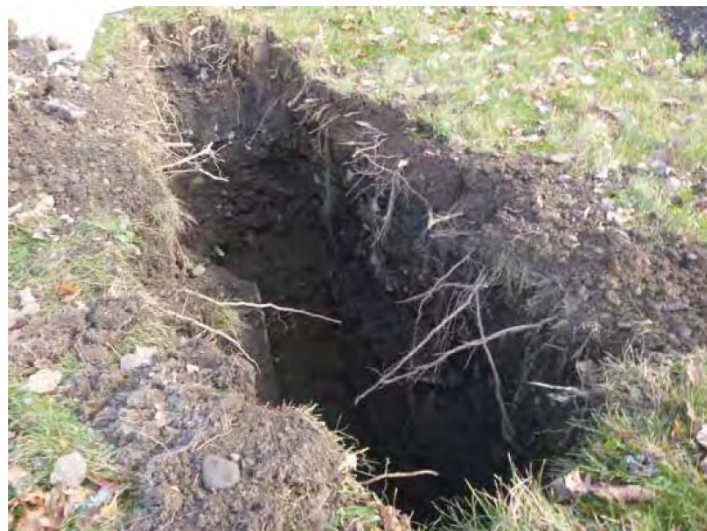
Comments: TP-3.1 reached dimensions of two (2) feet long, ten (10) feet wide, and eleven (11) feet deep. No structures were observed during TP-3.1 excavation.

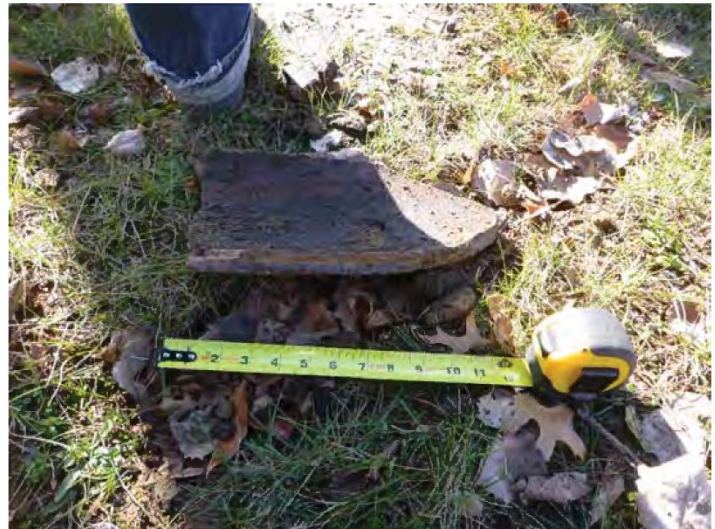
Comments: Clay pipe fragments
discovered in TP-3.2.

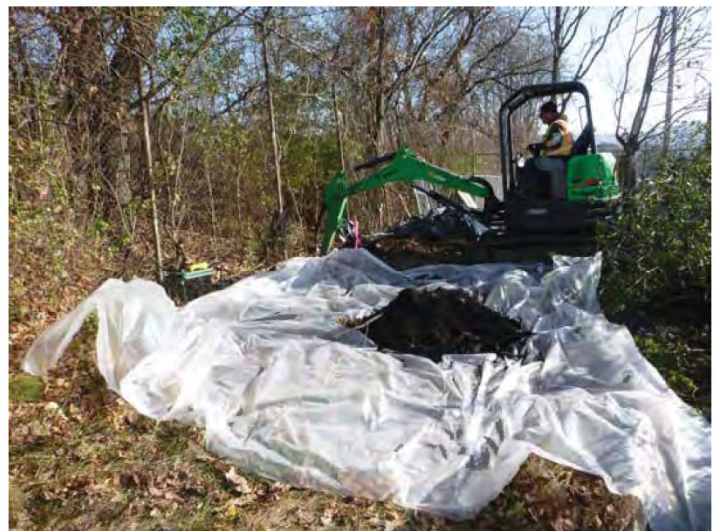
Photograph ID: 12

Comments: TP 4.1 was excavated
north-west of CB-15, perpendicular
to the EHS fence line.

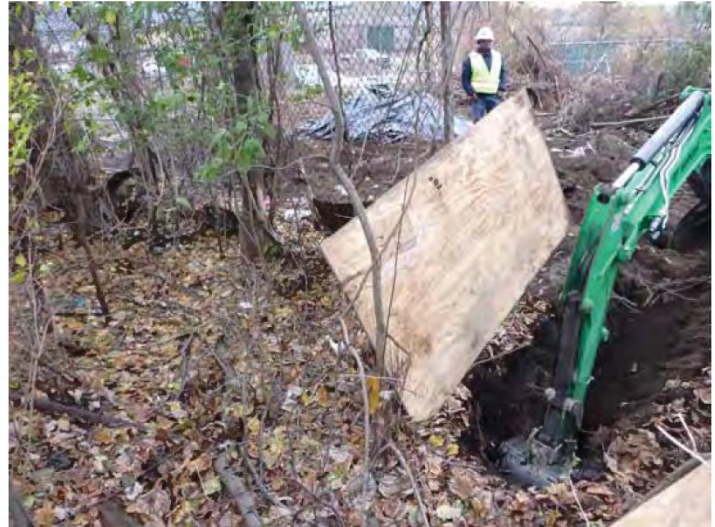
Comments: TP-4.1, excavated northwest of CB-15. CB-15's metal ring is visible to the left of TP-4.1.

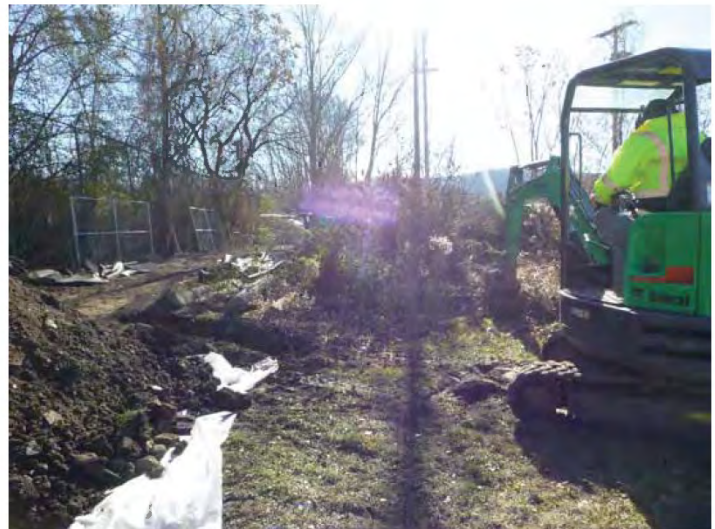
Photograph ID: 14

Comments: Test Pit 4.2 was excavated to the southwest of TP-4.1 to identify the location of the brick 36" connection to the 5-ft culvert connecting to OS2.

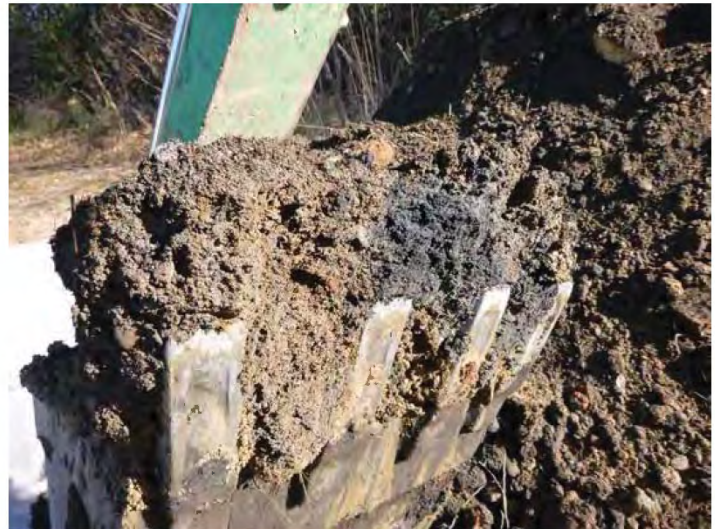
Comments: Soil spoils collected from approximately 11 ft bgs in TP-4.2. At 11 ft soil smelled like hydrocarbons and was visually stained.

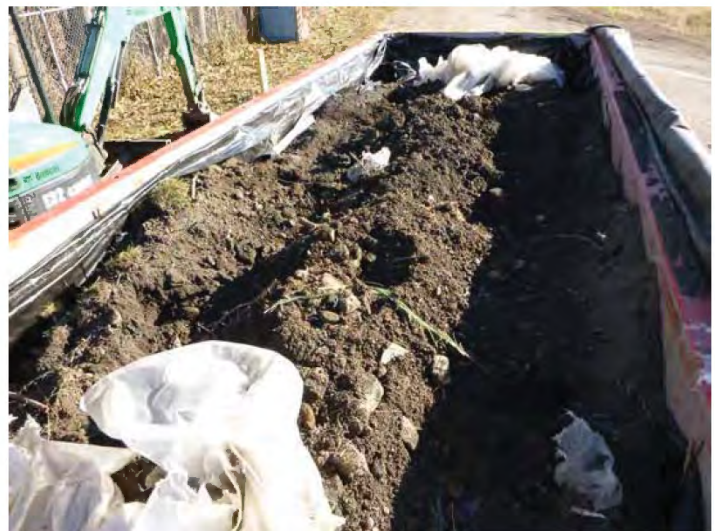
Photograph ID: 16

Comments: Excess soil spoils and plastic disposed of in the onsite Roll-off.

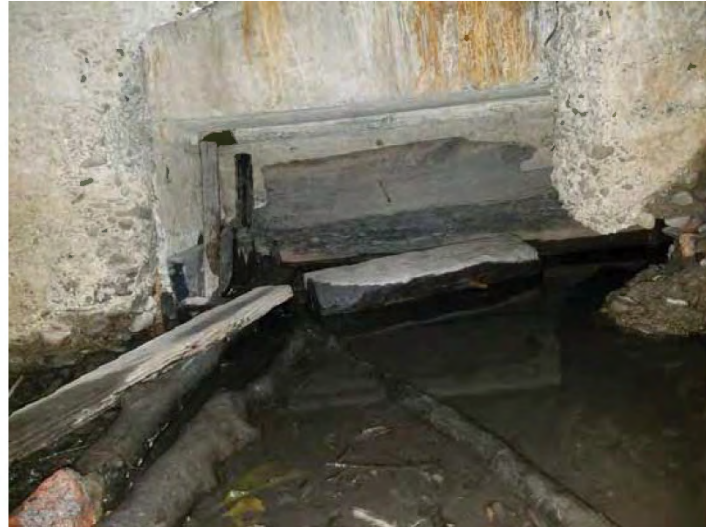
During the confined space entry, connections to CB-15 were visually inspected. A connection to the east toward the railroad tracks was observed to have been plugged with concrete. A connection to the northwest was constructed of clay tile and appeared to run parallel to the EHS property line. A connection to the southwest appeared to connect to OS2. A brick arch and 30-inch brick sewer line was observed (see photograph included in **Appendix F**) on the right side of this connection approximately ten (10) feet from CB-15.

**Comments: CB-15's northeast
connection, toward the railroad
tracks, was observed to have been
plugged with concrete.**

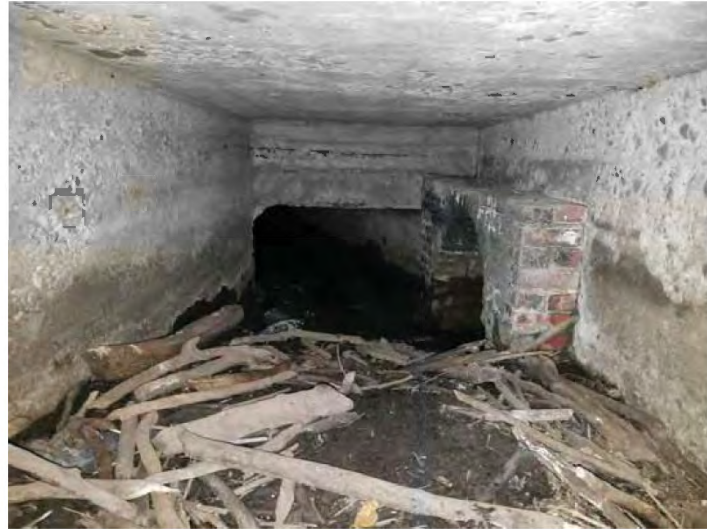
Comments: Looking from CB-15 toward OS-2, two connections were visible. The first connection to the southwest appeared to connect to OS2. A brick arch and 30-inch brick sewer line was observed on the right side of this connection approximately ten (10) feet southwest from CB-15.

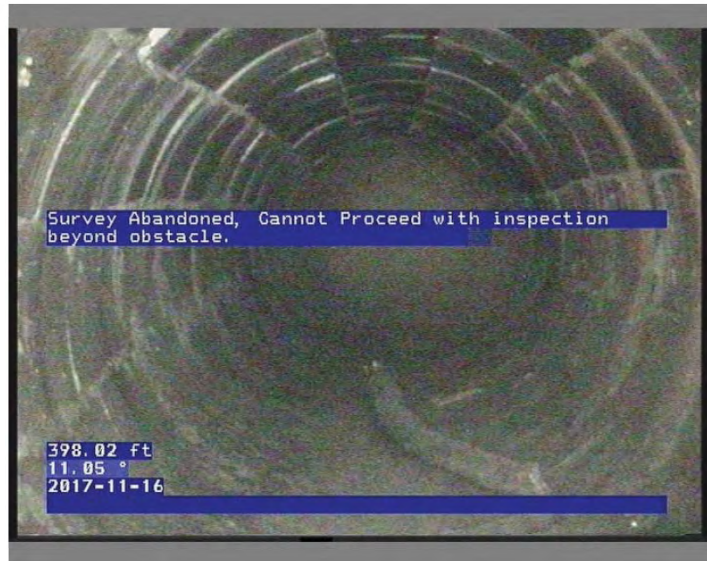
Photograph ID: 4

- A clay tile pipe connection connecting to CB-15 from the northwest extends approximately 395 feet. It was observed that this pipe had standing water and accumulated sludge in about ten 10 to twenty 20 percent (10-20%) of the pipe. Penetration by a two-inch PVC pipe and accumulated sand prevented further investigation at 395 ft. The structural compromise to the edge of the pipe at 395 ft is assumed to be piezometer MW-8 sand pack which obstructed further camera survey and flow. The location is consistent with a former

Comments: The thirty-six-inch (36-in) sewer line was surveyed from CB-15 to the northwest 398.02. The survey was abandoned because of blockage (sand).

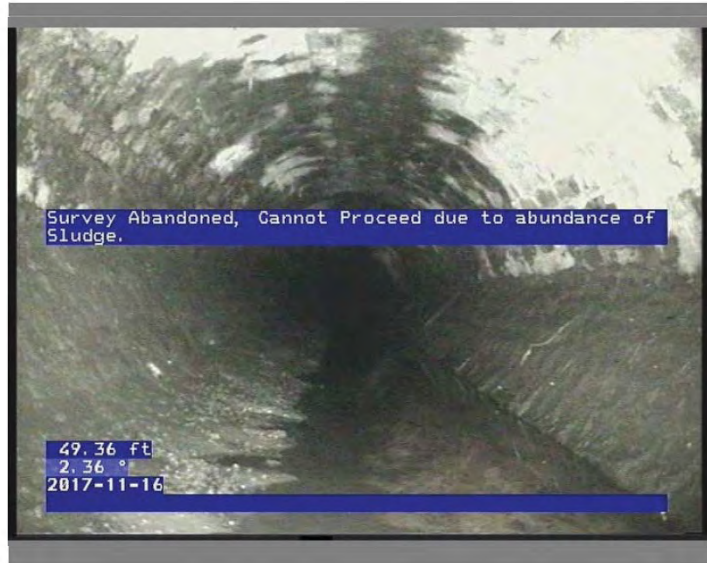
Comments: The 36-inch brick sewer line (10) feet southwest of CB-15 at a right angle to the 5-ft box culvert headed northwest. The survey was abandoned at 49.36 ft due to an abundance of sludge.

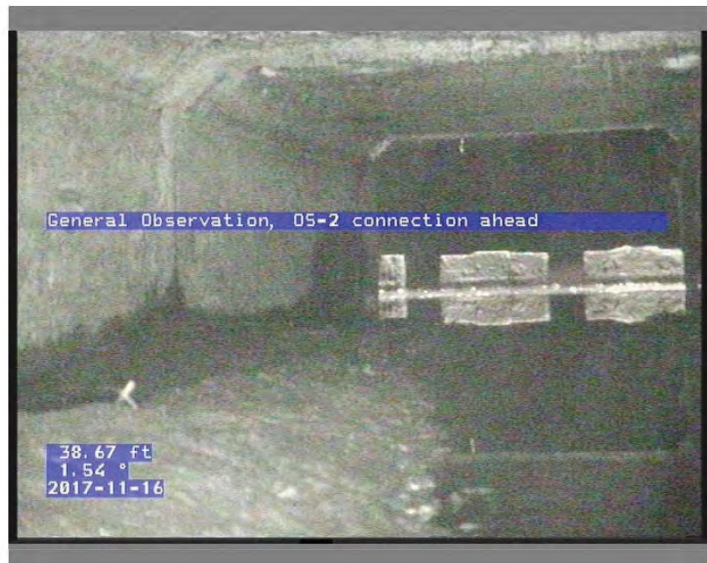
Photograph ID: 6

- The 5-ft box culvert connecting CB-15 to OS2 was surveyed to the southwest from CB-15. The culvert was wet with abundant fine-grained material, cobbles, wood, and standing water. The concrete culvert appears to be constructed of concrete segments. The survey extended a distance of approximately thirty-nine (39) ft until accumulated sludge prevented further progress and the survey was abandoned. The internal baffles at the northeast inlet to OS2 were observed. The connection to OS2 was confirmed by observation of an object that had been lowered through the OS2 manhole.

Comments: The 5-ft box culvert connecting CB-15 to OS2 was surveyed to the southwest from CB-15. The connection to OS2 was confirmed by a visual of the inlet weirs.

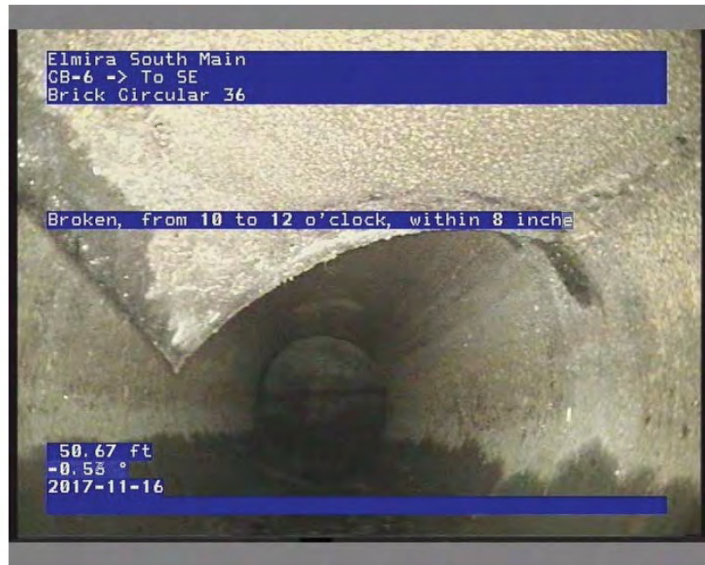
- The 36-inch circular brick pipe heading southeast from CB-6 was re-surveyed. The direction of stormwater flow is assumed to be to the southeast. Standing water, wood debris, rocks, and fine-grained material were observed in the line, making survey progress difficult. At a distance of approximately twenty-six (26) feet, two (2) connections are observed within a subsurface structure. The connection on the left (east) is sealed with brick and is not considered active. The connection to the right (west) continued straight. At a distance of approximately thirty-nine (39) feet from CB-6, the line transitions from brick to concrete and takes a right turn (between 30 and 80 degrees) to the southwest. At a linear distance of approximately forty-six (46) feet from CB-6, the line turns back to the left (east) at about the same angle as the previous turn. A structural fracture in the line was observed at 10-12 o'clock within eight (8) inches of the joint at a distance of approximately fifty (50) feet. At a distance of approximately sixty-seven (67) feet, the line again turns left (45 to 80 degrees) to the south and transitions to a clay tile built line. The survey ended at

Comments: The 36-inch circular brick pipe heading southeast from CB-6 was re-surveyed. A structural fracture in the line was observed at 10-12 o'clock within eight (8) inches of the joint at a distance of approximately fifty (50) feet.

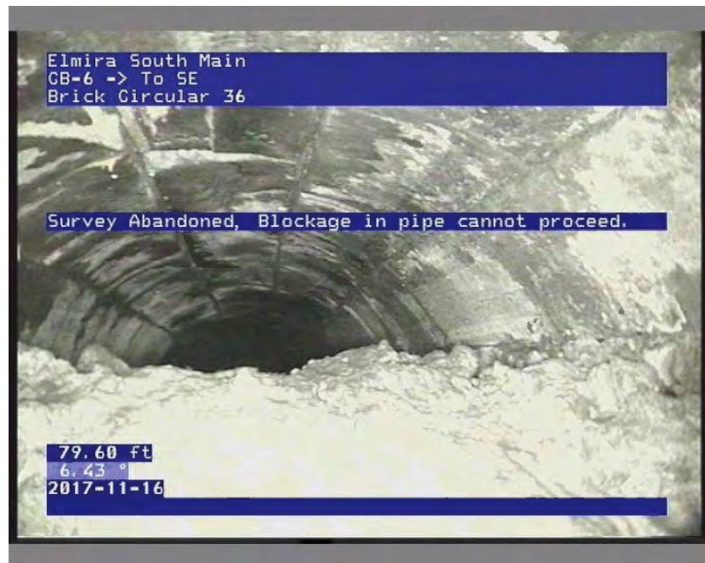
Photograph ID: 8

a linear distance of approximately eighty (80) feet at where approximately seventy-five (75) percent (75 %) of the connection was blocked by fine-grained material, wood, and rock. The survey of this connection was consistent with those from previous investigations while providing additional information regarding the condition of the western branch.

Comments: The survey ended at a linear distance of approximately eighty (80) feet at where approximately seventy-five (75) percent (75 %) of the connection was blocked by fine-grained material, wood, and rock.

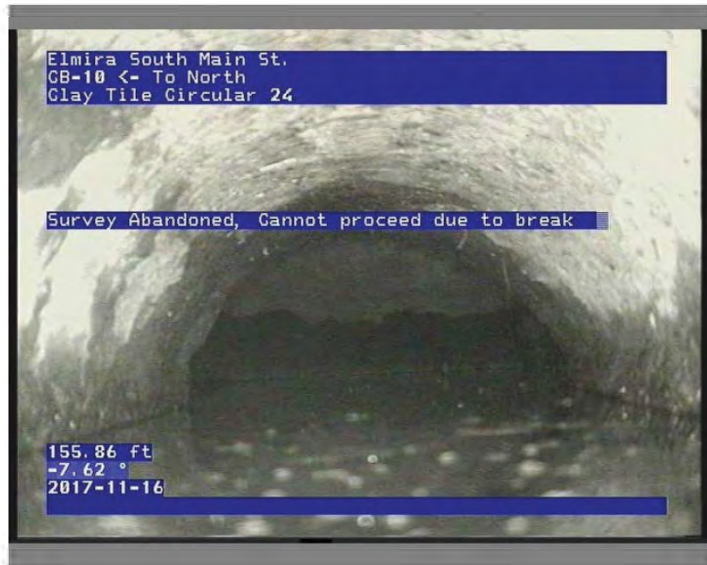
Comments: The connection heading northeast from CB-10 was re-surveyed in attempt to survey the entire line. An opening to another structure was observed at a distance of approximately one hundred fifty-seven (157) feet and the survey was ended. Based on distance and location, that structure is considered to be OS2.
