Department of
Environmental
Conservation

LAKE GEORGE BEACH

Pollution Source Investigation Update

June 2018

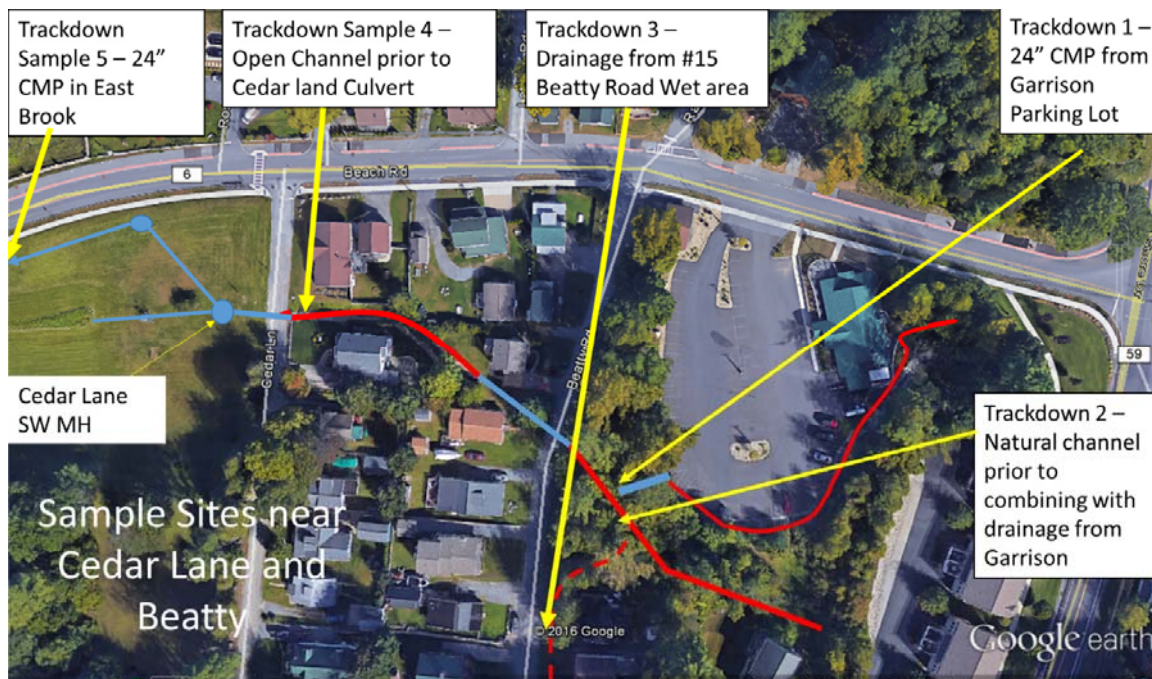
Cedar Lane and Beatty Road bacterial trackdown sampling sites

Consistently high *E. coli* levels were detected in the 24"-inch culvert and stormwater channel (Site #1A) that drains to a culvert on Cedar Lane and ultimately discharges from the 24" culvert. The stormwater system in the vicinity of Cedar Lane and Beatty Road became a focus of follow-up trackdown sampling and outfall identification to determine if there were any potential connection failures to the private residences in this neighborhood. Large increases in *E. coli* levels at these sites seemed to correspond to major holiday weekends (i.e., Independence Day weekend), possibly due to an increase in residential occupancy at seasonal homes during holiday weekends.

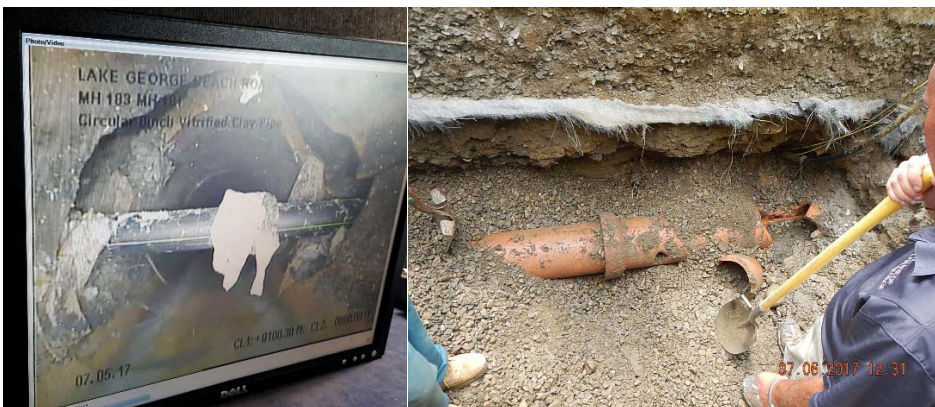
Dye testing was performed on the sanitary sewer lines located on Cedar Lane, Beatty Lane, Latham Road, Rose Point Lane, Front Street, West Brook Road, Route 9, Route 9L and Beach Road. Dye testing was also performed on a number of commercial buildings to verify that they were properly connected to the sanitary sewer system. No evidence of leakage or issues with the sanitary lines were detected through dye testing. Camera inspections were performed in the sanitary lines on Beatty Lane, Cedar Lane, and Beach Road. The camera investigation did reveal a break in the sewer main on Beach Road across from the Garrison Restaurant. A gas line installation had penetrated and broken the sewer pipe. The broken section was repaired the day after it was discovered.

Broken sewer line and actual photo from camera inspection

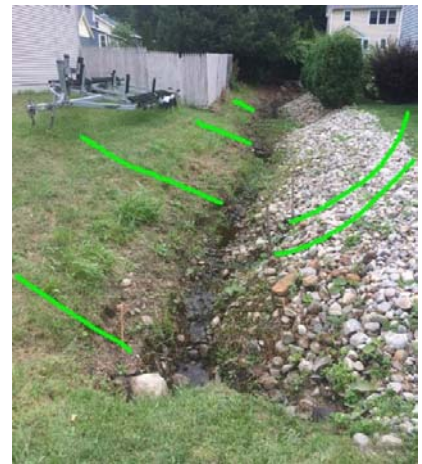
In August, local forces from the Town and Village of Lake George removed vegetation from the open swale between Cedar Lane and Beatty Road in order to locate any pipes or potential discharges into the swale. Several pipes were identified once the vegetation was removed. Outfall locations were marked and photographed. The pipes are believed to be footing drains or basement sumps from nearby residences. Ground Penetrating Radar (GPR) was brought in to locate the origin of the pipes. Two pipes appear to originate from residences adjacent to the channel. The GPR identified a total of six pipes that appear to discharge into the channel. Many residences in this neighborhood are occupied only seasonally or infrequently throughout the summer. Due to infrequent occupancy, obtaining permission from landowners to conduct follow up dye testing or inspections was difficult. DEC and its partners plan to follow up with dye testing of private residences in the vicinity of the swale in 2018.
