FLOOD MITIGATION & RESILIENCE REPORT

Little Chazy River - SD122

New York State Department of Environmental Conservation,
in cooperation with the New York State Office of General Services

June 2022

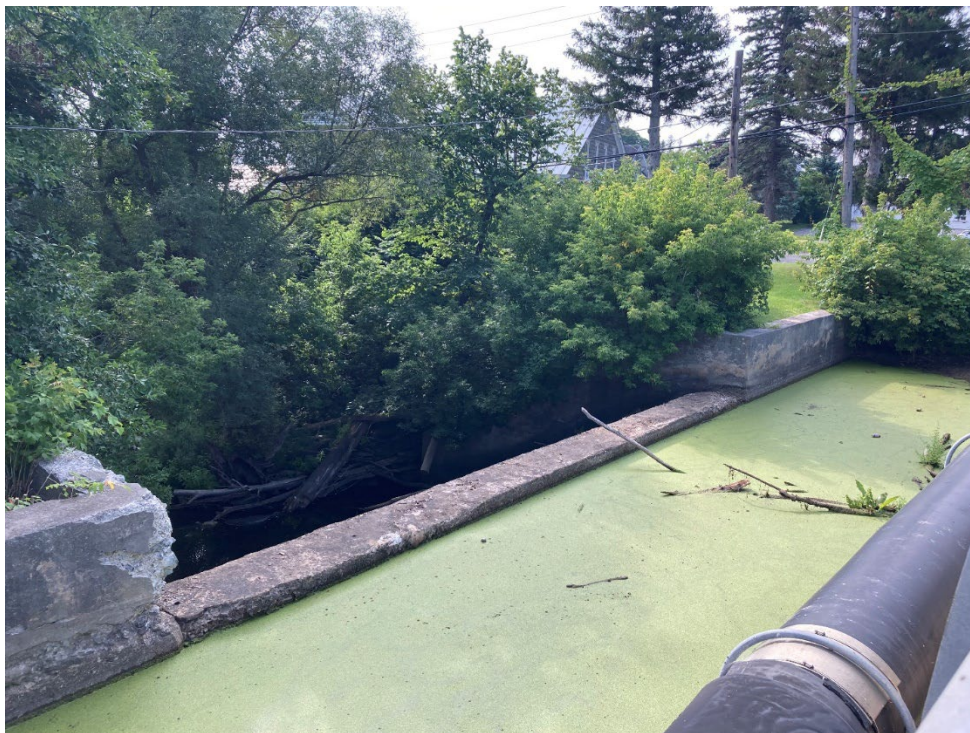
The Little Chazy Dam (Figures 4-4 and 4-5) sits just under 20 feet downstream of the downstream face of the US-9 bridge over the Little Chazy River in the town and hamlet of Chazy at STA 250+50 (NYSDEC ID: 235-0097; Federal ID: NY13995). This 18-foot-high, Class A Low Hazard concrete gravity dam was constructed in 1909 to provide hydroelectric power. It is presently owned by the Chazy Fire District; the fire station is located adjacent to the dam, depicted in Figure 4-2C, although the impoundment is reportedly no longer the district's primary water supply for firefighting. The last reported inspection was in 1971. During normal flows, this dam's impoundment reaches about 1,600 feet upstream, which can contribute to ice formation during the winter months that can exacerbate the severity of downstream ice jams, although problematic ice jamming was not reported in the Hamlet. During high flow events, the dam's backwaters contribute to flooding of 16 homes and businesses during the 10-year flood event, with a further 12 properties impacted during the 100-year flood event. Both 10-year and 100-year flood events cause overtopping of US-9 and River Street. It should be noted that neither the current effective nor preliminary FIS products appear to account for the presence of this dam; approximate methods hydraulic modeling associated with the 2020 Preliminary FIS does not include the structure. As a result, 100-year flood elevations in the hamlet upstream of the dam are underestimated by about 3 feet to over 5 feet compared to updated modeling developed for this study that does incorporate the dam.

Figure 4-4: View of Little Chazy Dam primary spillway from US-9 bridge. Chazy Fire District building is visible in background, partly obscured by vegetation.

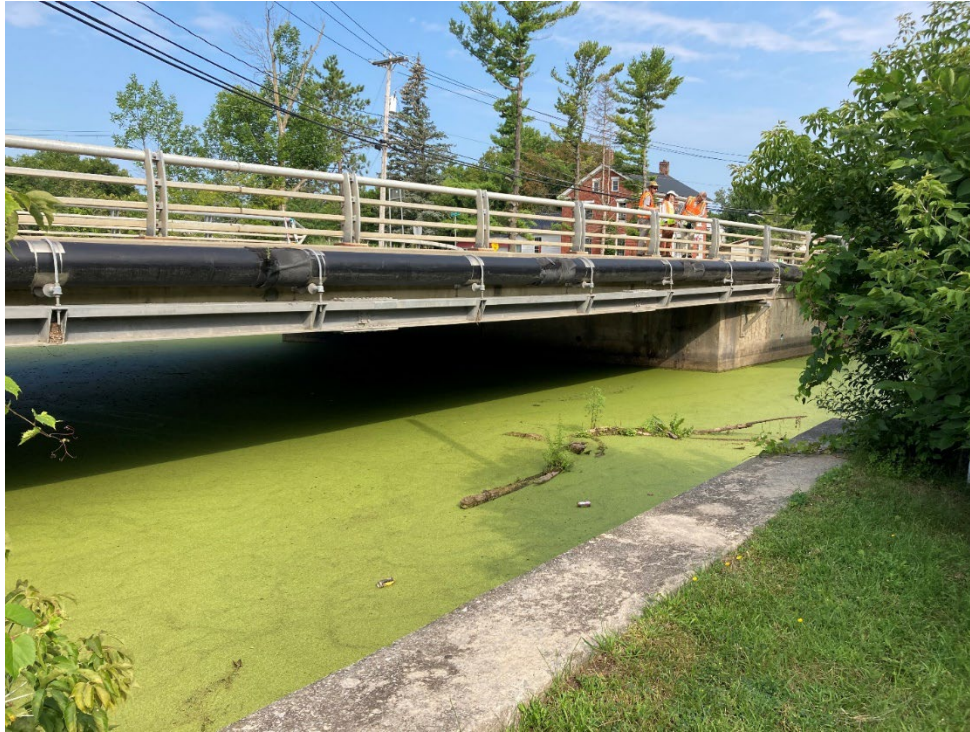
Figure 4-5: US-9 bridge, right training wall of Little Chazy Dam in foreground

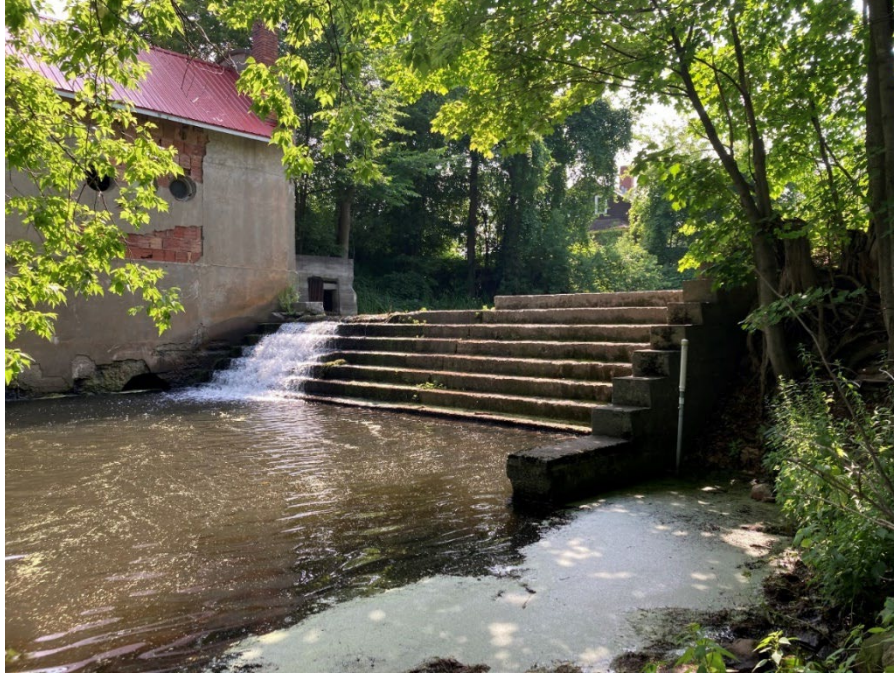
and inundation of Fiske Road during the 10-year flood event, with an additional five properties affected by the 100-year flood, which also overtops Duprey Road to the south. The 10-year flood also overtops the left training wall and top of dam, indicating a hydraulically undersized spillway and potential exposure to loadings in excess of design, both of which can increase the risk of dam failure.

Figure 4-6: The W.H. Miner Dam #2 in West Chazy. Note deteriorated concrete spillway and powerhouse building.

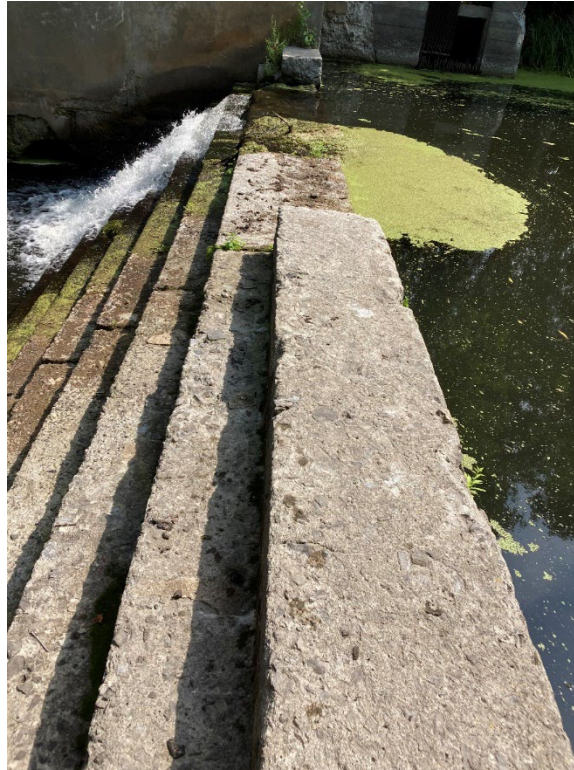
Figure 4-7: Spillway of the W.H. Miner Dam #2 in West Chazy

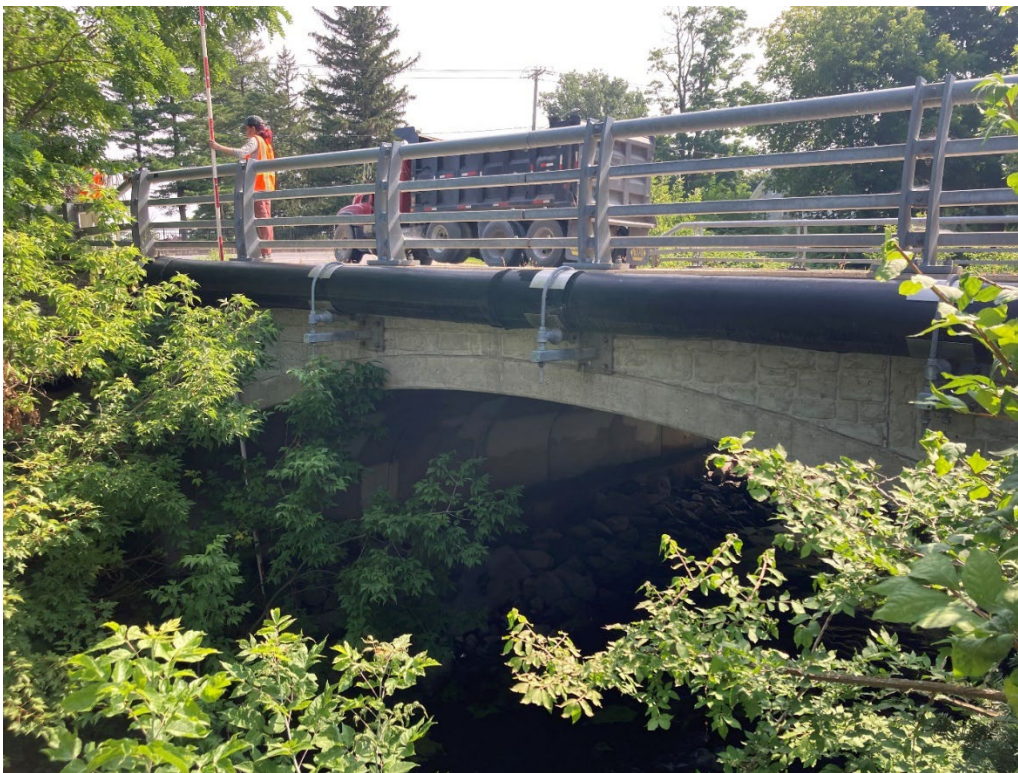
The Fiske Road bridge crosses the Little Chazy River at STA 272+00 (NBI BIN: 1046260), shown in Figure 4-13. Hydraulic modeling shows that this concrete arch bridge generates minor backwaters. It has the capacity to convey flood flows without overtopping, including the current 500-year flood and projected future 100-year flood events. However, the river is significantly laterally constricted by this crossing, which contracts the approximately 80-foot-wide upstream channel into the 36-foot-wide hydraulic opening of the bridge. This can contribute to debris and ice jamming, which can significantly inhibit the bridge's performance, leading to excess flooding or potentially overtopping. Such a contraction can also generate adverse scour conditions. The bridge is relatively new, having been constructed in 1995; when it is due for replacement, a minimum 80-foot single span is recommended along with updated hydrologic and hydraulic analyses that account for projected future flows relevant to the new structure's anticipated lifetime. The new bridge should adhere to appropriate NYS DOT and NYS DEC stream crossing standards and guidelines.

Figure 4-13: Fiske Road concrete arch bridge, looking upstream from the left bank

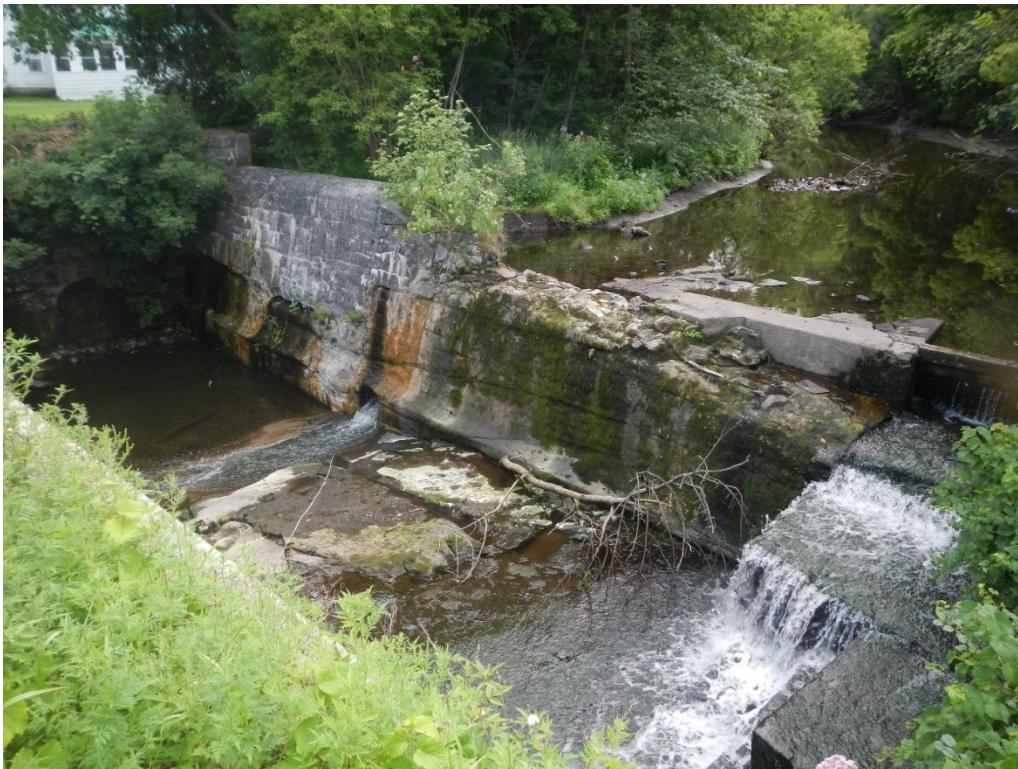
The West Chazy Dam structure's listed spillway height is 12 feet, although bedrock ledge was observed immediately upstream and downstream of the dam, indicating a natural falls at this location; the dam appears to raise the natural normal upstream water surface by just a few feet. Modeling indicates that this dam's backwater affects two upstream properties in both the 10-year and 100-year flood events, which would be alleviated by removing the dam. Hydraulic modeling also demonstrates that the right training wall and top of dam are overtopped in the 25-year flood event, indicating inadequate spillway performance and potential exposure to loadings in excess of design, both of which can increase the risk of dam failure. Removal of the dam and restoration of the natural falls is recommended. A more conventional dry hydrant system, which does not require impoundment of the river, is recommended to replace the current fire suppression appurtenances. A typical detail is shown in Figure 4-32.

Figure 4-16: West Chazy Dam. Note significant seep at center-bottom of main dam section, evidence of ASR in the concrete, crack and deteriorated concrete, and vegetation growing in the concrete spillway.

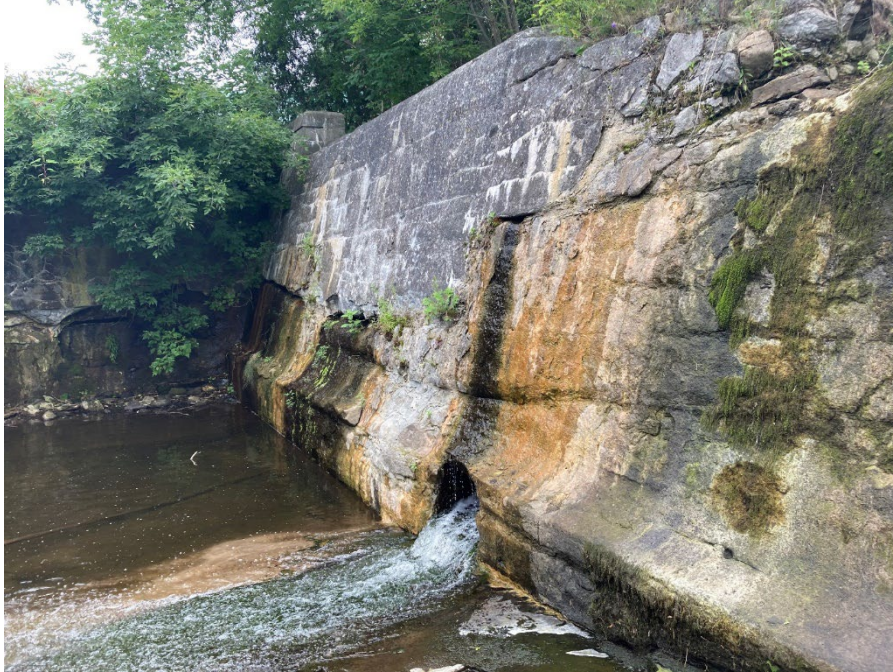
Figure 4-17: West Chazy Dam. Note major seep, ASR, cracks, and deteriorated concrete.

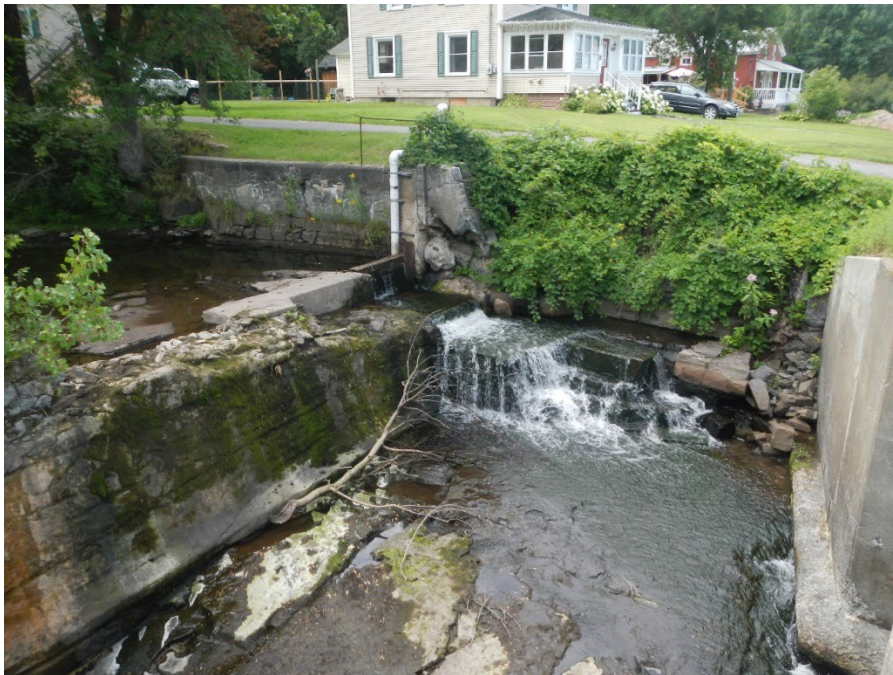
In the hamlet of West Chazy, a low-head dam is present at STA 780+00, immediately upstream of the NY-22 bridge crossing of the Little Chazy River ("West Chazy Dam;" NYSDEC: ID 217-0154; Federal ID: NY13635). According to NYSDEC's dam database, this concrete and masonry gravity dam is a Class A, High Hazard dam, built in 1901 and owned by a Stanley Farbotko. Its listed use is irrigation, although no such outlet works or diversions were observed; however, a dry hydrant, ostensibly for fire suppression, is present. It was last inspected in 1993, and its condition is currently not rated, although numerous seeps were observed during field investigations, one of which appeared to be significant along with structural cracking and evidence of alkali-silica reaction (ASR) within the concrete, shown in Figures 4-16, 4-17, and 4-18. The left upstream training wall was observed to be deteriorated as well and leaning toward the river; the left downstream abutment wingwall appears to be completely undermined (Figure 4-18).

Figure 4-18: West Chazy Dam. Dry hydrant is visible near the center of the image, and the left abutment of NY-22 bridge is visible at right. Note deteriorated spillway crest and deteriorated left upstream training wall is leaning toward the river. The dam's left downstream abutment wingwall appears to be completely undermined (visible just to the right of vertical section of dry hydrant).

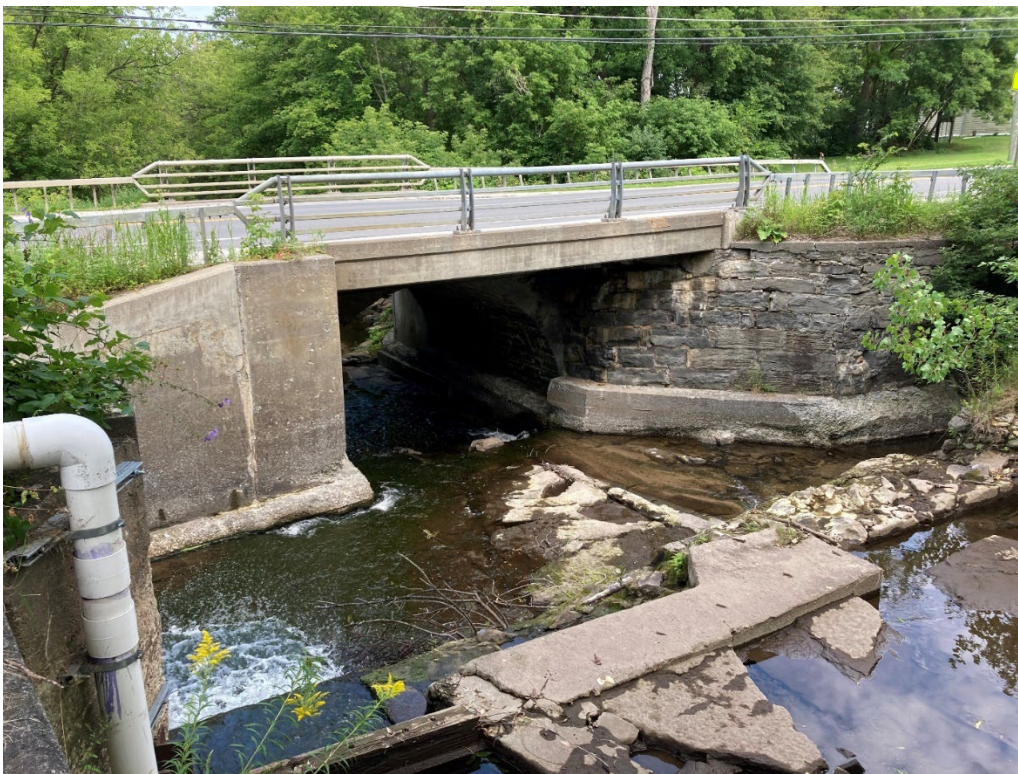
The NY-22 bridge at STA 779+50, just downstream of the West Chazy Dam, consists of an older stone masonry arch bridge, with a newer, wider, concrete superstructure and deck set on top of the old structure (NBI BIN: Not Listed). Hydraulic modeling shows that the bridge passes the current 100-year flood event but is expected to overtop in the projected future 100-year flood. The structure represents an extreme lateral constriction, contracting the 60-foot-wide channel into a roughly 19-foot-wide bridge opening, as shown in Figures 4-19 and 4-20. Generally, such a flow contraction can generate adverse scour conditions; however, this bridge is founded on bedrock, which reduces this hazard somewhat. The bridge's short span is also prone to debris jamming. When it is due for replacement or significant upgrade or repair, a minimum 60-foot replacement single-span bridge is recommended, to be verified with updated detailed hydrologic and hydraulic analyses that account for projected future flows relevant to the new structure's anticipated lifespan. The new bridge should adhere to appropriate NYSDOT and NYSDEC stream crossing standards and guidelines. The current bridge does not appear in the 2020 National Bridge Inventory (NBI), presumably because its less-than-20-foot span does not meet the NYSDOT definition of a bridge. Replacement of this bridge in itself is not expected to significantly reduce the clear water flooding hazard in its proximity unless accompanied by removal of the West Chazy Dam, which is largely a consequence of the hydraulic interdependence between the two structures.

Figure 4-19: NY-22 bridge immediately downstream of the West Chazy Dam. Note significant contraction into bridge and dry hydrant in foreground as well as deteriorated spillway concrete.

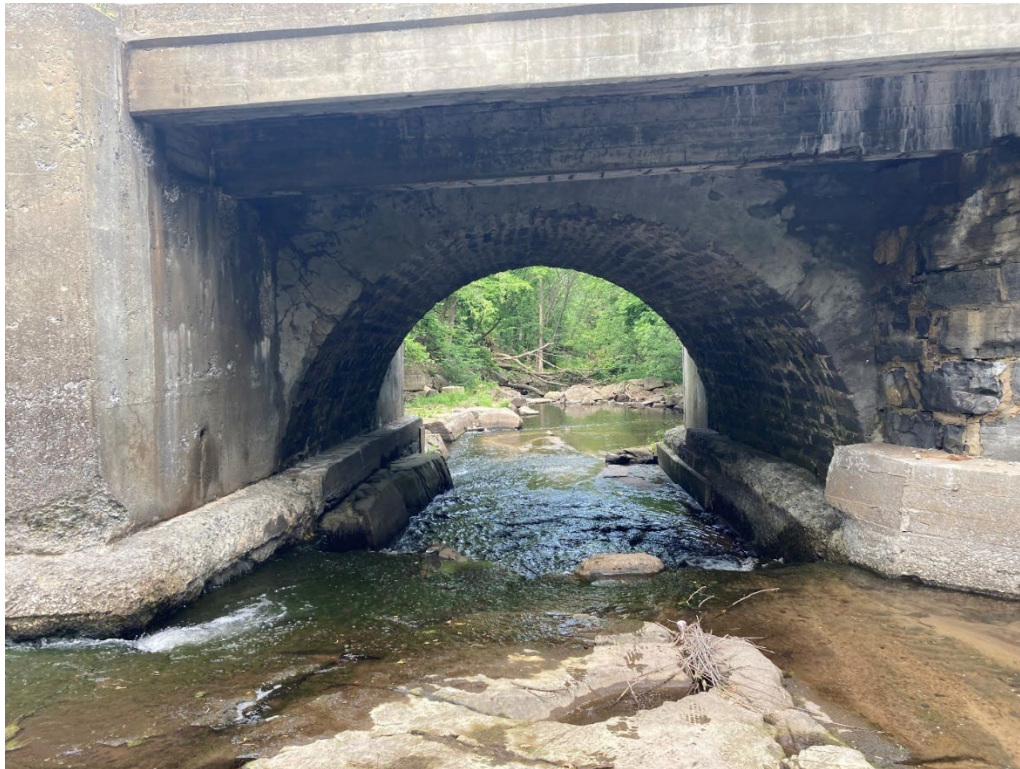
Figure 4-20: NY-22 bridge, looking downstream. Note the additional contraction into the older masonry arch within the bridge; deterioration of concrete knee walls, and spalling, ASR, and exposed rebar in the new concrete superstructure.

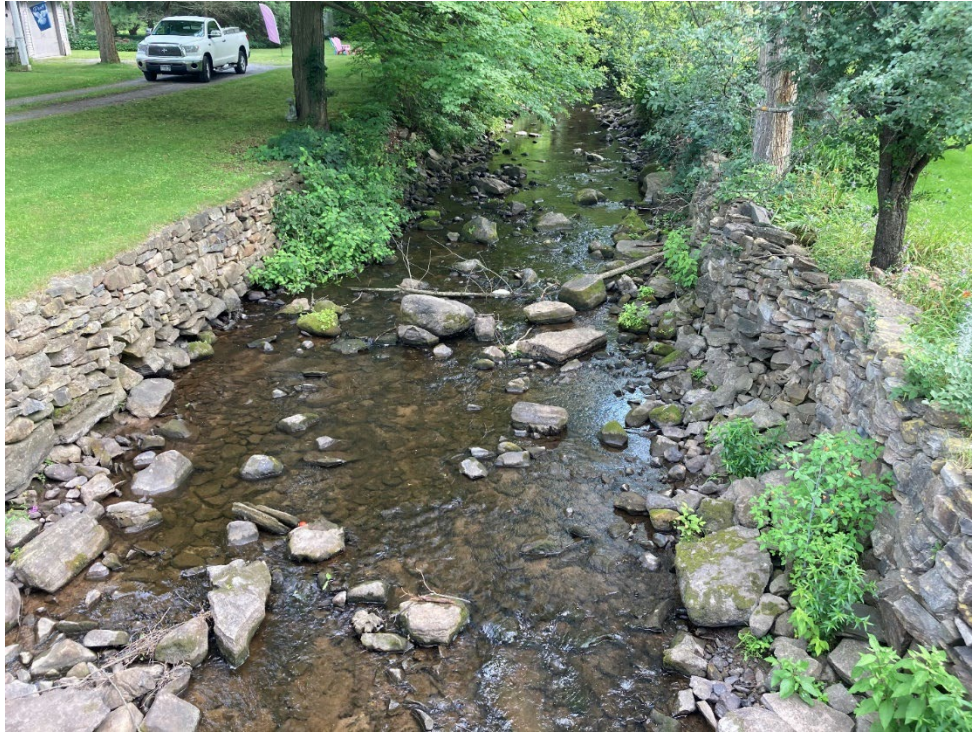
Figure 4-22: Confined and entrenched channel immediately upstream of the West Church Street bridge

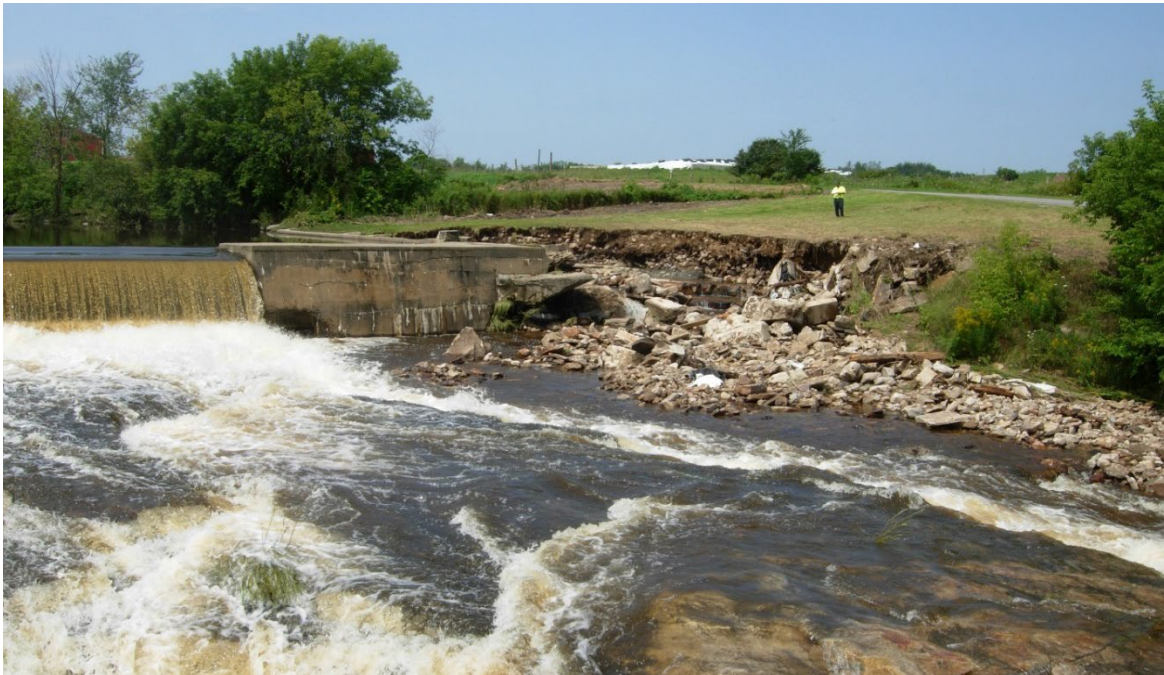
Figure 4-31: Overtopping during flooding in August 2010 caused washout of left embankment and undermining of abutment of McGregor Dam near the Canaan Road bridge in Ellenburg Depot. Photo provided by Clinton County Emergency Services.

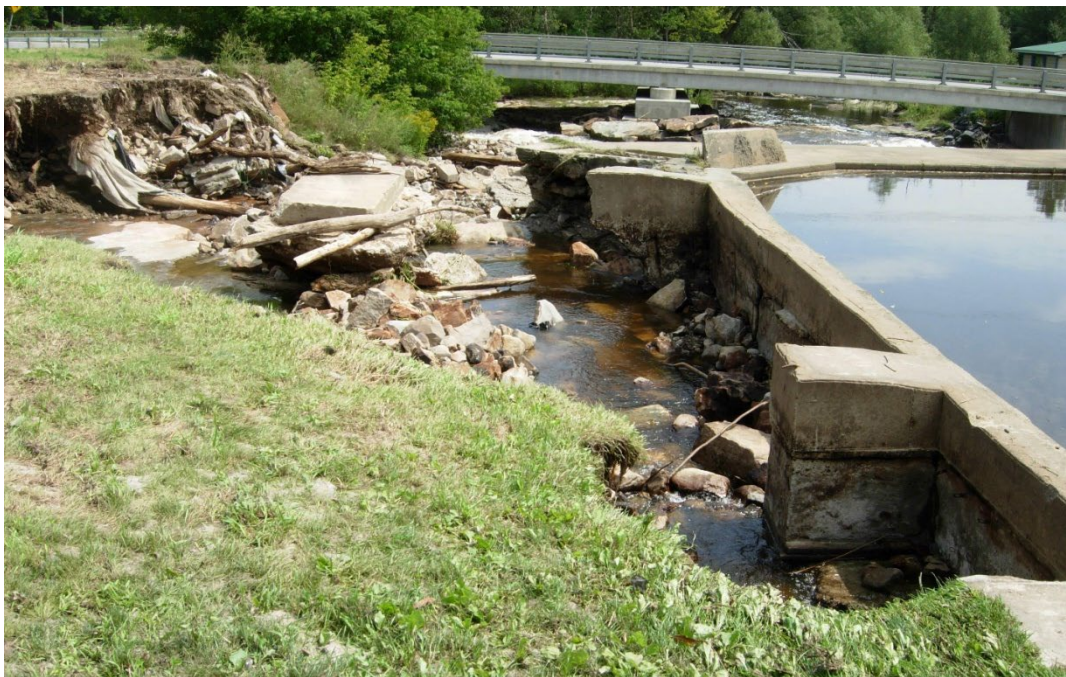
Figure 4-32: Damage to McGregor Dam on North Branch Great Chazy River due to overtopping in August 2010. Canaan Road bridge in background. Photo provided by Clinton County Emergency Services.

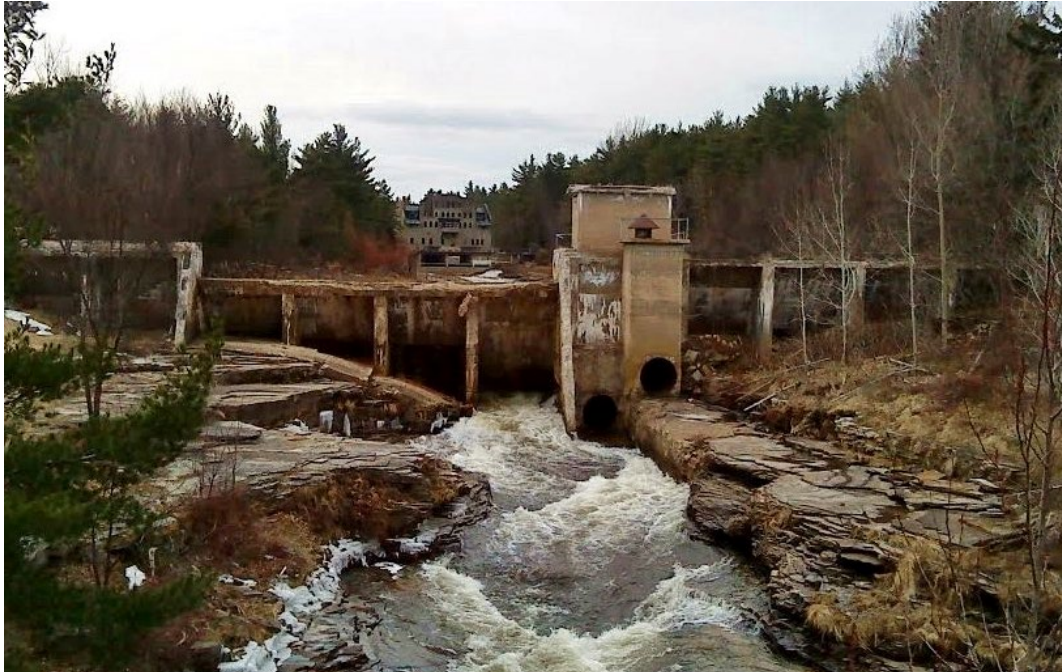
Figure 4-34: LaSell Dam on the Great Chazy River in 2007. The hydroelectric project was abandoned in the late 1950s – early 1960s and the penstocks and turbines sold for scrap. Note severe deterioration and evidence of alkali-silica reaction in the structural concrete and that one of the slabs in the primary spillway section had failed.
