# FLOOD MITIGATION & RESILIENCE REPORT

## Saddle River Watershed SD114

New York State Department of Environmental Conservation,  
in cooperation with the New York State Office of General Services

June 2022

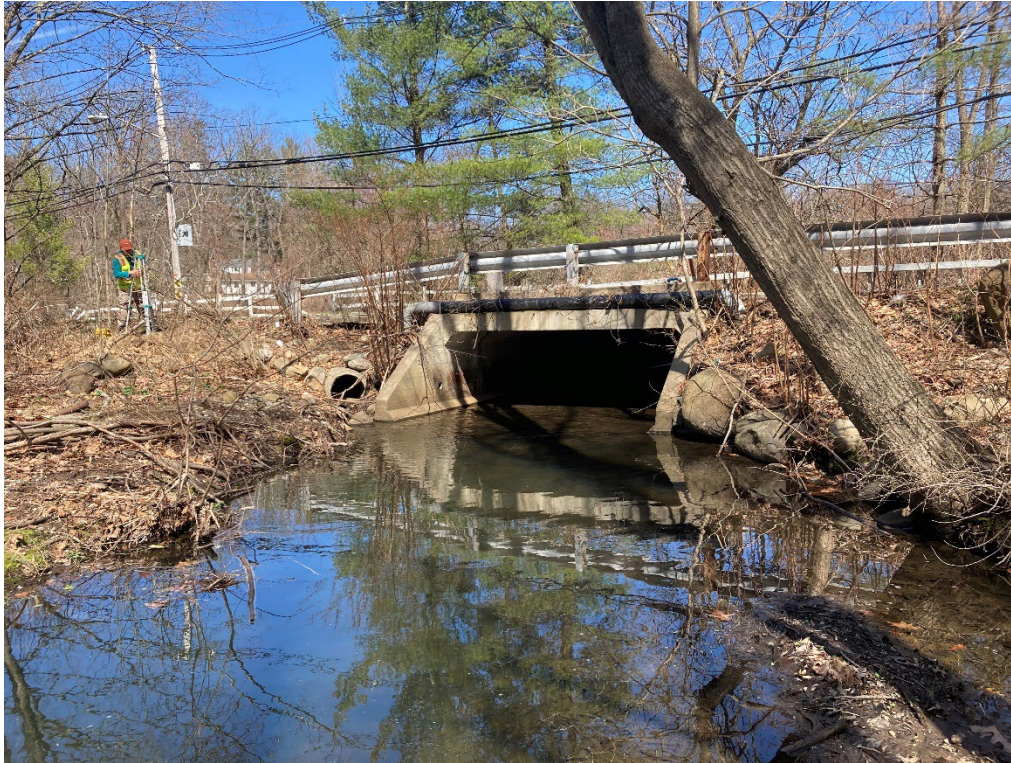
**Figure 4-3: Pine Brook Road crossing of Pine Brook**

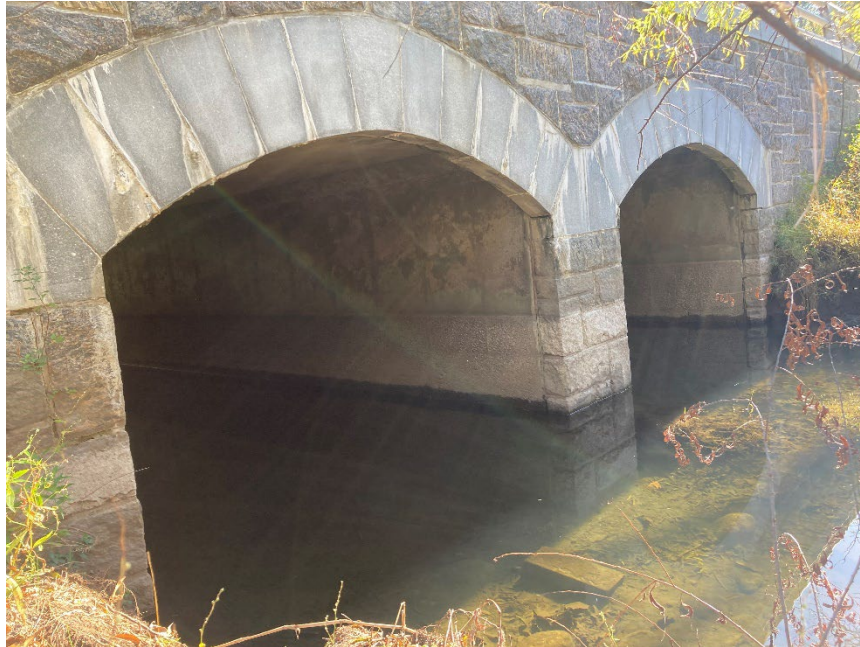
Furthest upstream in this section, the privately owned Ascension Cemetery driveway crosses the East Branch Saddle River at STA 25+00 with two open-bottom concrete arches (Figure 4-6). An HY-8 analysis of the crossing shows a capacity of 413 cfs. This is less than the 10-year flood peak flow of 710 cfs, resulting in overtopping of the crossing. The slope of the tailwater is very flat due to a downstream dam.

**Figure 4-6: Ascension Cemetery driveway crossing of East Branch Saddle River**

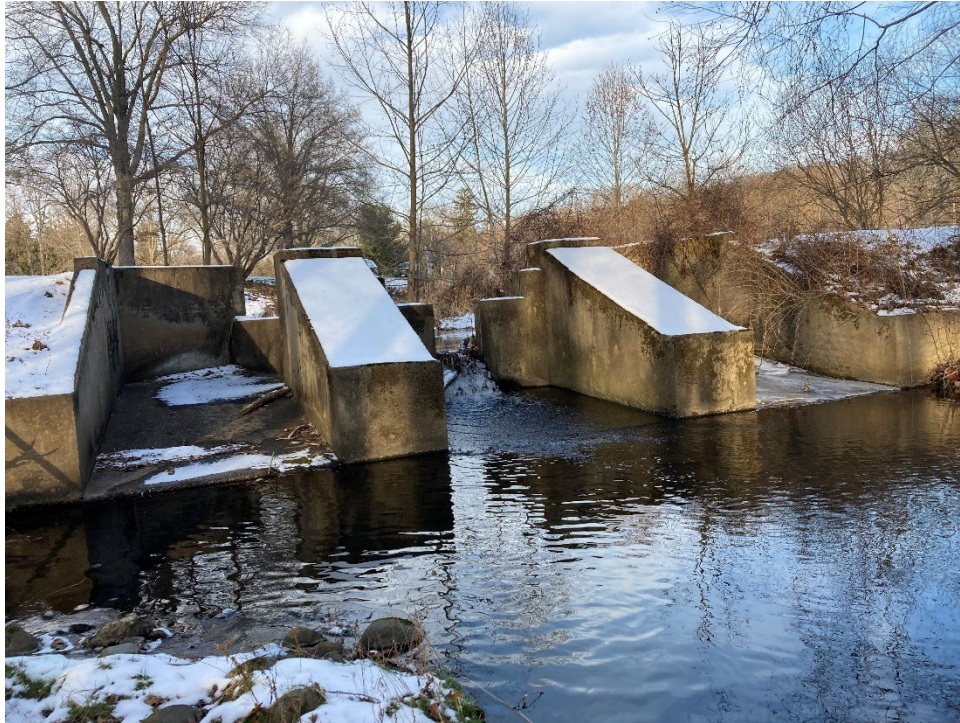
Between the Ascension Cemetery and Gates of Zion Cemetery driveways is the St. Patrick Cathedral Cemetery Dam (State ID 196-5797; Federal ID NY 16950) at STA 22+00 (Figure 4-7). Based on review of NYSDEC dam information, this dam is privately owned and has a hazard classification of D. Class D dams are considered by NYSDEC to be defunct dams posing negligible or no hazard. During SLR's site visit, the area behind the dam was dry and vegetated. The East Branch Saddle River was a single channel with some pooling at the inlet and outlet of the dam. During high water events, the dam restricts flow, flooding the upstream area. While the flooded area is undeveloped, the pooling reduces the capacity of the crossing of the Ascension Cemetery driveway.

**Figure 4-7: Outlet of dam downstream of Ascension Cemetery driveway**

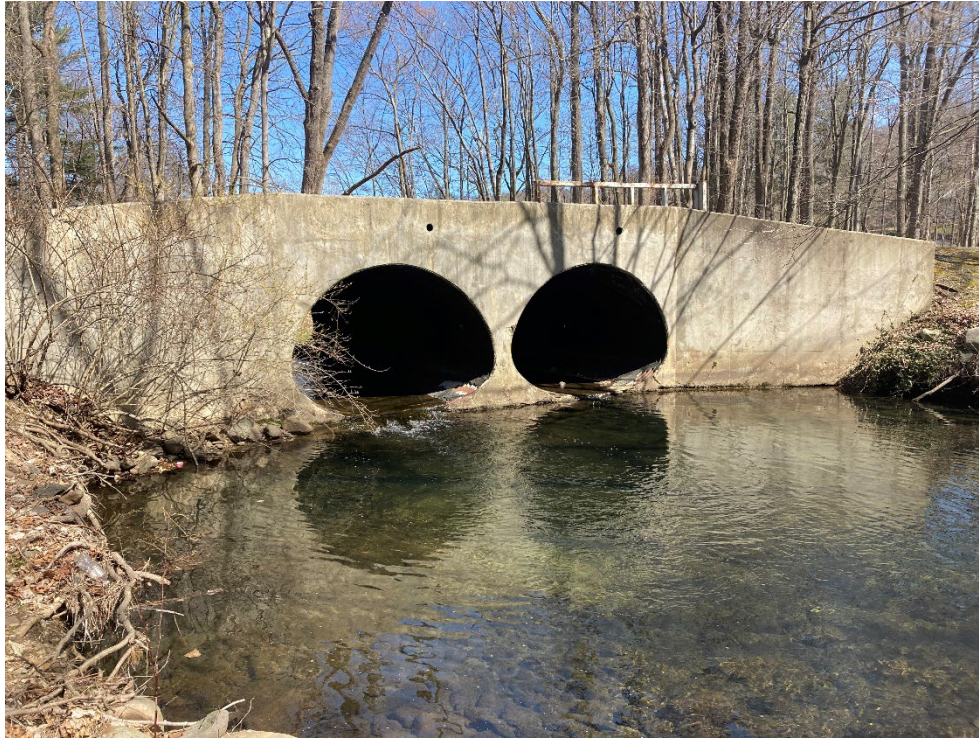
The next crossing of the East Branch Saddle River is the driveway of the Gates of Zion Cemetery at STA 20+00. It is made up of two arched pipes and is privately owned. The tailwater slope is very flat, approximately 0.5 percent, which is influenced by the scour pool at the outlet in Figure 4-8. An HY-8 analysis of the crossing shows that its current capacity is 760 cfs before overtopping, which is greater than the current 10-year peak flow of 710 cfs.

**Figure 4-8: Gates of Zion Cemetery driveway crossing outlet**

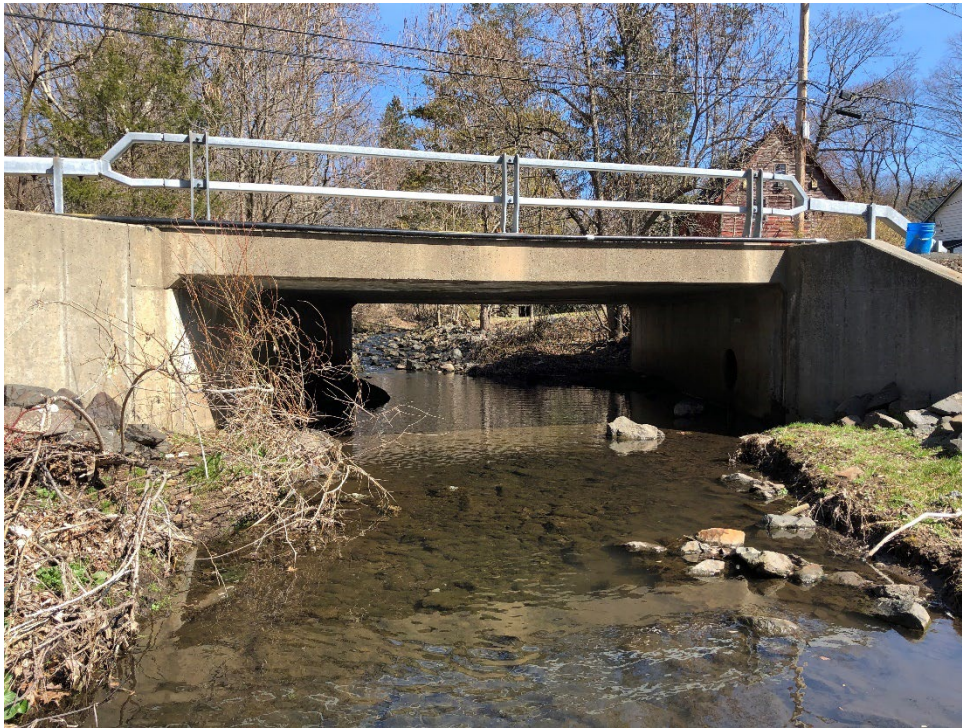
**Figure 4-9: Looking upstream through the crossing of Hillside Avenue over the East Branch Saddle River**

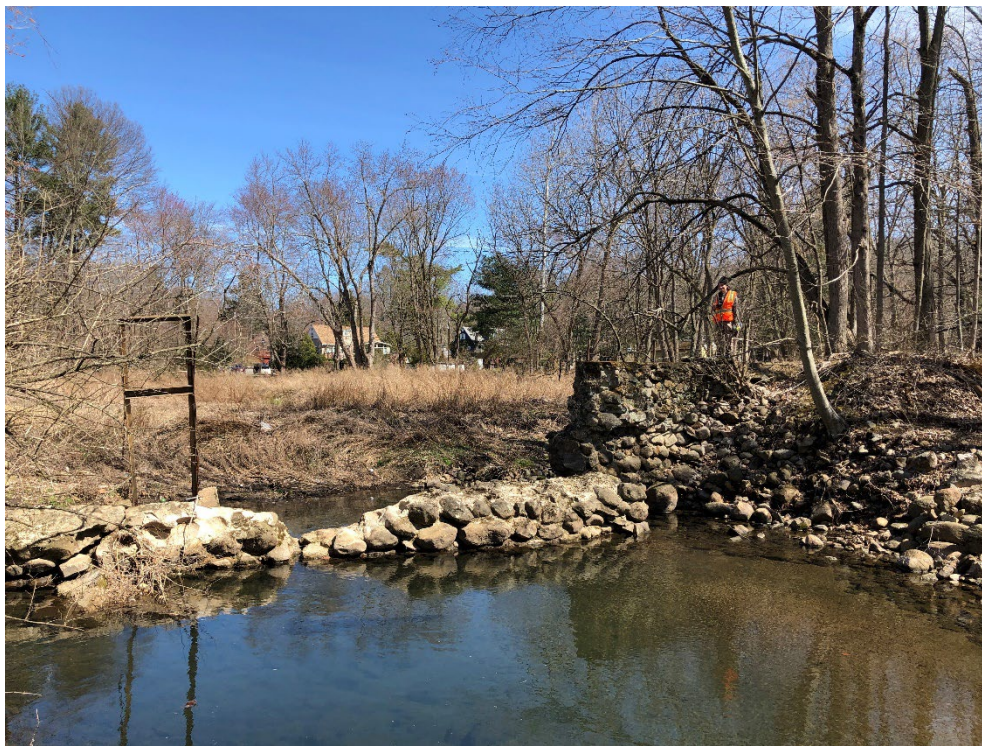
The dam measures over 250 feet long, ranges from 4 to 10 feet high, and is approximately 6 feet wide. Although the structure has been breached over the active channel, its levees cutoff floodplain access relief and may be influencing upstream water surface elevations. A full removal of the former dam and its components is recommended. This would entail the removal of about 225 liner feet of embankment fill material over the East Branch Saddle River's floodplain. Restoration of the immediate channel reach that is being disrupted by the presence of the collapsed mortared stone is also recommended. Removal of the obstruction will provide stream health and aquatic organism passage benefits, and the potential for flood reduction benefits may also exist. A rigorous hydrologic and hydraulic examination is recommended to assess the flood mitigation impacts of the recommended dam removal.

**Figure 4-11: Looking upstream at the breached section of the unregistered dam over the East Branch Saddle River at STA 4+50**

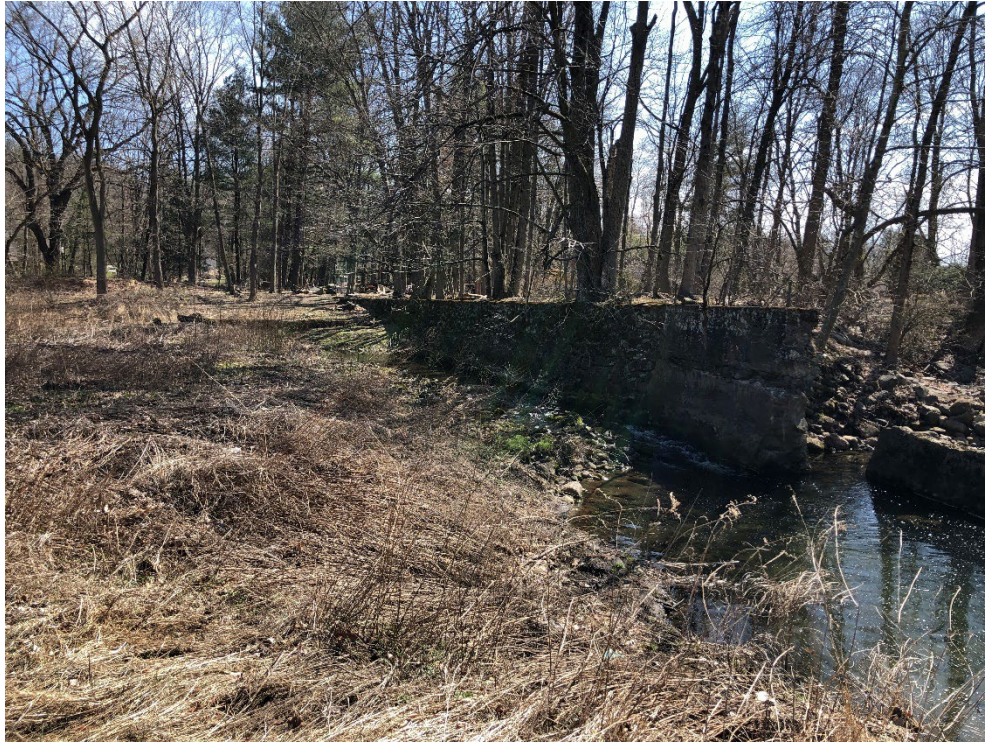
**Figure 4-12: Looking downstream at the dam remnants to the left of the breach**

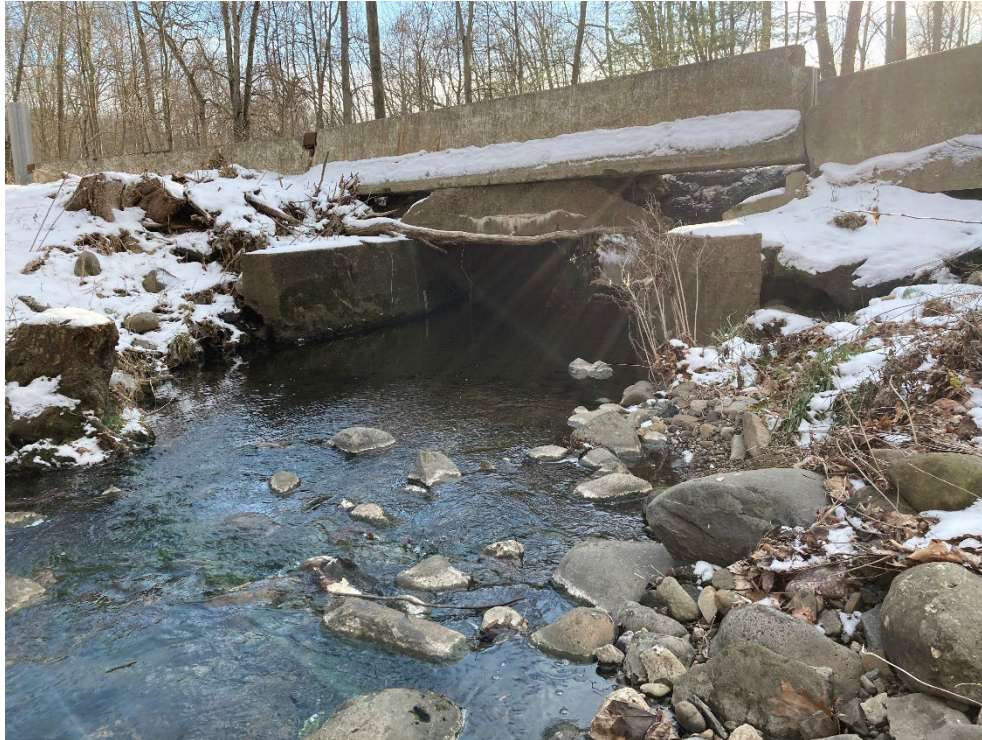
**Figure 4-15: Inlet of South Monsey Road crossing of East Branch Saddle River**

For the East Branch Saddle River crossing, an open-bottom crossing is recommended by the NYSDEC. The bed slope should match that of the tailwater, 2.5 percent. This is an increase from 0.5 percent slope of the current culvert, which will increase the capacity of the crossing. The HY-8 analysis of a crossing with a 34-foot span, 4-foot rise, open bottom, and 2.5 percent slope gives a capacity of 998 cfs and no overtopping of the road in 100-year future flow. A detailed hydraulic and hydrologic analysis is recommended to properly size a replacement structure. Restoration of the channel upstream and downstream of the crossing is recommended to address the change in slope.

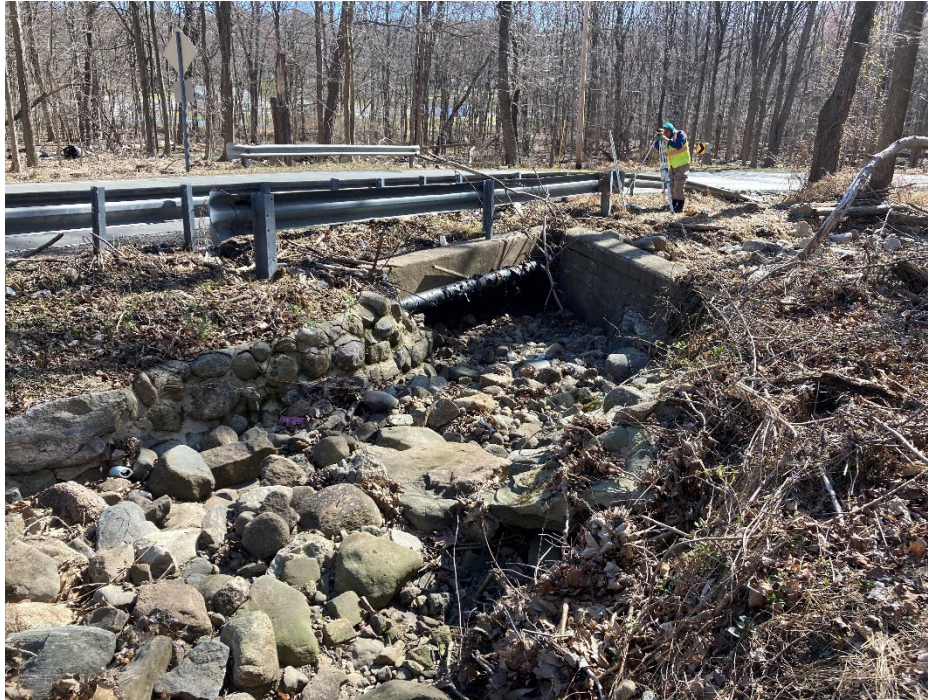
**Figure 4-16: Inlet of unnamed tributary of East Branch Saddle River crossing under South Monsey Road**

For the crossing over the unnamed tributary, the HY-8 analysis shows that expanding the span from 10 feet to 17 feet and removing some of the large rocks at the inlet to increase the rise to 2.4 feet at the inlet results in a capacity of 211 cfs and no overtopping at 100-year future flow levels. Additional hydraulic and hydrologic analysis is recommended to resize this culvert when it is due for replacement.

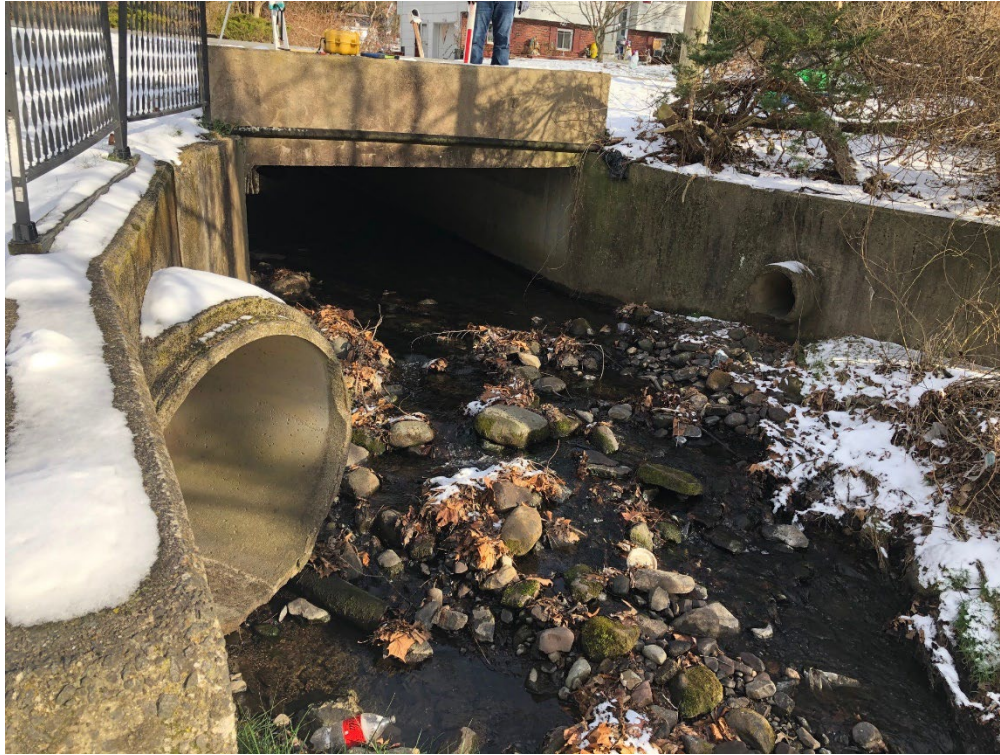
**Figure 4-19: Outlet of Regina Road crossing of East Branch Saddle River**

The HY-8 analysis of a crossing with a 22-foot span, 3.4-foot rise, open bottom, and slope of 2 percent shows a capacity of 690 cfs, which passes the 100-year future flow without overtopping. When due for replacement, a detailed hydraulic and hydrologic analysis is recommended to properly size a replacement structure for the culvert under Regina Road and should include restoration of the upstream and downstream channel sections to correct for the break in slope.

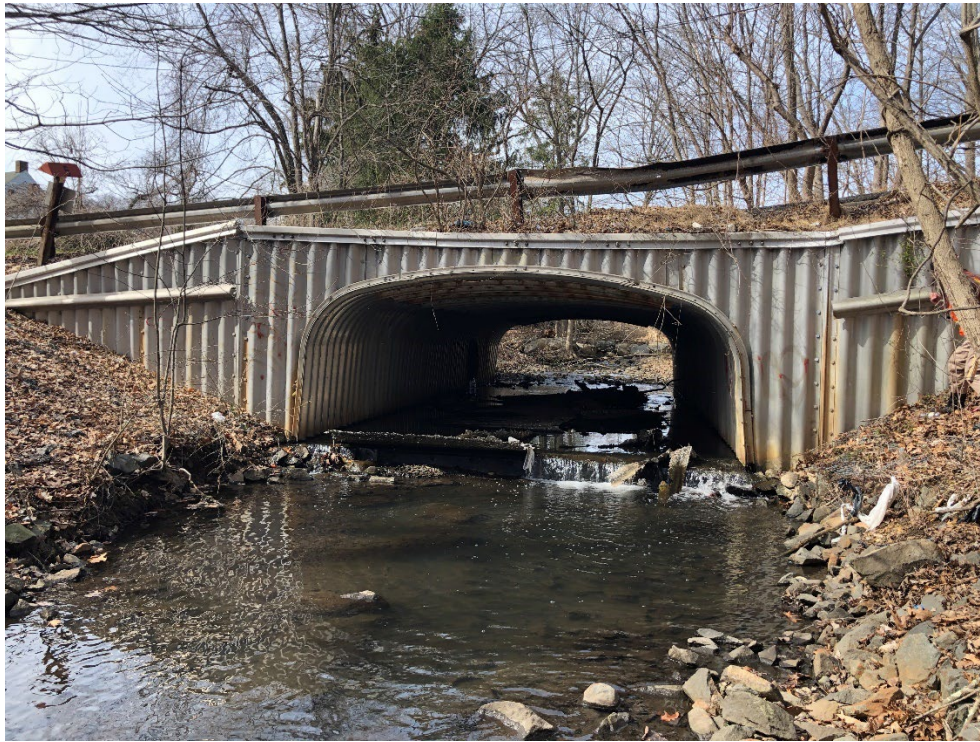
The stream crossing at Christmas Hill Road (ownership unknown) consists of a corrugated metal closed-bottom arch culvert with a span of 17 feet and a rise of 6.5 feet (Figure 4-23). The culvert currently passes up to the current 50-year flood event but overtops at the current 100-year and 500-year flood events. Based on modeling results, the structure is flanked by floodwaters at the current 50-year flood event at a low spot in the road to the right of the culvert (Figure 4-24). The culvert lacks the hydraulic capacity to pass the future 50-year, 100-year, or 500-year flood events. The structure's hydraulic performance is controlled by its outlet. While visiting the structure for a field assessment, it was noted that the floor of the culvert was severely deteriorated. The culvert outlet is perched, which presents a barrier to aquatic organism passage, and a scour pool was observed at the outlet, indicating high velocities through the culvert during high flow events.

**Figure 4-23: Looking upstream at the outlet of Christmas Hill Road culvert**

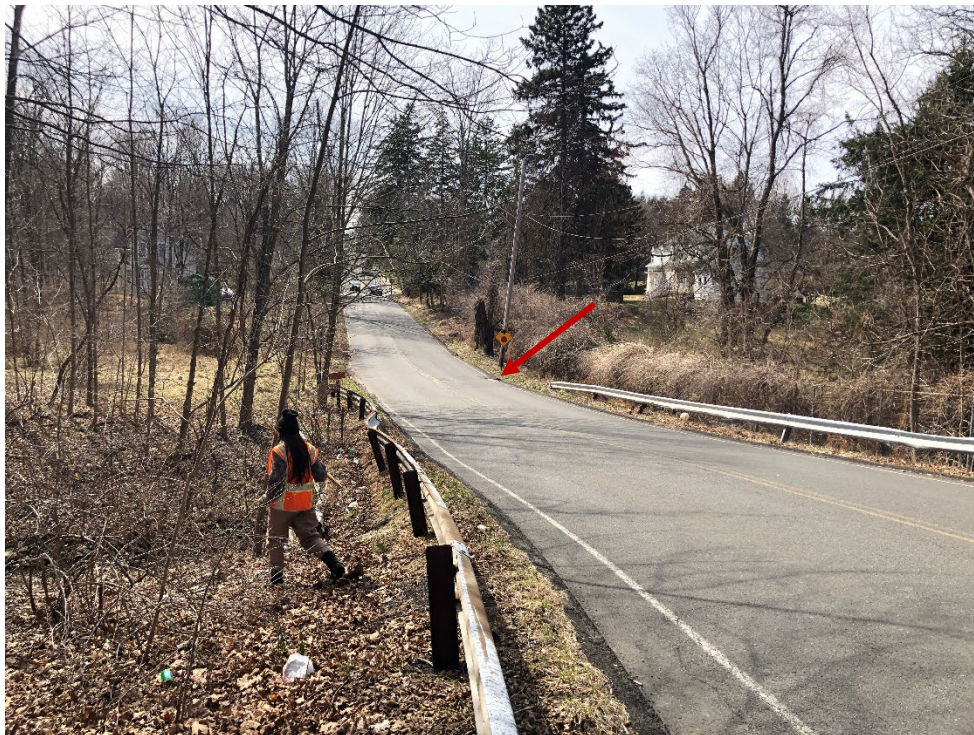
**Figure 4-24: Low spot in Christmas Hill Road where culvert gets flanked**

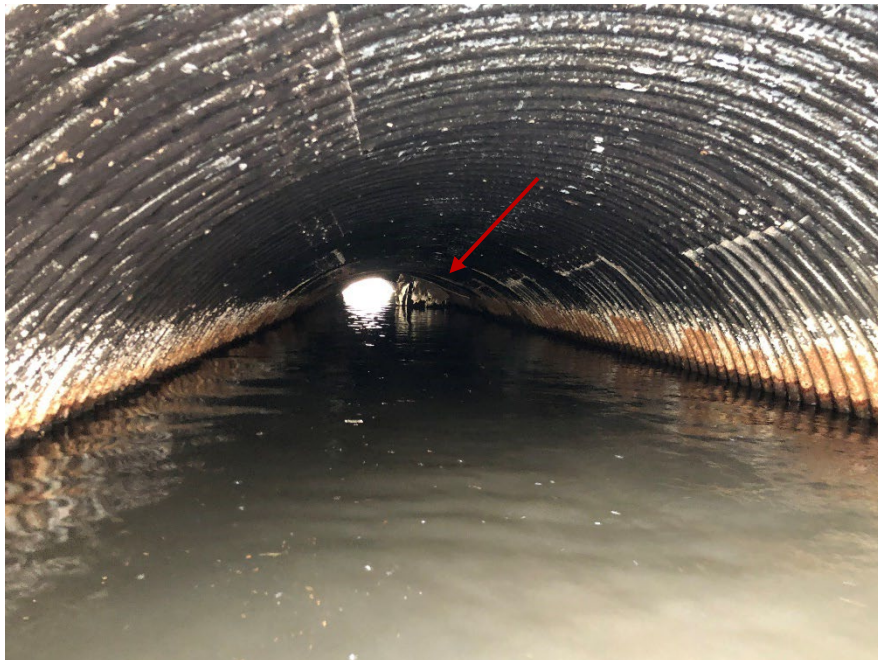
The stream crossing at East Blossom Road (STA 88+80), ownership unknown, consists of two corrugated metal arch culverts (Figure 4-29). The left culvert has a height of 3.55 feet and a width of 5.5 feet. The right culvert has a height of 3.1 feet and a width of 5.5 feet. Both culverts are likely supposed to be identical and have a height of 4.0 feet, but deposition of fine sediment at the inlet has created some discrepancies in height. Upon inspection in the field, the right culvert appears to be bowing at the center underneath the road and may have started to collapse (Figure 4-30). Based on hydraulic modeling results, the twin culverts are capable of passing the current 10-year flood event but overtop at the 50-, 100-, and 500-year flood events. The culverts cannot pass any of the modeled future flood events. A map of the East Blossom Road crossing is depicted in Figure 4-28.

Figure 4-30: Looking downstream at the inside of the river-right culvert. The collapse in the center of the culvert is indicated by the red arrow.

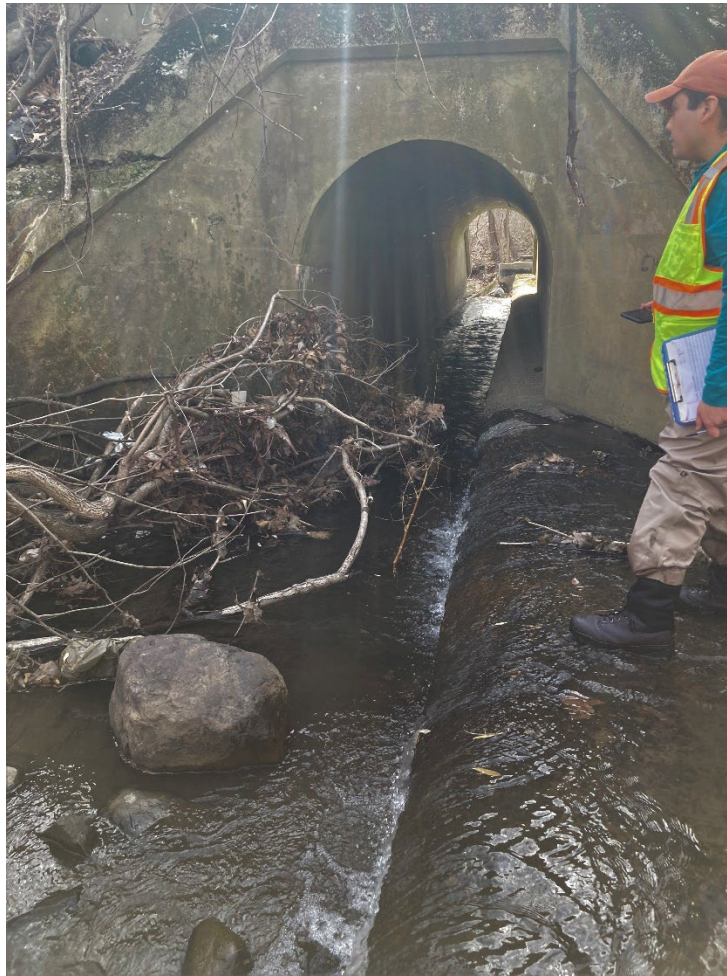
The stream crossing at the Conrail railroad tracks is located at STA 104+00 and consists of a concrete arch culvert approximately 7.6 feet high and 6 feet wide (Figure 4-34). The culvert has a rectangular curb at the bottom right of the arch that is approximately 1.5 feet high. The West Branch Saddle River enters the inlet at a near 90-degree bend. The drainage area at this location is 0.65 square miles. The West Branch Saddle River flows through a moderately developed area in this reach and is sandwiched between properties on Glenmere Court on its river left, with a plaza and an abandoned railroad embankment on its river right. While the neighborhood is not shown to be in the FEMA Special Flood Hazard 100-year or 500-year floodplain, it was noted in the Rockland County Hazard Mitigation Plan that the area is prone to flooding. A map of the railroad crossing is depicted in Figure 4-33.

**Figure 4-34: Looking downstream at the inlet of the Conrail bridge structure**

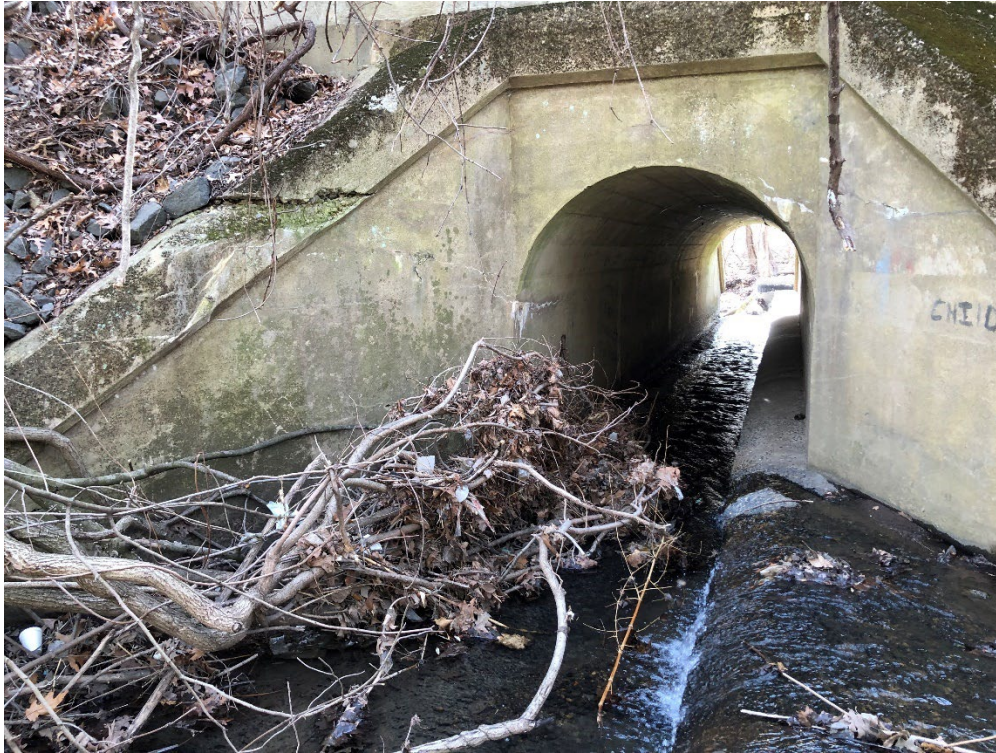
While conducting a field inspection, woody debris was noted to be partially obstructing the inlet (Figure 4-35). Additional debris, both woody and anthropogenic, was noted along the stream upstream of the inlet. According to the NYSDEC, crossings that are susceptible to be clogged or partially clogged, especially undersized ones, can intensify the effect of floods. When the structure is modeled with an inlet 25 percent clogged by debris to represent conditions observed in the field, flood extents expand during all modeled flood events. Multiple houses adjacent to the West Branch Saddle River on river left become inundated during the current 50- and 100-year flood events.

**Figure 4-35: Looking at woody debris partially obstructing Conrail structure inlet**

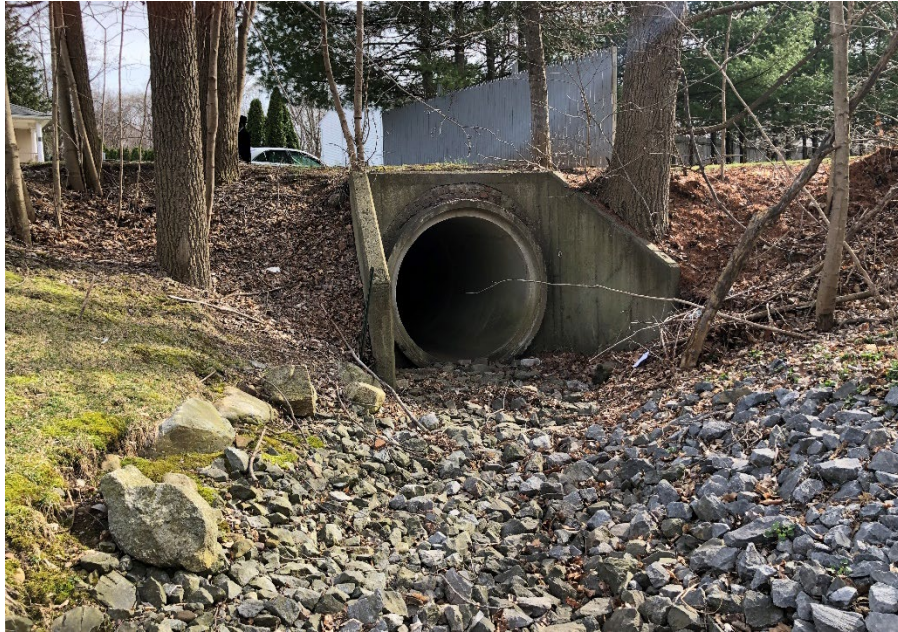
The most upstream stream crossing in HRA 5 is at Olympia Lane (Figure 4-41). This crossing (STA 129+25), ownership unknown, is within the headwaters of the West Branch Saddle River watershed, which is located within the hamlet of Viola. The West Branch Saddle River flows through a residential neighborhood in this section. The Olympia Lane crossing consists of a 6-foot circular concrete pipe and has a length of approximately 280 feet. The pipe bends approximately 30 degrees underground (Figure 4-42). The structure is capable of passing the 10-year flow event but overtops at the 50-year, 100-year, and 500-year flood events. A map of the Olympia Lane crossing is depicted in Figure 4-40.

**Figure 4-41: Looking downstream at the inlet of the Olympia Lane culvert**

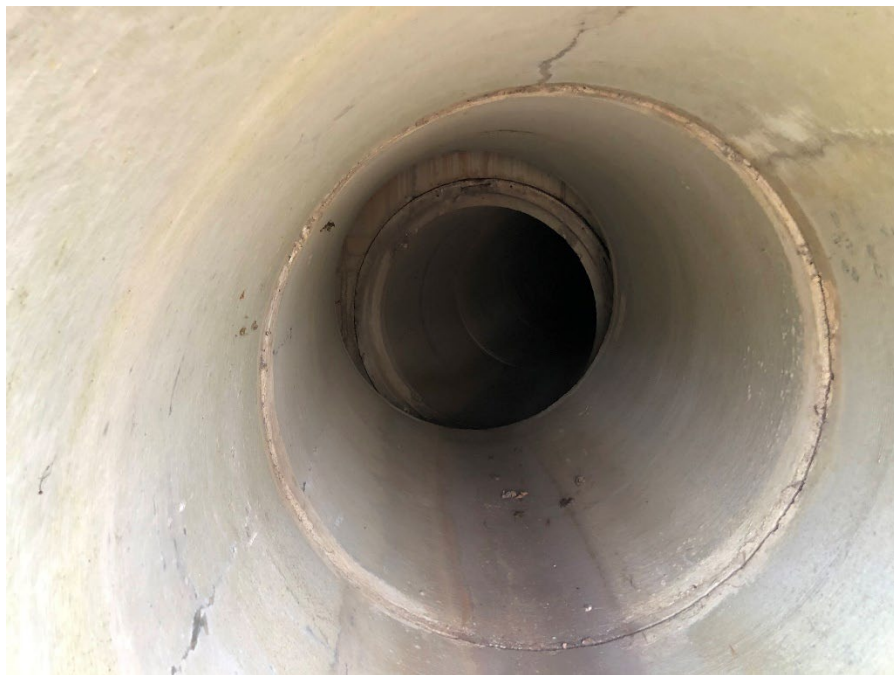
**Figure 4-42: Looking downstream inside the Olympia Lane culvert at the 30-degree bend**
