RE: Mohawk Valley Landfill
Facility No. 22S03
2017 Annual Report

MOHAWK VALLEY LANDFILL
ANNUAL REPORT

SITE PLAN AND ENVIRONMENTAL
SAMPLING LOCATIONS

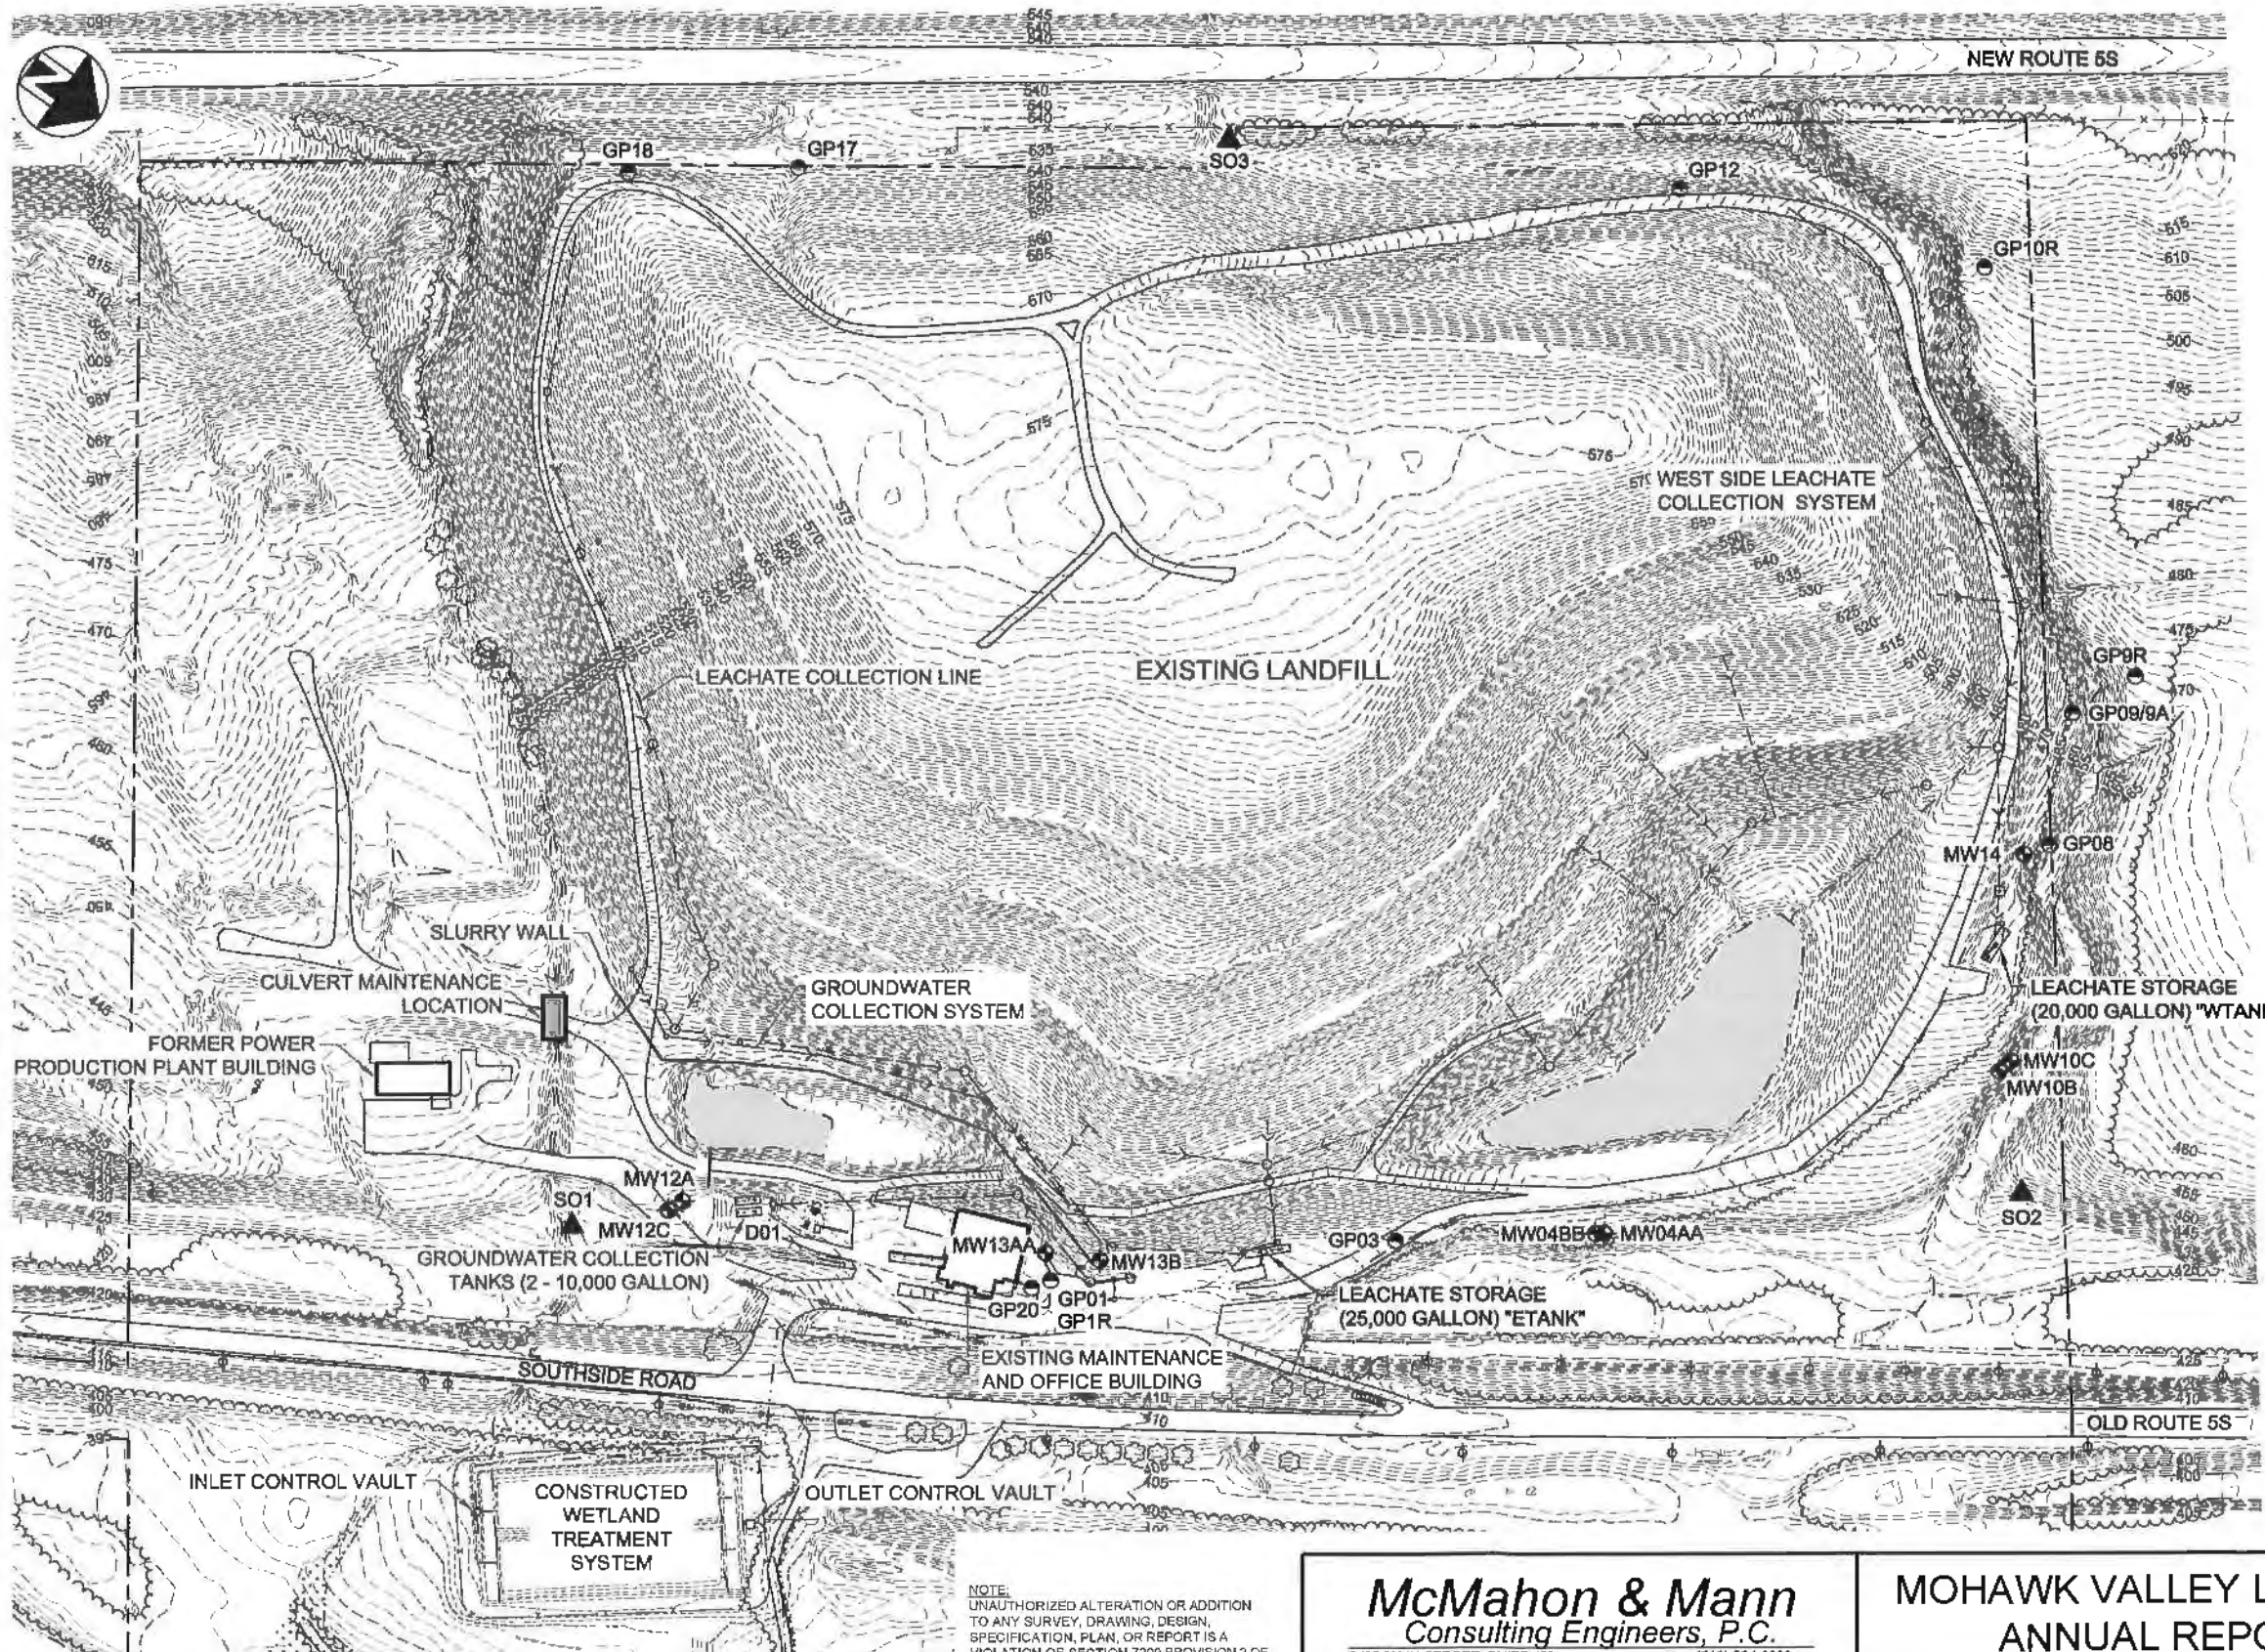
FIGURE 1

Run-off Control System – Stormwater ponds were functioning properly. Excess vegetation and brush was observed in the perimeter ditches requiring maintenance (see Maintenance Program below). A 30-foot section of culvert pipe was observed to have collapsed requiring maintenance (see Figure 1 for location and Maintenance Program below for more details).

Run-off Control – All surface water drainage systems have been installed in compliance with the above-mentioned closure plan. The riser pipes that outlet the stormwater ponds were replaced in 2015 and are functioning well. Excess vegetation was cleared out from the perimeter ditches in the fall of 2017. The collapsed portion of the culvert (see Figure 1) was repaired in the fall of 2017.
