Re: Town of Oyster Bay
Interim Remedial Measure at Bethpage Community Park
Borella Field – Alternate Source of Backfill
H2M Project No. TOBY 04-02

Proposed Environmental Sampling Plan of Town of Oyster Bay Soil Stockpiles at Syosset DPW Yard

PHASE I ENVIRONMENTAL SITE ASSESSMENT

**BORELLA FIELD
PLAINVIEW ROAD
BETHPAGE, NEW YORK 11803**

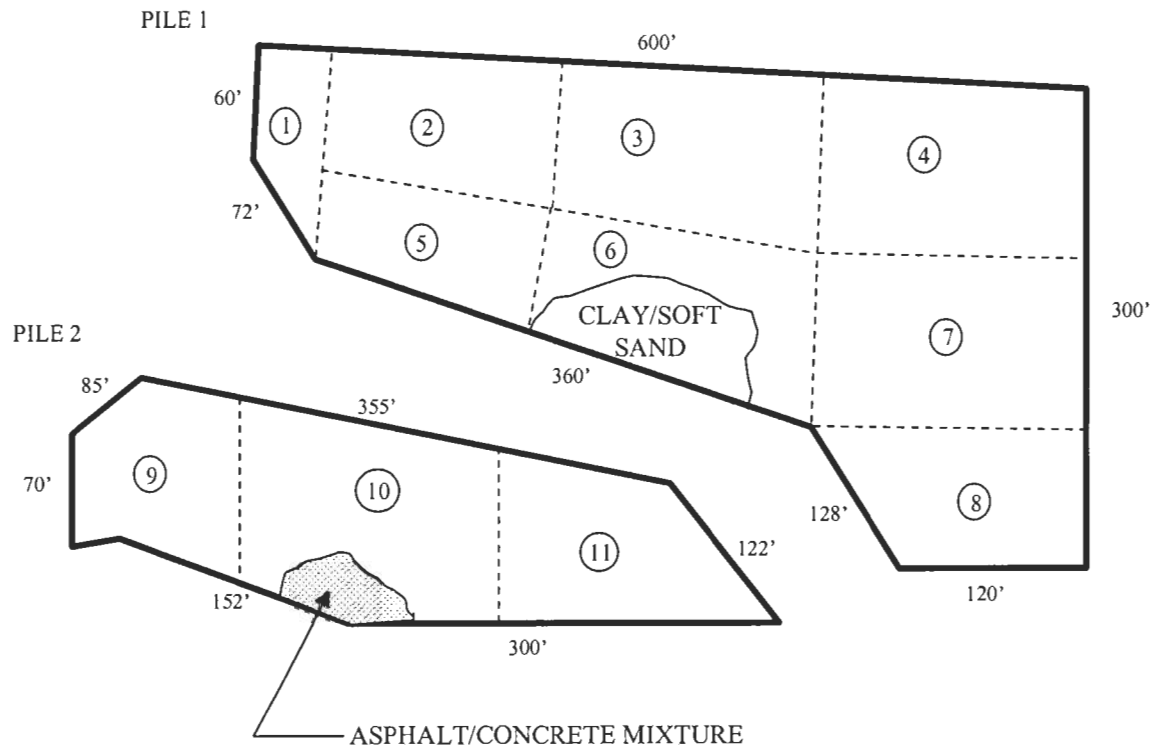
- Two stockpiles total approx. 40-60,000 cubic yards.
- Stockpiles subdivided into (11) areas, each measuring approx. 3,500 – 5,500 cubic yards.
- (11) Composite samples for PCBs, Metals, VOCs, SVOCs, Pesticides (8081, 8141), and Herbicides (8151)
- *Each composite to comprise (5) grab samples collected from random areas within the pile using an excavator.
- **Any visible asphalt/concrete or organic matter (i.e., tree roots) to be segregated and excluded as potential fill.

Schematic of soil piles located at Town of Oyster Bay DPW facility in Syosset, NY.

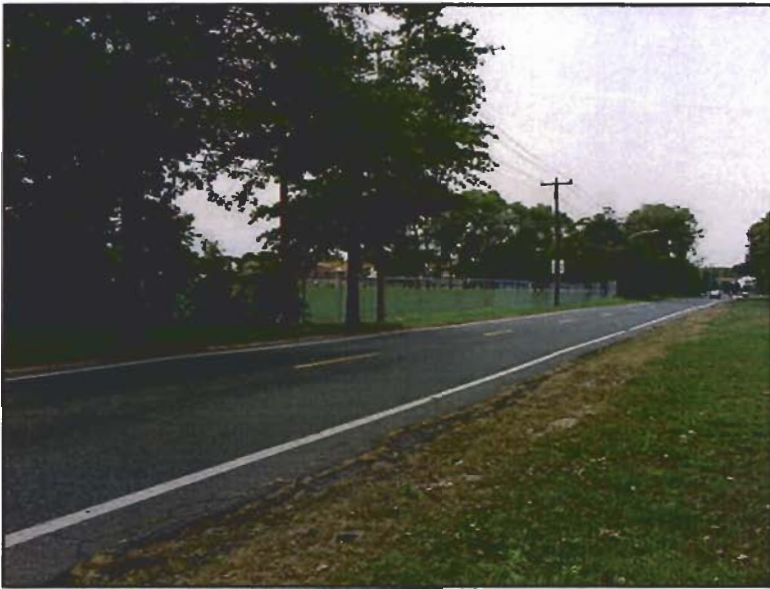
Photograph #1 - View of the subject property (Borella Field) located along Plainview Road, Bethpage, NY.

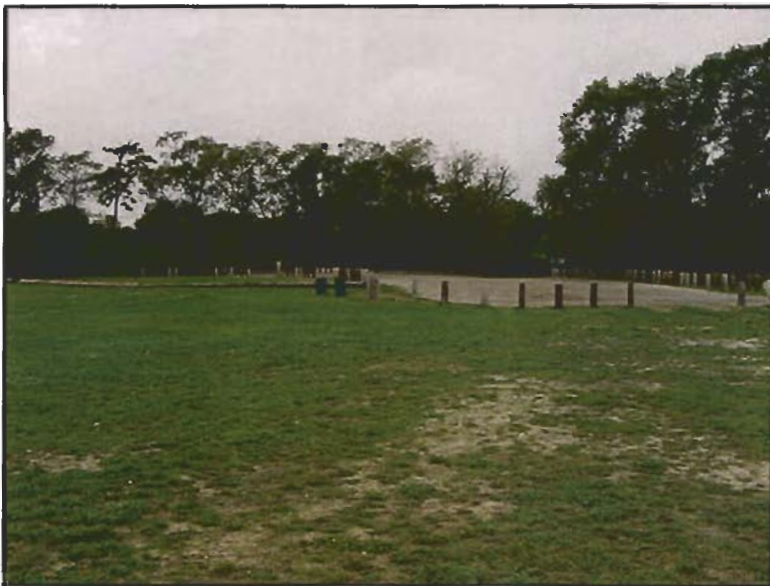
Photograph #5 - View of the parking lot located on the southern portion of the subject property.

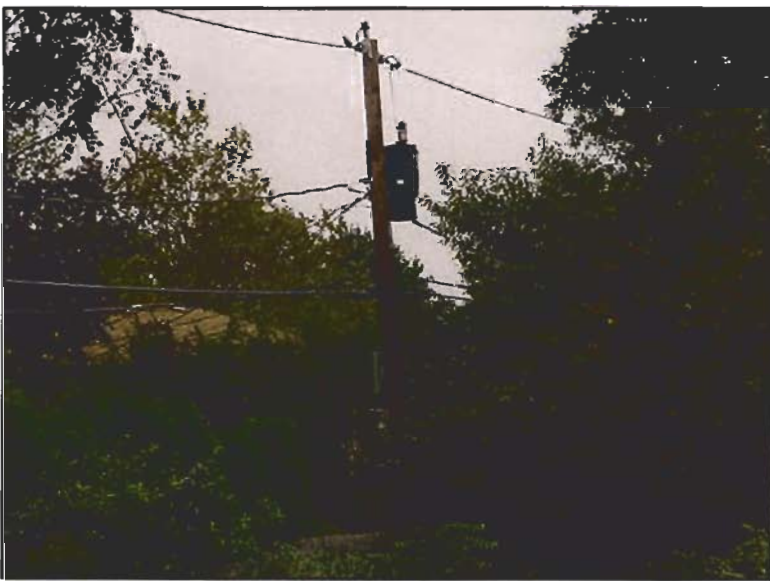
CA observed pole-mounted transformers along the north side property line of the subject property. CA observed that the transformer appeared in good condition, with no evidence of leaks or spills. This equipment reportedly is the property of the local electrical utility, the Long Island Power Authority (LIPA). LIPA is responsible for its equipment and the company reports that none of the utility-owned transformers

Photograph #9 - View of a pole-mounted transformer located on the northern property line.
