MEMORANDUM

TO:	Glen Schmiesing, Bill Ashton (Hercules)	JOB NO: 18539.001 cc: I. Tucker, Ciba
FROM:	Bob O'Neill	
DATE:	April 12, 2001	APR 16 200
SUBJECT:	Evaluation of Leakage from Glens Falls Feeder Canal Adjacent to Ciba Site, Glens Falls, New York	BUSTLADOF MANDATE LAB HAZATUOODO ATHE MATE DUBLIN DIVIDENTI OF BODEA HAZAHOOUS MALLHAUS

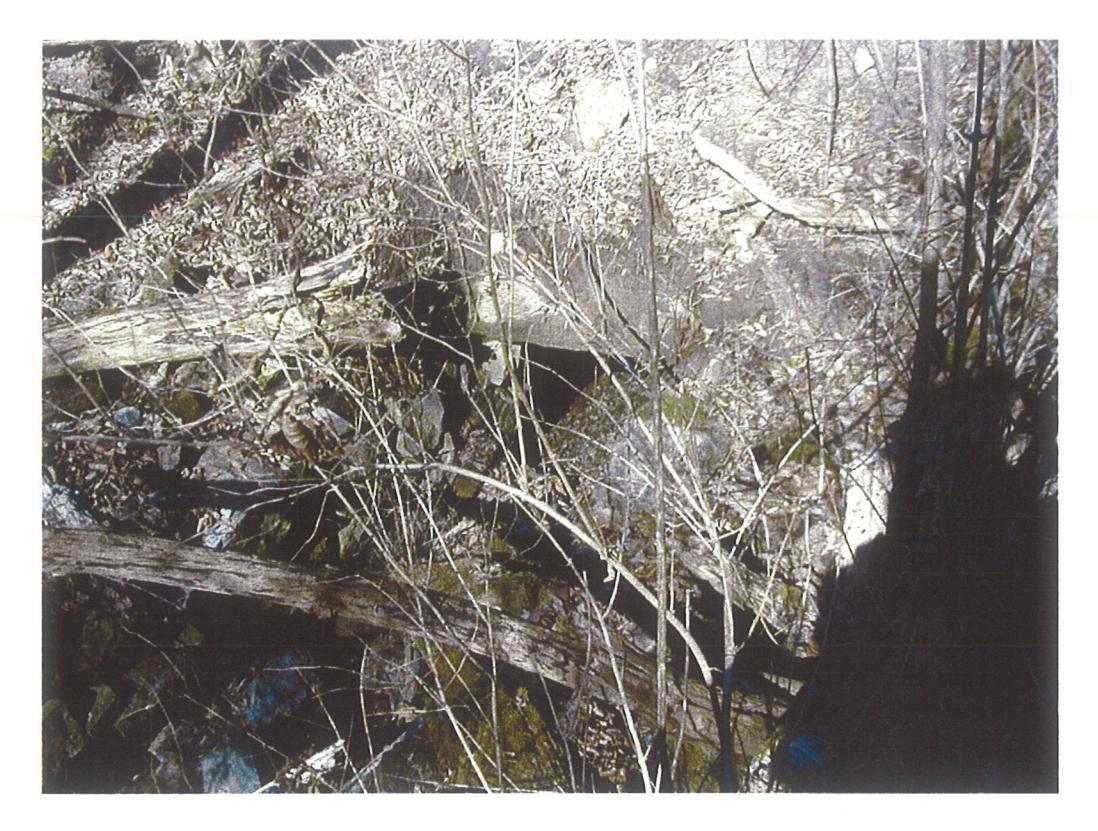
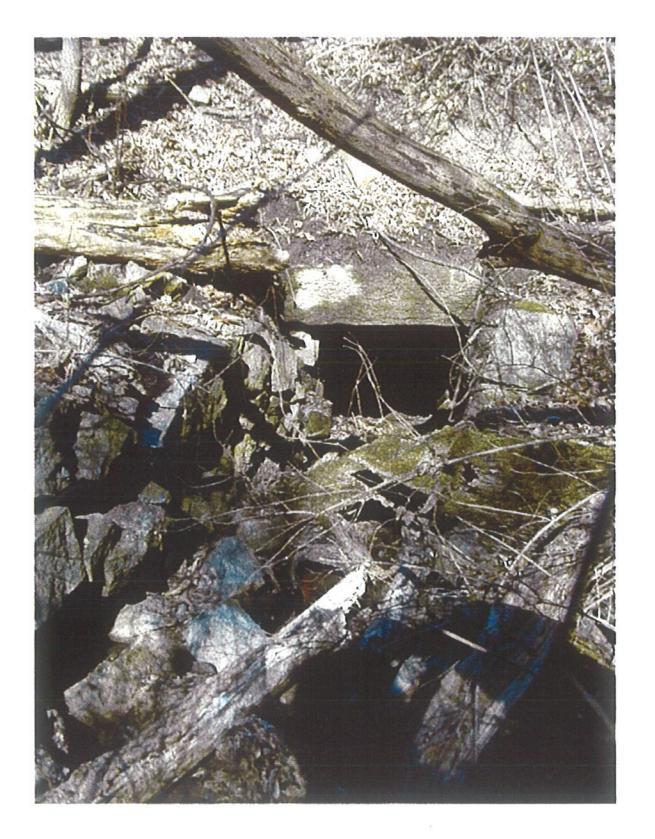
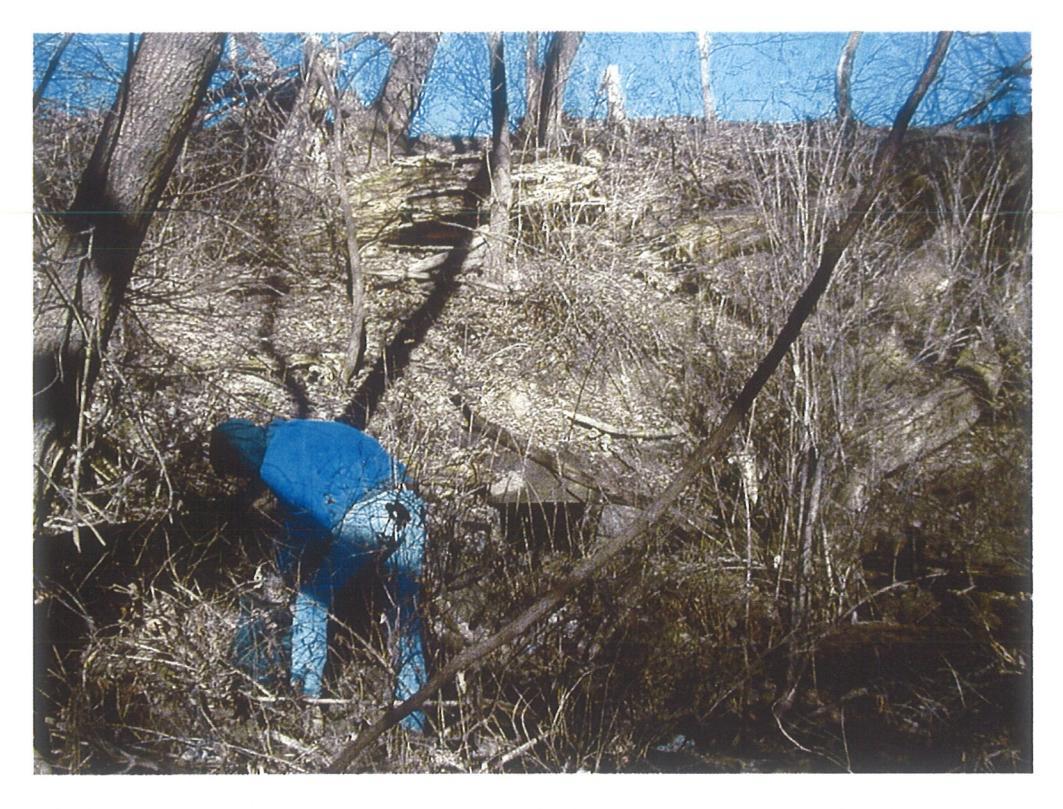
Stone culverts passing beneath the canal have been identified at several locations beyond the portions of the canal adjacent to the site. Photographs 1, 2 and 3 in Attachment 2 depict a culvert that was observed during the reconnaissance as an example. The construction of this culvert is similar to those identified on the Ciba Site. As these culverts are apparently common along the length of the canal, it is possible that there are additional buried culverts on the Ciba Site that have not been identified.

1. Stone culvert under canal by Northeast Lot (looking northeast).

2. Stone culvert under canal by Northeast Lot (looking north).

3. Stone culvert under canal by Northeast Lot (looking north).

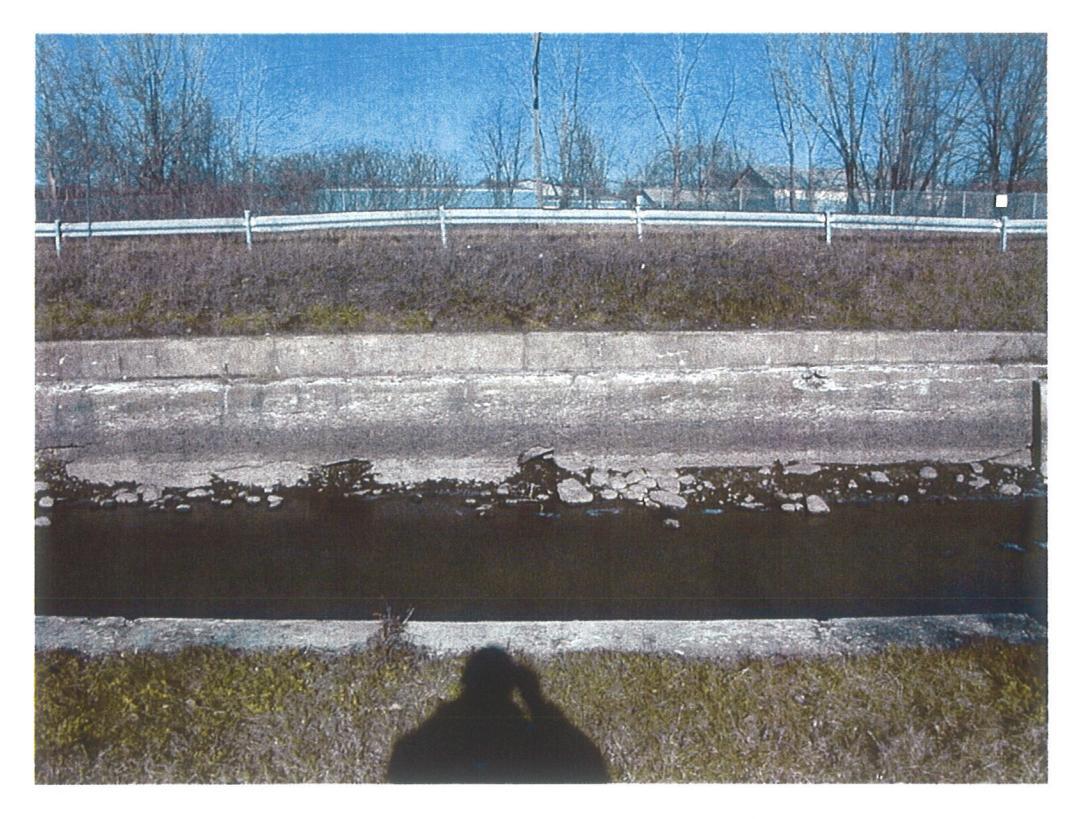
Along much of the area observed, the walls of the canal show substantial deterioration. The outer concrete portion of the canal wall has degraded such that the limestone blocks, that were apparently the original walls of the canal, are exposed. There appear to be several generations of local concrete repairs on the canal wall in various places. Along the south wall of the canal, adjacent to the Ciba Site, an approximately 1,700-foot long segment of the south wall was repaired by driving steel sheet piles north of the old canal wall, and filling the volume between the sheet piling and south wall with concrete. Based on records provided by the NYSCC, this repair was completed in 1988. Along one portion of this repaired section, approximately 250 feet east of the gate to Weir Brook, it appears that tie-backs were placed, apparently to stabilize the sheet piles (see Photograph 25 in Attachment 2). The floor of the canal was not readily observable due to overlying sediment and debris, or due the presence of liners in the canal (see below).

6. Deterioration in north wall of canal, opposite from middle of North Lot (looking north).

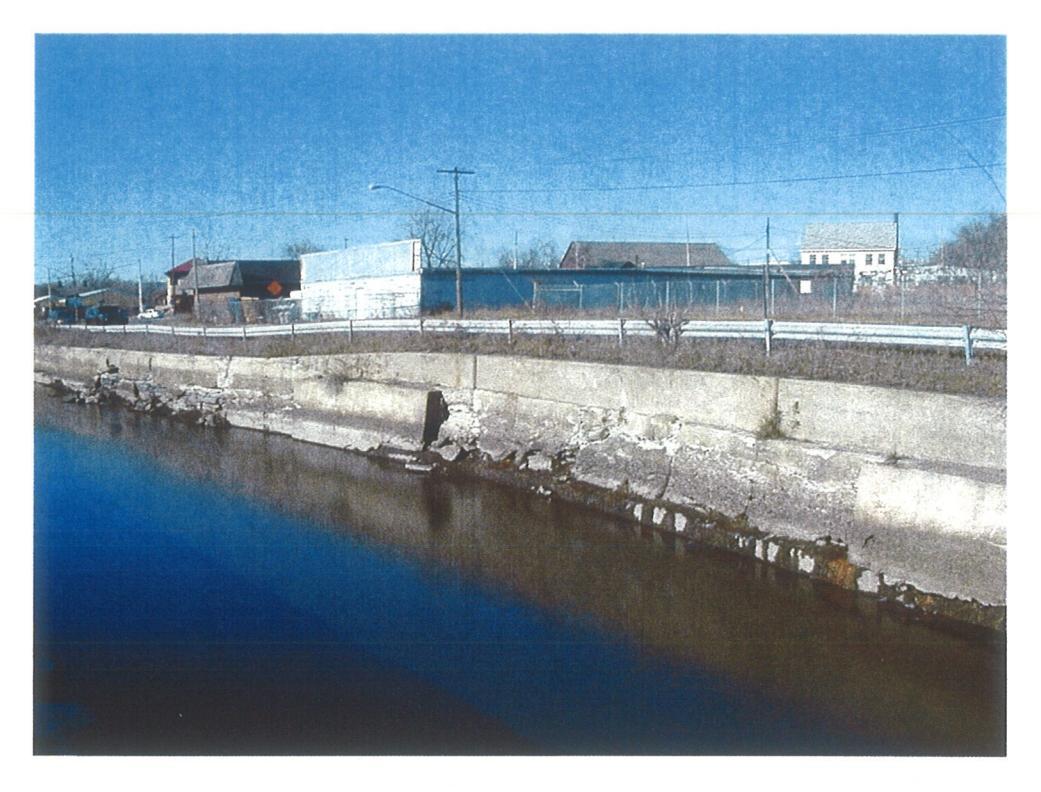
7. Deterioration in north wall of canal and local repair in wall, opposite west end of North Lot (looking northwest).

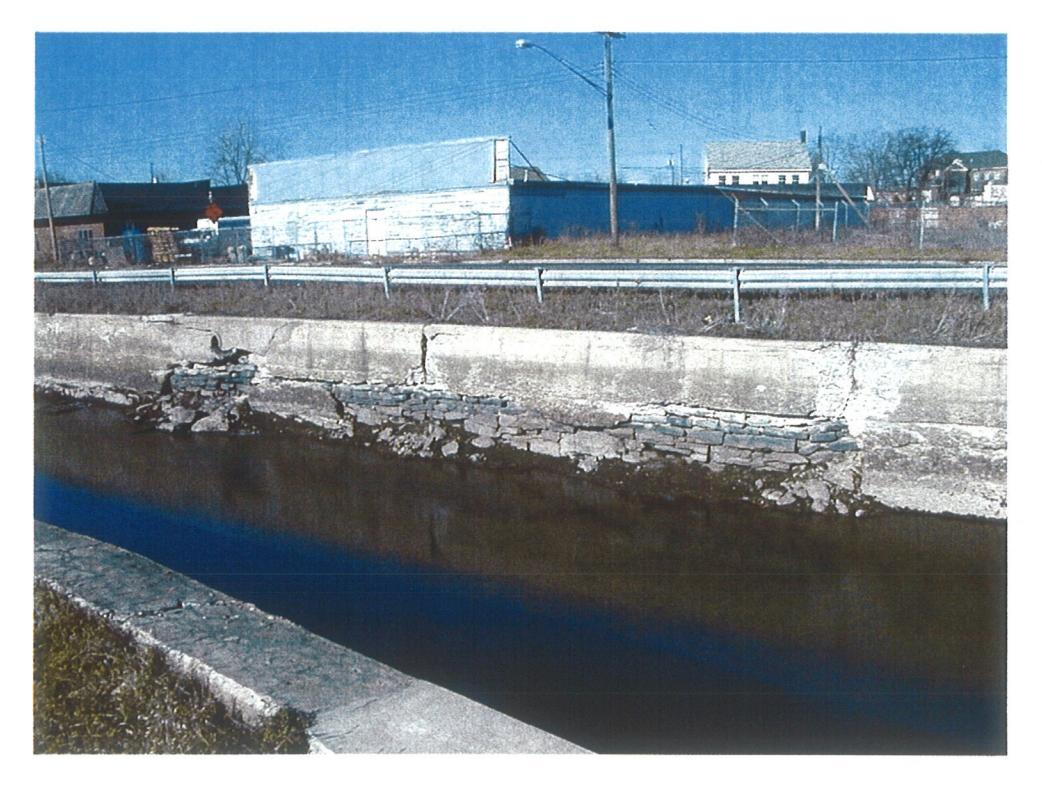
8. Deterioration in north wall of canal and local repair in wall, opposite west end of North Lot (looking northwest).

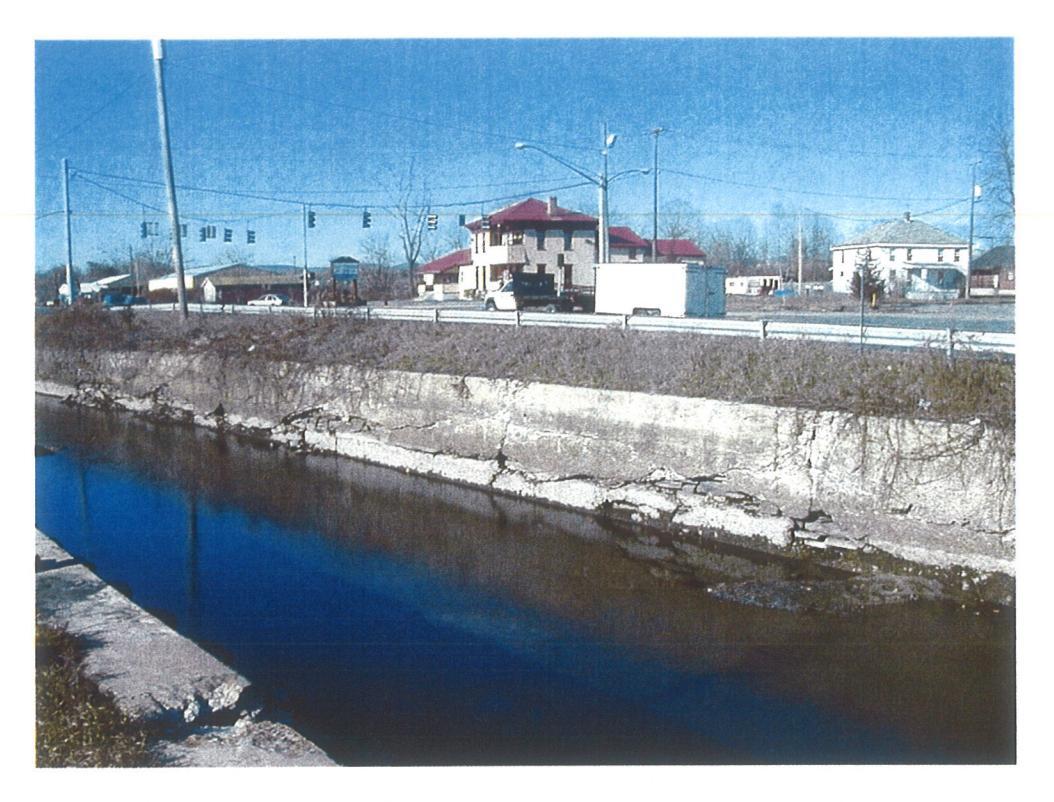
9. Deterioration in north wall of canal opposite intersection of Boulevard and Lower Warren St. (looking northwest).

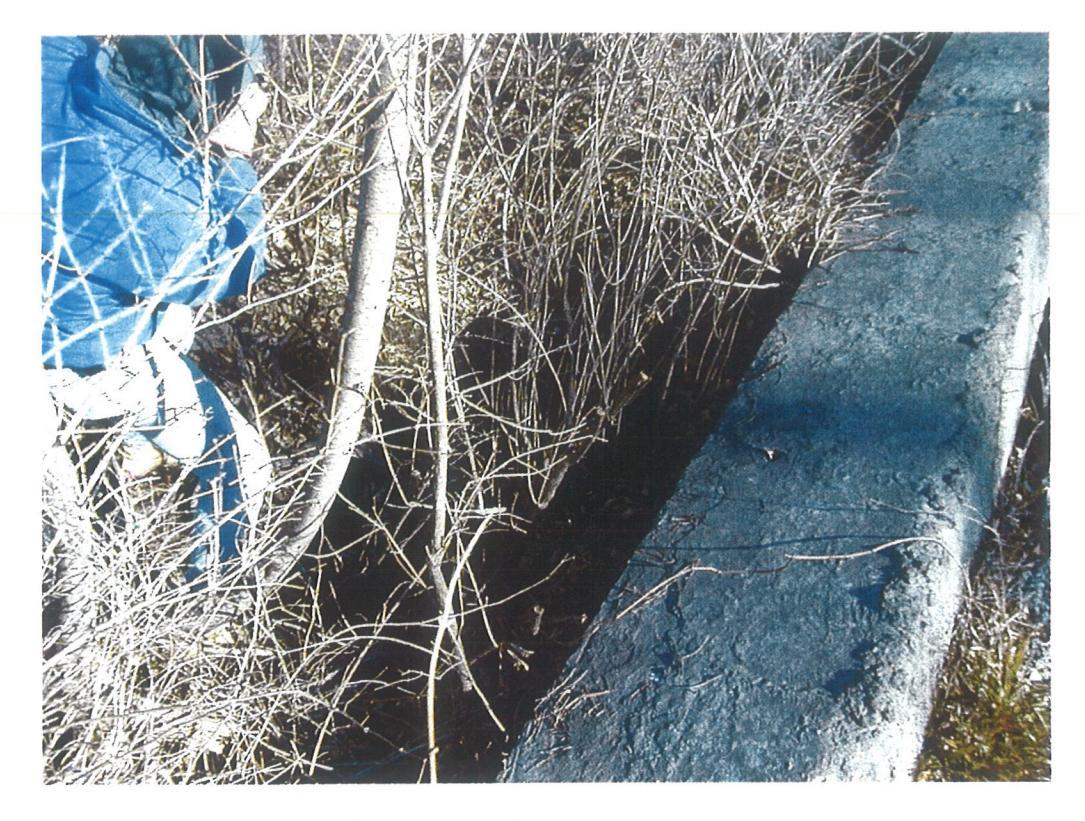
Sinkholes in the soil were noted directly behind the northern canal walls at a few locations, which is an indication of potential leakage (See Photograph 19 and 26). Sinkholes were less evident behind the southern wall. One sinkhole was observed behind the southern wall on November 19, 1999 at a location a few feet beyond the western end of the sheet pile repair work, directly across from the Sliver Quarry. Observations showed a large void extending partly beneath the canal towpath to the south (see Photograph A3 and A4). This void was filled the same day by personnel from the NYSCC. Thus, although sinkholes are not as evident on the south side, it is not known whether sinks, when present, are routinely filled by the NYSCC in order to maintain the towpath for recreation.

19. Sinkhole/washout in soil behind north wall of canal, approximately 15 feet east of sluice into canal (looking down to northeast).

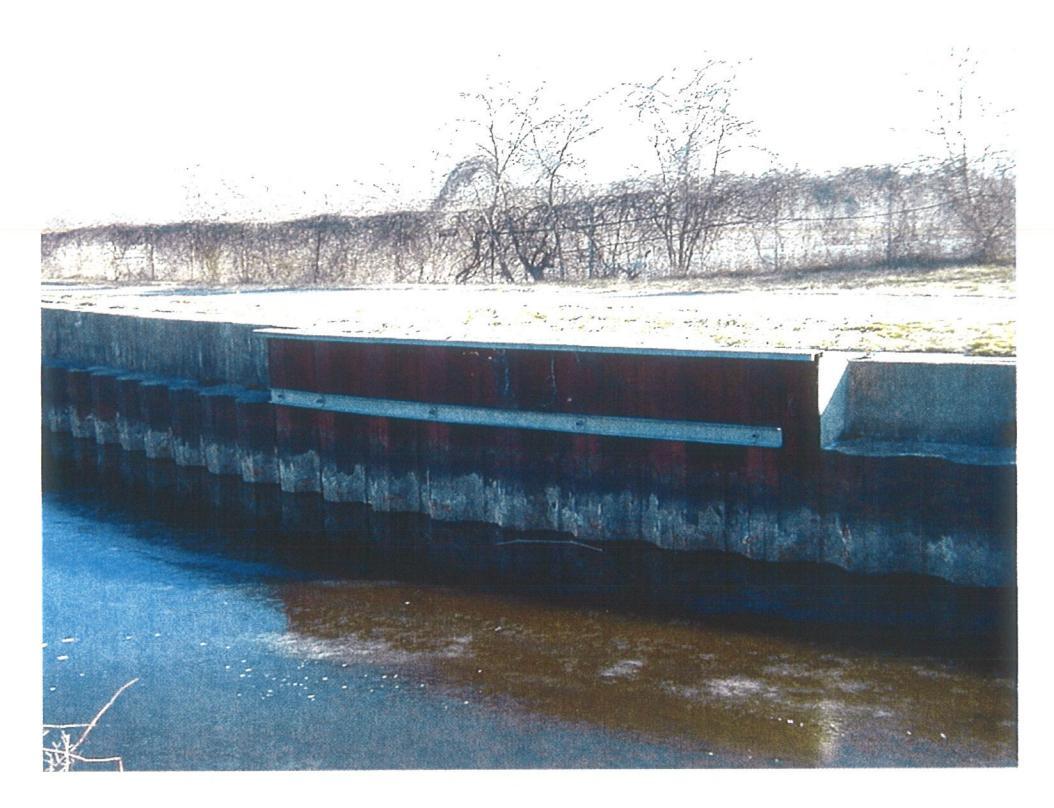
Another potential location for a passage beneath the canal is north of former Building 47, to the east of Weir Brook. A plant drawing, entitled "Plant Map, Storm Sewer Lines" (Drawing 051-8711-21008-5GF, Revision 7) dated September 7, 1970 indicates that an "old brook" entered the site storm sewer system at this location (see copy of a portion of drawing in Attachment 4). Alternatively, the "old brook" depicted in this drawing may have been a leakage point from the canal. Noteworthy is that the "old brook" is adjacent to the section of the canal where during the sheet pile repair work in 1988 (see above), additional support for the sheet piles was apparently required, as evidenced by the tie-backs installed (see Photograph 25 in Attachment 2).

25. Repair to south wall of canal with tie-backs east of Weir Brook gate (looking southeast).

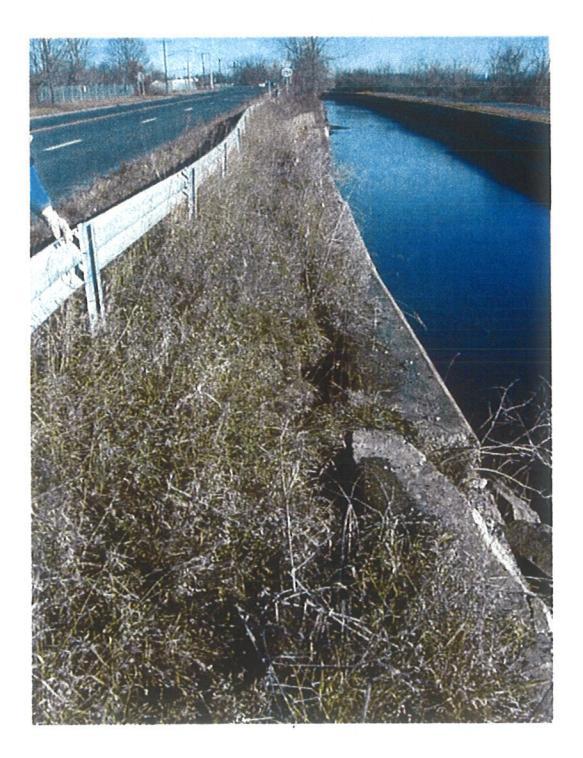
26. Sinkhole/washout behind north wall of canal, opposite from southwest corner of North Lot (looking east).

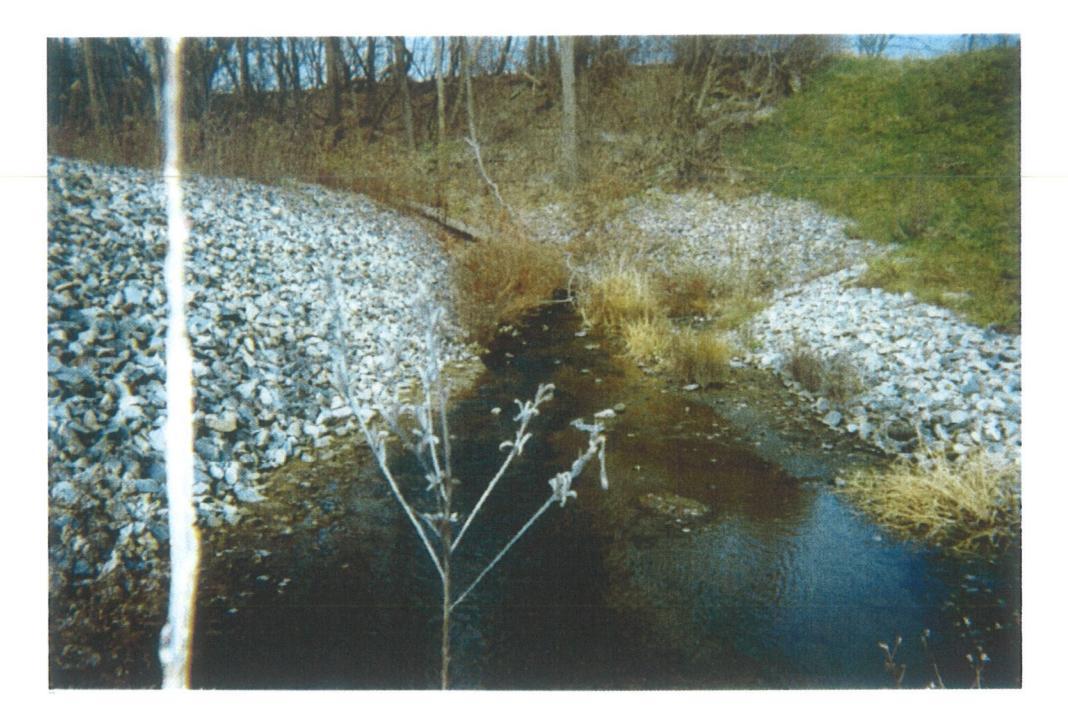
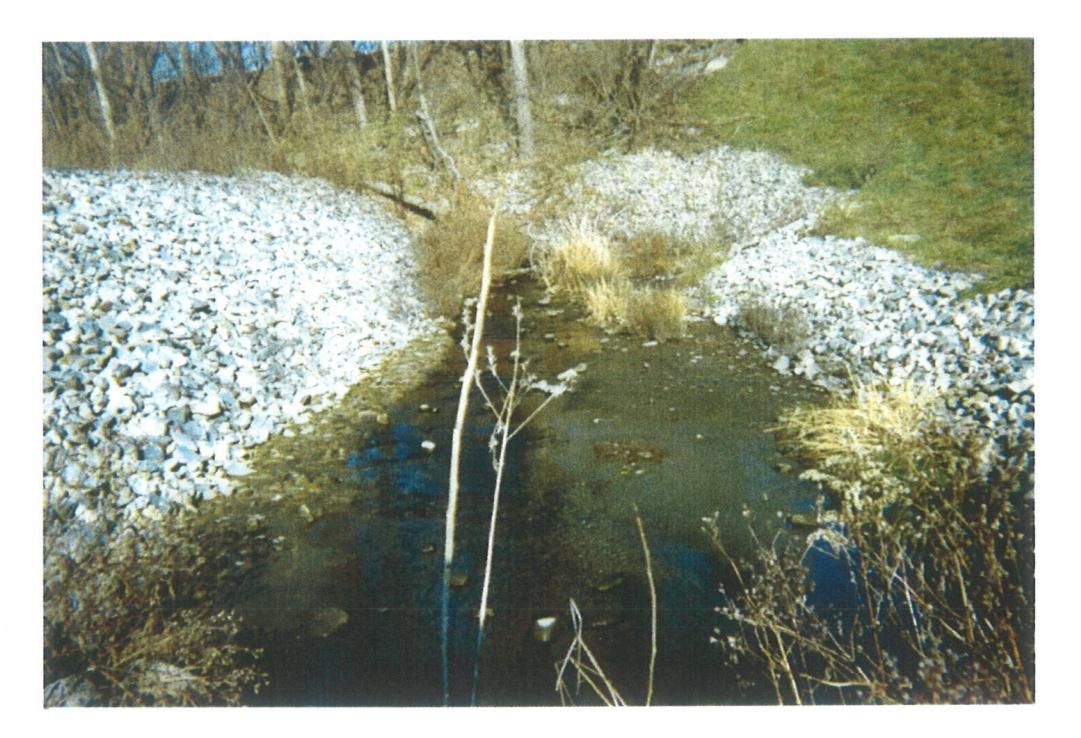
Observations of the stream that feeds the Cement Company Pond indicate that the width and height of the flow of the stream decreased as the canal was being drained. Photographs A1 and A2 in Attachment 2 were taken of this stream on November 18, 1999, before the opening the gate from the canal to Weir Brook, and November 19, 1999, approximately 3 ¹/₂ hours after the gate was opened, respectively. These photographs indicate a substantial decrease in the width of flow in the stream. Although the volumetric flow decreased, the stream continued to flow after the canal was drained.

A1. Stream feeding Cement Company Pond (looking north) on 11/18/99, prior to opening of gate from canal to Weir Brook.

A2. Stream feeding Cement Company Pond (looking north) on 11/19/99 at approximately 1115 hours, approximately 3.5 hours after the opening of the gate from canal to Weir Brook.

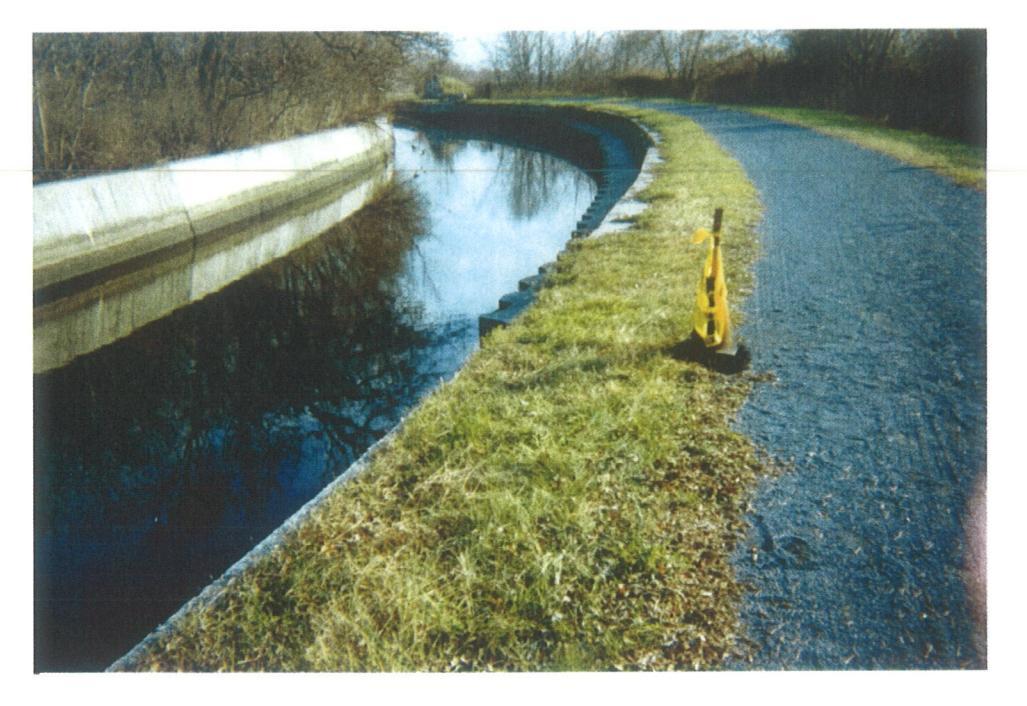
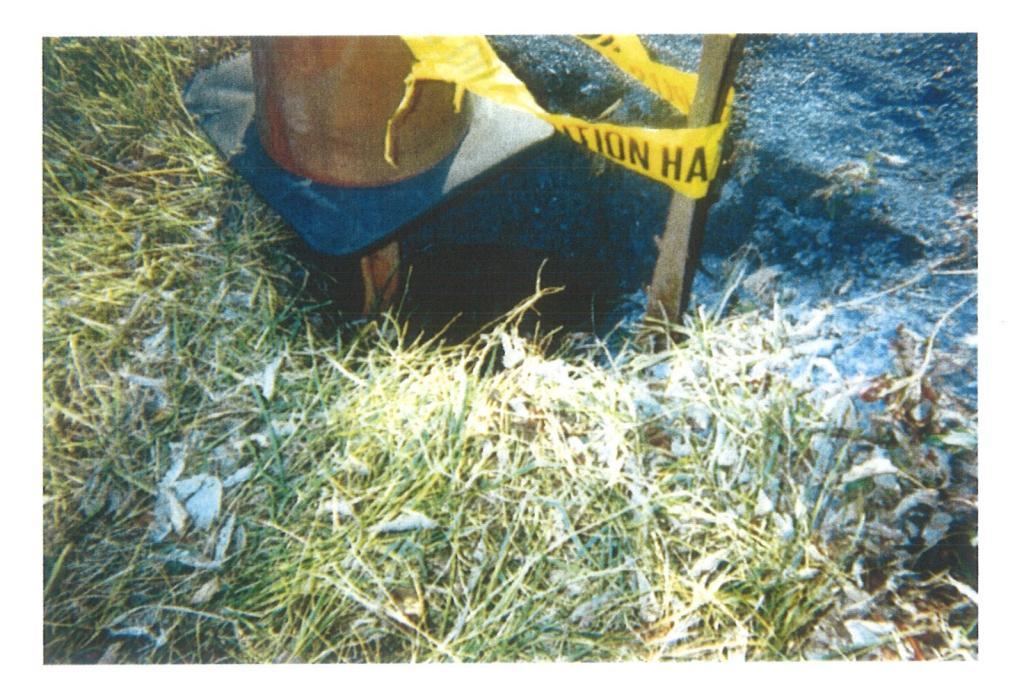
A3. Sinkhole between south wall of canal and towpath observed on 11/19/99 (looking east). Sinkhole is located on opposite side of the canal from the Sliver Quarry and a few feet west of the western end of the sheetpile repair work in the canal.

A4. Close-up of sinkhole in photograph A3.
