## APPENDIX L

### TDCS EXTENSOMOTER INSTALLATION DATA

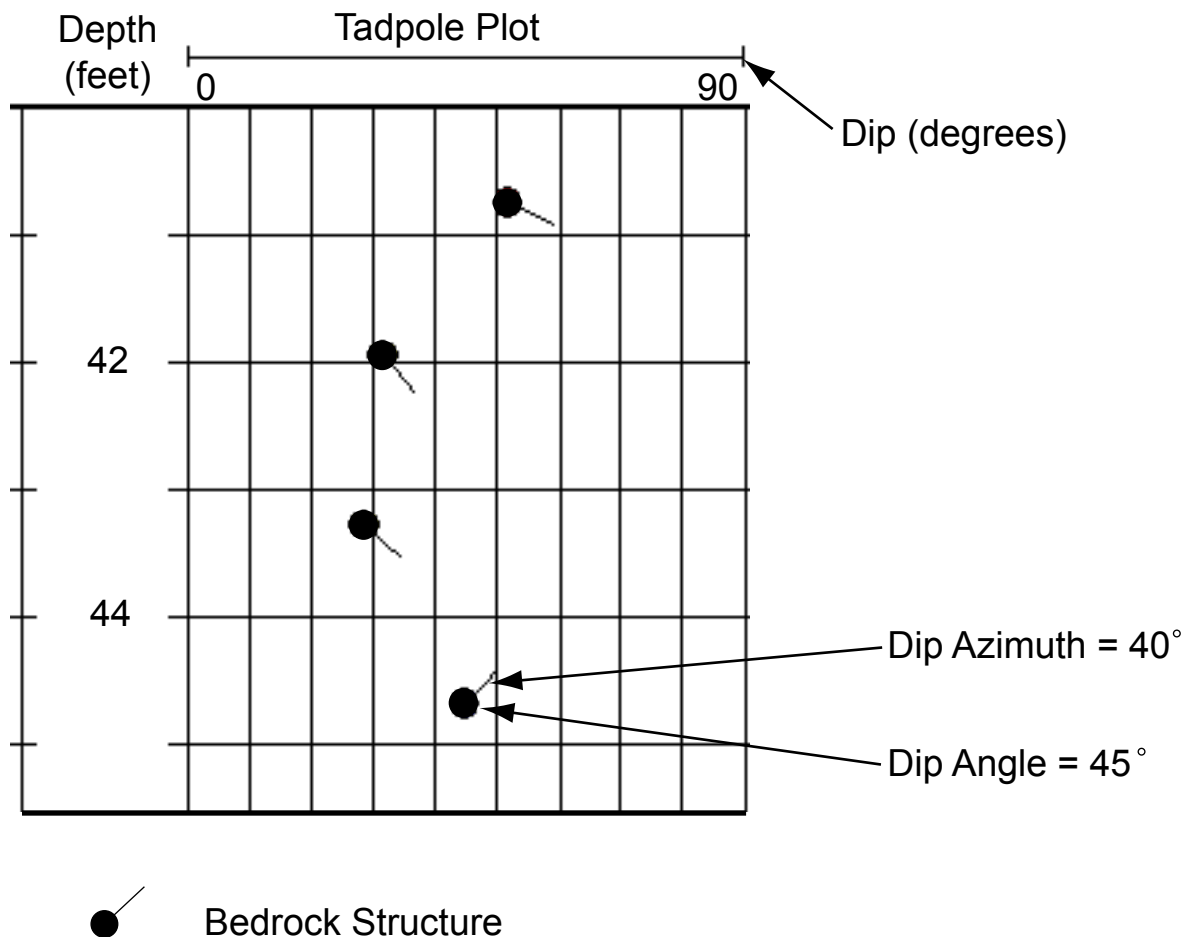
**Figure 4.** Key to tadpoles. The orientation of the bedrock structures is graphically displayed by a tadpole made up of a circle, the head, and a line, the tail. The position of the head, left to right on the tadpole plot, gives the dip angle of the structure. The left side of the track indicates a dip angle of  $0^\circ$ , and the right side of the track indicates a dip angle of  $90^\circ$  from horizontal. The position of the tail gives the dip azimuth of the structure and can be read like a compass. The tail pointing directly up is  $0^\circ$ , magnetic north.

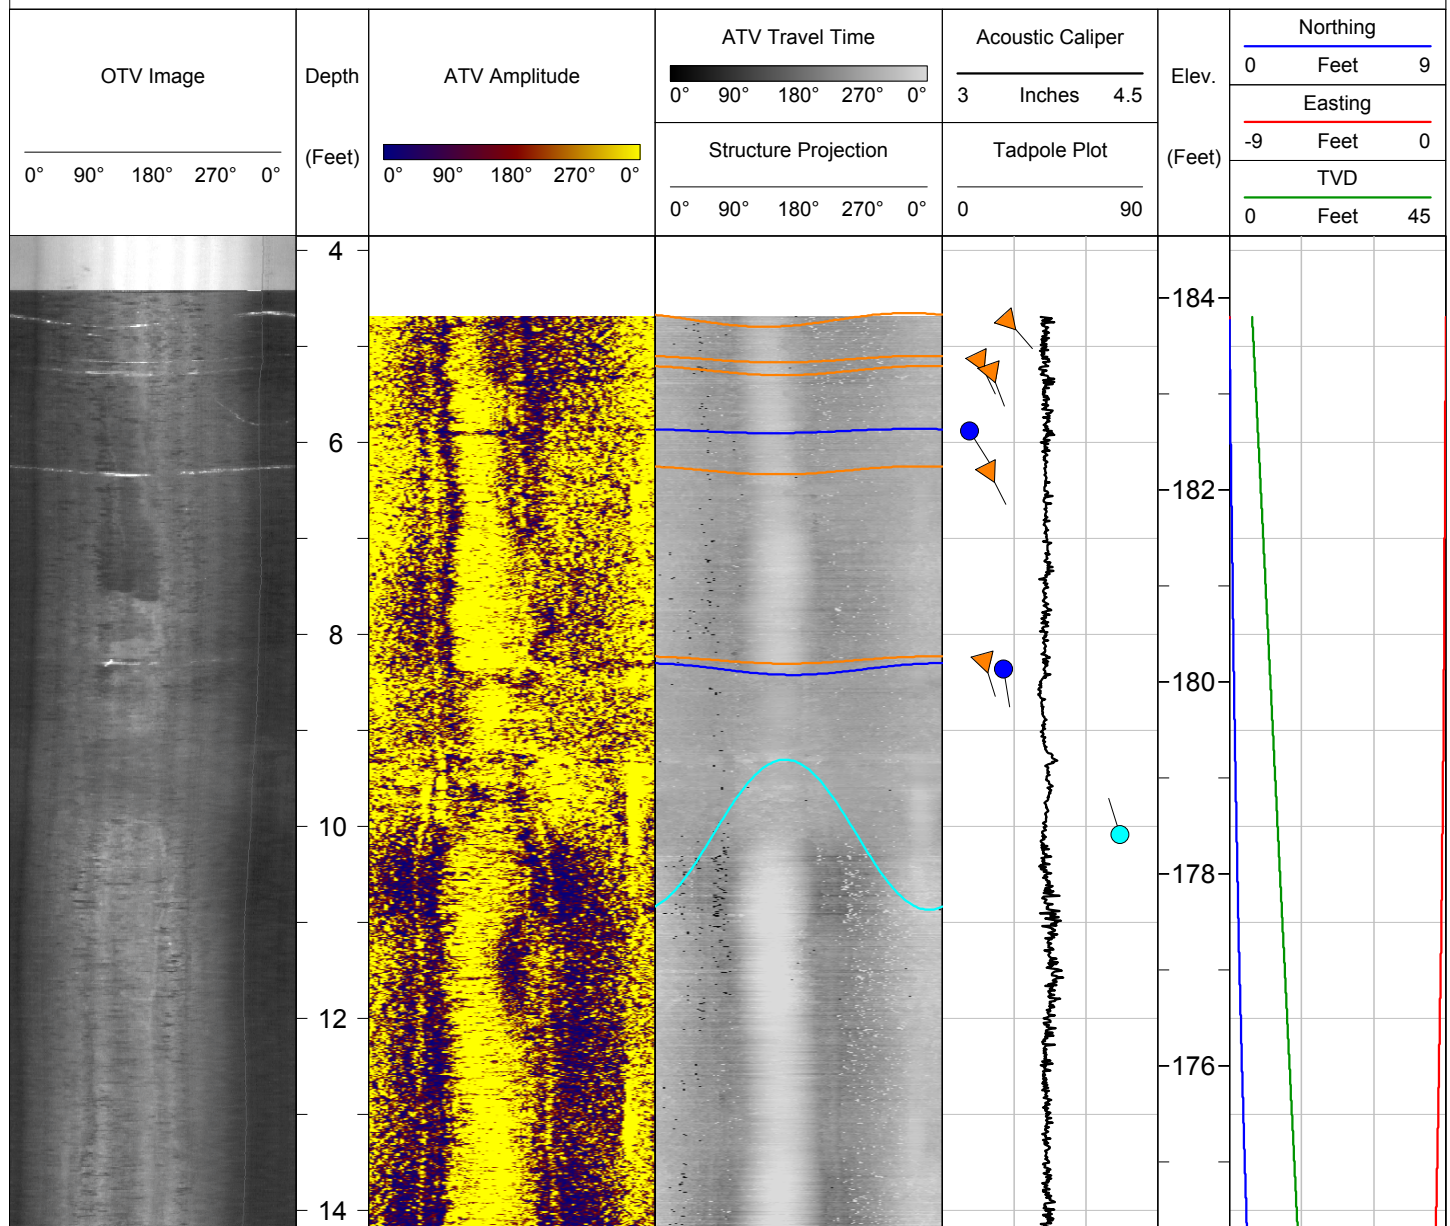
Healed Fracture or Vein

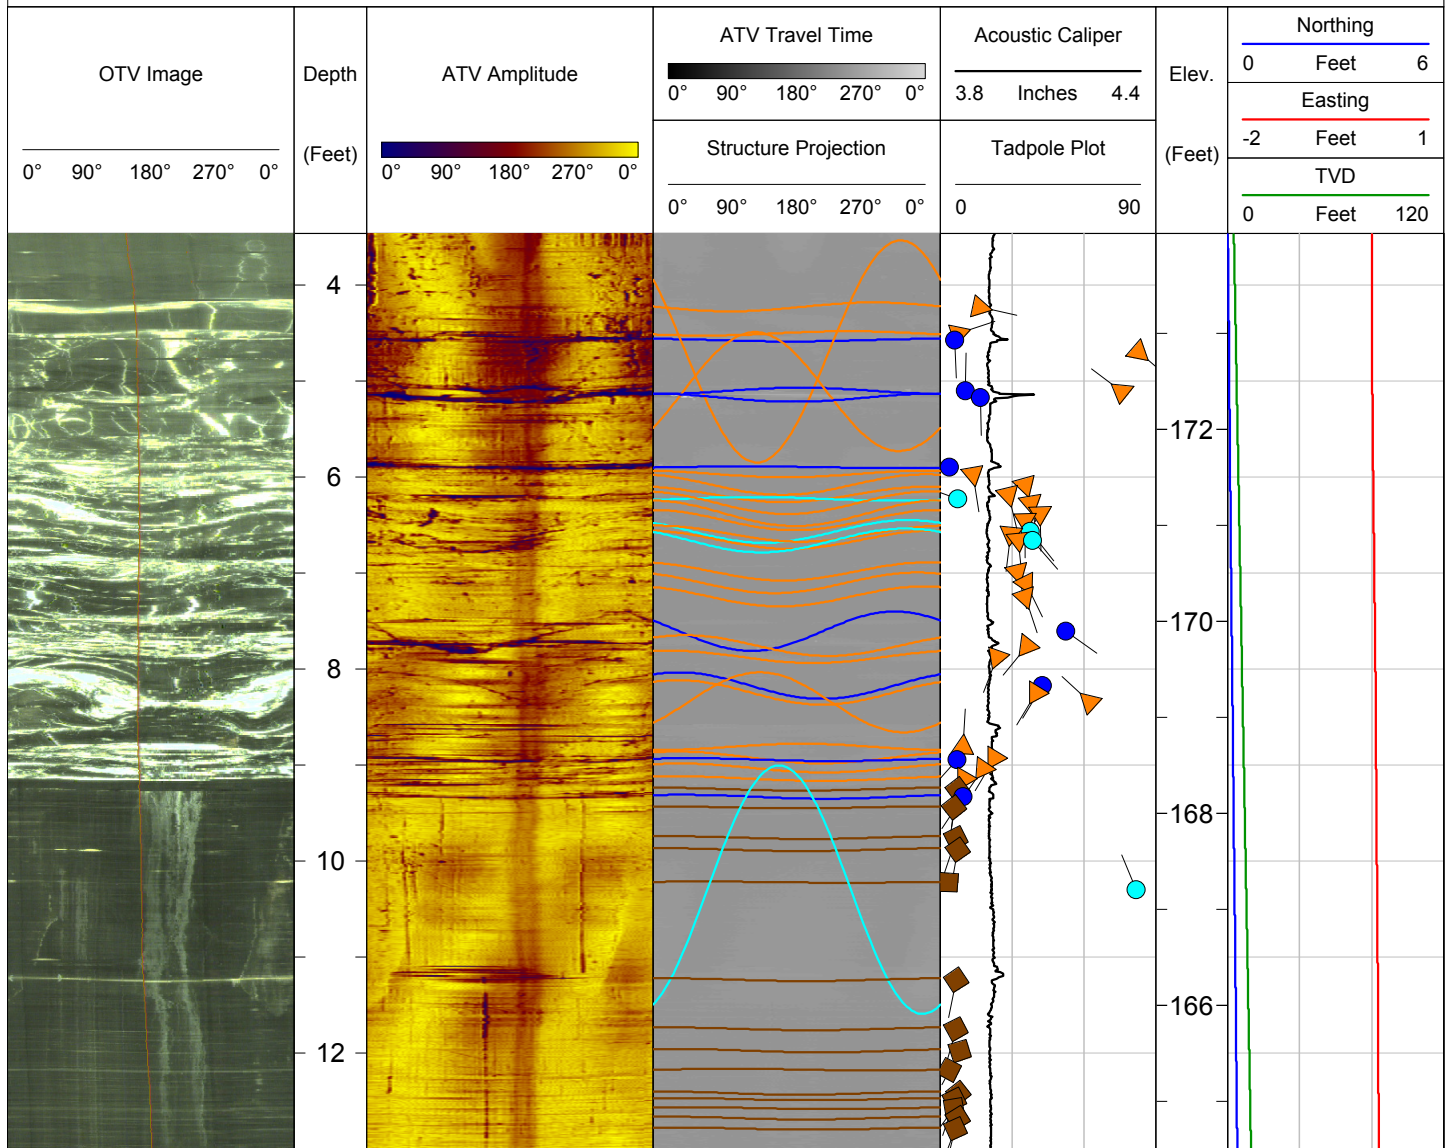
NOTE: Water was added to the borehole in order to acquire ATV data for the entire un-cased portion of the borehole.

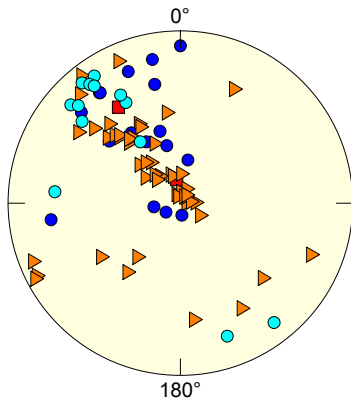
| | Counts | Dip[deg] | Azi[deg] |

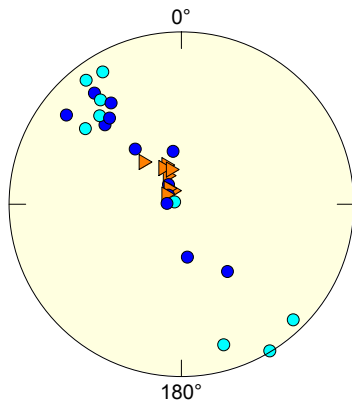
| | Counts | Dip[deg] | Azi[deg] |

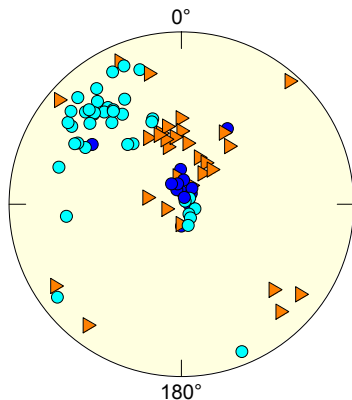
| | Counts | Dip[deg] | Azi[deg] |
