**SPDES STORMWATER ACTION
PLAN**

**2200 Bleecker Street
Utica, New York
SPDES Permit No. NY0108537**

June 2000

**SECOR International Incorporated
120 East Washington Street Suite 421
Syracuse, New York 13202**

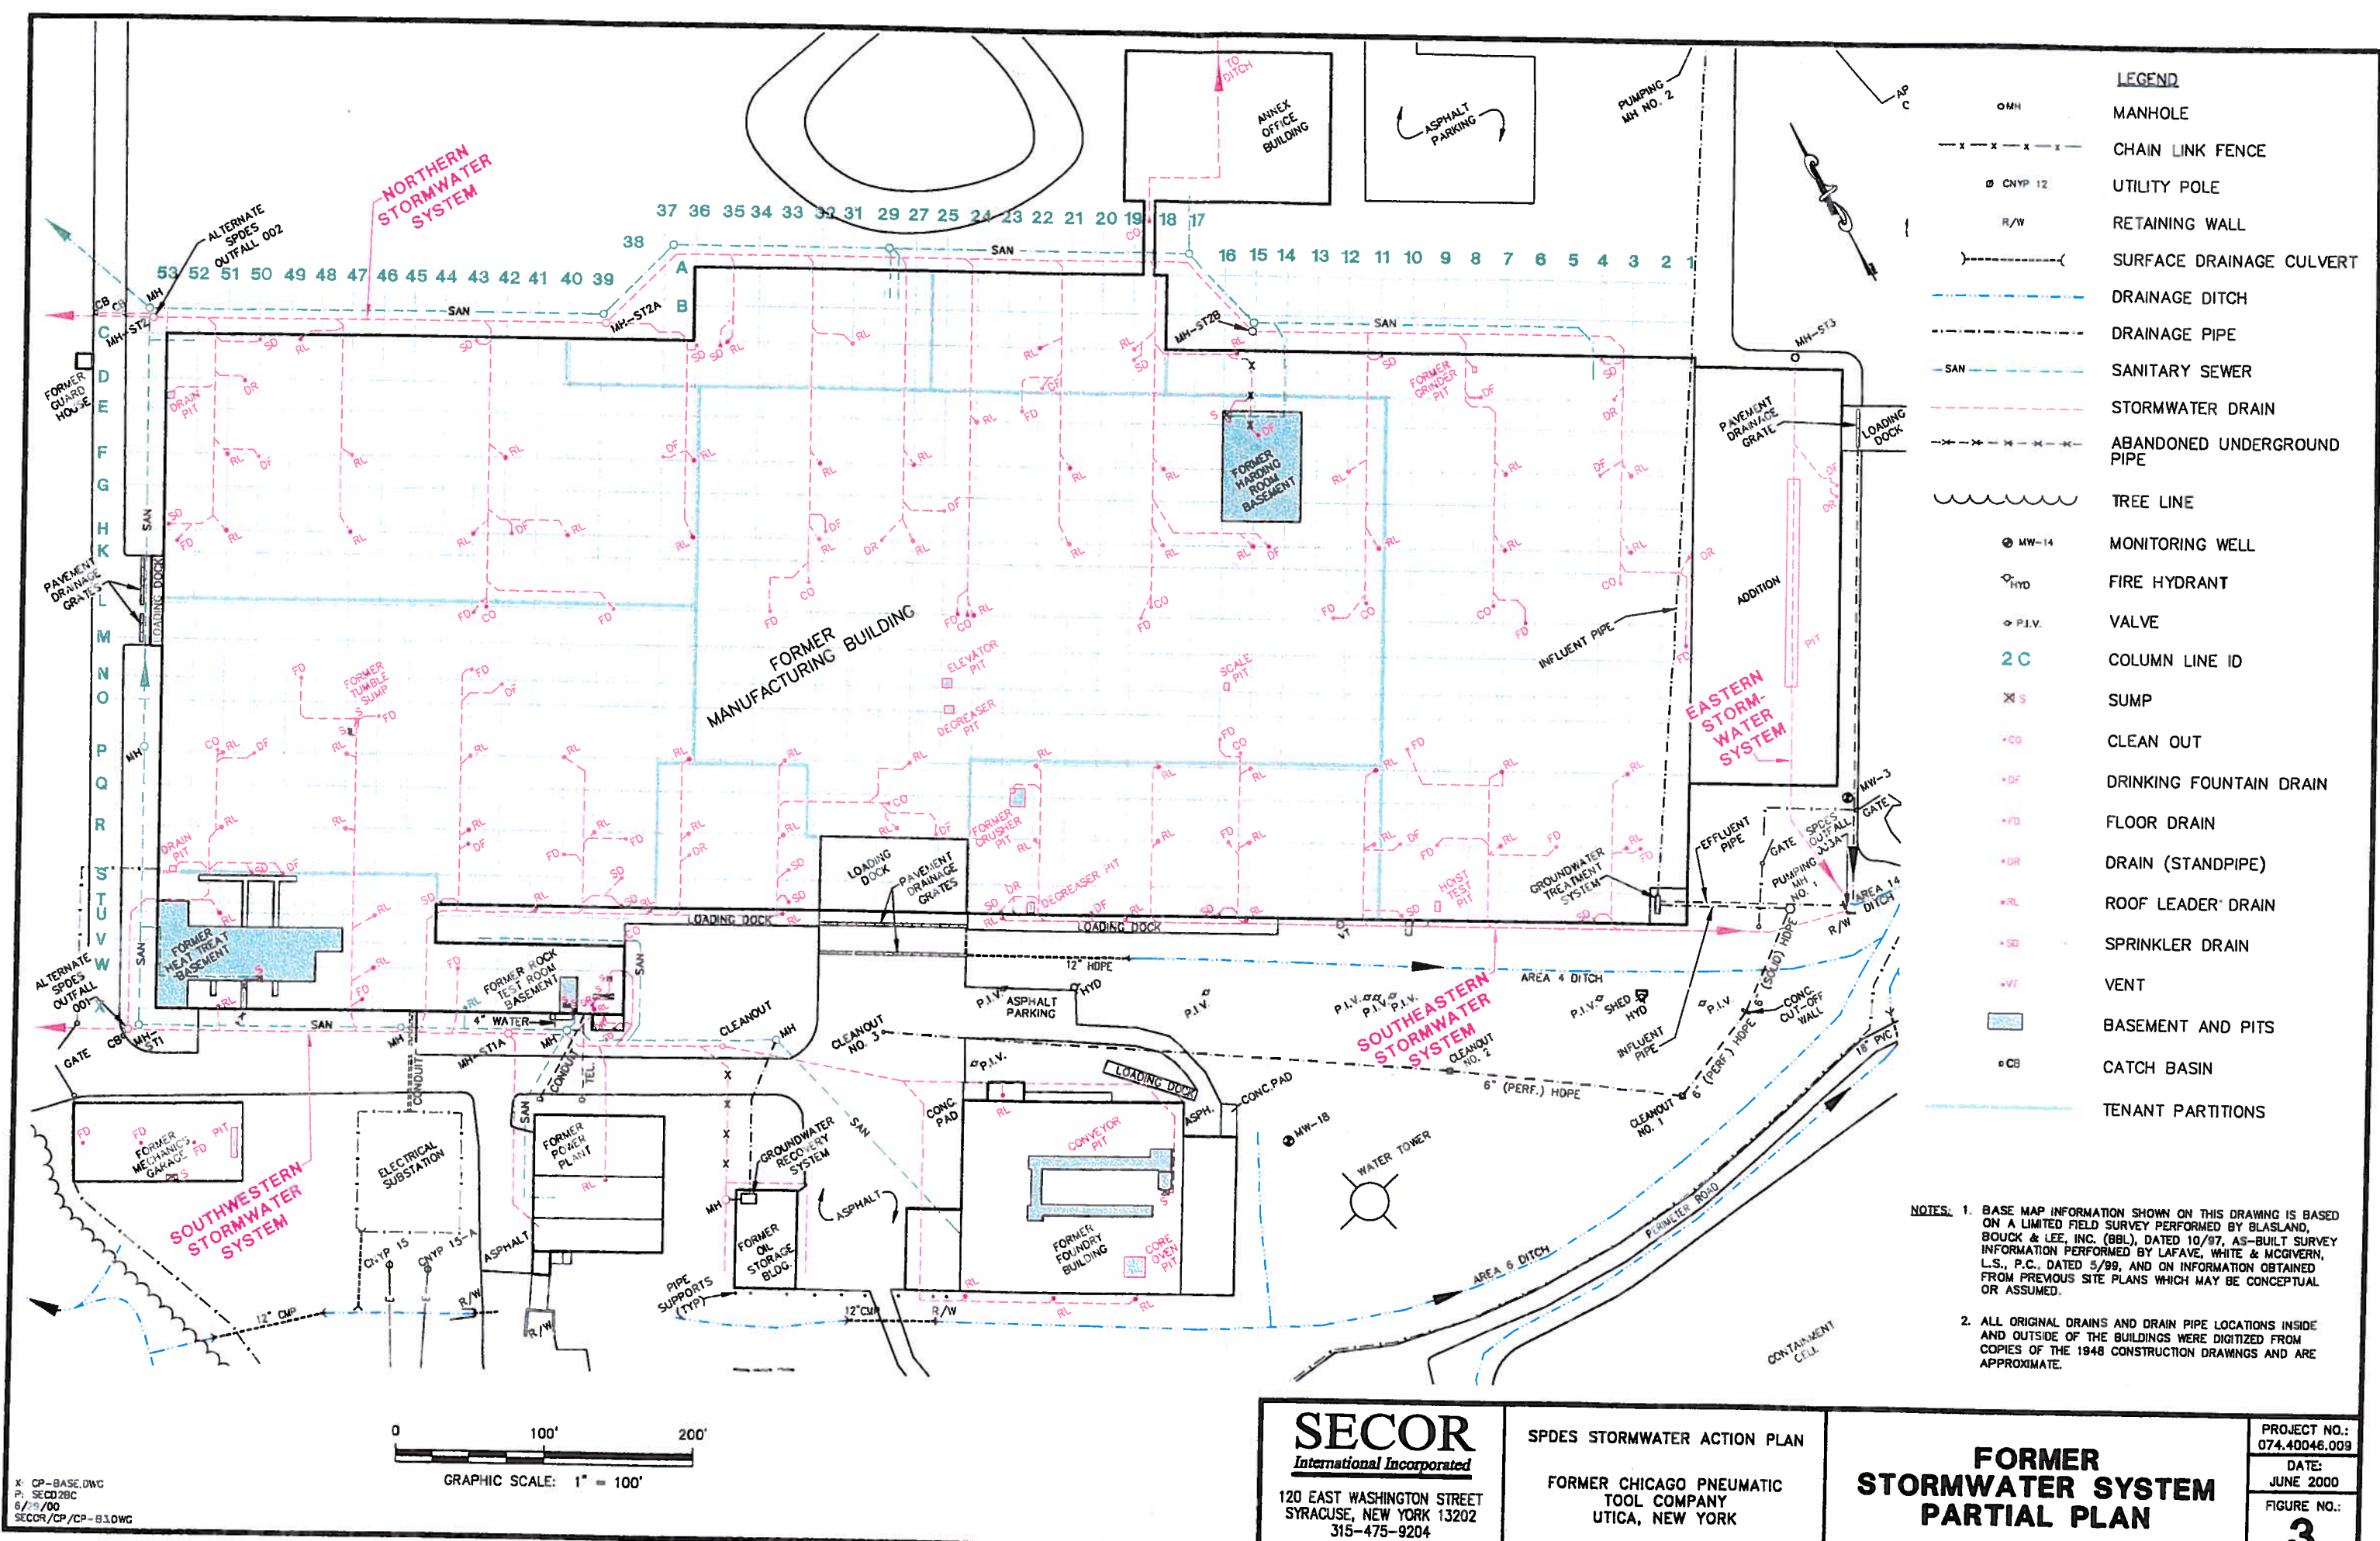
SECOR <i>International Incorporated</i> 120 EAST WASHINGTON STREET SYRACUSE, NEW YORK 13202 315-475-9204	SPDES STORMWATER ACTION PLAN	FORMER STORMWATER SYSTEM PARTIAL PLAN	PROJECT NO.: 074.40046.009
	FORMER CHICAGO PNEUMATIC TOOL COMPANY UTICA, NEW YORK		DATE: JUNE 2000
			FIGURE NO.:
			3

The former foundry building contributed to the southwestern stormwater system (SPDES 001), as indicated on the original construction drawings (see Figures 1 and 3). Generally, contributions were from two sources: the roof leader and the conveyor pit pump. The following are observations and subsequent corrective actions taken:

The former power plant original construction plans indicate that one interior roof leader and one western stormwater pipe contribute to SPDES Outfall 001 (see Figures 1 and 3). The corrective measures included disconnecting the interior roof leader from the stormwater system and rerouting it to discharge to the southern drainage ditch (Area 6) (see Figures 4 and 5). The roof leader now contributes to SPDES Outfall 003. The western stormwater pipe was disconnected and abandoned during replacement of the southwestern stormwater system.

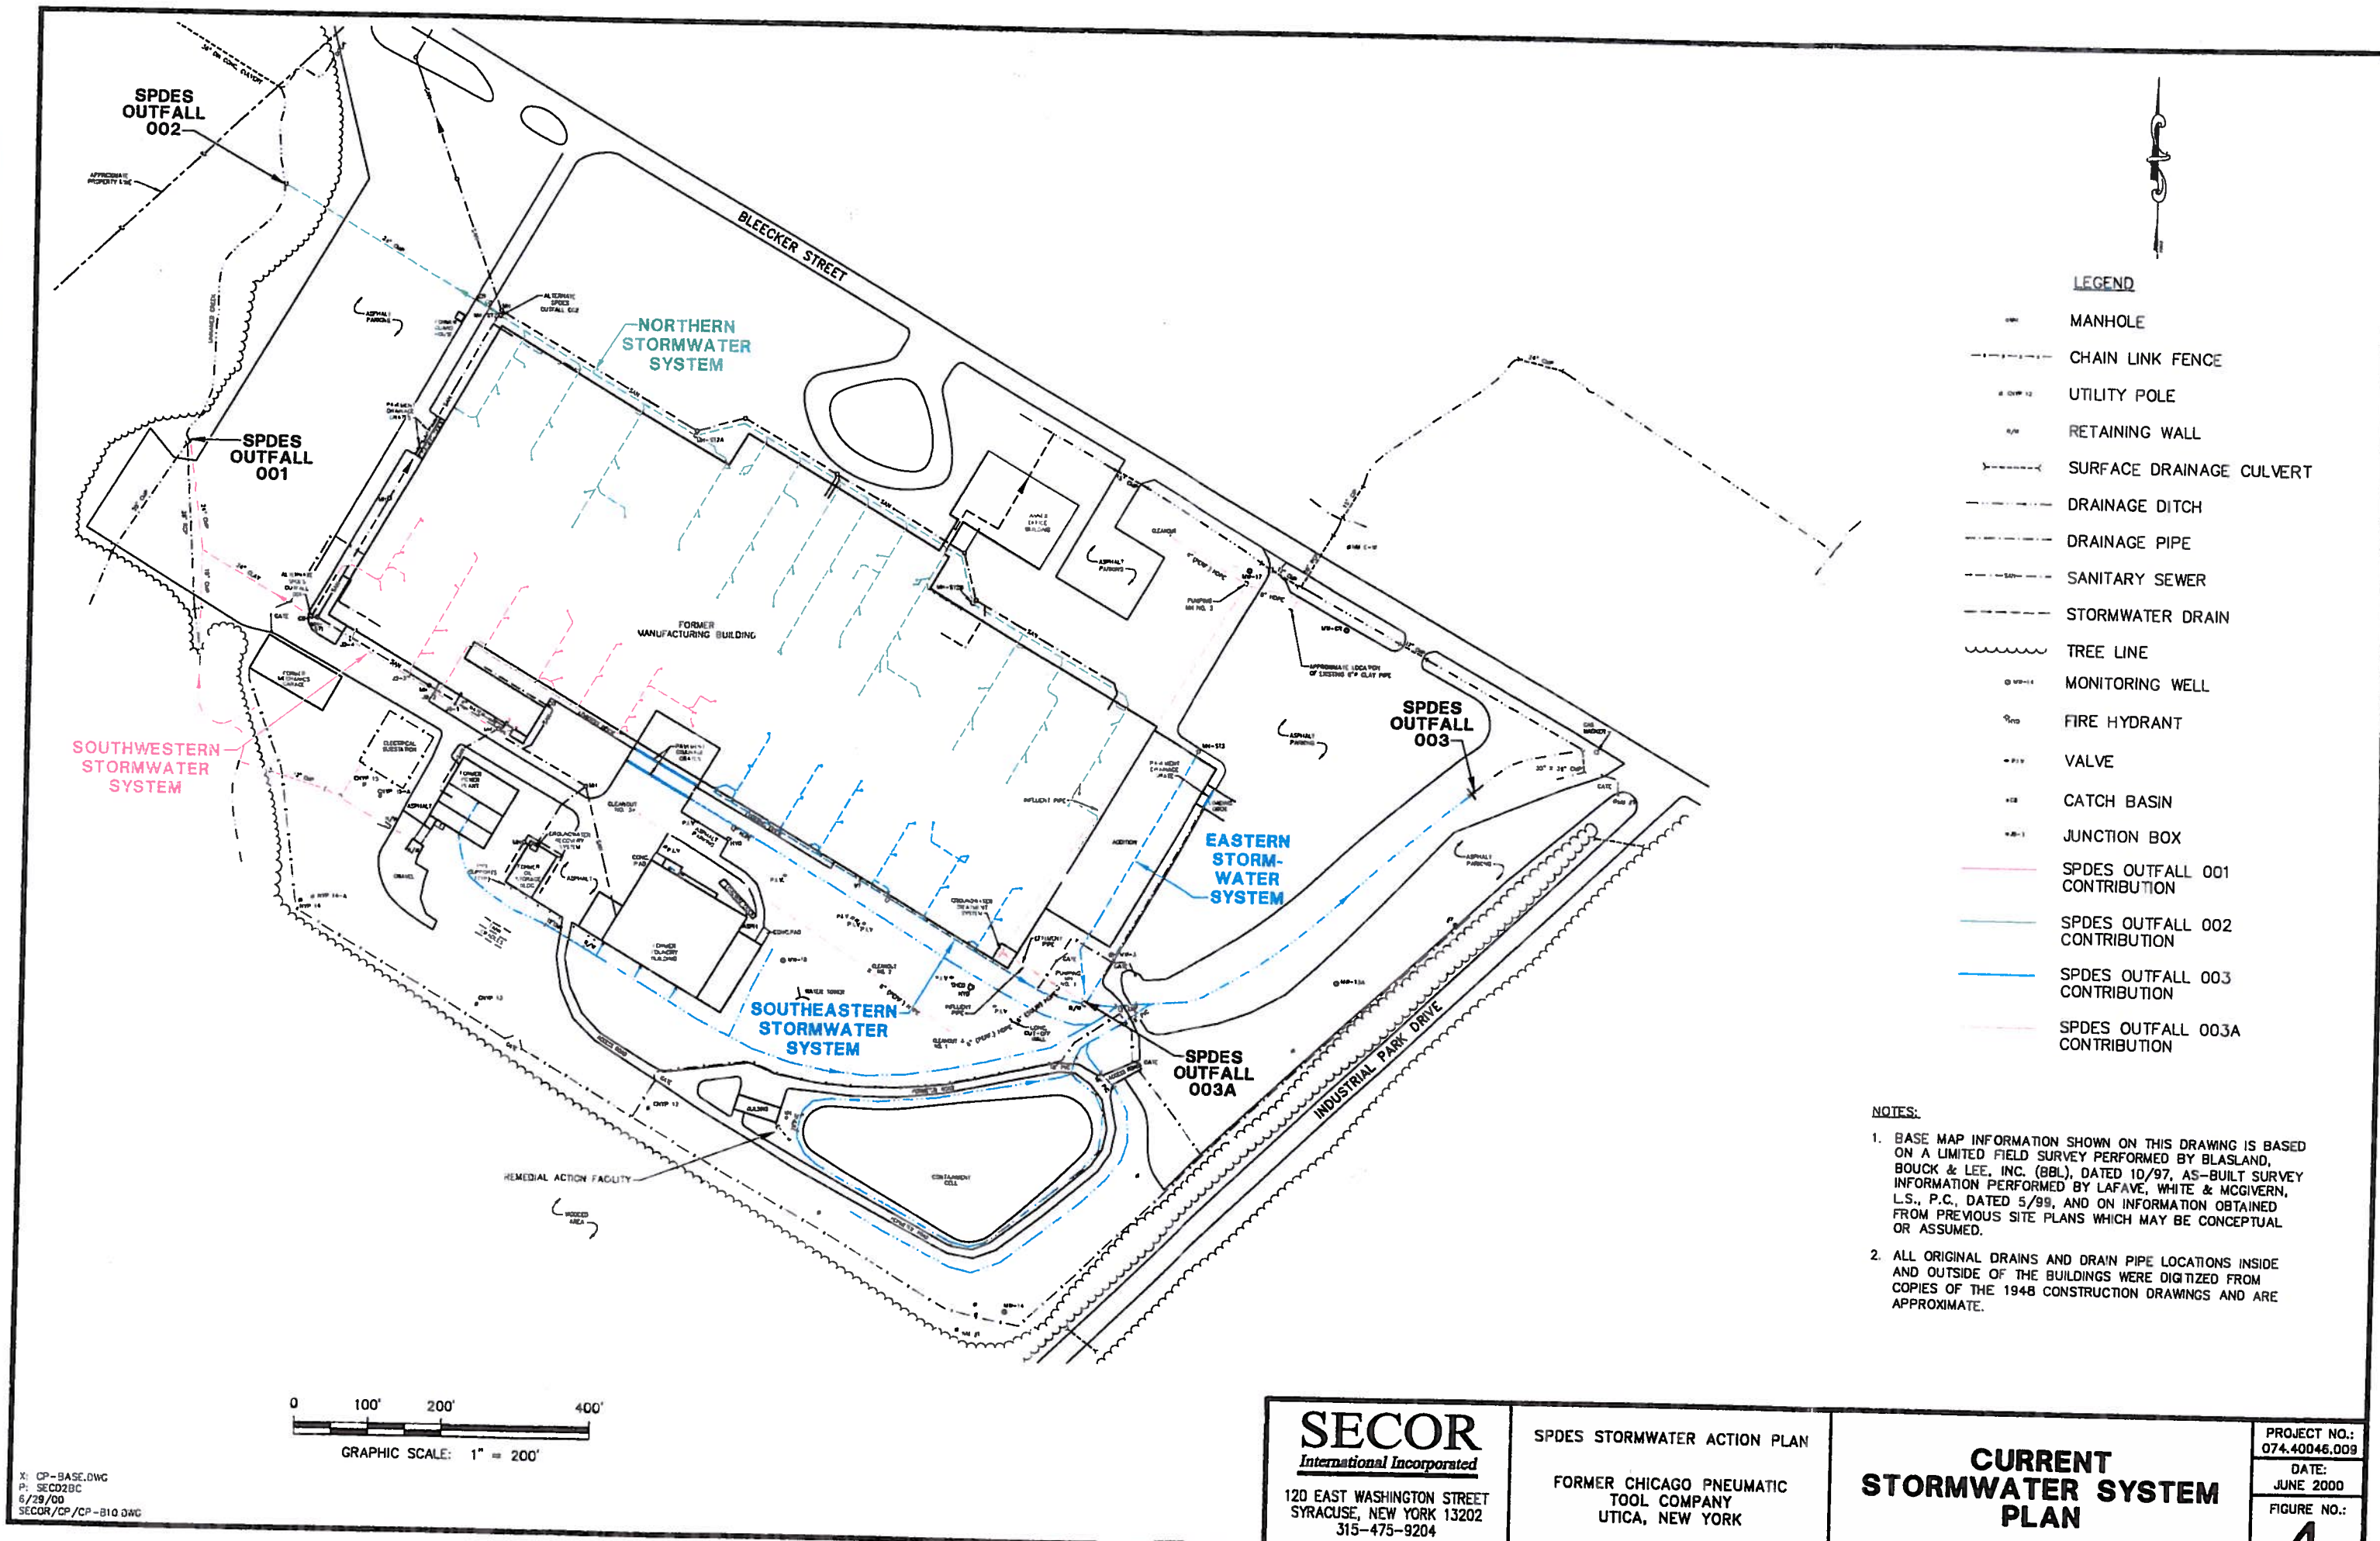
SECOR <i>International Incorporated</i> 120 EAST WASHINGTON STREET SYRACUSE, NEW YORK 13202 315-475-9204	SPDES STORMWATER ACTION PLAN	CURRENT STORMWATER SYSTEM PLAN	PROJECT NO.: 074.40046.009
	FORMER CHICAGO PNEUMATIC TOOL COMPANY UTICA, NEW YORK		DATE: JUNE 2000
			FIGURE NO.:
			4

- Adjacent to interior east wall of the former manufacturing building addition, a drinking fountain was found to discharge to a standpipe drain. The corrective measure included completely disconnecting the drinking fountain and installation of a threaded plug on April 5, 2000. This drained into the eastern stormwater system, which empties into Area 14 ditch (see Figure 3).

- Area 6 drainage ditch that collects surface water runoff from the southern portion of the site and stormwater discharge from the former foundry building and the former power plant (see Figure 4);
