Date: June 17, 2025 Our Ref: 30229726 Subject: Response to Comments – 2024 Restoration Monitoring Report NYSEG Cortland-Homer Former MGP Site NYSDEC Site No. 7-12-005 Arcadis of New York, Inc. One Lincoln Center 110 West Fayette Street Suite 300 Syracuse, NY 13202 United States Phone: 315 446 9120 Fax: 315 449 0017 www.arcadis.com

NYSEG - CORTLAND-HOMER FORMER MGP SITE HOMER, NEW YORK 2024 RESTORATION MONITORING REPORT

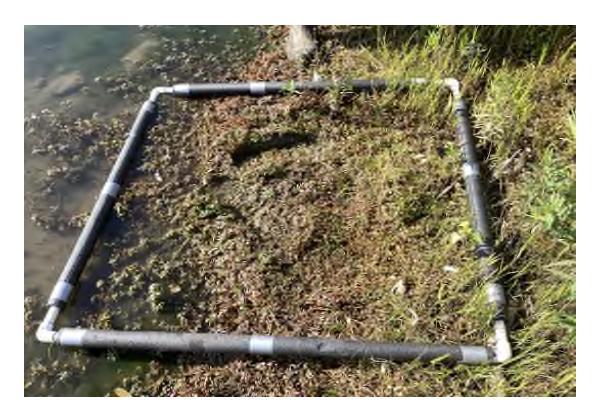
Monitoring Location : EV-01Q1				
Habital Type : Emergent Vegetation				
Survey Date : 09/09/2024				
Staff: Jason Vogel				
Aerial Cover				
Dimensions	1	meters		
	Opiewijije News	Alto a luta O aura 0/	Nativity (native, non	N/
Common Name	Scientific Name	Absolute Cover %	native, weed)	vigor
Trees

Herbs				
Purple Loosestrife	Lythrum salicaria	6	Non-Native	N/A
Water Speedwell	Veronica anagallis-aquatica	70	Non-Native	N/A
European Cocklebur	Xanthium strumarium	1	Non-Native	N/A
Green Algae	Chlorophyta spp.	7	Native	N/A
Rice Cut Grass	Leersia oryzoides	7	Native	N/A
Needle Spike Rush	Eleocharis acicularis	5	Native	N/A

Absolute Vegetative Cover (%)	90	
Total Species Cover (%)	96	
Native Cover (%)	12	
Invasive/Target Weed (%)	6

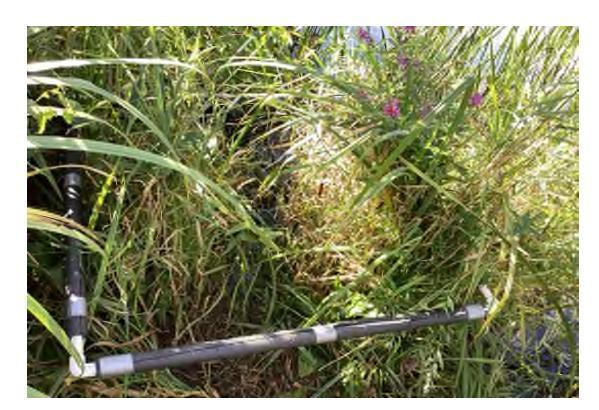
Monitoring Location: EV-04Q1				
Habital Type : Emergent Vegetation				
Survey Date : 09/10/2024				
Staff: Jason Vogel				
Aerial Cover				
Dimensions	1	meters		
Common Name Scientific Name Absolute Cover % Nativity (native, non native, weed) Vigor				
Trees

Total Vegetative Cover (%)	75	
Total Species Cover (%)	110	
Native Cover (%)	55	
Invasive/Target Weed (%)	55

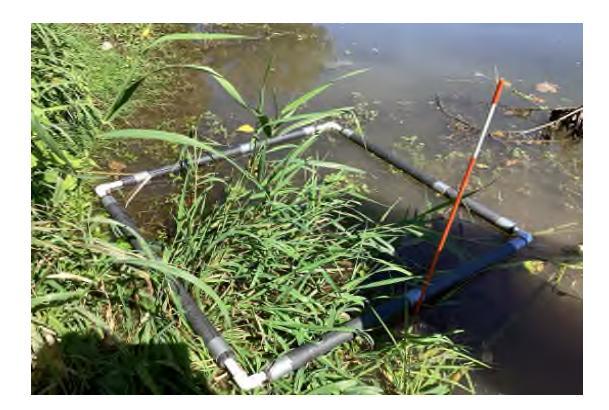
Total Vegetative Cover (%)	50	
Total Species Cover (%)	67	
Native Cover (%)	0	
Invasive/Target Weed (%)	25

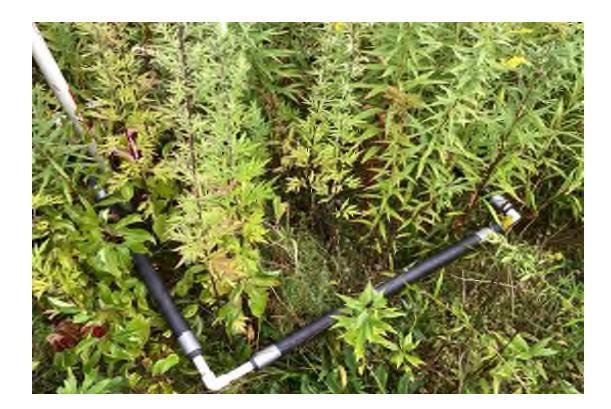
Monitoring Location: IS-07Q1						
Habital Type: Inundated Shoreline						
Survey Date: 09/10/2024						
Staff: Jason Vogel						
Aerial Cover						
Dimensions	1	meters				
Common Name Scientific Name Absolute Cover % Nativity (native, non native, weed) Vigor						
Trees

Total Vegetative Cover (%)	98	
Total Species Cover (%)	126	
Native Cover (%)	70	
Invasive/Target Weed (%)	20

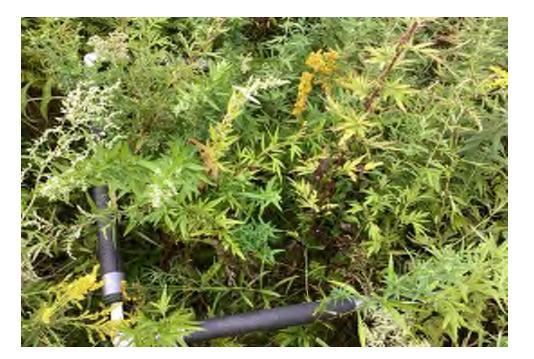
Common Name Scientific Name Absolute Cover % Nativity (native, non						
Dimensions	Dimensions 1 meters					
Aerial Cover						
Staff: Jason Vogel						
Survey Date : 09/10/2024						
Habital Type : Inundated Shoreline						
Monitoring Location : IS-07Q2

Total Vegetative Cover (%)	95	
Total Species Cover (%)	147	
Native Cover (%)	32	
Invasive/Target Weed (%)	50
