EAST DELAVAN PROPERTY, LLC

Re: Transmittal
Preliminary Work Plan, Comments and Responses
Former American Axle Site
Buffalo, New York
Site No. 915196

Table W-3
Recommendations
East Delevan Property
Buffalo, New York

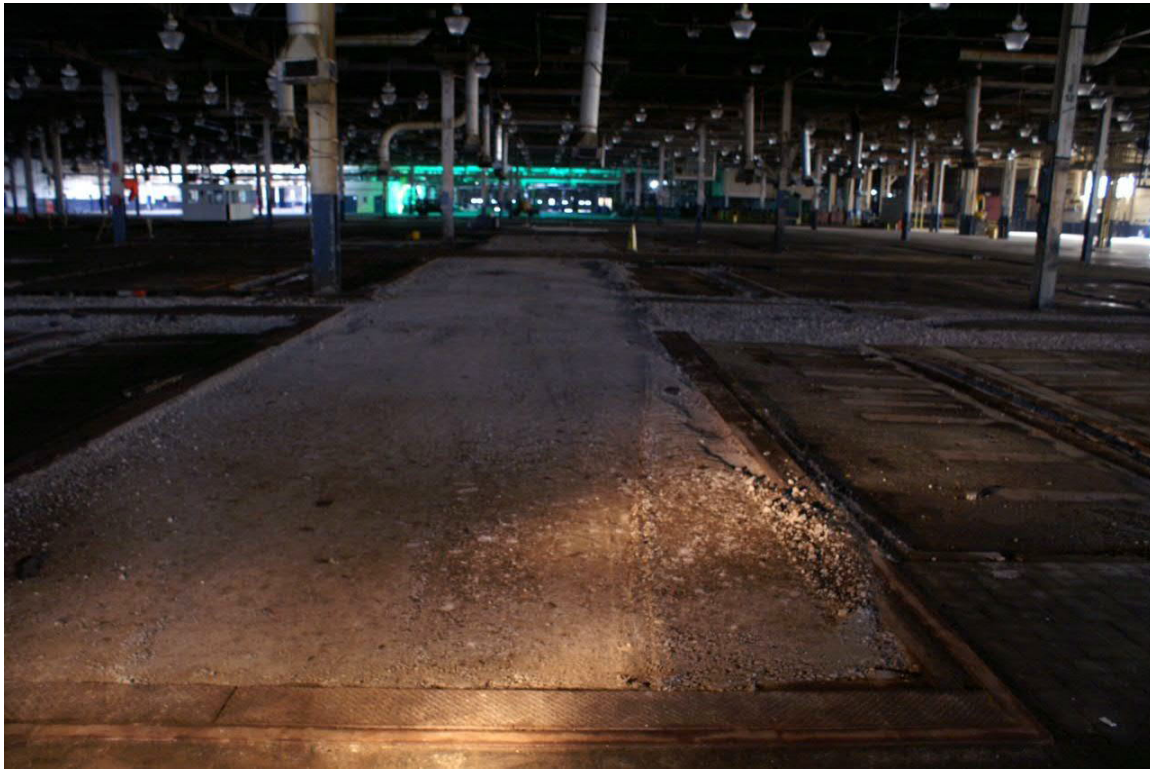
Photograph 2
View of Interior After Equipment Removed
Circa 2009

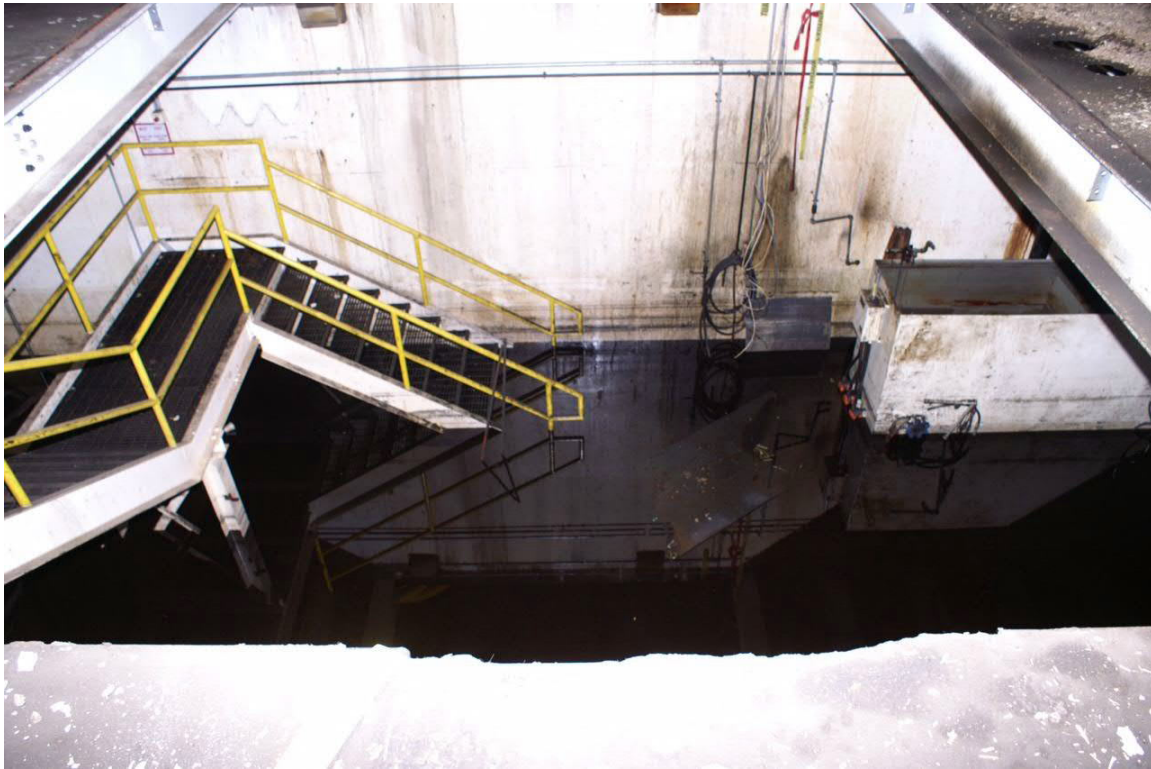
Photograph 3
Pit Containing Oily Substance and Wastewater
Circa 2009
(Before GM Bankruptcy)

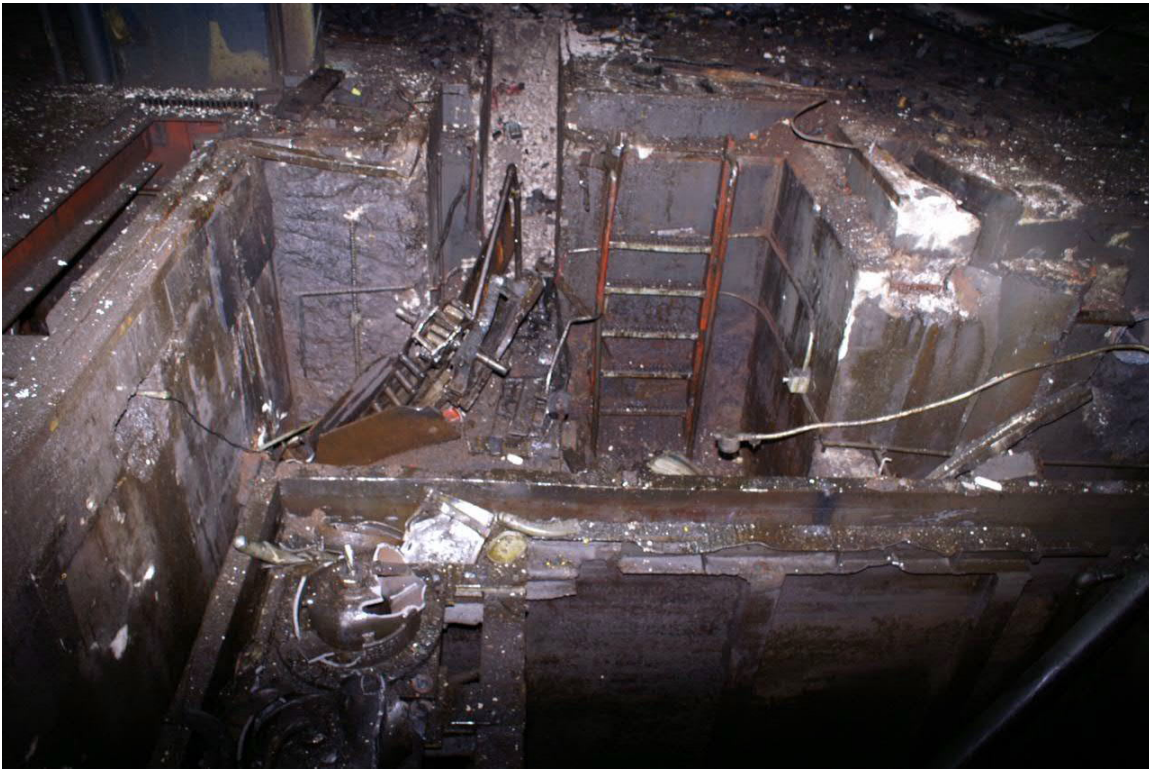
Photograph 4
Pit During Cleaning
Circa 2009
(Before GM Bankruptcy)

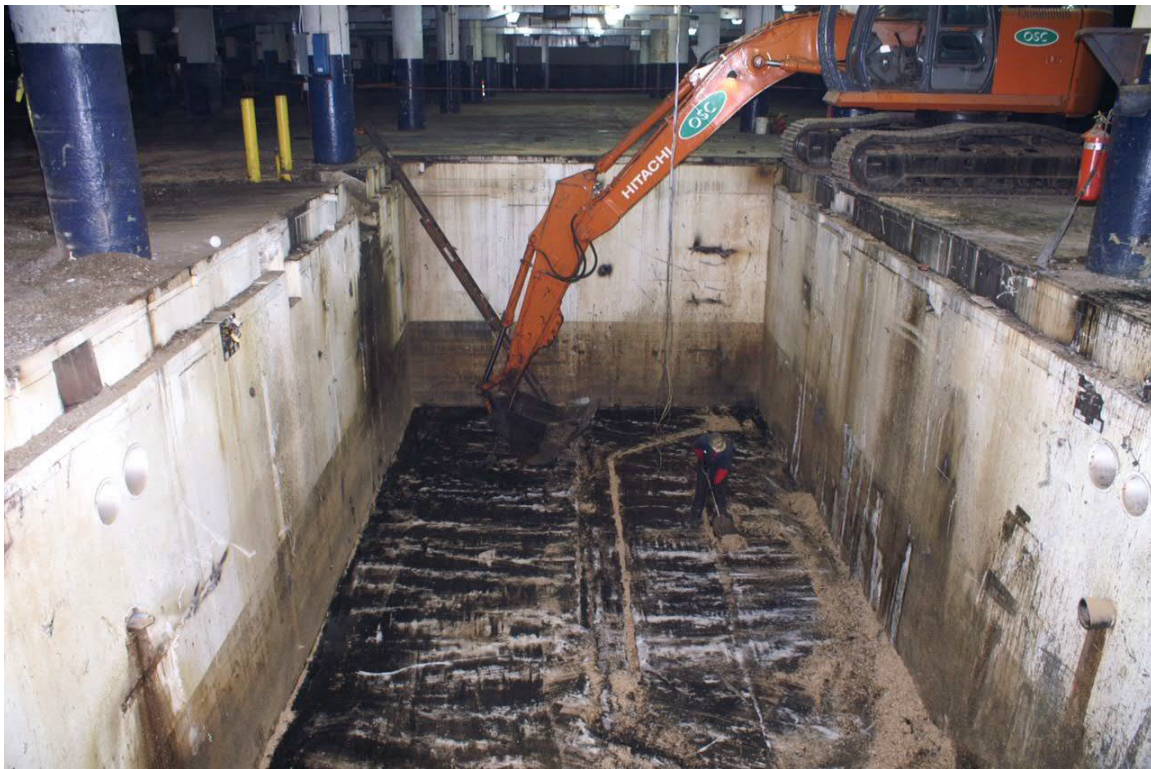
Photograph 5

Pit During Cleaning

Note: Height of Worker Relative to Height of Staining of Wall; Indicative of Oily Wastewater Elevation and Pressure on Concrete

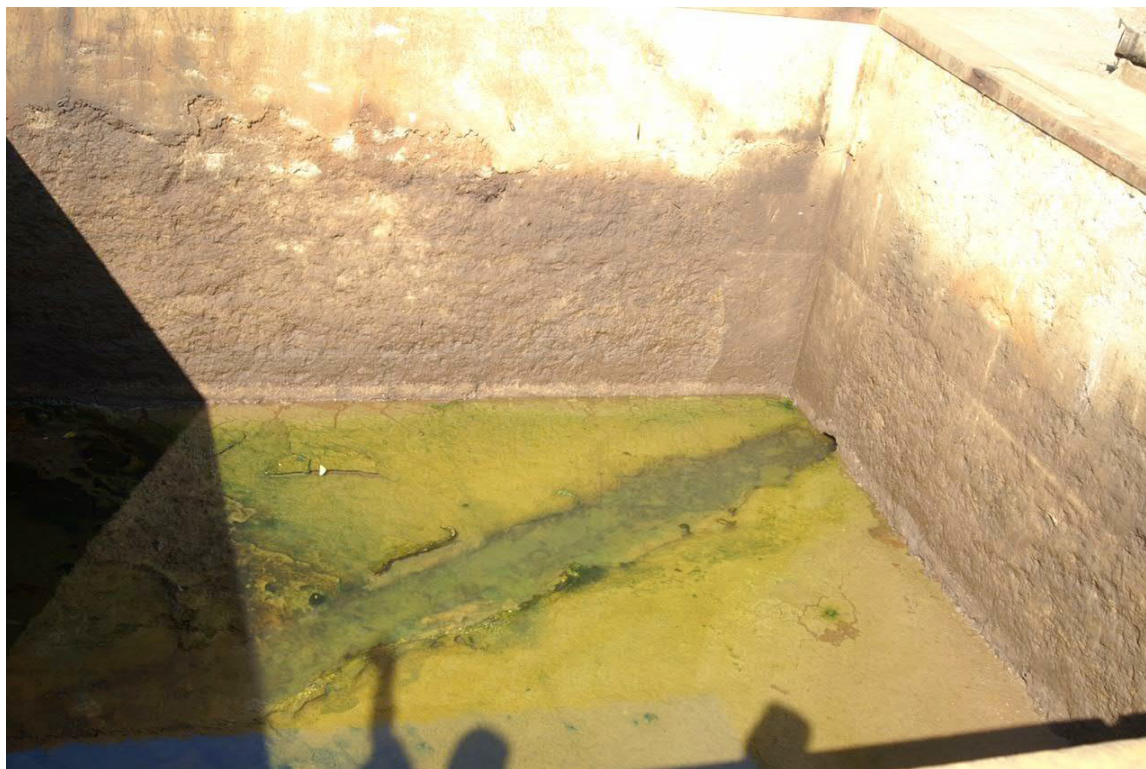
Photograph 6

Pit During Cleaning

Notes: (1) Height of Staining of Wall; Indicative of Oily Wastewater Elevation and Pressure on Concrete
