January 10, 2013 Reference: 12-276-1

Subject: Geophysical Investigation Results Former Doro Cleaners Site 3466 Genesee Street Cheektowaga, New York

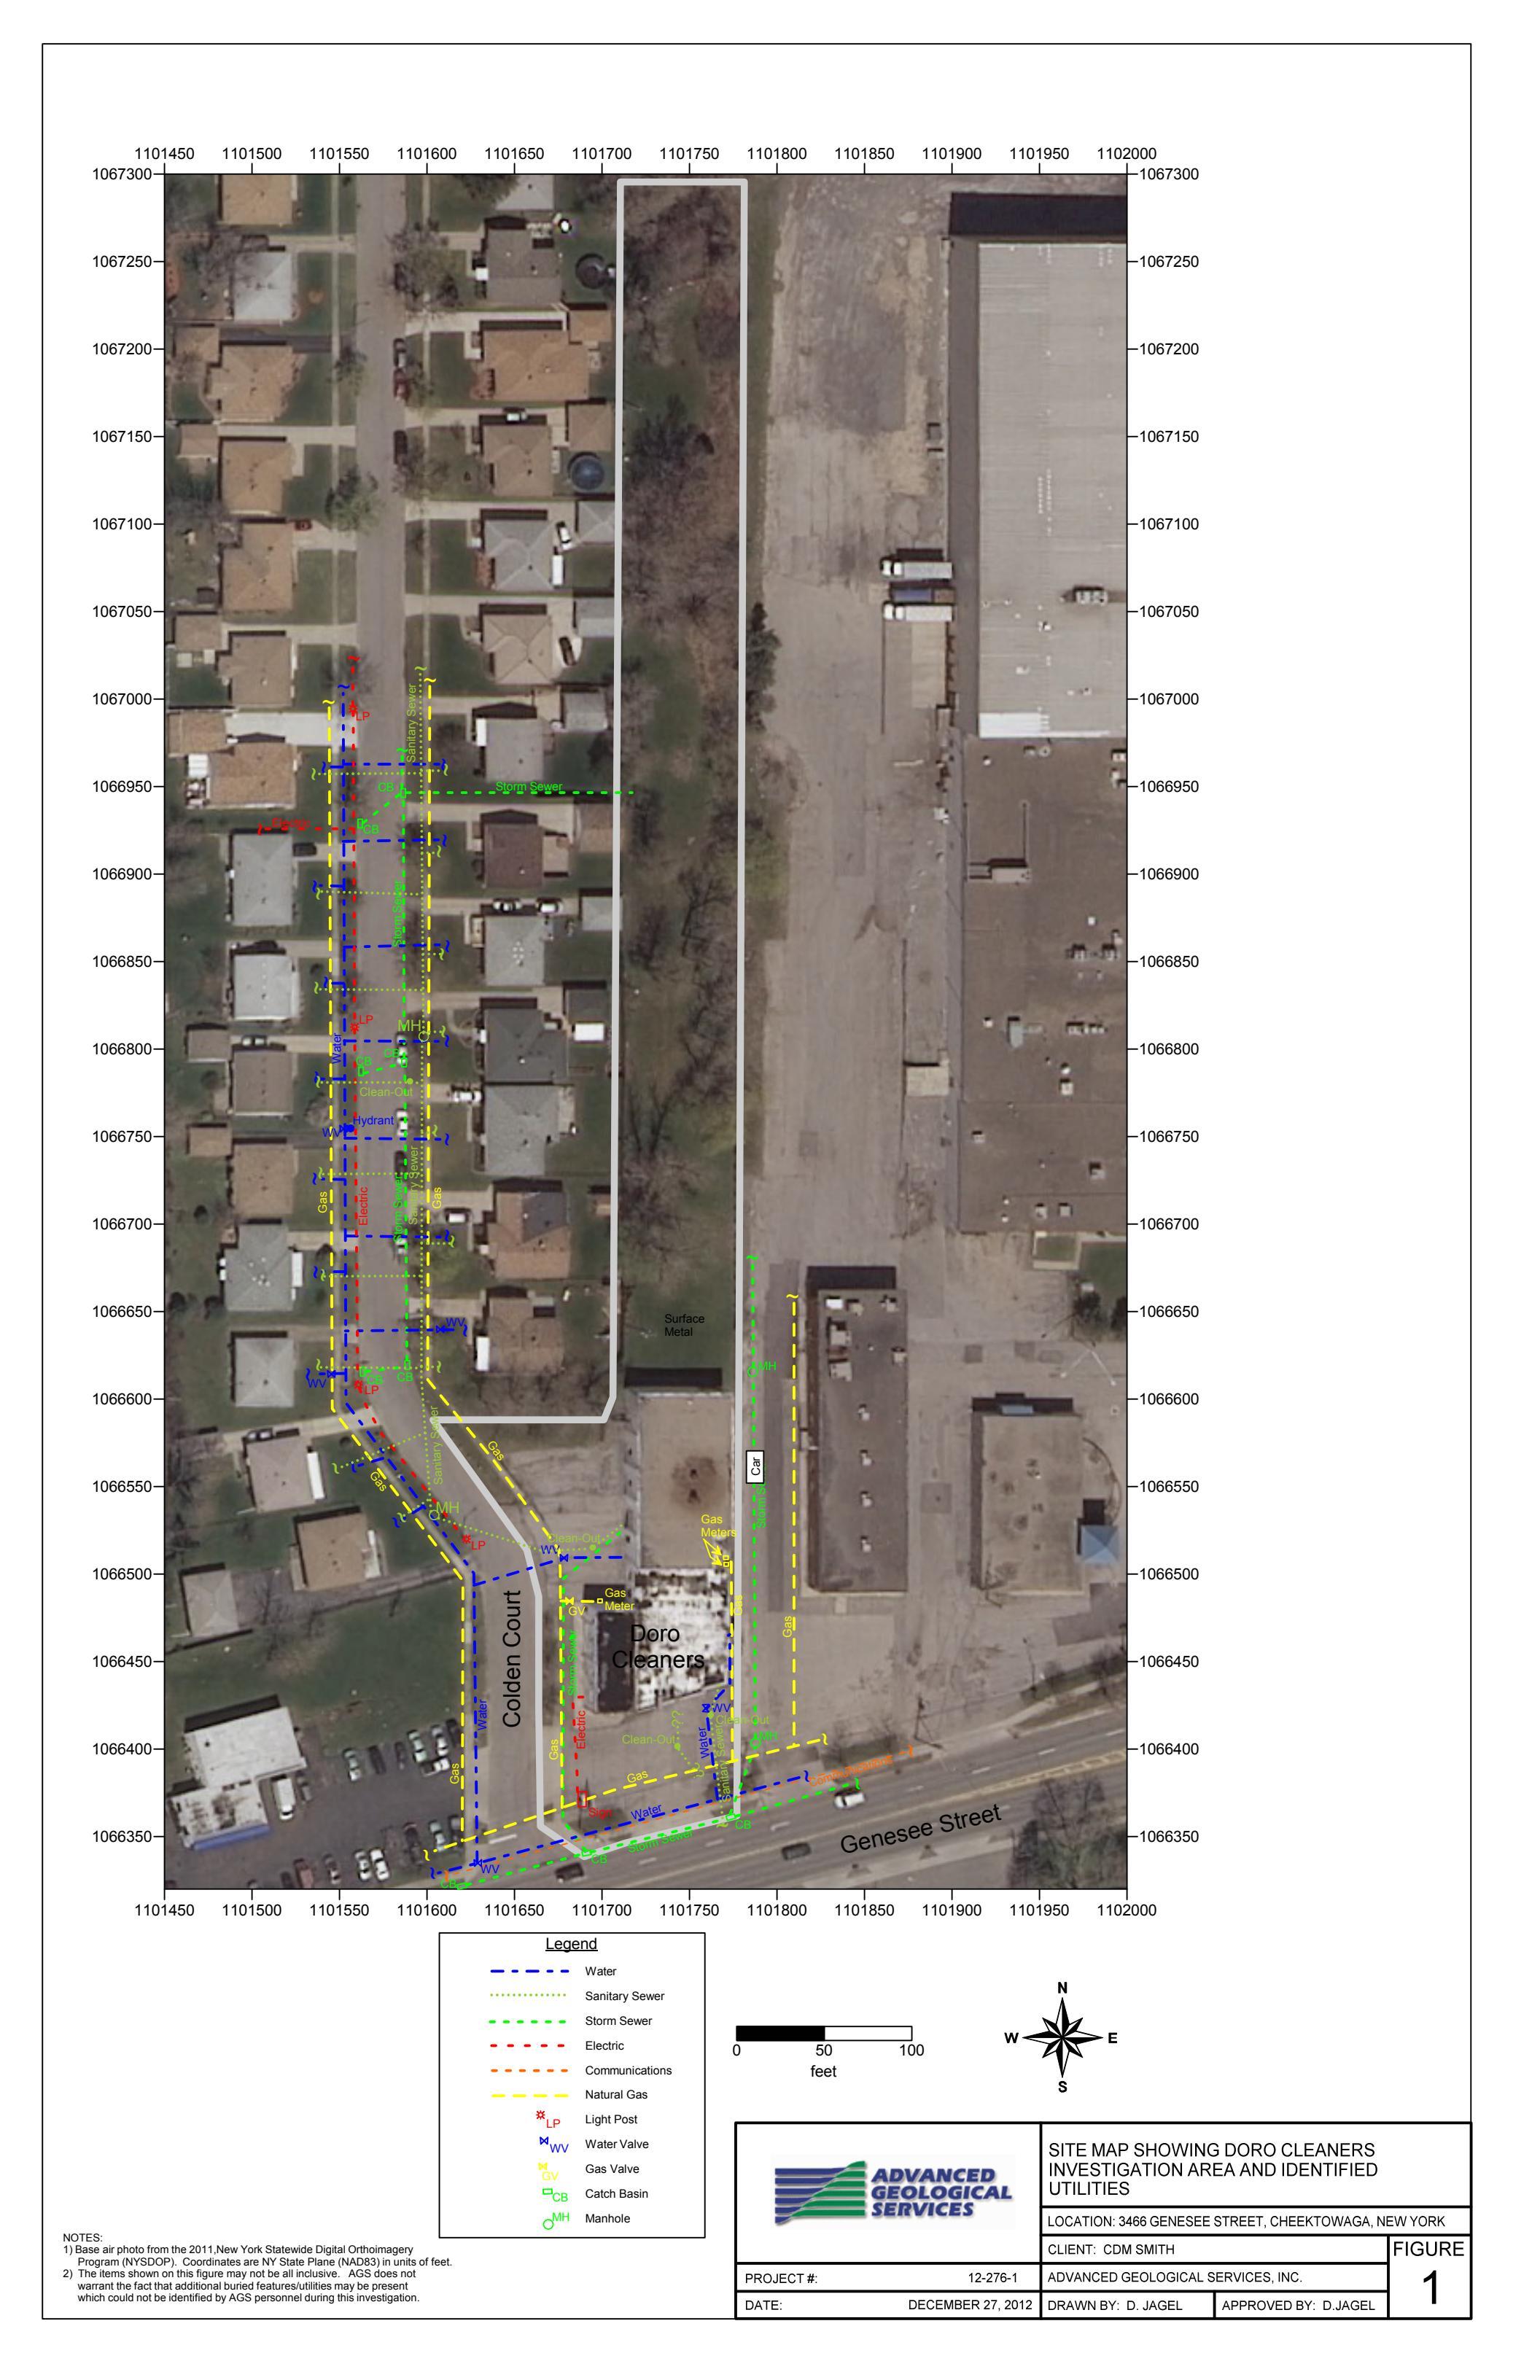
• Water, sanitary sewer, storm sewer, natural gas and electrical mains located in the public ROW along Colden Court were marked out on site. The water and sanitary sewer connections to the houses along Colden Court were also marked out on site (Fig. 1).

- A storm sewer pipe and the natural gas service to the property located to the east of the Doro Cleaners property were identified and marked on site (Fig. 1).
- Water, storm sewer, sanitary sewer, natural gas, electrical and telecommunications utilities were identified and marked out on the Doro Cleaners property (Fig. 1).
- A clean-out was observed in the parking lot area on the south side (front) of the Doro Cleaners building (Fig. 1). It could not be determined using available geophysical methods whether this clean-out was for a sanitary sewer, or a storm sewer connection. Furthermore, it was not possible to trace the pipe(s) leading to and from this clean-out with any degree of certainty.

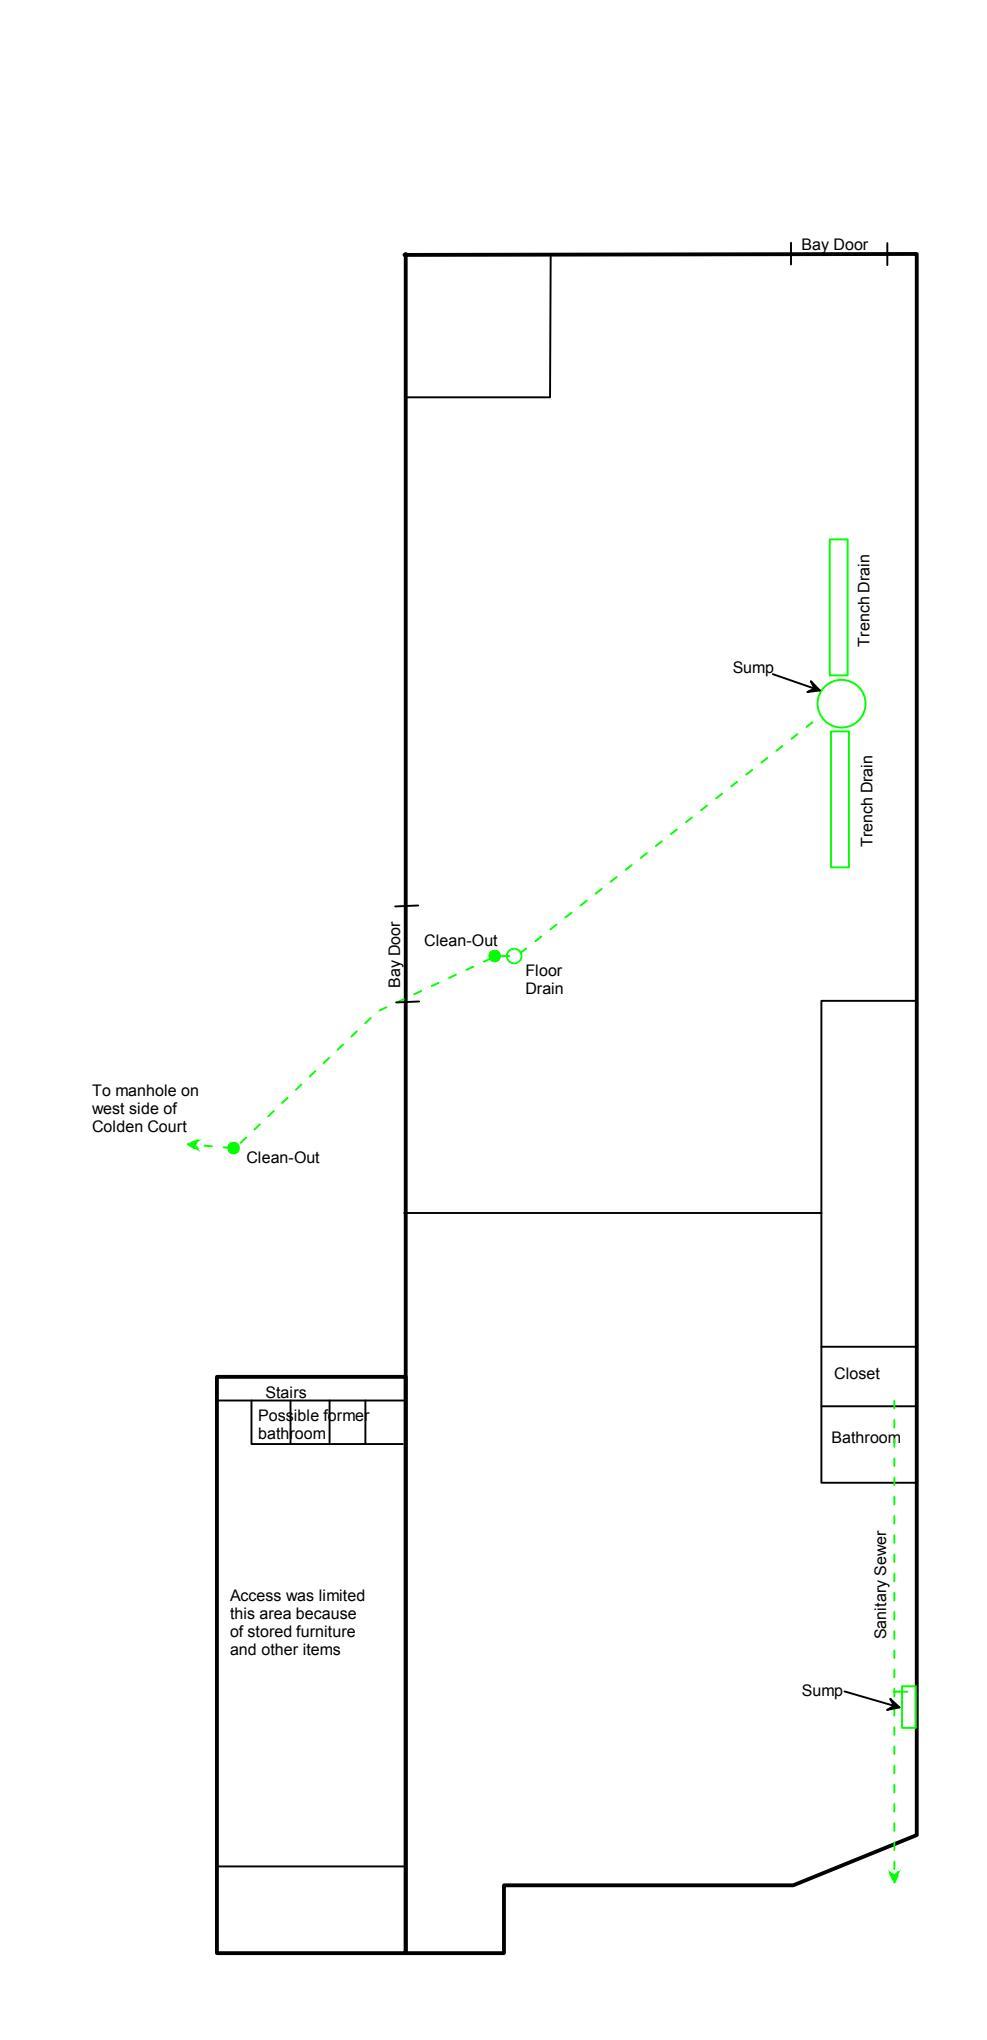
- A 4-foot diameter sump pit and connected trench drains that lead the sump is located in the northern (rear) portion of the building, near the eastern wall (Fig. 2). This sump drains through a pipe that extends to a floor drain and clean-out located near the bay door on the west side of the building, then continues to a clean-out located in the parking area on the west side of the building (Fig. 1). From there it continues into a sanitary sewer manhole located on the west side of Colden Court.

- A sanitary sewer pipe extends from a bathroom on the east side of the building towards the south, exiting the building, and continuing to a sanitary sewer main in Genesee Street (Fig. 2). A rectangular sump pit is located along the eastern wall of the building, near the southeast corner of the building. This sump pit connects into the sanitary sewer pipe that continues to Genesee Street.

- There were one or two possible former bathrooms and located in the north end of the western building extension (near the stairs; see Fig. 2). Pipes that appeared to be from former toilets were observed in the floor in two of the small rooms. Because of limited space, debris and stored/stacked furniture and other items, AGS was not able to determine where these possible sewer pipes went, or what they connected into. Tracing these pipes, and determining where they connect into the municipal sewer system may require pipes inspection methods such as video, and sonde insertion methods.

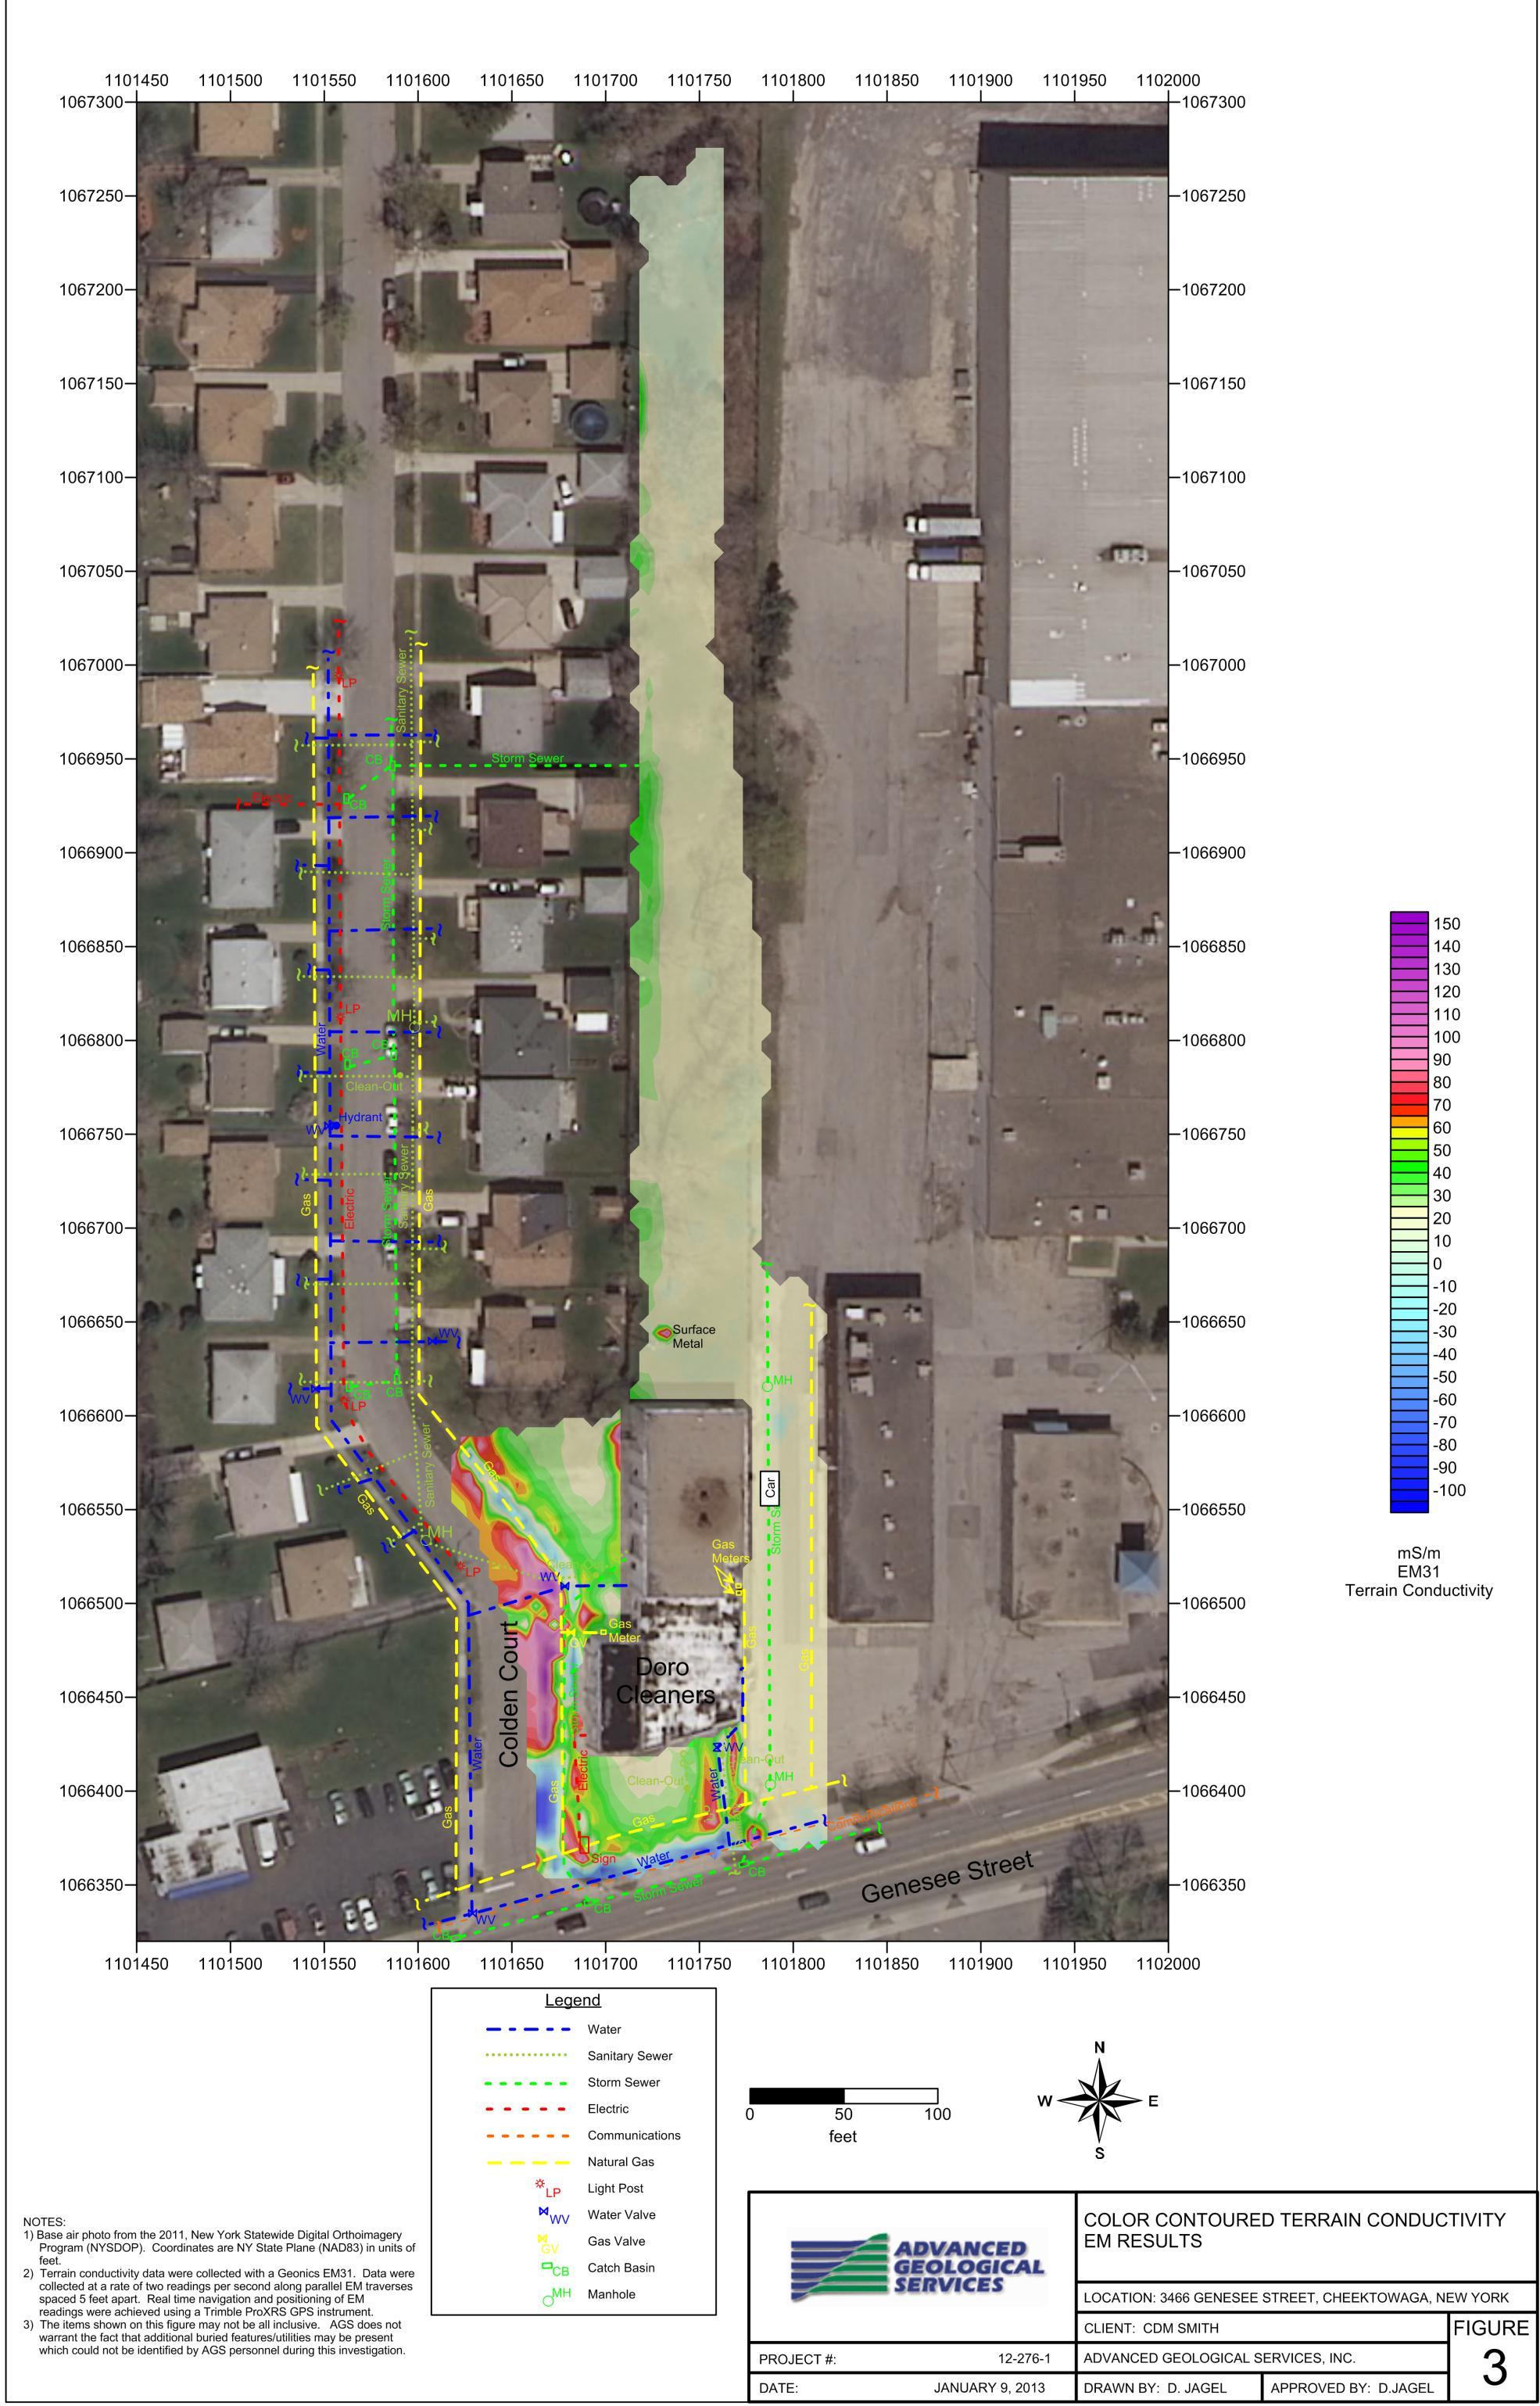
the area to the north of the Doro Cleaners building. There was some metal containing surface debris located approximately 45 feet to the north of the northern wall of the building that did produce a strong terrain conductivity response (labeled as "Surface Metal" on Fig. 3). However, there were no anomalies in either the terrain conductivity EM, or the in-phase EM results indicating that any features such as septic tanks, septic drain fields, or USTs were present. A number of GPR traverses were completed in the area to the north of the building from the north building wall to approximately 65 feet north of the building. The GPR records did not indicate that any buried features were present in this area, agreeing with the EM results.

Strong EM responses along the west and south sides of the Doro Cleaners property were caused by the presence of buried utilities, metal reinforced concrete in driveway aprons and some sidewalks (Figs. 3 and 4). The locations of utilities were verified using RF utility locating methods and GPR methods. No anomalies were identified that would indicate the presence of any USTs, septic tanks, settling tanks, or other previously unknown subsurface features along the west or south sides of the property.
