# ASBESTOS-CONTAINING MATERIALS REMEDIATION

## FOR FORMER PHOTECH IMAGING SYSTEMS FACILITY

1000 DRIVING PARK AVENUE  
ROCHESTER, NEW YORK

ASBESTOS-CONTAINING MATERIALS  
REMEDICATION PLAN  
PROJECT NO. 209288

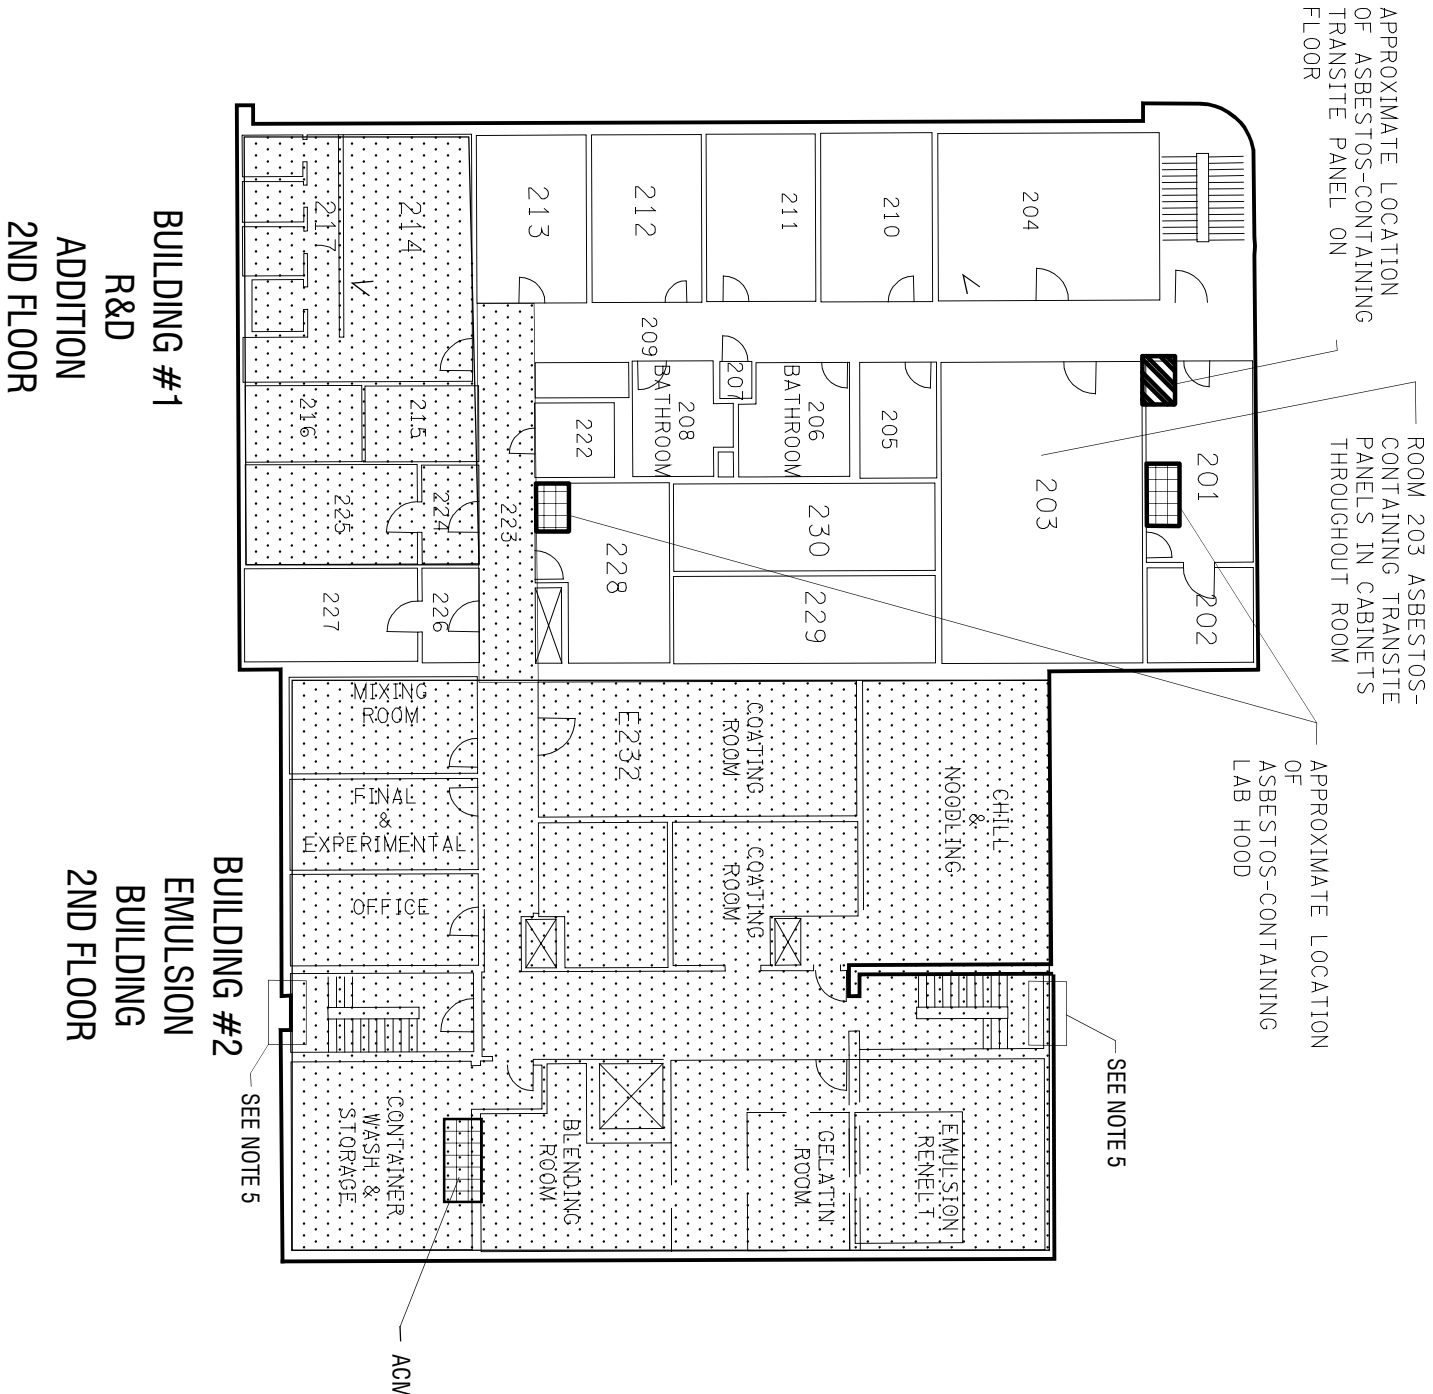
**AA.02**

**NOTE: 1st FLOOR BLDG. 2 DEBRIS EXCEEDS USEPA TCLP  
HAZARDOUS WASTE VALUE FOR RCRA METALS  
REMOVE AND DISPOSE OF ALL DEBRIS AS A  
CHARACTERISTIC HAZARDOUS WASTE.**

1. BLDG. 1 & BLDG. 2 - ALL EXTERIOR CAULK BETWEEN WINDOW FRAMES AND WALL IS ASBESTOS CONTAINING.
2. BLDG. 1 & BLDG. 2 - ALL HVAC DUCT CAULK IS ASBESTOS-CONTAINING
3. BLDG. 2 - ALL GRAY WALL CAULK IN EXTERIOR JOINTS, DOORS & OTHER PENETRATIONS IS ASBESTOS-CONTAINING.
4. SOME INTACT AND IN PLACE ACM PIPE AND DUCT INSULATION IS PRESENT ON ALL FLOORS OF BLDG. 2.
5. ACM TAR OVER CORK AROUND ALL SIDES OF GLASS BLOCK WINDOWS.

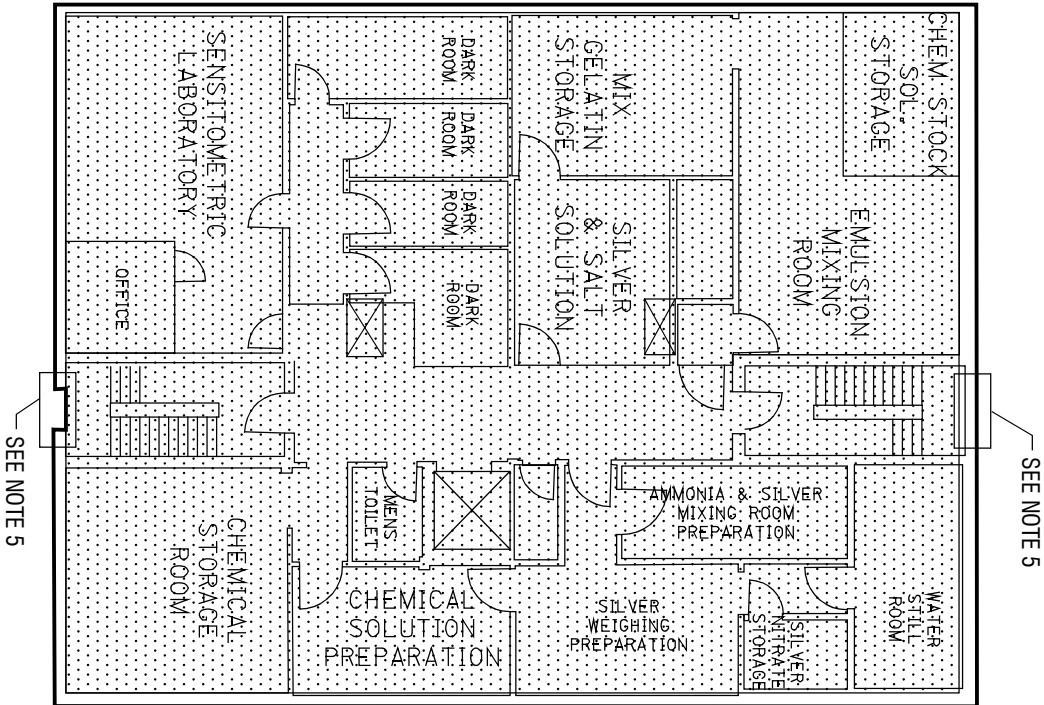
AA.03

- BLDG. 1 & BLDG. 2 - ALL EXTERIOR CAULK BETWEEN WINDOW FRAME AND WALL IS ASBESTOS CONTAINING.
- BLDG. 1 & BLDG. 2 - ALL HVAC DUCT CAULK IS ASBESTOS-CONTAINING
- BLDG. 2 - ALL GRAY WALL CAULK IN EXTERIOR JOINTS, DOORS & OTHER PENETRATIONS IS ASBESTOS-CONTAINING.
- SOME INTACT AND IN PLACE ACM PIPE AND DUCT INSULATION IS PRESENT ON ALL FLOORS OF BLDG. 2.
- ACM TAR OVER CORK AROUND ALL SIDES OF GLASS BLOCK WINDOWS.

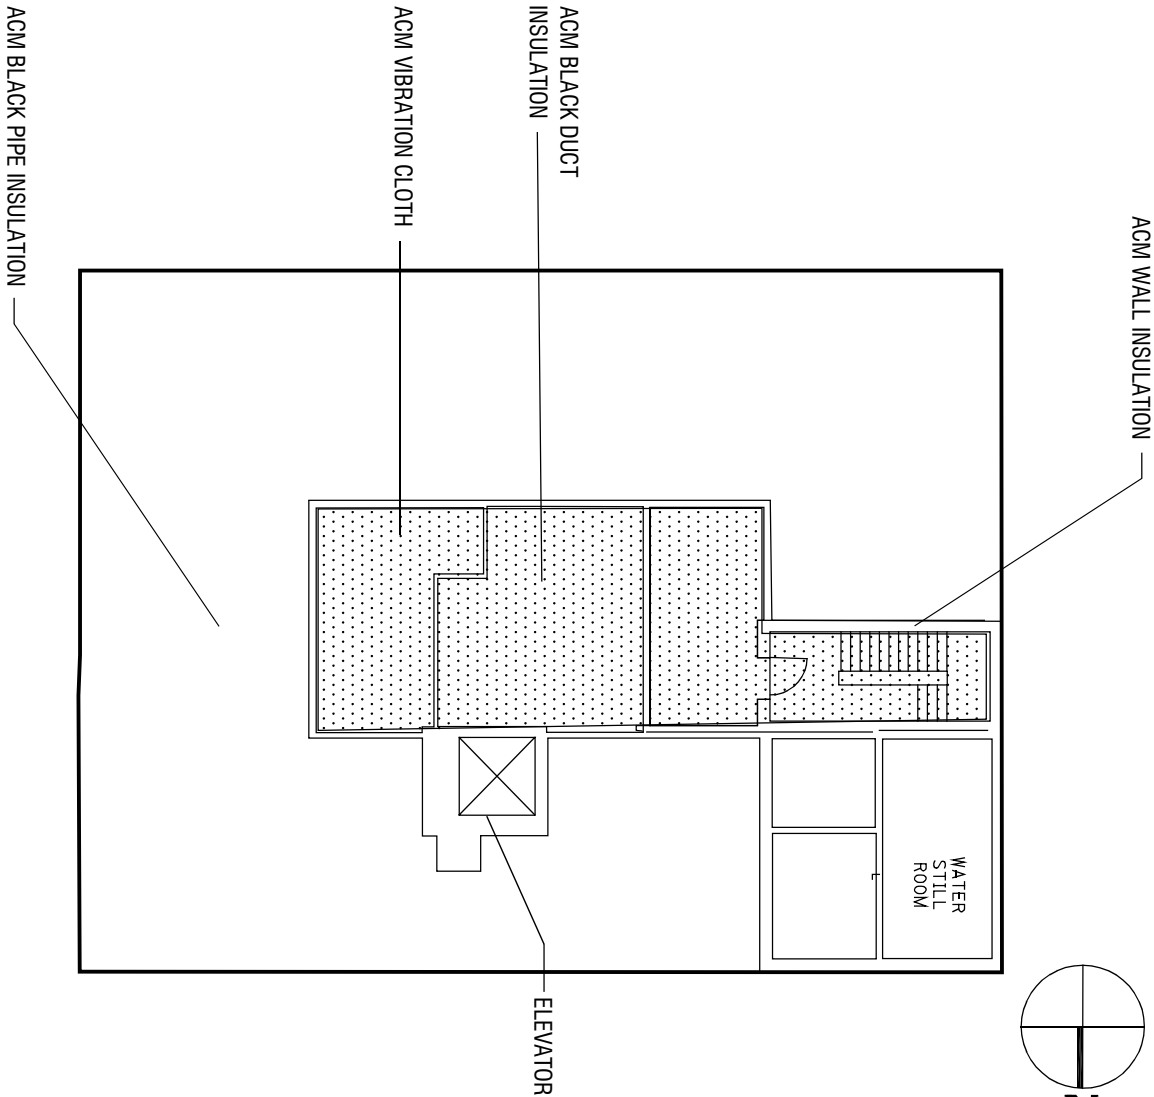
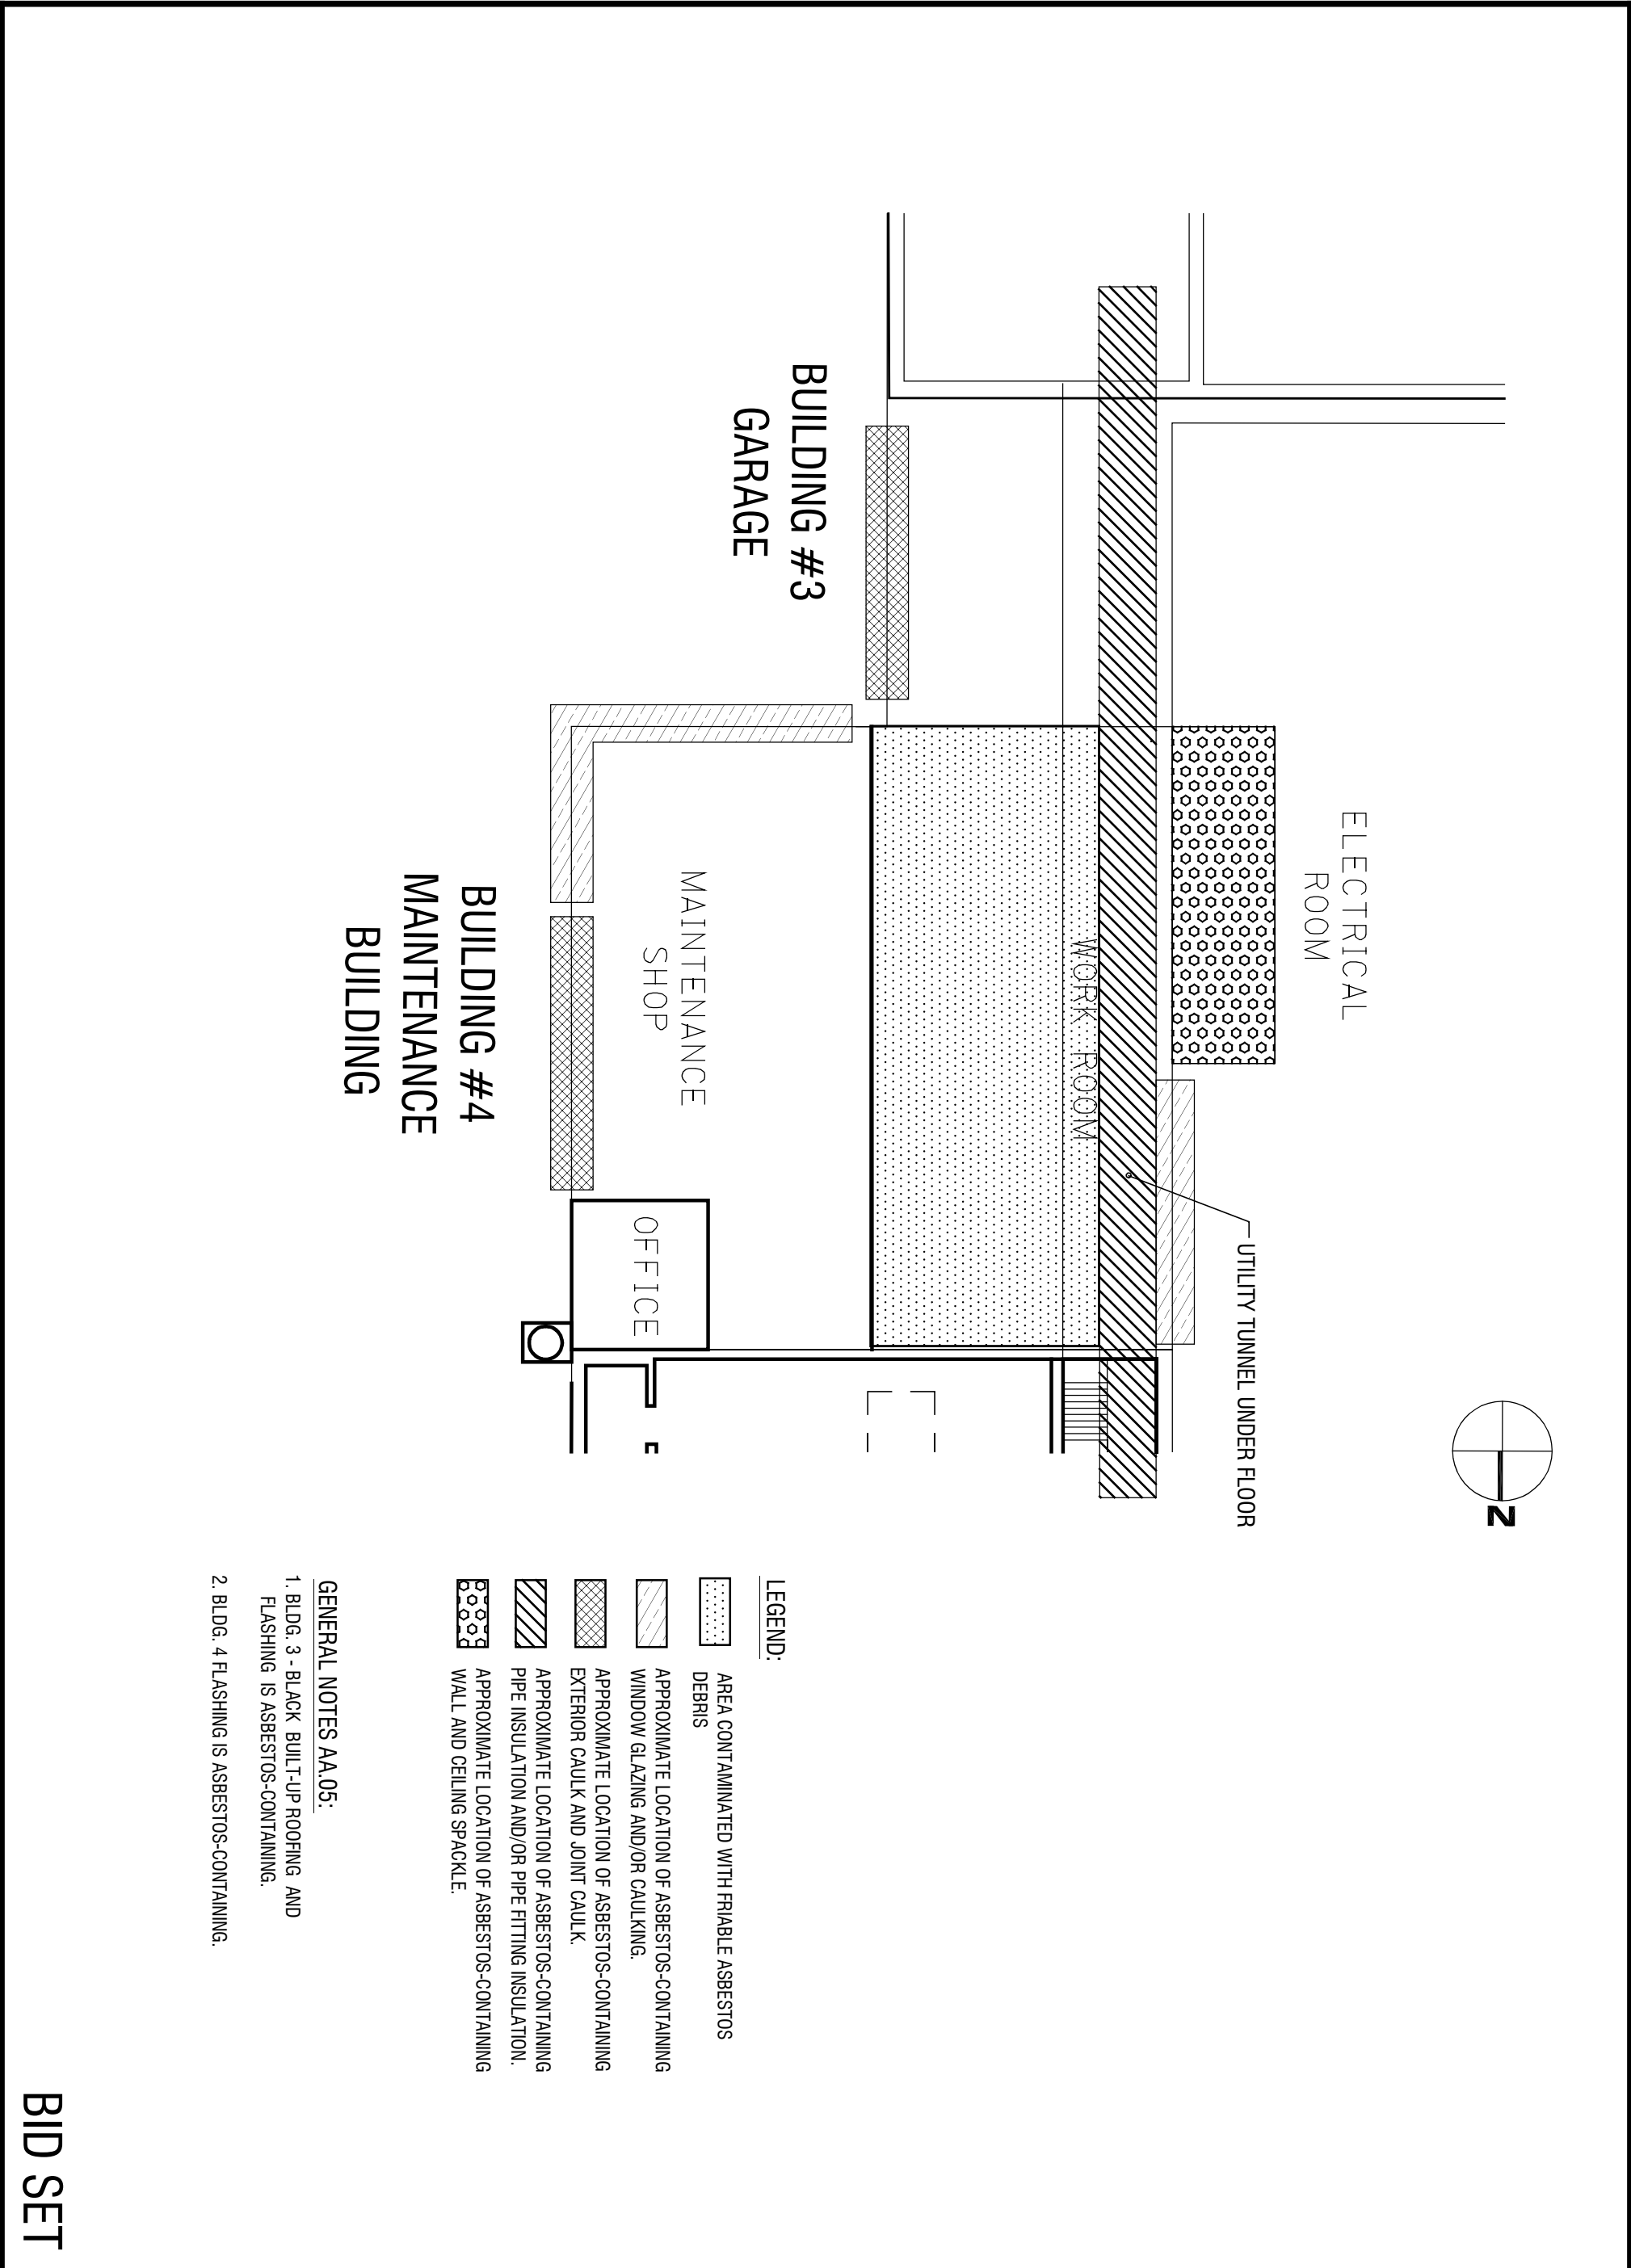
AA.04

1. BLDG. 1 & BLDG. 2 - ALL EXTERIOR CAULK BETWEEN WINDOW FRAME AND WALL IS ASBESTOS CONTAINING.
2. BLDG. 1 & BLDG. 2 - ALL HVAC DUCT CAULK IS ASBESTOS-CONTAINING
3. BLDG. 2 - ALL GRAY WALL CAULK IN EXTERIOR JOINTS, DOORS AND OTHER PENETRATIONS IS ASBESTOS-CONTAINING.
4. SOME INTACT AND IN PLACE ACM PIPE AND DUCT INSULATION IS PRESENT ON ALL FLOORS OF BLDG. 2.
5. ACM TAR OVER CORK AROUND ALL SIDES OF GLASS BLOCK WINDOWS.

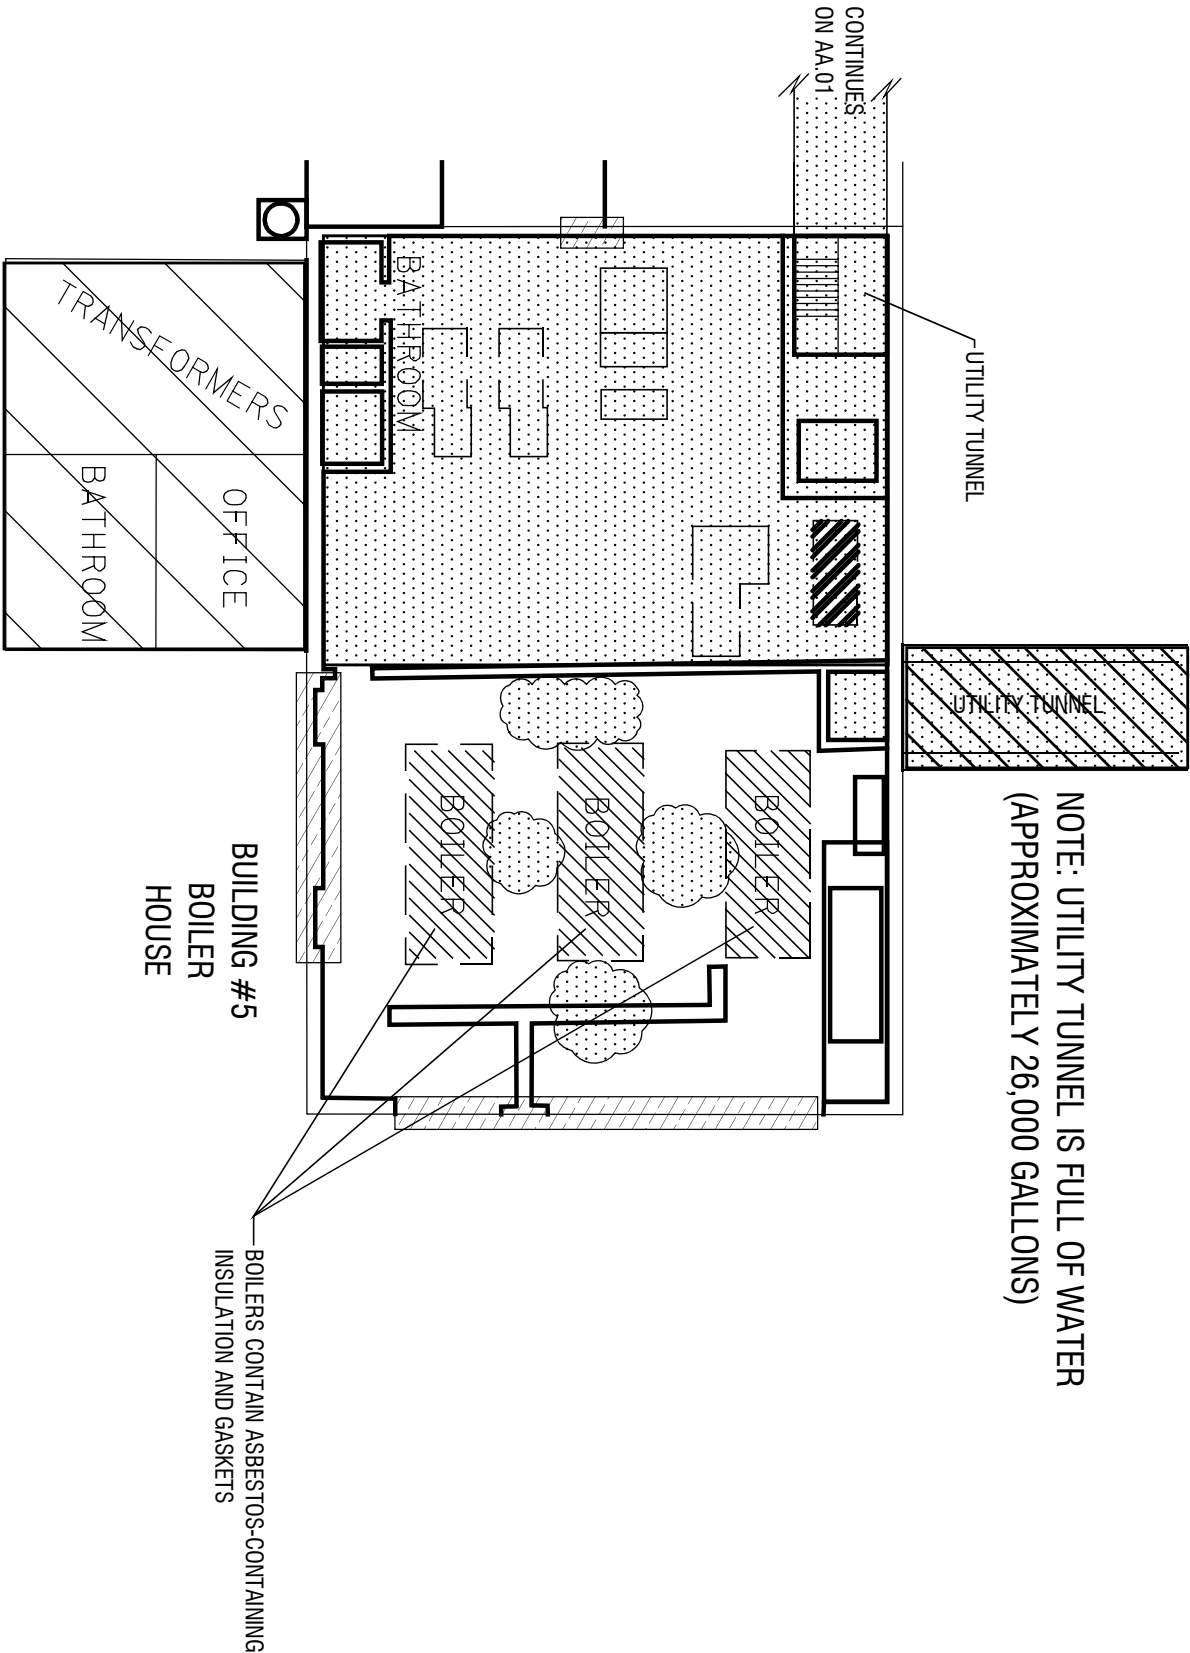
AA.06

NOTE: BLDG. 6 FLOOR DEBRIS EXCEEDS USEPA TCLP  
HAZARDOUS WASTE VALUS FOR RCRA METALS  
REMOVE AND DISPOSE OF ALL DEBRIS AS A  
CHARACTERISTIC HAZARDOUS WASTE

1. BLDGs 5 & 6 - ACM PIPE INSULATION IN-PLACE THROUGHOUT AND IN UTILITY TUNNELS AND NOT ACCURATELY QUANTIFIED.

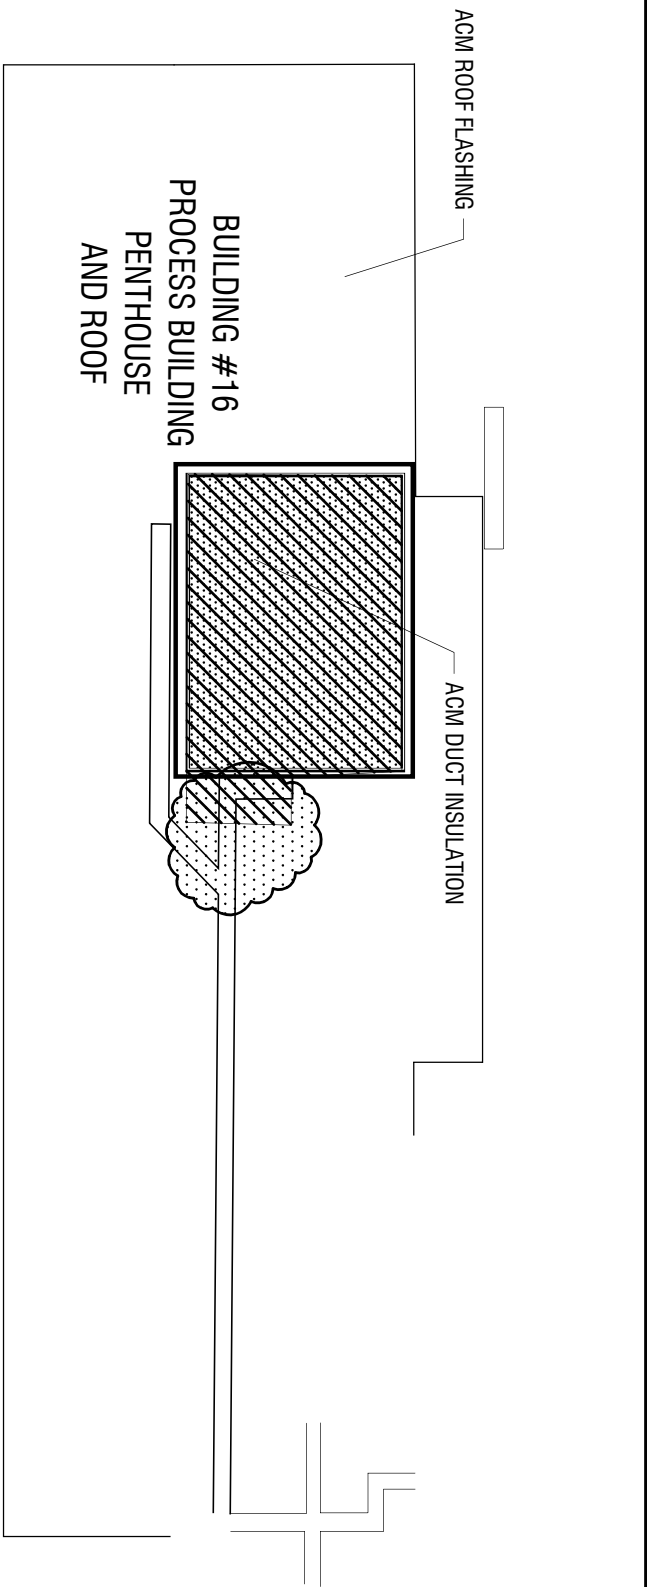
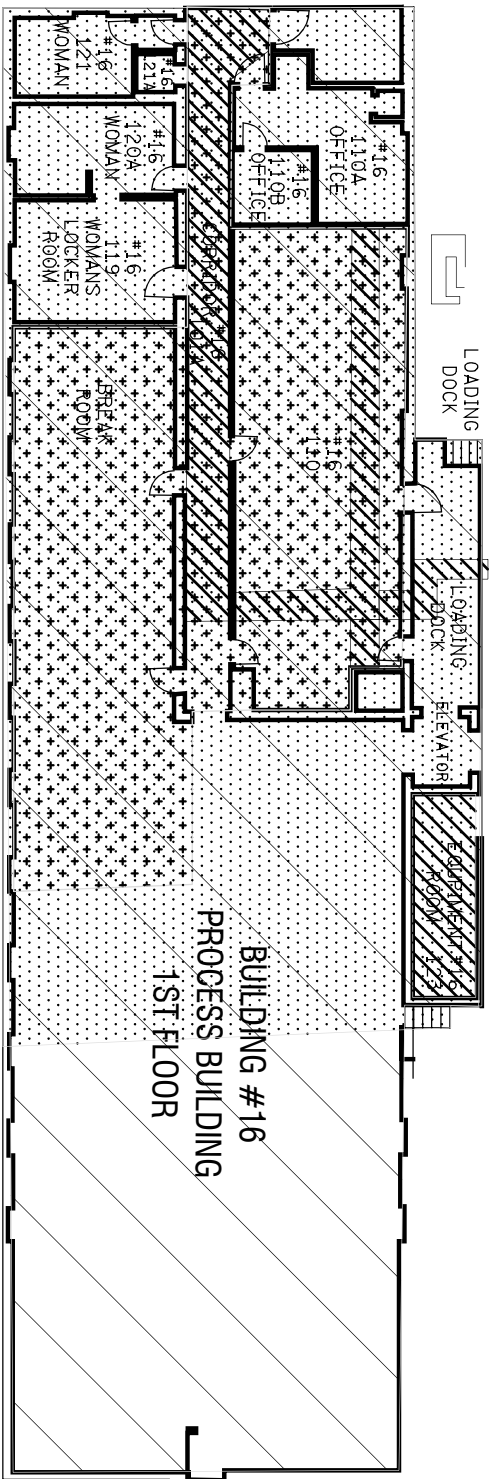
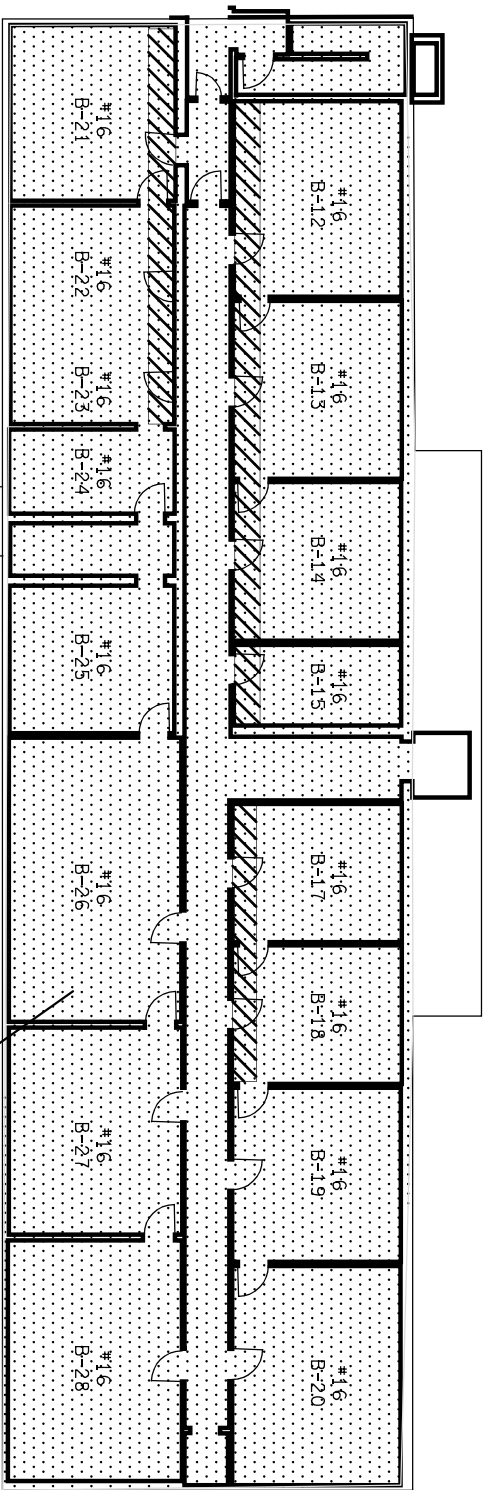
**AA.09**

- BLDG. 16 - ACM PIPE INSULATION IN-PLACE THROUGHOUT AND IN UTILITY TUNNEL AND NOT ACCURATELY QUANTIFIED.

NOTE: BLDG. 16 1st FLOOR DEBRIS EXCEEDS USEPA TCLP HAZARDOUS WASTE VALUES FOR RCRA METALS REMOVE AND DISPOSE OF ALL DEBRIS AS A CHARACTERISTIC HAZARDOUS WASTE

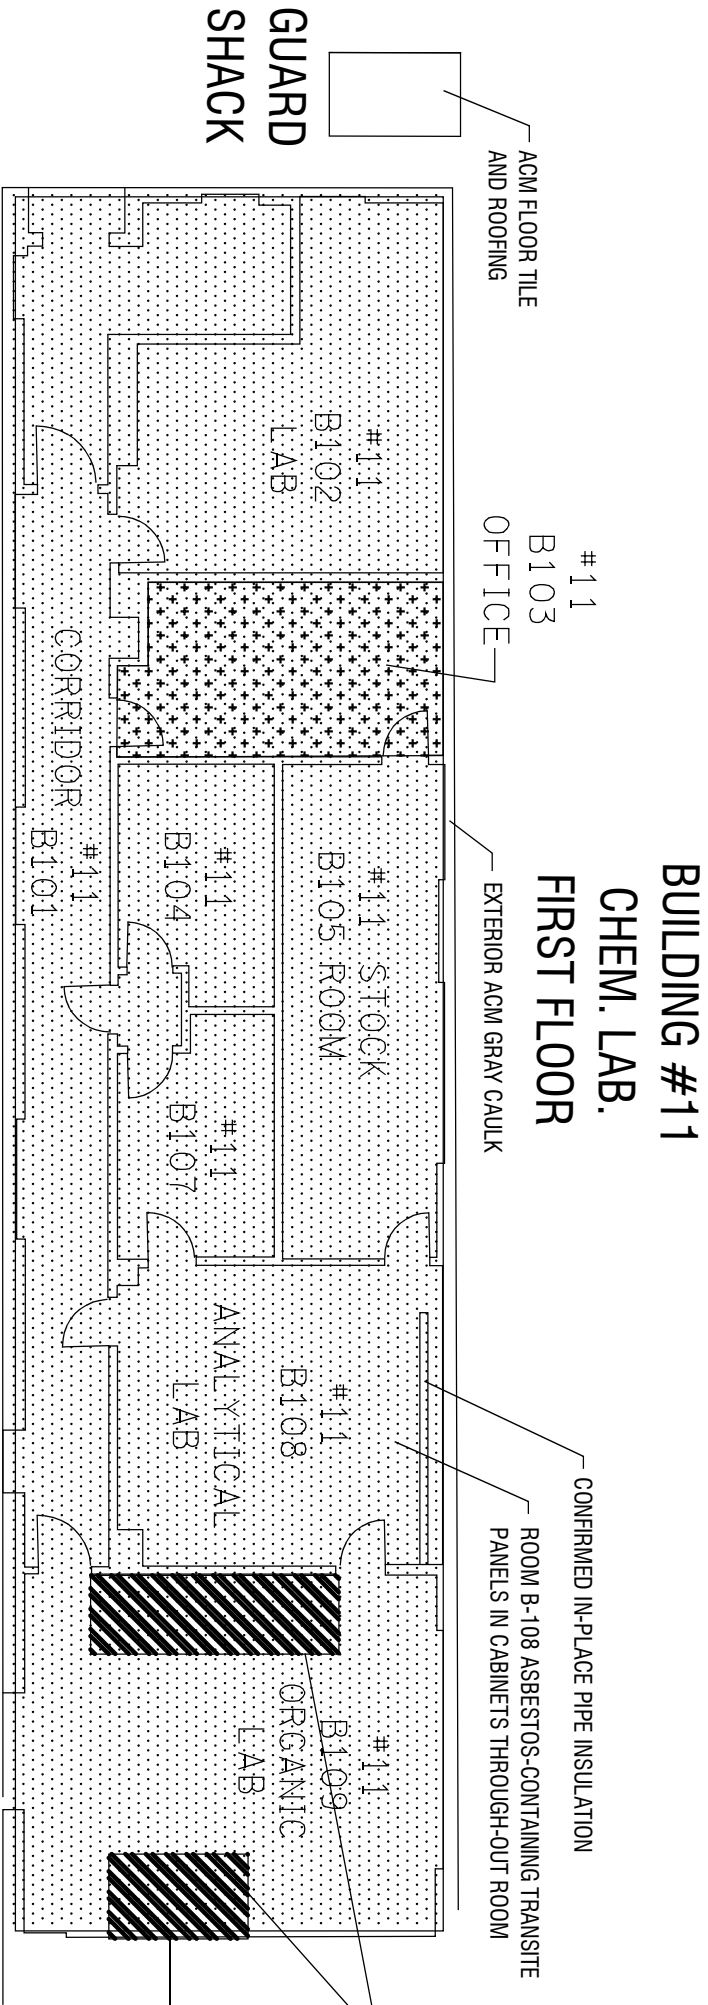
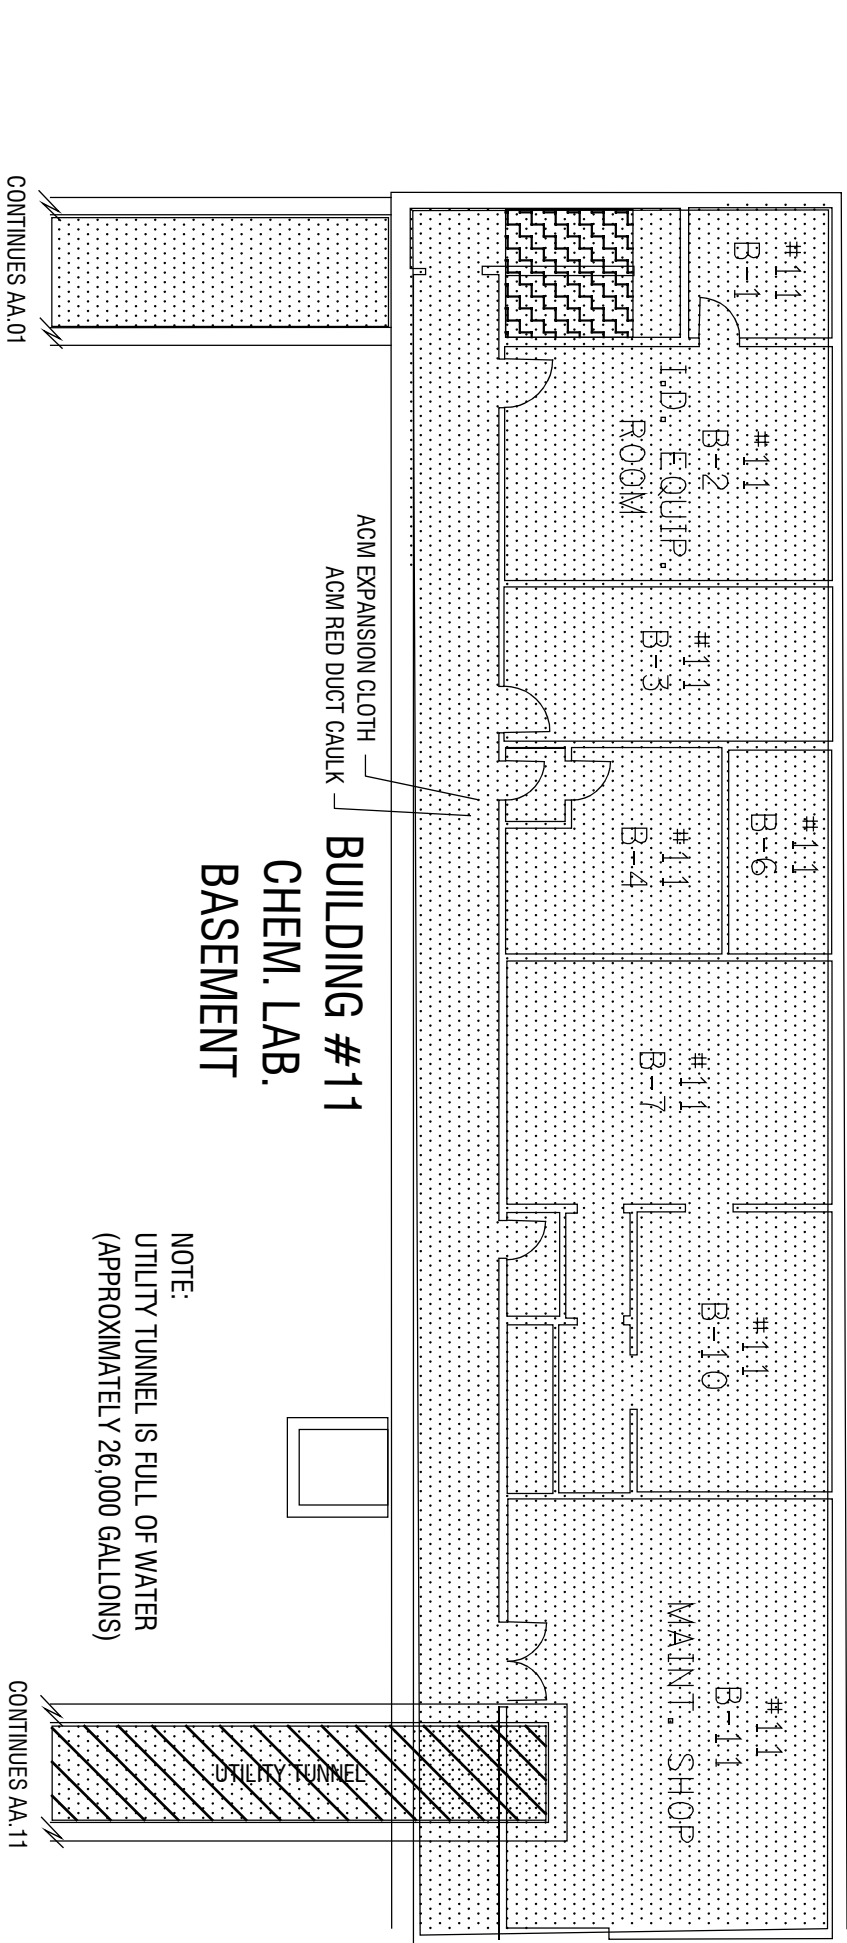
DRAWING NO:  
**AA.10**

- BLDG. 11 - ACM PIPE INSULATION IN-PLACE THROUGHOUT AND IN UTILITY TUNNEL AND NOT ACCURATELY QUANTIFIED.
- BLDG. 11 (BASEMENT) - ACM WINDOW GLAZE ON BASEMENT WINDOWS.
- BLDG. 11 (1st FLOOR) - ACM FIRE DOORS FOUND THROUGHOUT FIRST FLOOR.

NOTE:  
UTILITY TUNNEL IS FULL OF WATER  
(APPROXIMATELY 26,000 GALLONS)

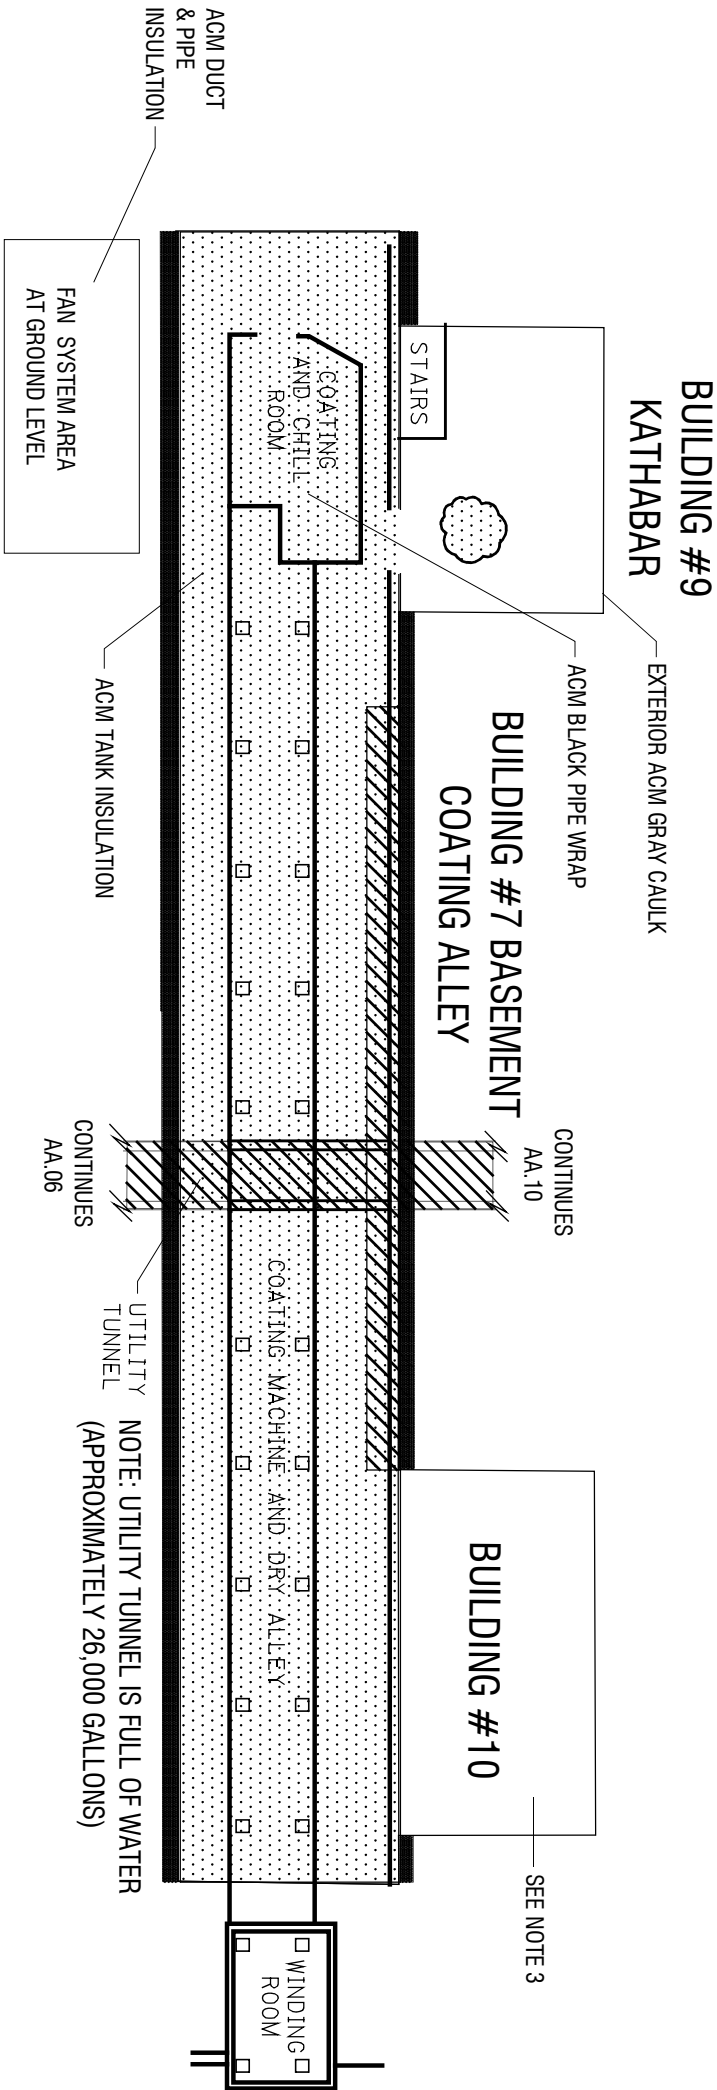
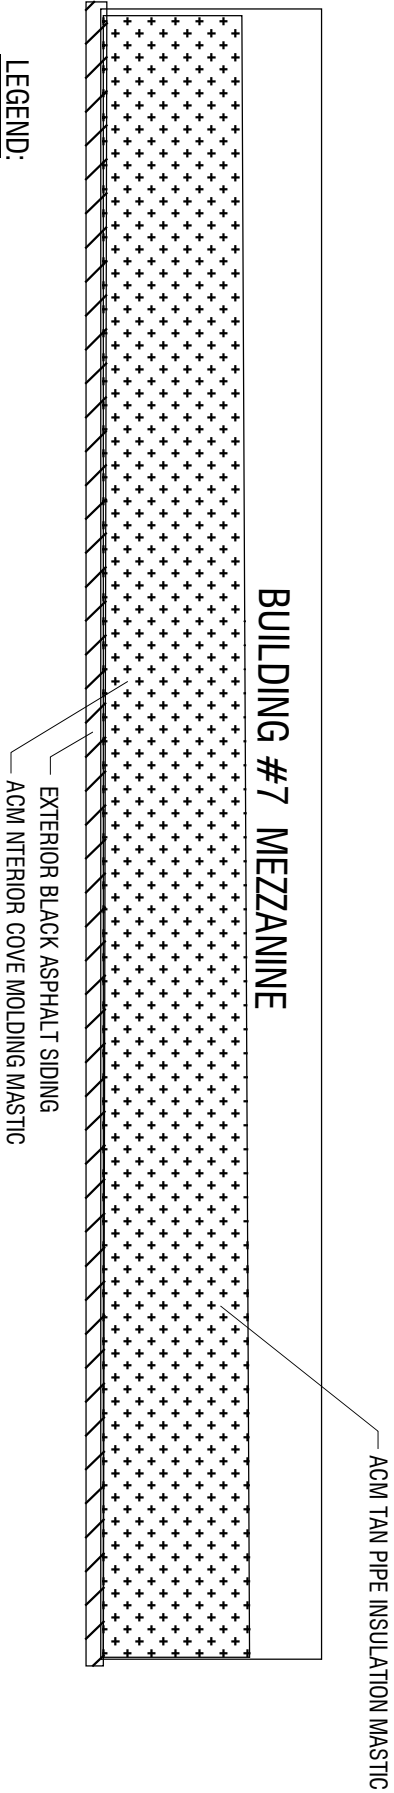
AA.11

- BLDG. 7 - ACM PIPE INSULATION IN-PLACE THROUGHOUT AND IN UTILITY TUNNEL AND NOT ACCURATELY QUANTIFIED.
- BLDG. 9 - EXTERIOR CAULK IS ASBESTOS-CONTAINING
- BLDG. 10 - ACM PIPE INSULATION IN-PLACE
