Re: Site Management Periodic Review Report and IC/EC Certification Submittal for Barretto Point, C302809

2017-2019 Periodic Review Report Barretto Point Site Bronx County, New York NYSDEC Site Number: B00032-2

Prepared for New York City Department of Environmental Protection March 2019

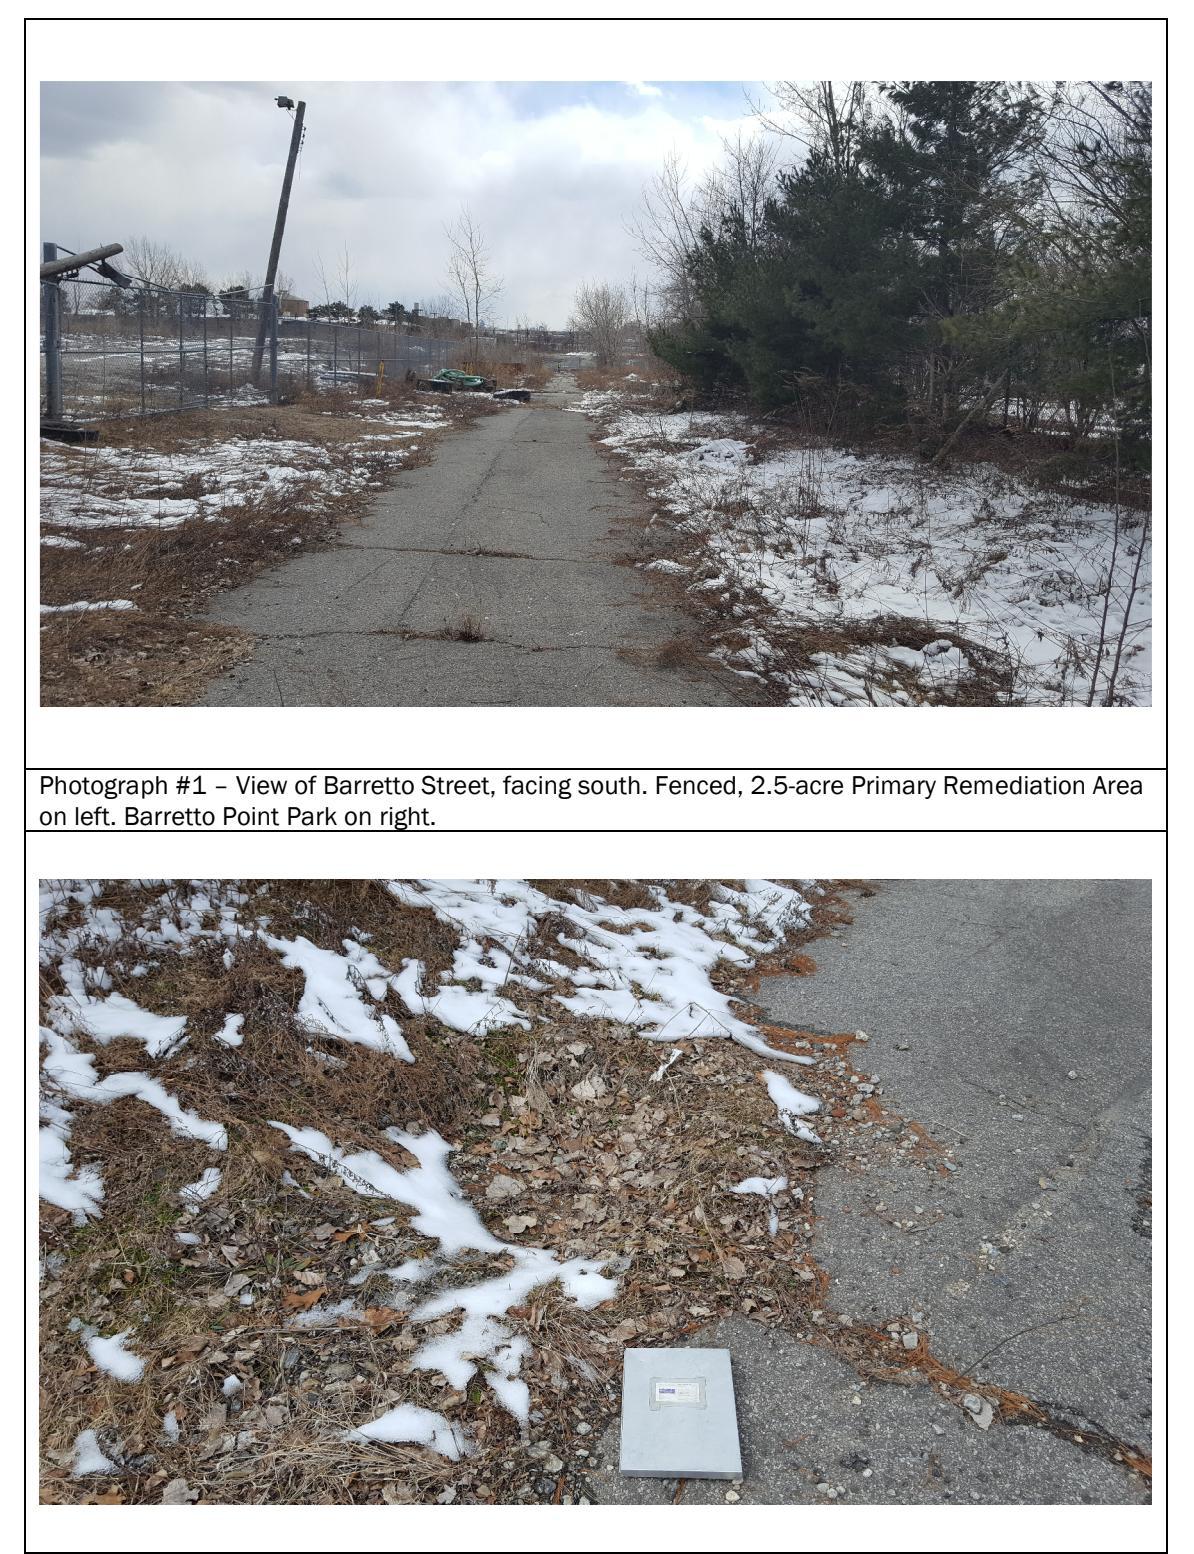
Photograph #2 – Surface depression (apparent subsidence) adjacent to Barretto Street pavement. Depression is approximately 2 feet diameter, 10 inches deep.

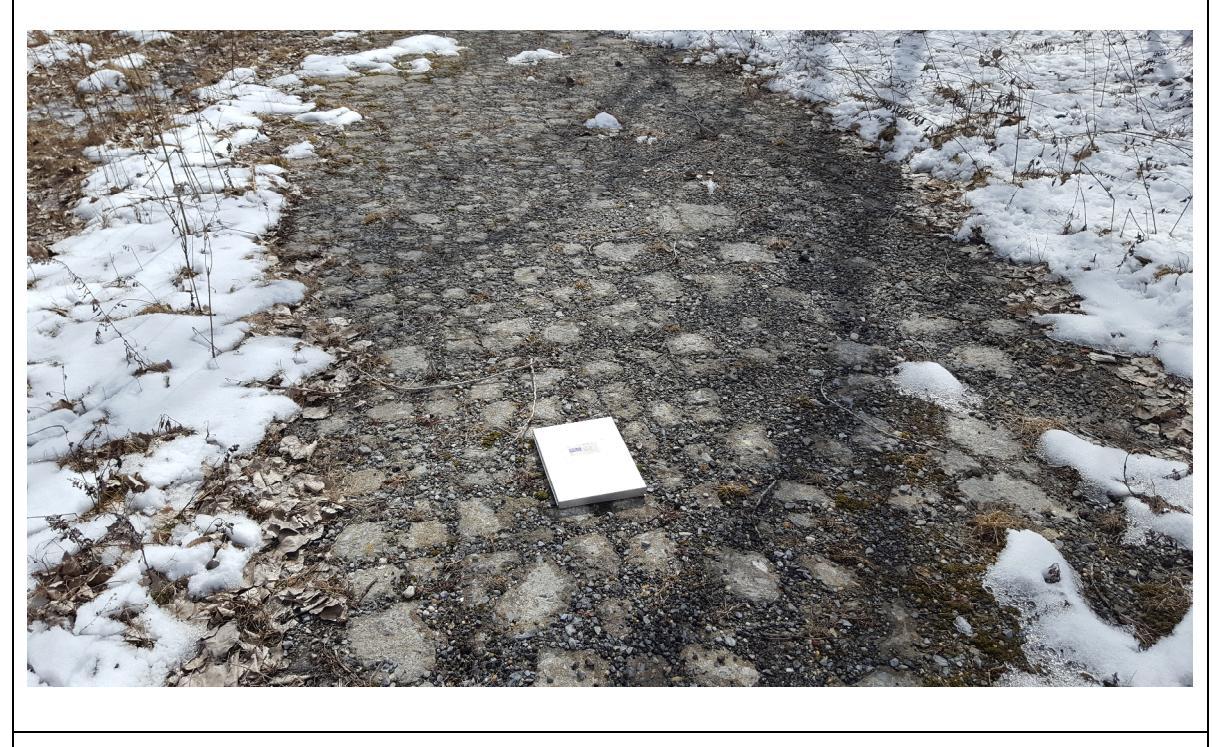
In most areas the asphalt pavement has deteriorated to varying degrees due to ordinary weathering processes. This was particularly evident in areas such as the southern portion of the de-mapped length of Barretto Street (Photograph #4), and the portion of Ryawa Avenue inside the entrance gate (Photograph #11). Some areas of subsidence were noted, including a two-foot diameter depression adjacent to the de-mapped length of Barretto Street (Photograph #2) and the intersection of the de-mapped length of Barretto Street and Ryawa Avenue (Photograph #12). The subsidence may be associated with subsurface utilities in these areas.

Cracks and separations observed in the pavement do not appear to be compromising the function of the pavement in preventing direct exposure to underlying soil, as no such soil was observed to be exposed. The deteriorated pavement will continue to be inspected on an annual basis and corrective action taken, as necessary to maintain the intended function.

Photograph #4 – Deteriorated Barretto Street pavement.

No corrective measures are recommended at this time. Continued, regular monitoring of cover materials, including deteriorating pavement, should be performed to ensure that underlying soils remain unavailable to direct contact.

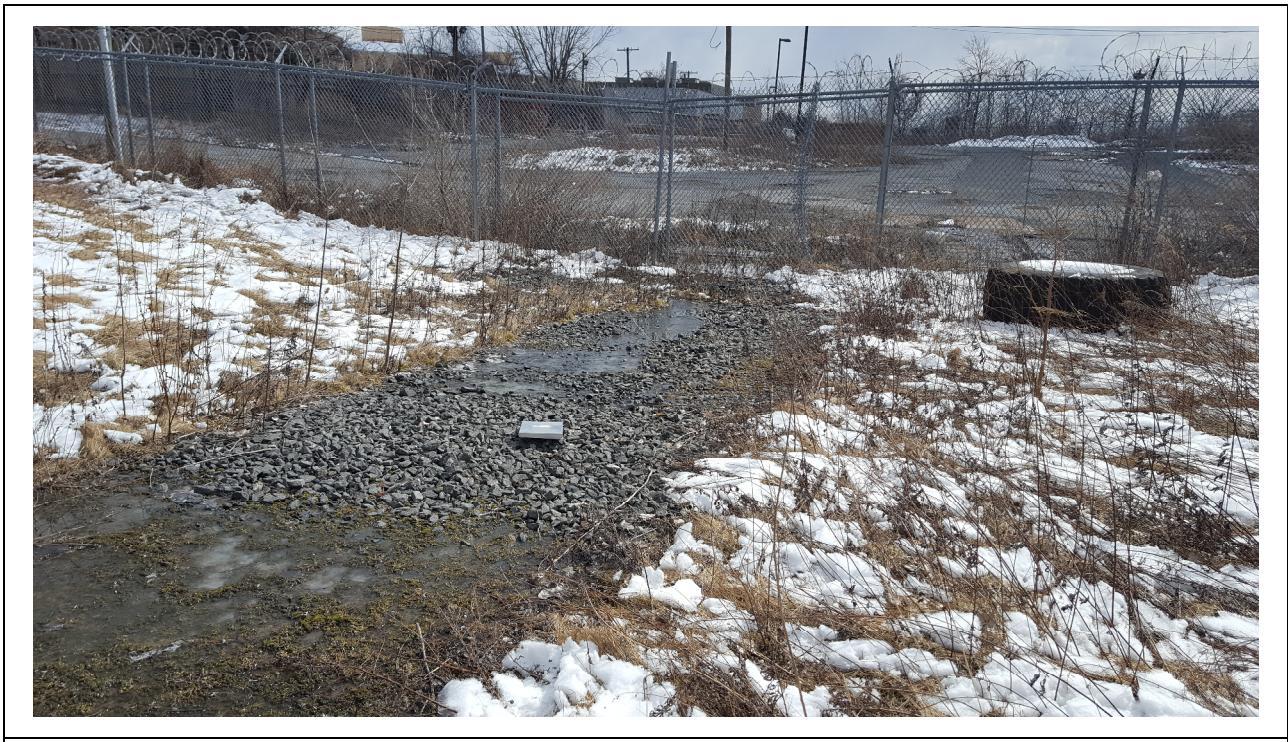
Photograph #5 – Stone and ponded water at south end of Barretto Street. Ryawa Avenue extending left to right beyond fence.

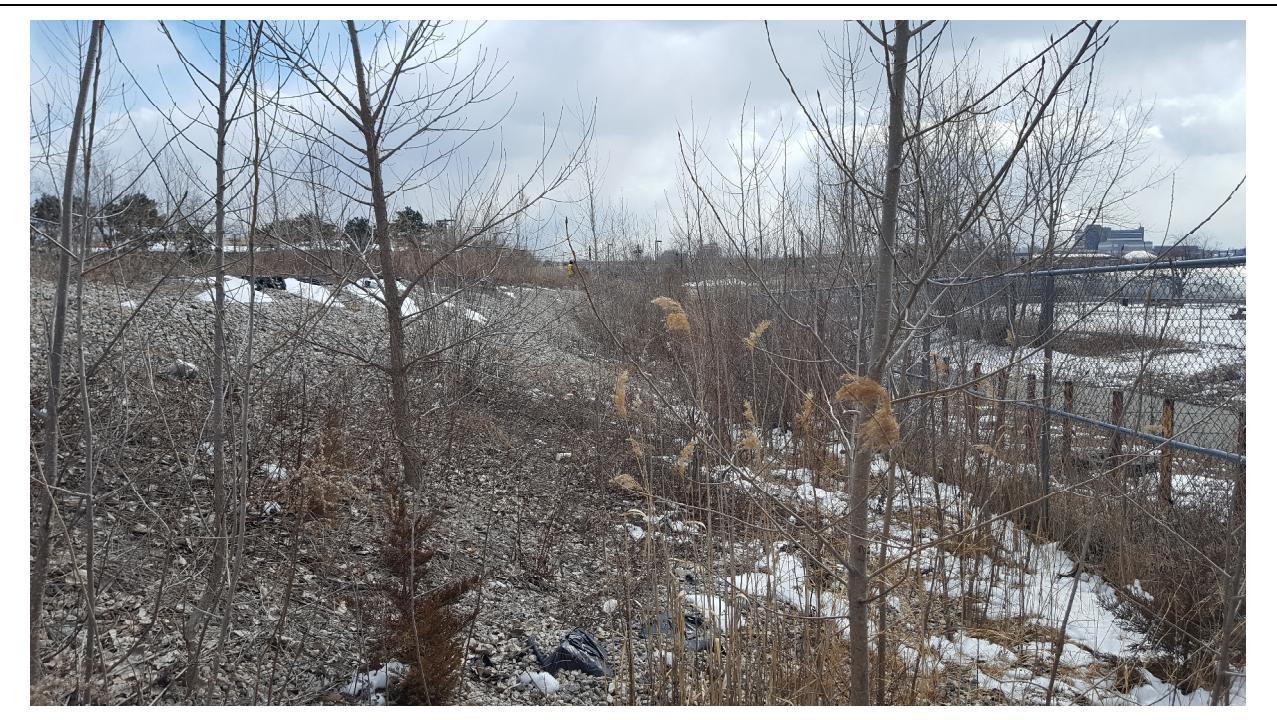
The aggregate appears to be stable and no areas of erosion were observed. The soil fill underlying the aggregate was not exposed. No evidence of man-made disturbance or excavation of the cover material was observed.

Photograph #6 – Cover material (crushed stone) on west side of Primary Remediation Area, facing south. Barretto Street on right, beyond fence.

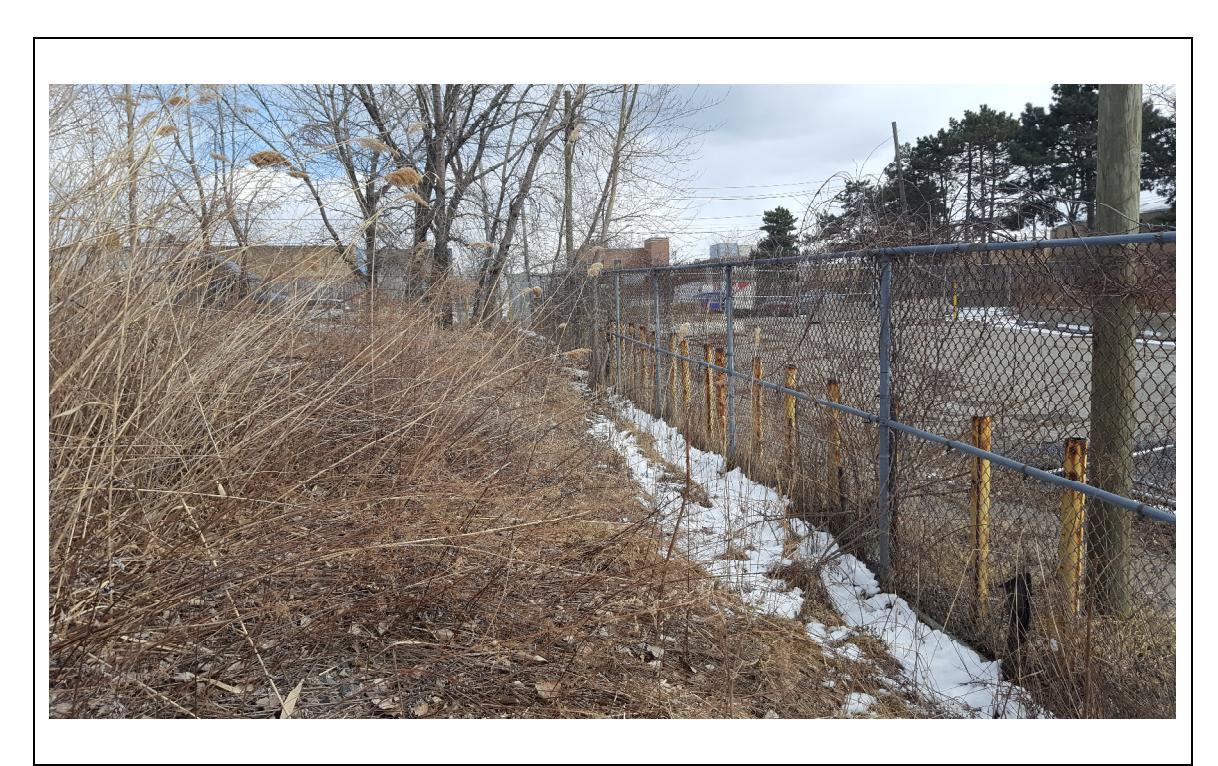
Photograph #7 – Cover material (crushed stone) on south side of Primary Remediation Area, facing east. Ryawa Avenue on right, beyond fence.

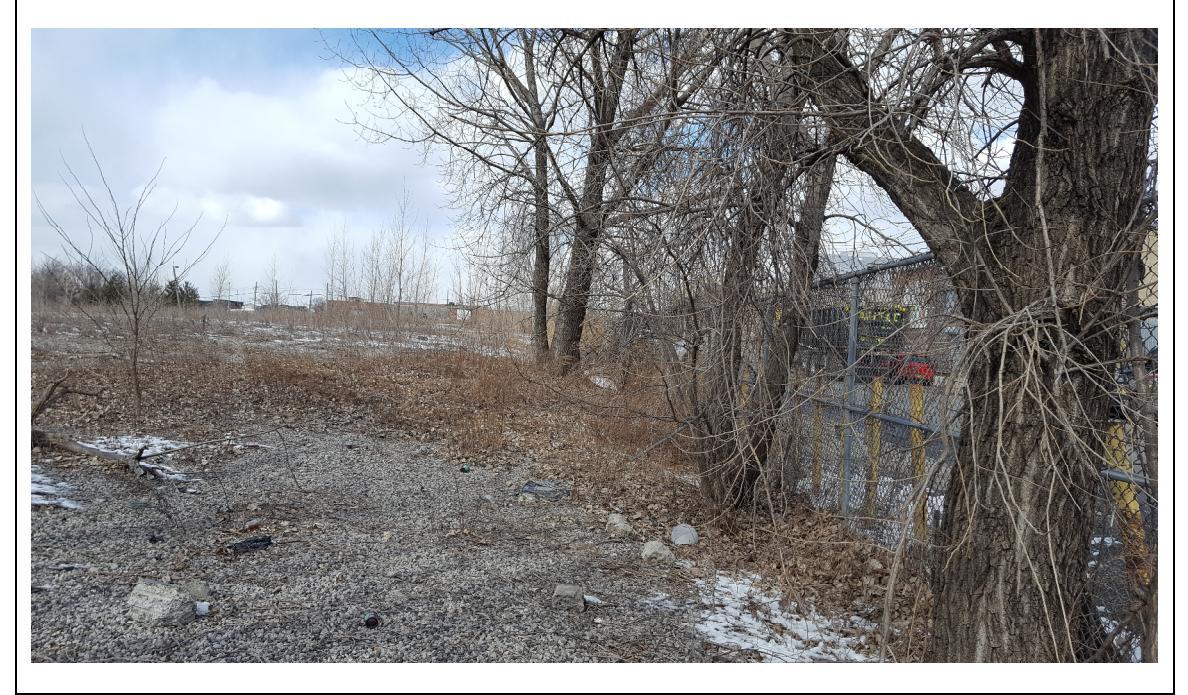
Photograph #8 – Cover material (crushed stone) on east side of Primary Remediation Area, facing north. Manida Street on right, beyond fence.

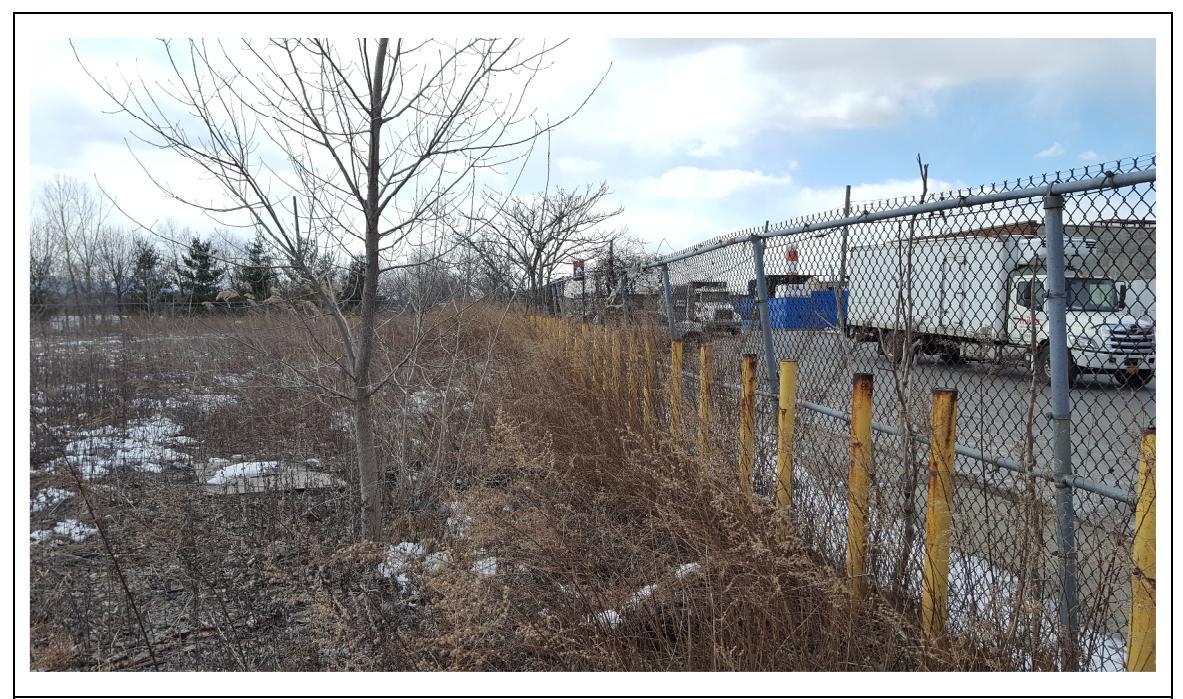
Photograph #9 - Cover material (crushed stone) on north side of Primary Remediation Area, facing west. Viele Avenue on right, beyond fence.

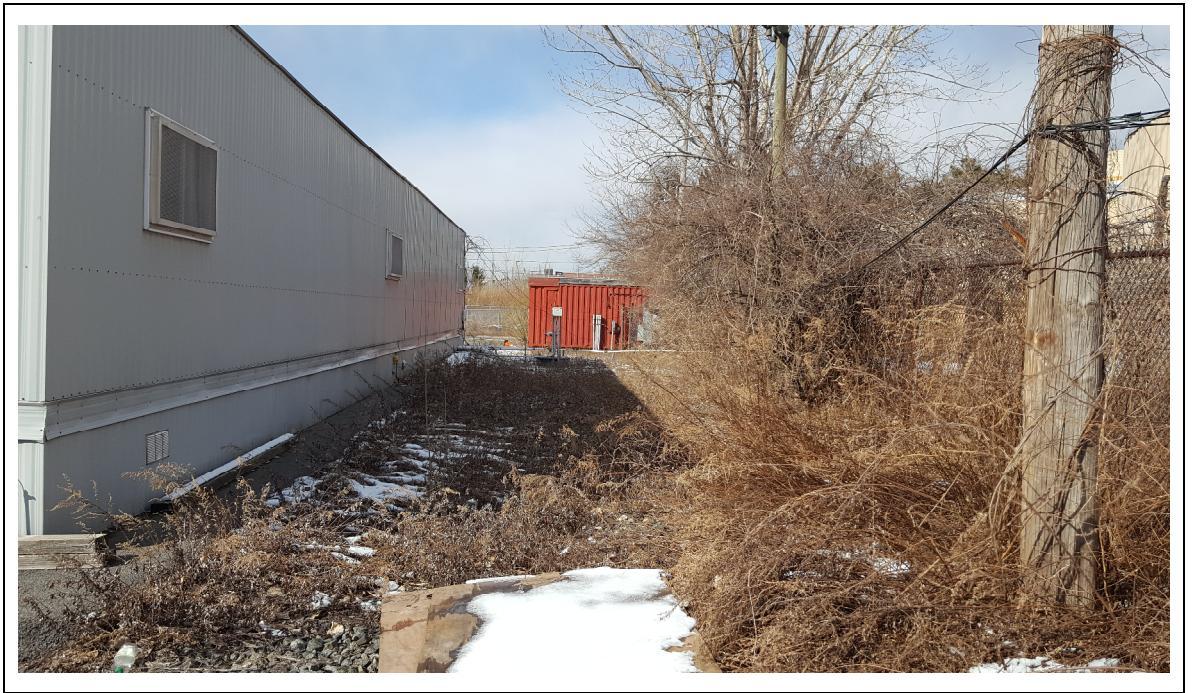
Photograph #17 – Area east of construction trailers, facing north. Note vents in skirting around trailers. Thickeners beyond fence to right.

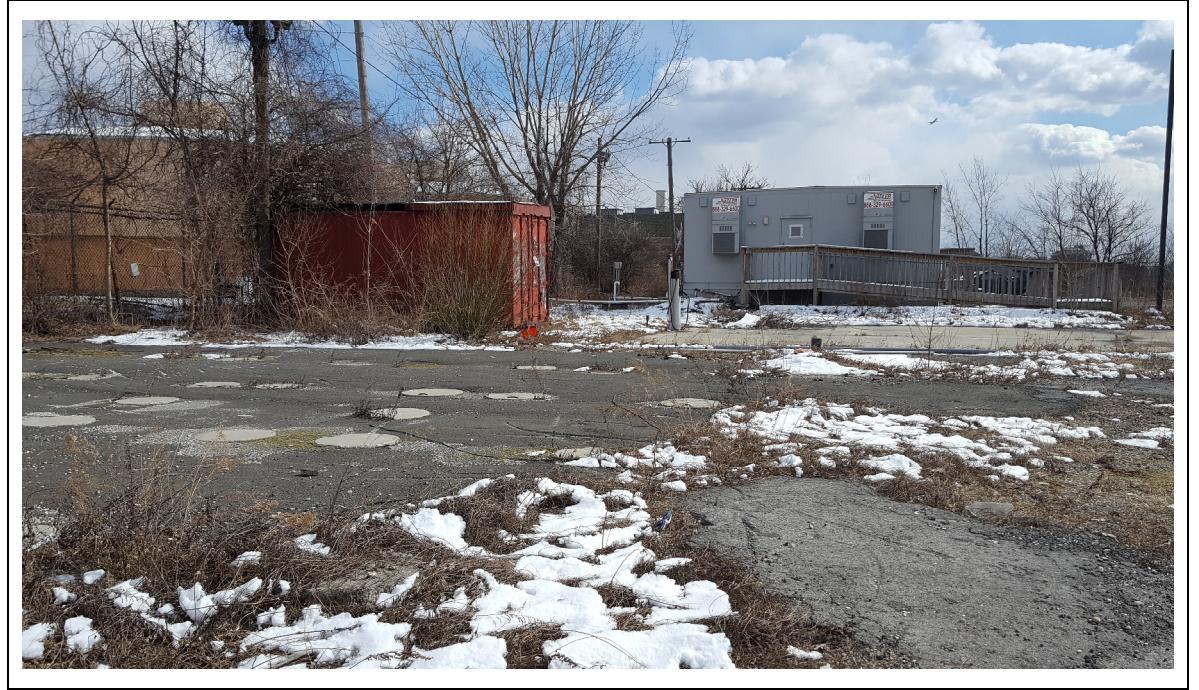
Photograph #18 – Paved area north of construction trailers. Concrete disks appear to be part of foundation for previously existing building.
