## **Construction Services: Storm Cleanup and Erosion Repair at Port-Greenbelt Shoreline Trail**

**ATTACHMENT 1**  
**FIGURE 1**  
**APPROXIMATE WORK AREA LOCATIONS**

**ATTACHMENT 2  
PORT GREEN-BELT PHOTOS**

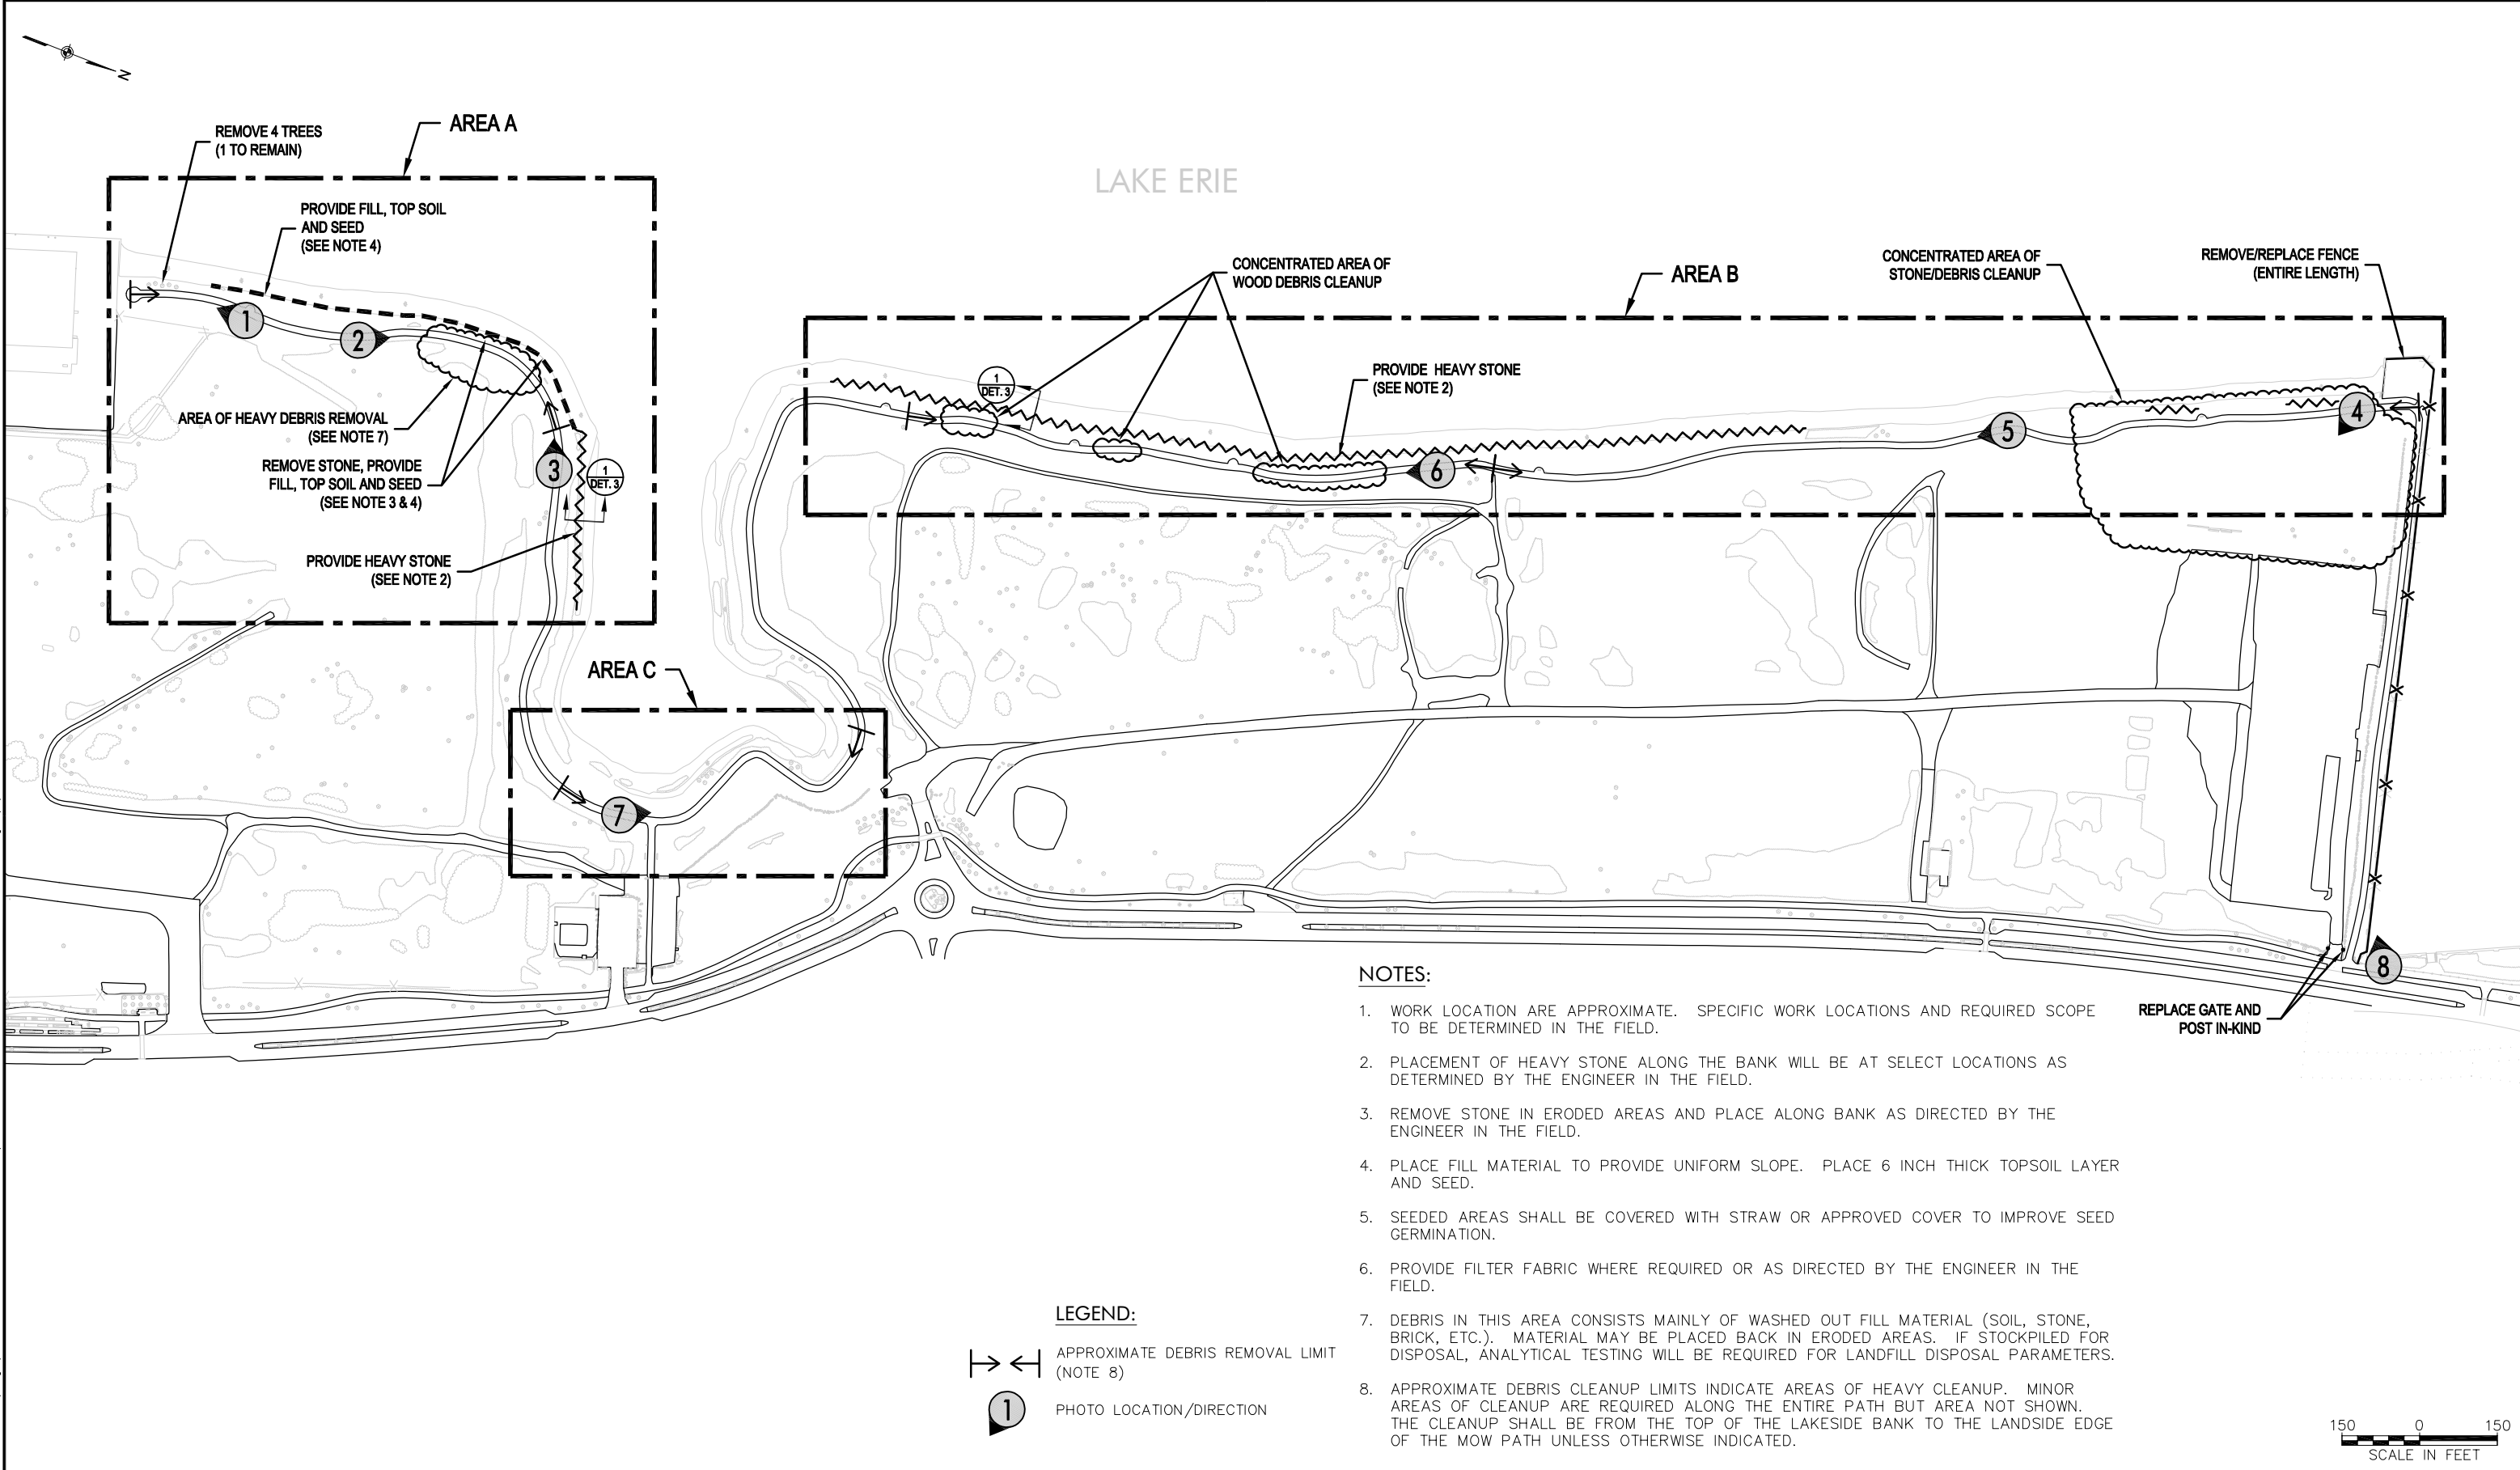
**Work Area A** – The cleanup shall include the removal of various size stone, displaced fill material, wood debris and other materials from the area shown on Figure 1. Displaced fill material may be collected and placed back in the eroded areas behind the stone embankment. Other materials shall be collected and staged onsite at a location to be determined. Staged material designated for disposal shall be samples and characterized for landfill disposal criteria. The limits of the debris cleanup shall extend from the top of the lakeside bank to the landside edge of the mow path. The work shall include the removal of four trees uprooted by the storm. Trees shall be cut flush with the stone bank. Trees stumps and roots will remain.

**Work Area B** - The cleanup shall include the removal of various size stone, displaced fill material, wood debris and other materials from the area shown on Figure 1. Materials shall be collected and staged onsite at a location to be determined. Staged material designated for disposal shall be samples and characterized for landfill disposal criteria. The limits of the debris cleanup shall extend from the top of the lakeside bank to the landside edge of the mow path except where indicated on Figure 1.

**Work Area C** - The cleanup shall include the removal of various size stone, displaced fill material, wood debris and other materials from the area shown on Figure 1. Materials shall be collected and staged onsite at a location to be determined. Staged material designated for disposal shall be samples and characterized for landfill disposal criteria.

**Work Area D** – The cleanup shall include removal and disposal of the damaged fencing. The Contractor shall replace the fencing in-kind. Fencing shall be anchored into the existing concrete at the bulkhead to match existing installation. The contractor shall remove and dispose of damaged gate and gate support post. The contractor shall replace the gate and post in-kind.

Eroded areas will be cut back as needed to provide a uniform edge. In areas where the filter fabric is intact but has been displaced, the fabric will be laid out flat to its original extents. In areas where the filter fabric is missing or deteriorated, new filter fabric will be placed. New filter fabric shall meet the specs of Mirafi 600X geotextile.

Following repair/replacement of the filter fabric, a Heavy Stone Fill will be placed on the shoreline slope to the extent of the erosion. The Heavy Stone Fill placement will build up the revetment to slightly exceed

Areas of erosion, behind new and/or existing Stone Fill will be filled with imported fill to create a uniform slope, covered with 6 inches of topsoil, and seeded.

Approximate work locations are shown on Figure 1 in Attachment 1. Specific work locations and stone placement will be as directed by LiRo in the field.
