Project Name: Washington Plaza, 445 East 163rd Street, Bronx, New York 10451

Project Number: 10EHAZ232X

Inspection Date: September 30, 2020

Site Inspection and Certification Letter Report

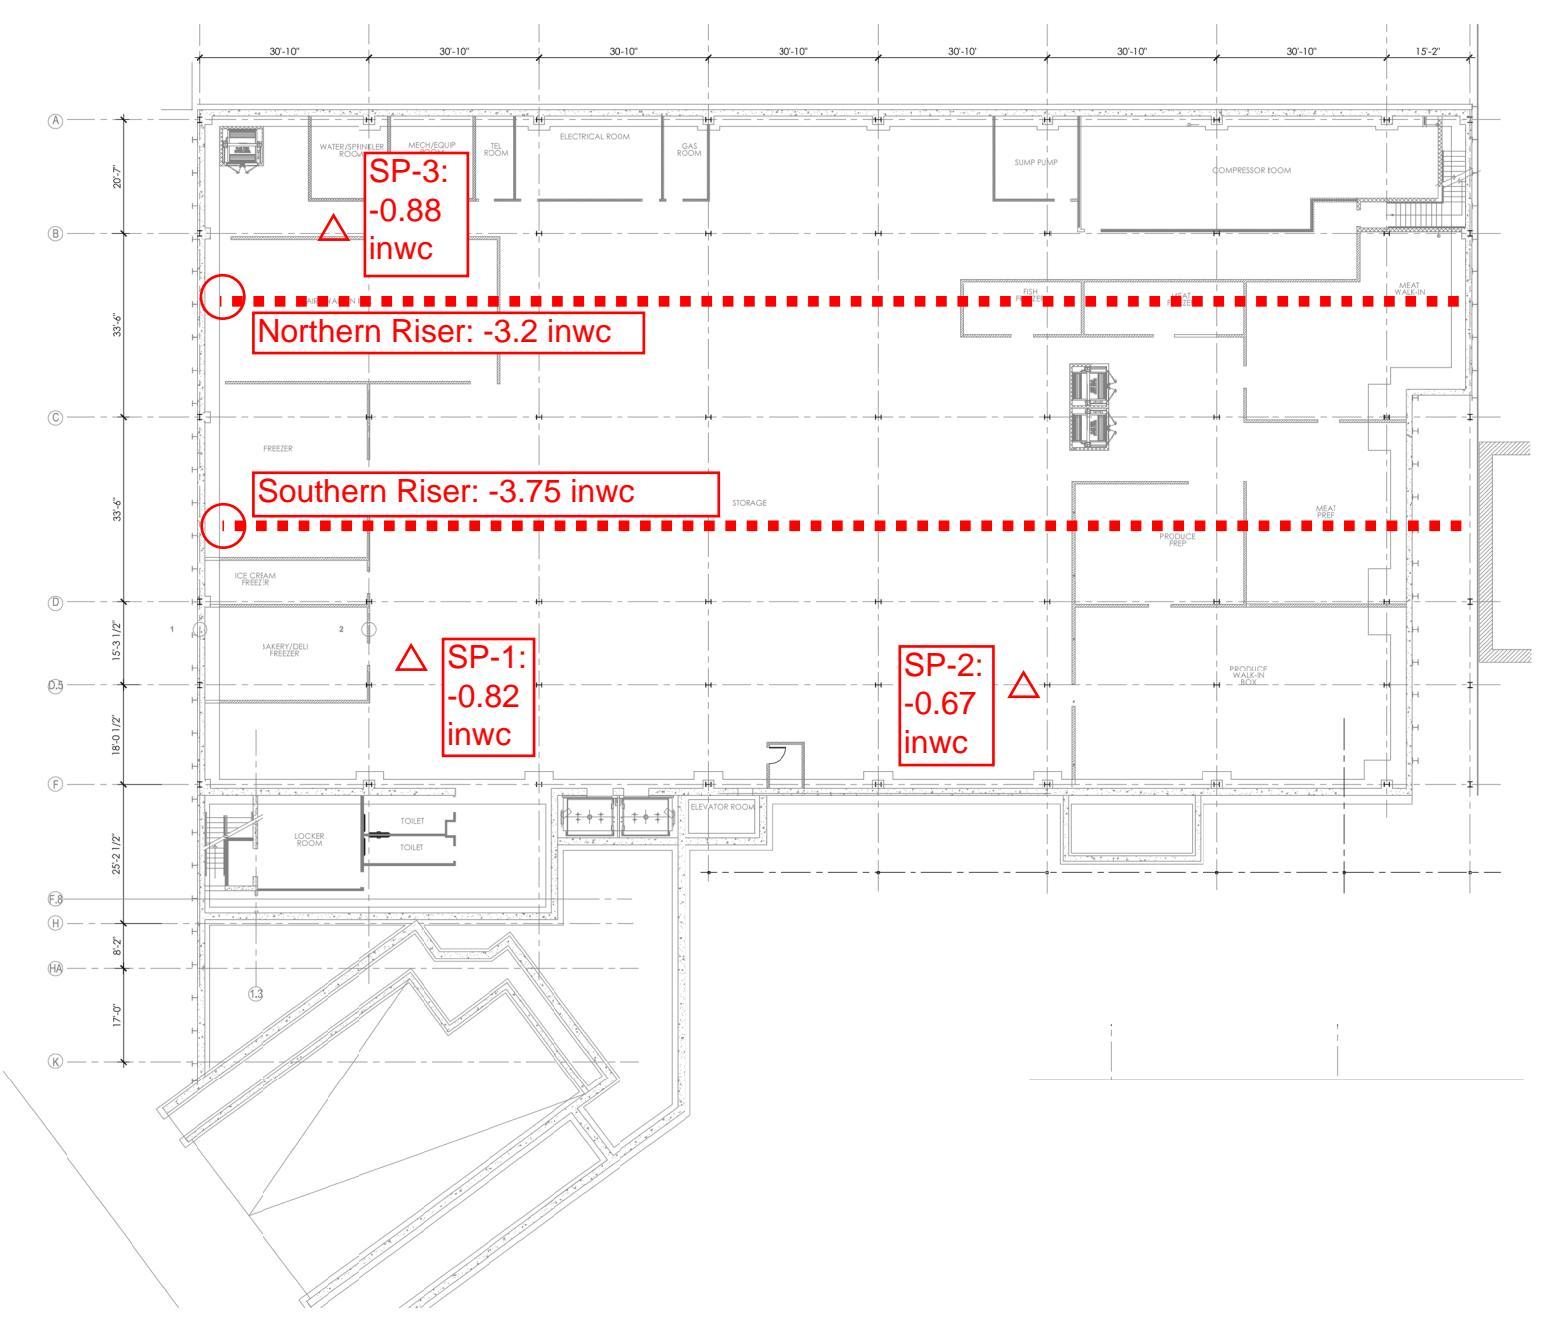
NY nt Locations Layout

Athenica measured vacuum readings from the three permanent monitoring points located in the cellar slab, using a handheld manometer. The vacuum pressure at SP-1 was -0.82 inwc. The vacuum pressure at SP-2 was -0.67 inwc. The vacuum pressure at SP-3 was -0.88 inwc. A figure depicting the monitoring point locations is attached below.

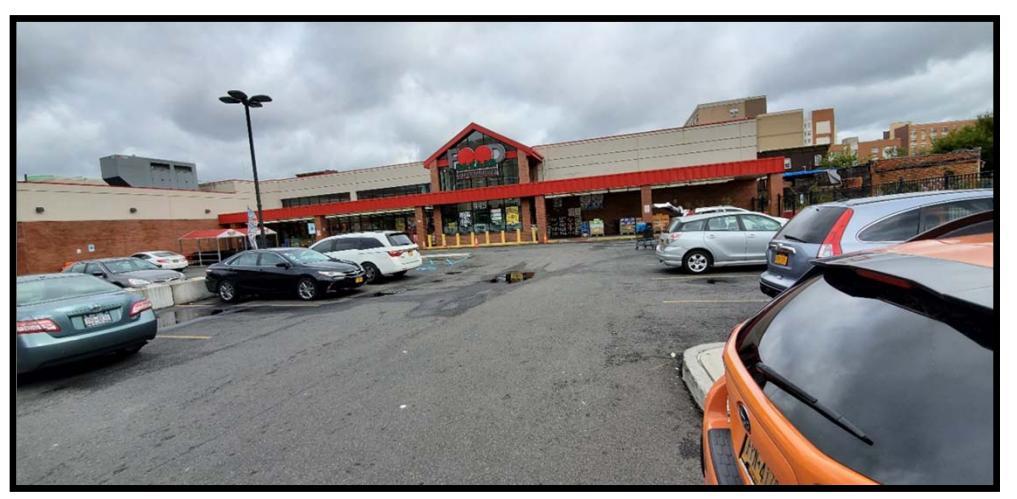
View of the parking lot of the Site. The parking lot's composite cover appeared to be in good condition.

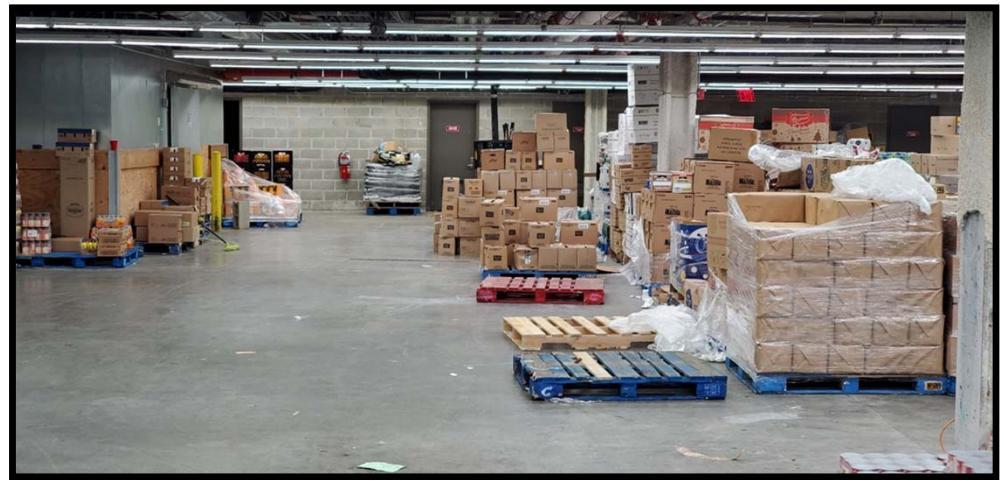
Overview of the basement floor's composite cover, which appeared to be in good condition.

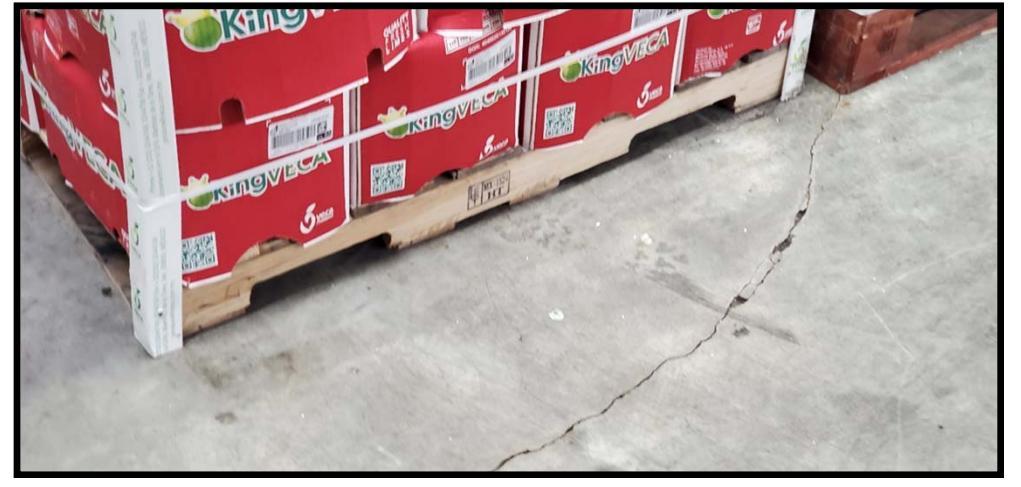
During the inspection, Athenica performed visual inspection of the engineering controls. Several minor cracks were observed in the composite slab. Vapor barrier was not exposed in any area. There were no observable cracks in any of the concrete sidewalls. Several areas of the composite cover were not visible due to the presence of multiple walk-in refrigeration units in the cellar. Additionally, Athenica inspected the composite cover in the loading dock and parking lot portions of the Site. No major cracks or damage was visible.

View of minor cracks in the basement floor. No vapor barrier is exposed.

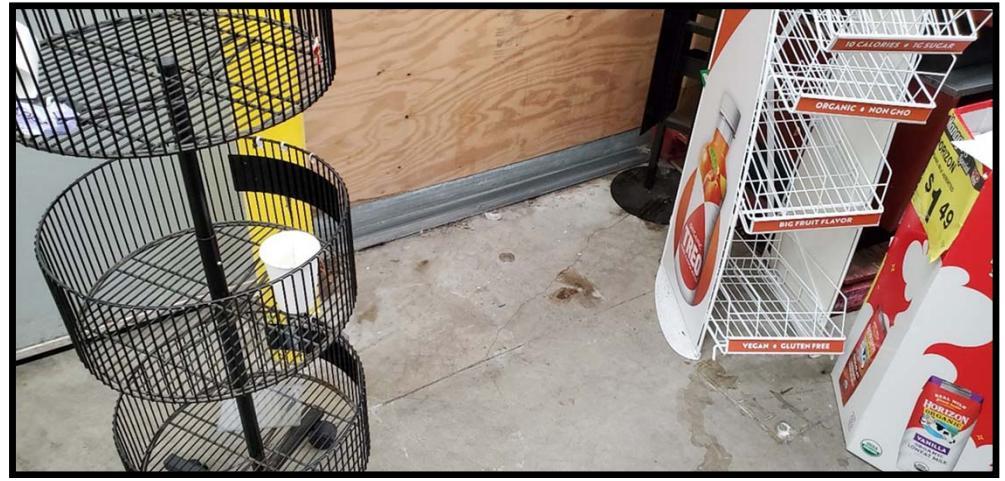
View of an SSDS monitoring point with a flush-mount steel cap.

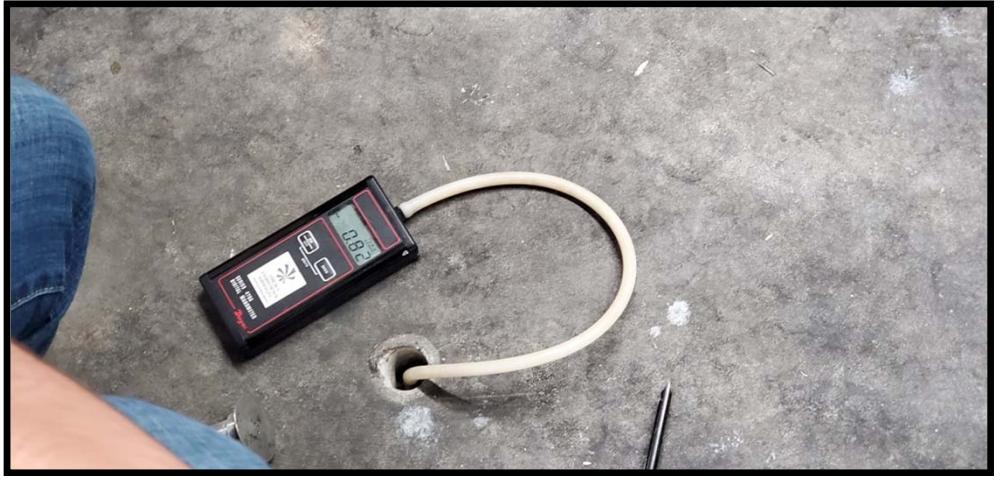
View of monitoring point SP-1, showing a vacuum reading of -0.82 inches water column.

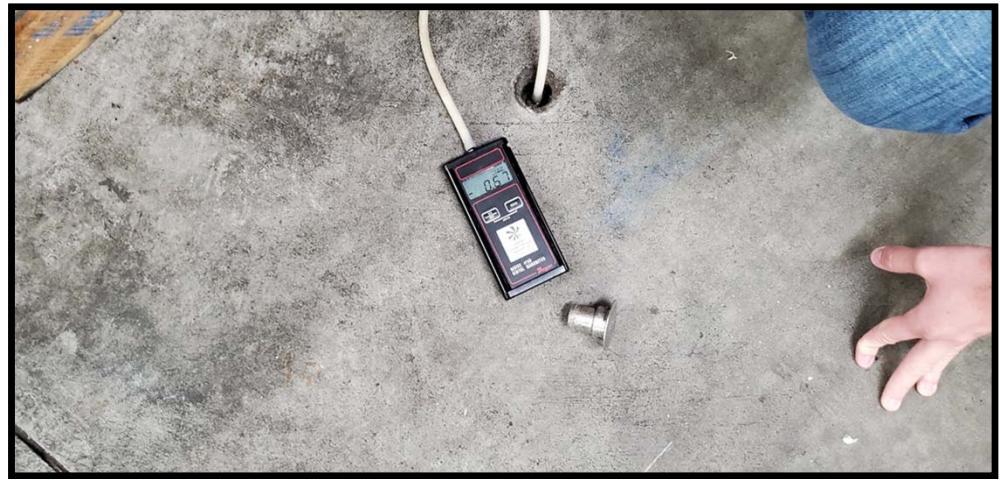
View of monitoring point SP-2, showing a vacuum reading of -0.67 inches water column.

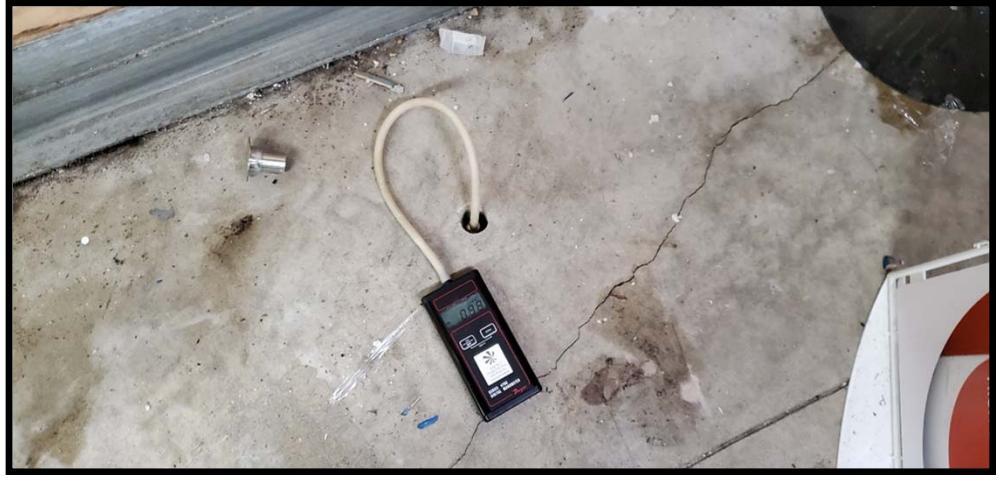
View of monitoring point SP-3, showing a vacuum reading of -0.88 inches water column.

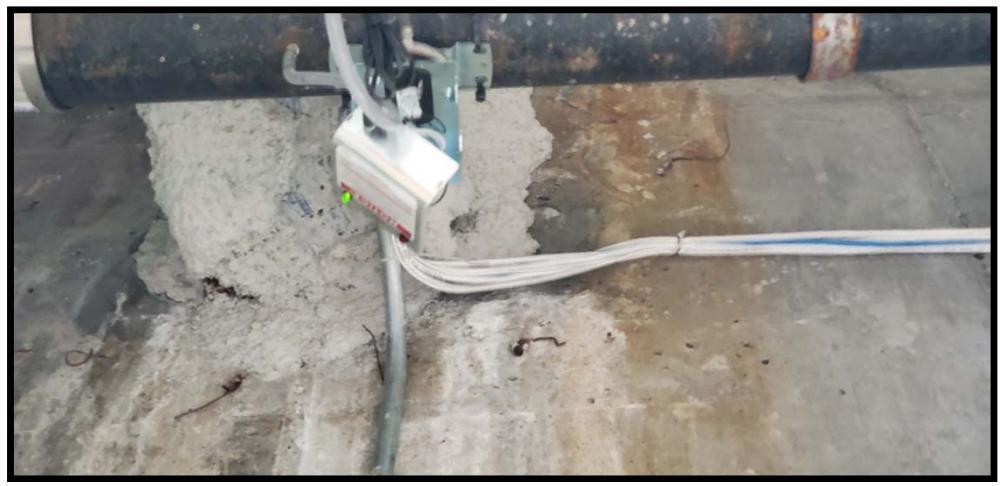
View of the alarm unit for the northern riser.

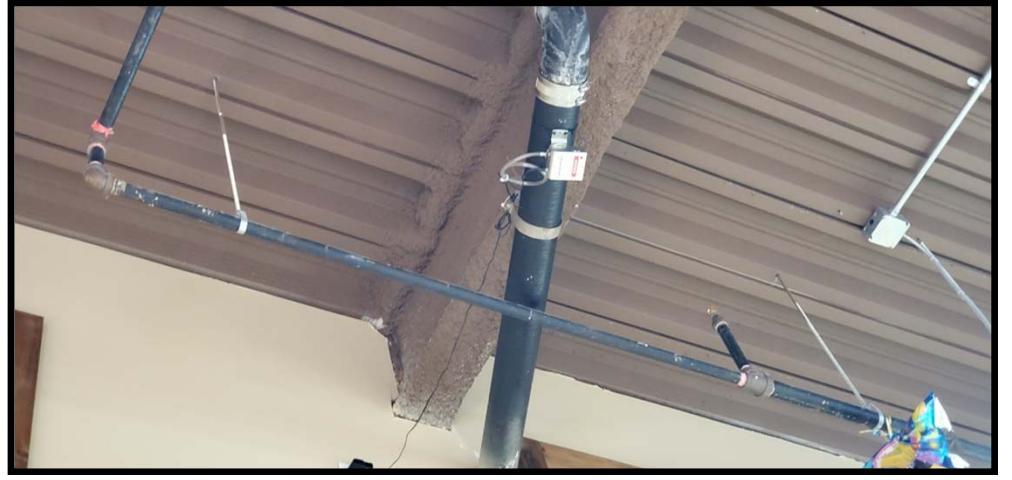
View of the alarm unit for the southern riser.

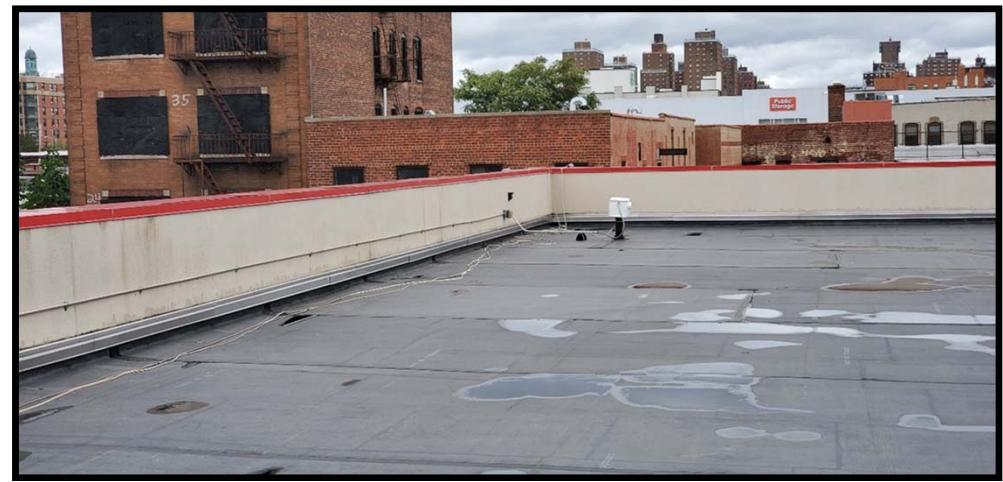
Athenica previously installed a Dwyer Minihelic[®] differential pressure gauge on each of the two risers, located on the roof. The vacuum pressure on the northern riser was observed to be -3.2 inwc. The vacuum pressure on the southern riser was observed to be -3.75 inwc.

View of the northern blower fan unit on the roof, which read -3.2 inches water column.

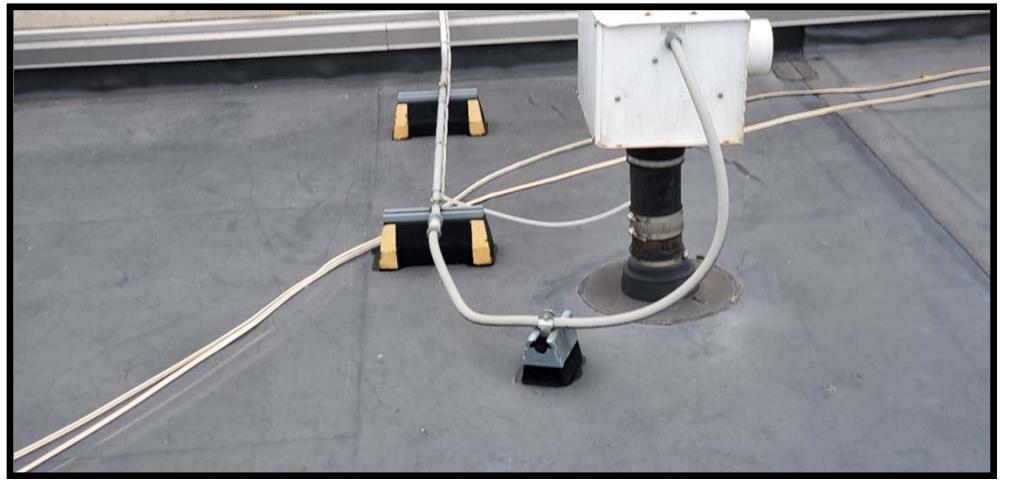
View of the southern blower fan unit on the roof, which read -3.75 inches water column.

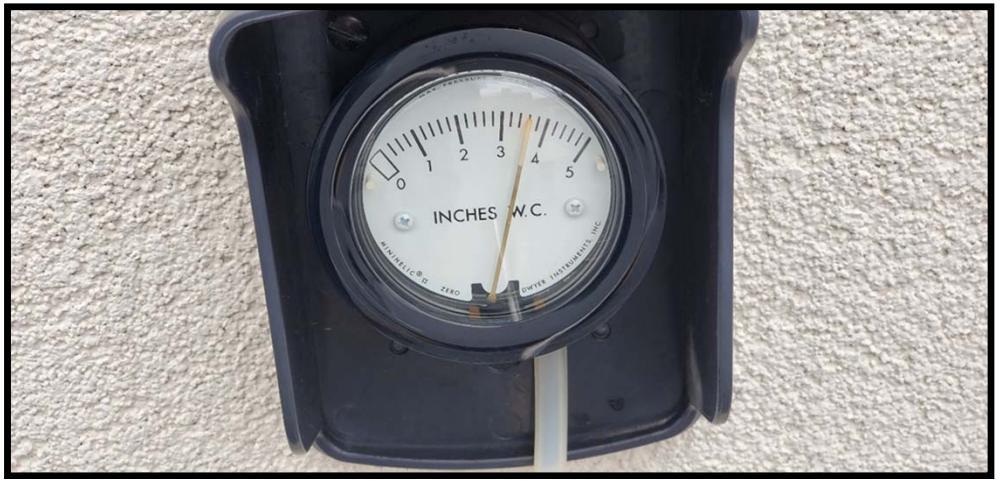
View of the gauge for the southern riser showing a vacuum pressure of -3.75 inches water column.
