# **Periodic Review Report**

149 Kent Avenue Brooklyn, New York Site Number C224159

April 3, 2024

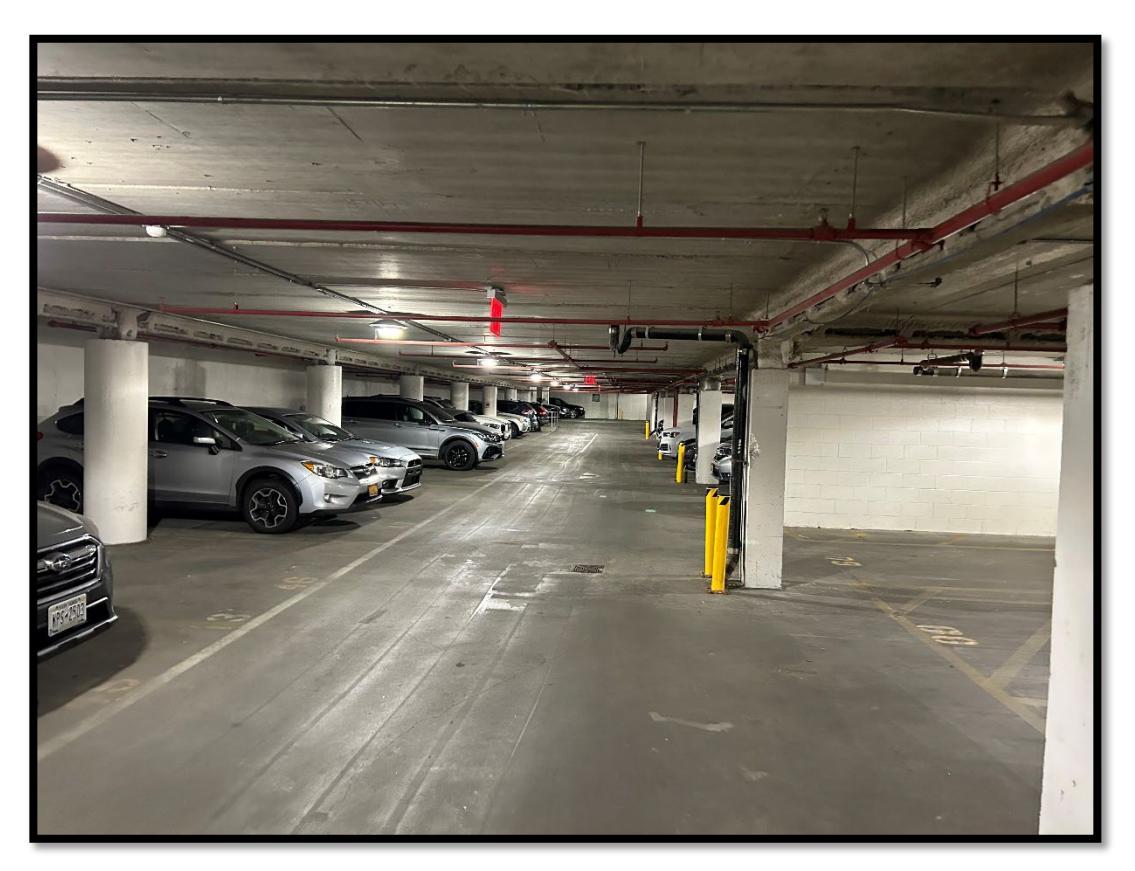
Photograph 1: View of cellar parking garage, looking east. All visible foundation elements were inspected.

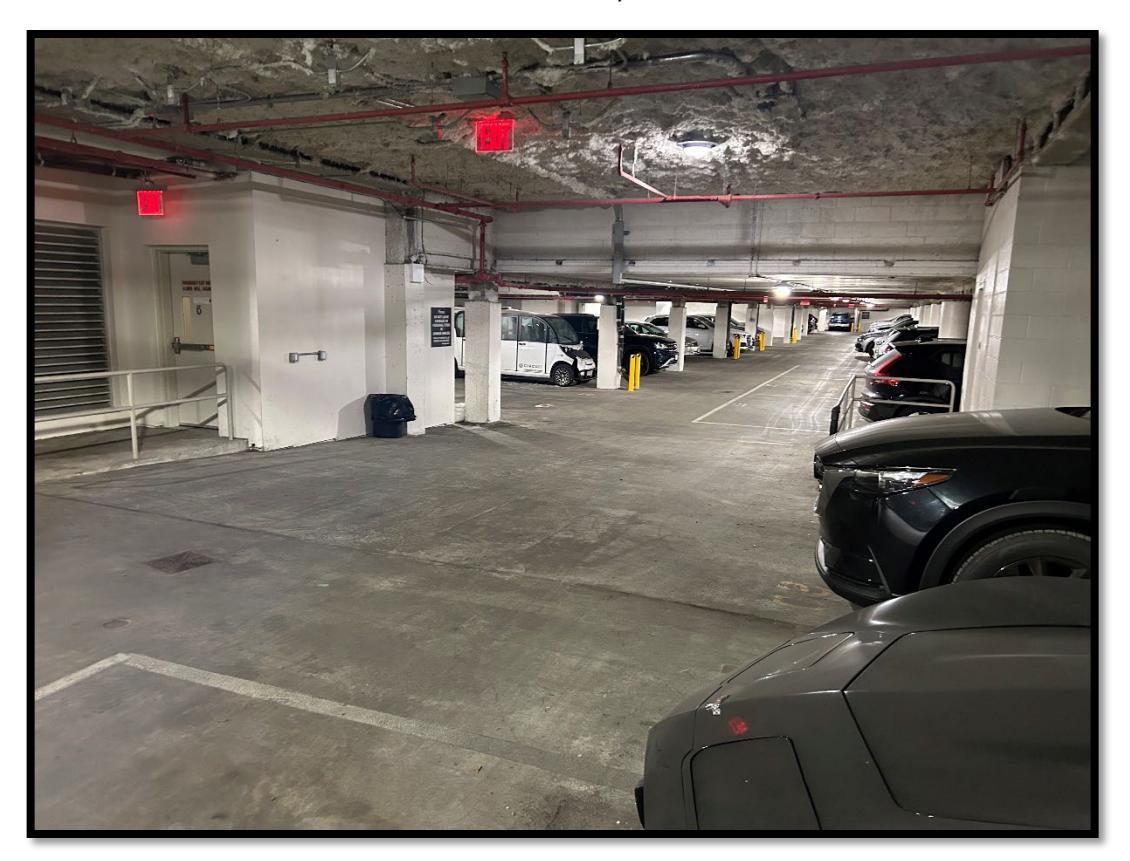
Photograph 2: View of cellar parking garage, looking west. All visible foundation elements were inspected.

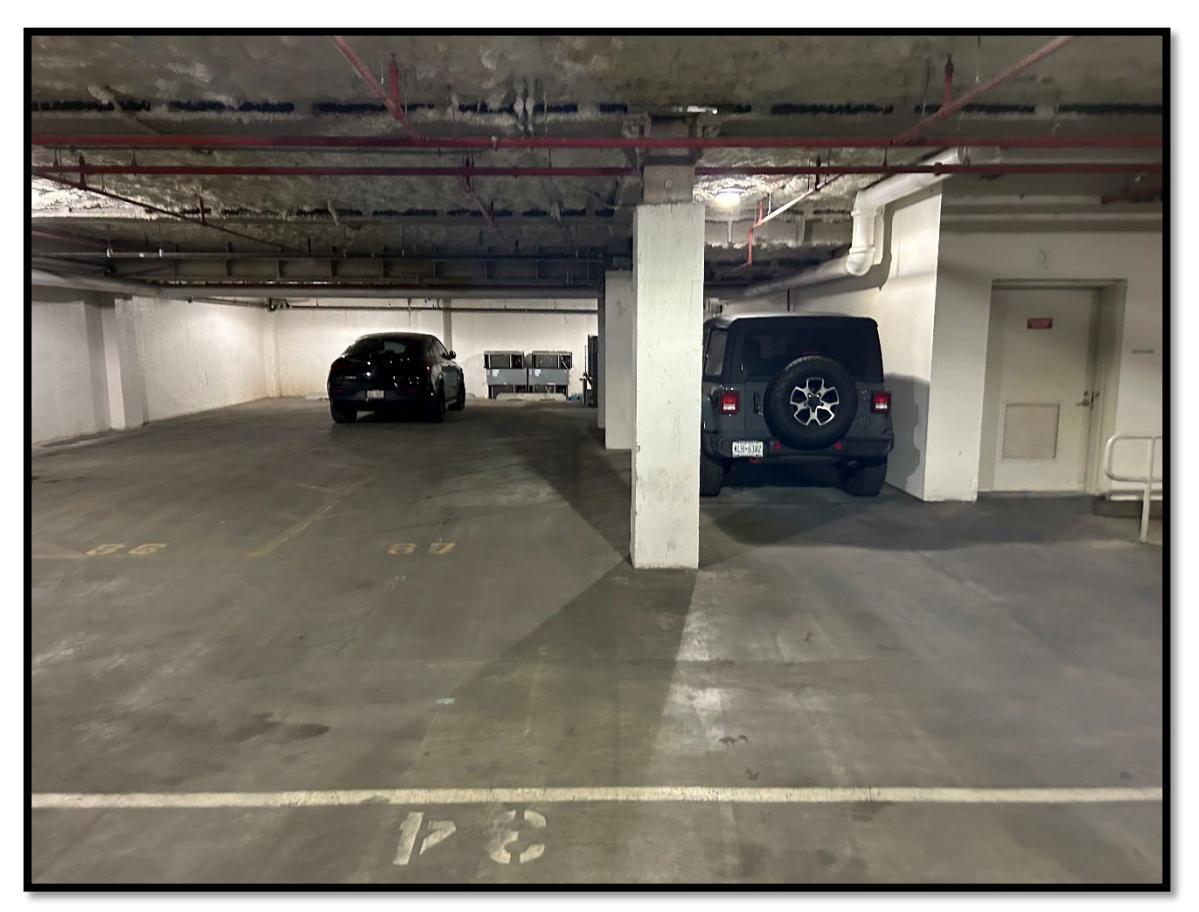
Photograph 3: Looking south, view of cellar in the southeast corner. All site cover components were intact.

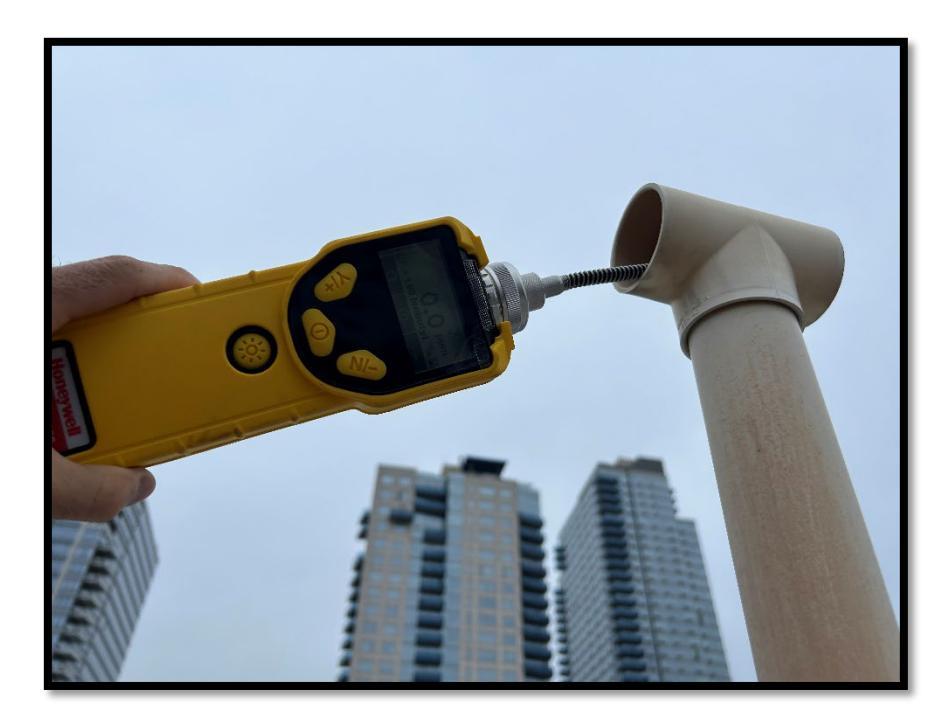
Photograph 9: View of 0.0ppm PID reading at SSDS Blower 1 (west).

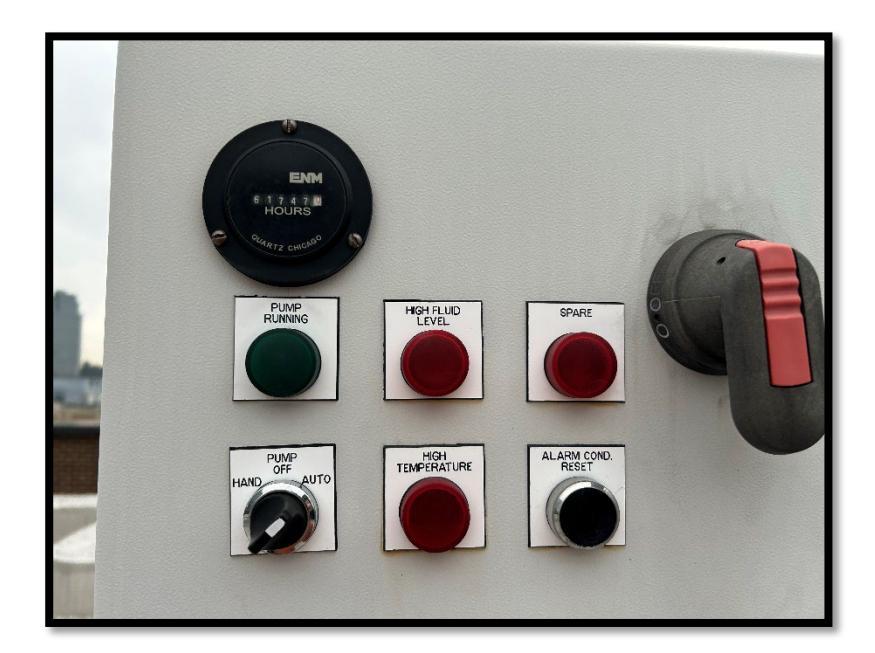
The required monthly SSDS O&M logs that were completed during the operation of the SSDS during the reporting period are provided in chronological order in Appendix E. O&M activities described herein determined that the O&M Plan was carried out as designed during the reporting period of the PRR and it is protective of human health and the environment. The green running light on SSDS-1 was not working during the annual inspection. This light will be repaired.

Photograph 10: View of SSDS Blower 1 (west) control panel; green pilot light bulb is out; other indicators show system is operational.

The ICs and ECs are performing as designed, are effective, and are compliant with specifications described in the SMP. The green running light on SSDS-1 was not working during the annual inspection. This light will be repaired. No changes to the monitoring plan are recommended at this time.

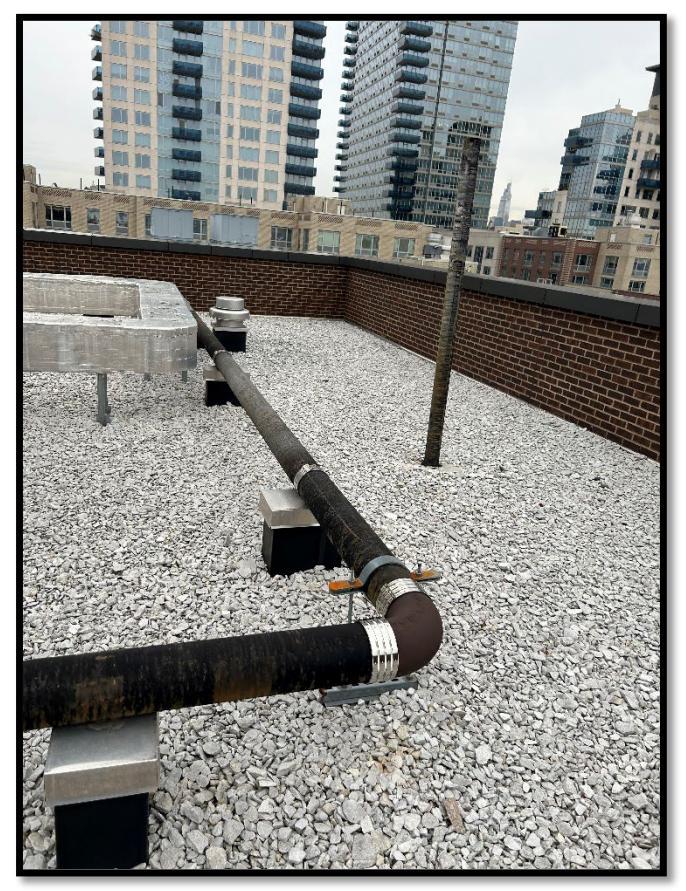
Photograph 12: Representative view of aboveground piping located on the roof leading to the SSDS Blower 1. All piping and couplings were intact.

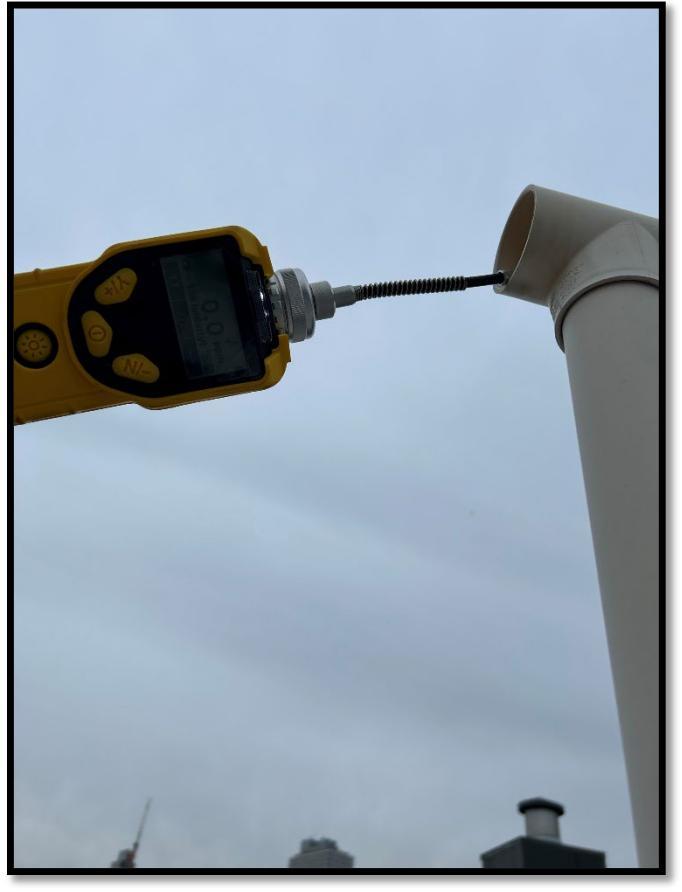
Photograph 13: View of 0.0ppm PID reading at SSDS Blower 2 (east).
