Periodic Review Report

Marcus Garvey Apartments
NYSDEC BCP #C224198
650 Rockaway Avenue
Brooklyn, New York

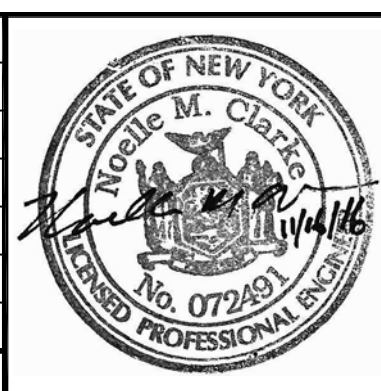
UNAUTHORIZED ALTERATION OR ADDITION TO THIS DOCUMENT IS A VIOLATION OF STATE LAW.
 THESE DOCUMENTS (OR COPIES OF ANY THEREOF) PREPARED BY OR BEARING THE SEAL OF THE ENGINEER, SHALL NOT BE REUSED FOR ANY EXTENSIONS OF THE PROJECT OR ANY OTHER PROJECT WITHOUT THE WRITTEN CONSENT OF THE ENGINEER.

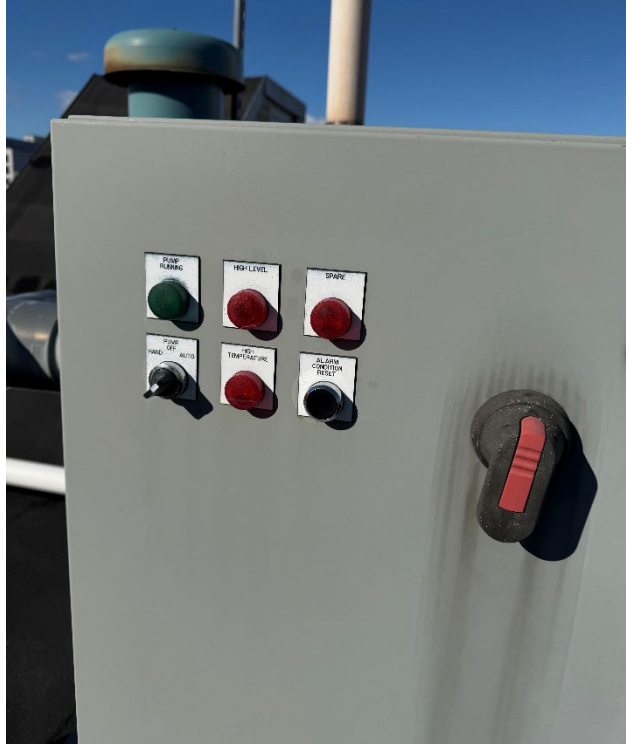
Photo 1: View of Blower B (northern) SSDS control panel.
