SSDS AS-BUILT DRAWINGS – BUILDING 4

THE SHOPS AT ATLAS PARK
BUILDING 4 SUB-SLAB DEPRESSURIZATION SYSTEM
AS-BUILT DRAWINGS
QUEENS, NEW YORK

Re: Atlas Park Sub-Slab Evaluation and Smoke Test
Buildings 4 & 6, Glendale, Queens, NY
LEA Project #05-323

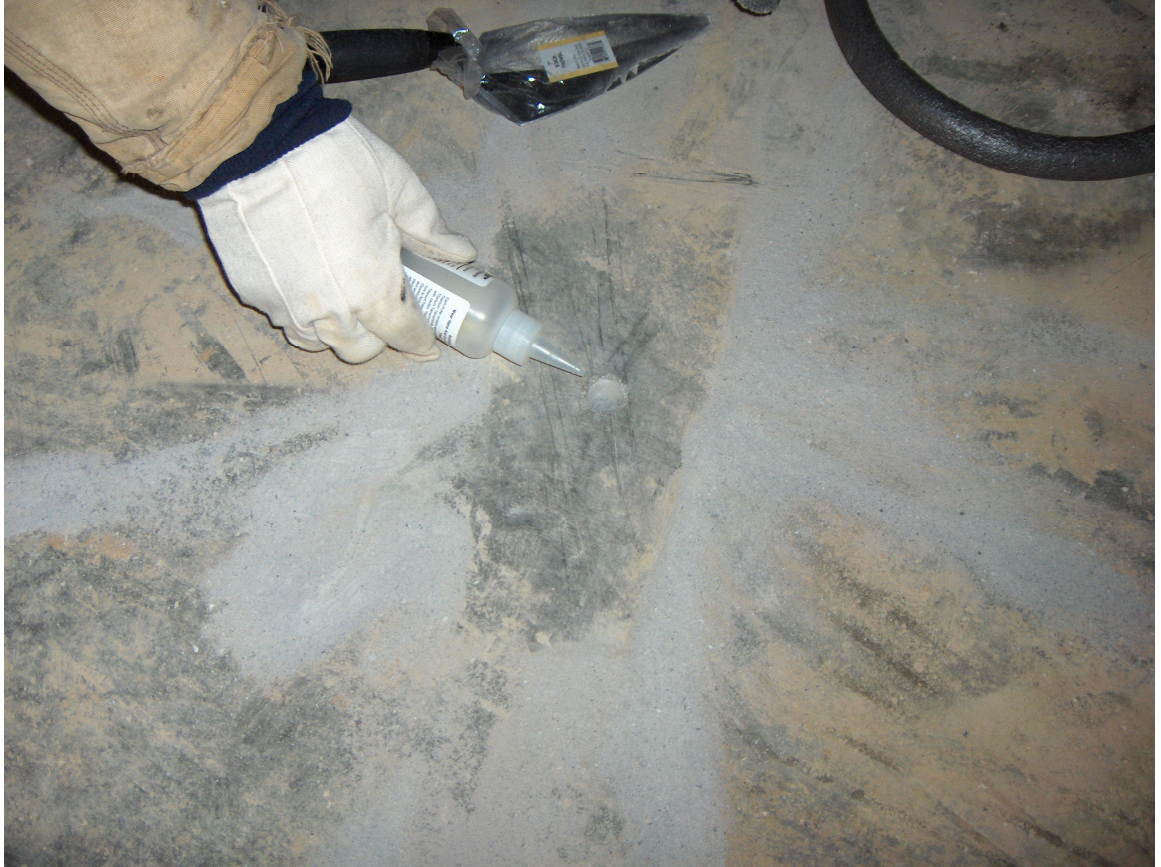
Photo 1, Smoke test at test point

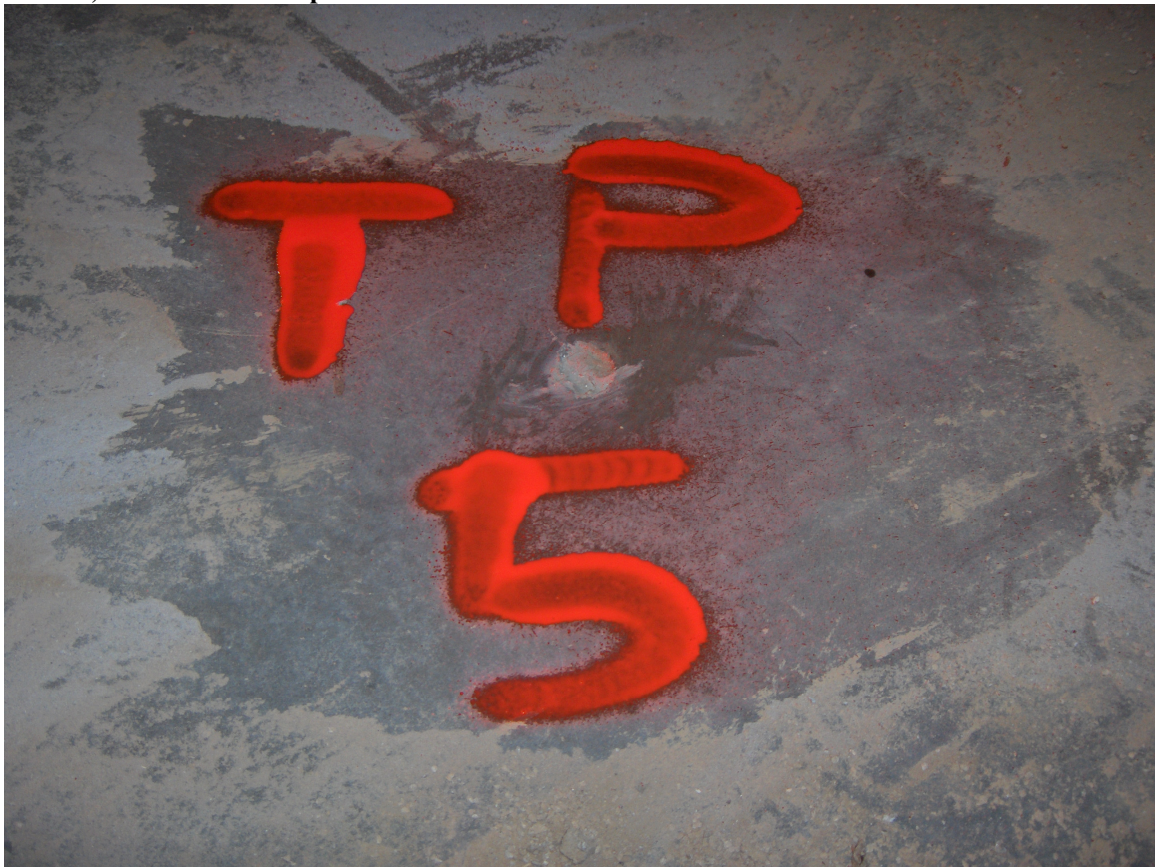
Photo 2, Sealed and labeled test point

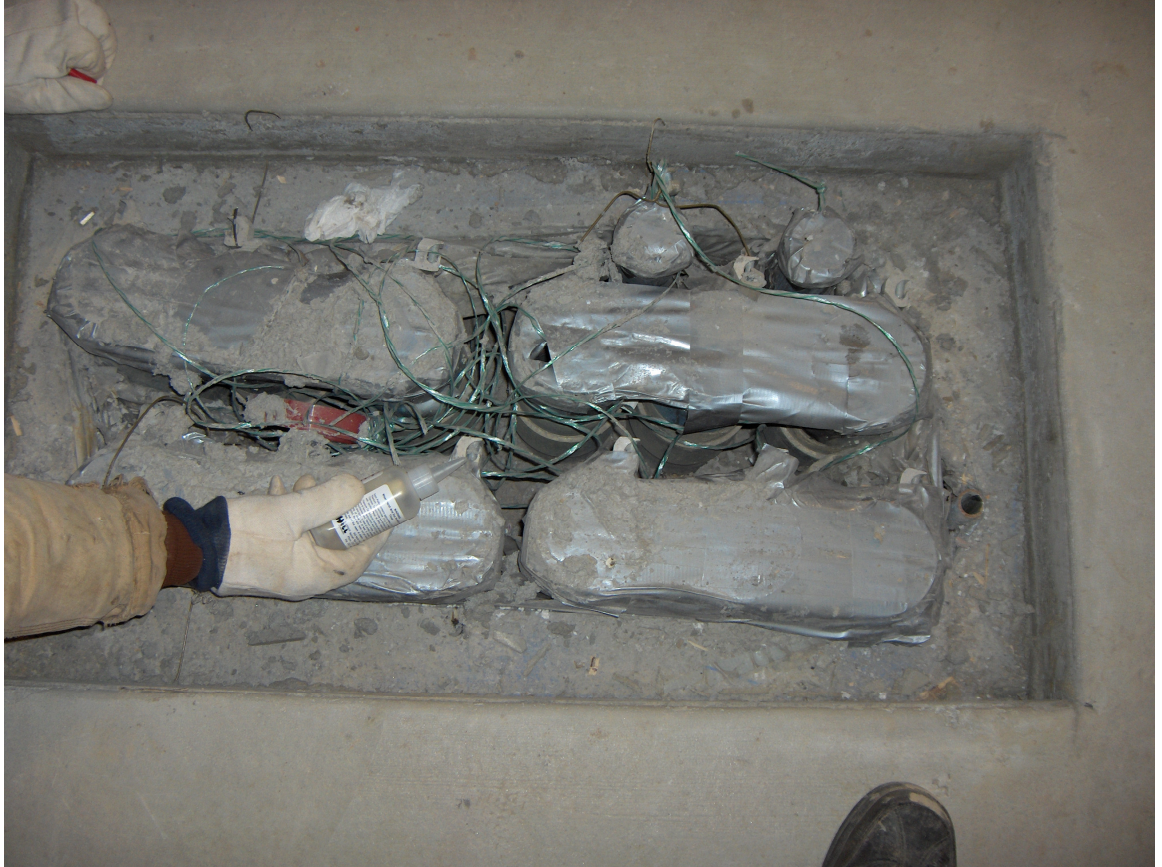
Photo 3, Smoke test of electrical conduits

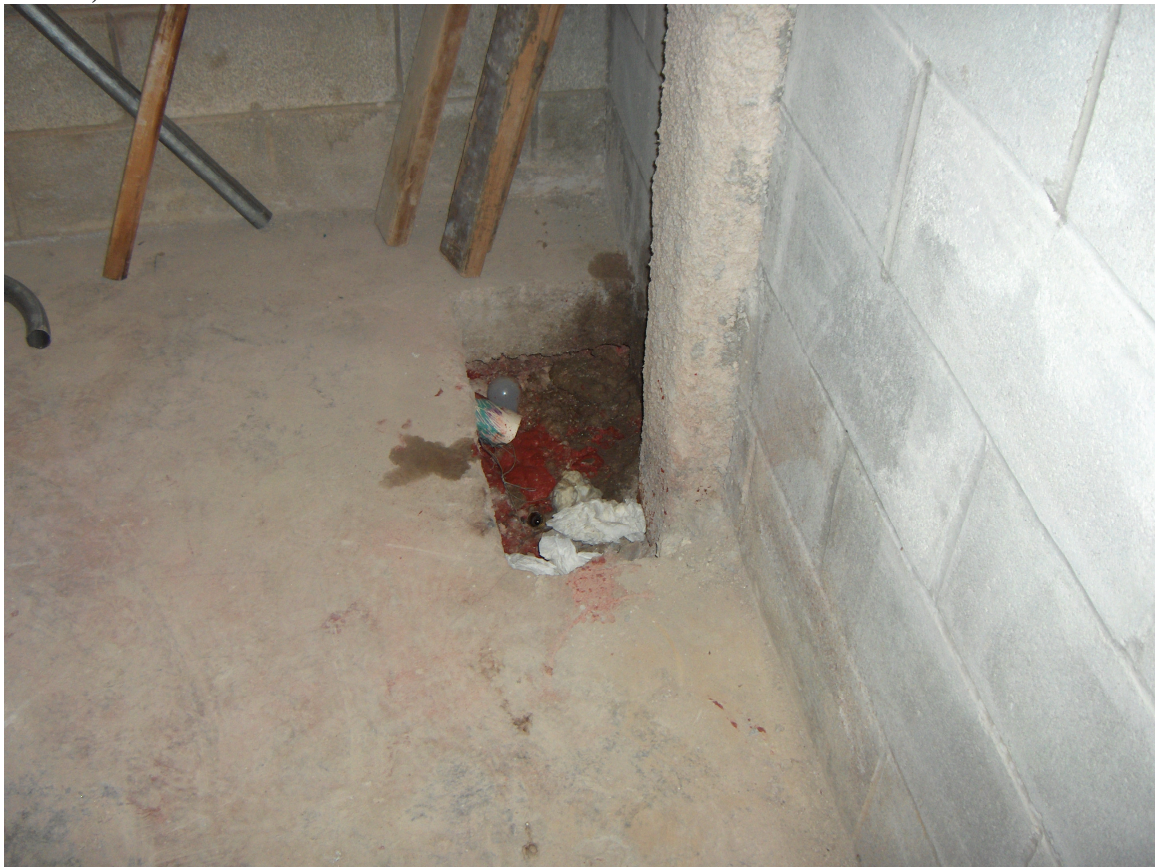
1. An inspection of risers and suction pits found all locations complete, with no deficiencies noted.
2. A number of deficiencies in the slab were noted near suction pits 6-1 and 6-2. These consisted of non-caulked joints along the parking garage wall in the 6-2 floor and several areas missing a concrete slab in the 6-1 floor. Sewer or drainage sumps noted near 6-1 are not connected with the sub slab, as smoke did not get drawn into openings at grade.
3. With the exception of deficiencies noted in the concrete slabs near suction pits 6-1 and 6-2, smoke testing did not observe any drawdown of smoke into the slab along expansion joints, cracks, piping protrusions and other likely points of connection to the sub-slab.

4. A quantitative evaluation of the effectiveness sub-slab system to create a measurable negative pressure field that extends throughout the sub-slab(s) of each building found satisfactory negative pressure fields in slabs treated by suction pits 4-1 and 6-3. The slabs serviced by suction pits 6-1 and 6-2 failed the test. Vacuum measured at the pipe leading into suction pit 6-1 was 0.117 inches of water and was similarly low at 6-2. With a vacuum at the blower specified at 35 inches of water, there was an obvious system malfunction. There was no measurable negative pressure field beyond forty feet from suction pit 6-1. There was no measurable negative pressure field and beyond ninety feet from suction pit 6-2.

Photo 4, unfinished slab in close proximity to Suction Point 6-1

A re-evaluation of the effectiveness of suction pits 6-1 and 6-2 should be completed after repairs have been made to the system blower, valves and/or slab and joints. The actual date of system evaluation will be based on weather conditions favorable to performance of the tests in an environment open to the weather, e.g. in the absence of heavy winds that could affect the results of the evaluation.
