SSDS As-Built Drawings – Building 6

THE SHOPS AT ATLAS PARK **BUILDING 6 SUB-SLAB DEPRESSURIZATION SYSTEM AS-BUILT DRAWINGS QUEENS, NEW YORK**

Re: Atlas Park Sub-Slab Evaluation and Smoke Test Buildings 4 & 6, Glendale, Queens, NY LEA Project #05-323

Re: Atlas Park Sub-Slab Evaluation and Smoke Test Buildings 6 & 7, Glendale, Queens, NY LEA Project #05-323

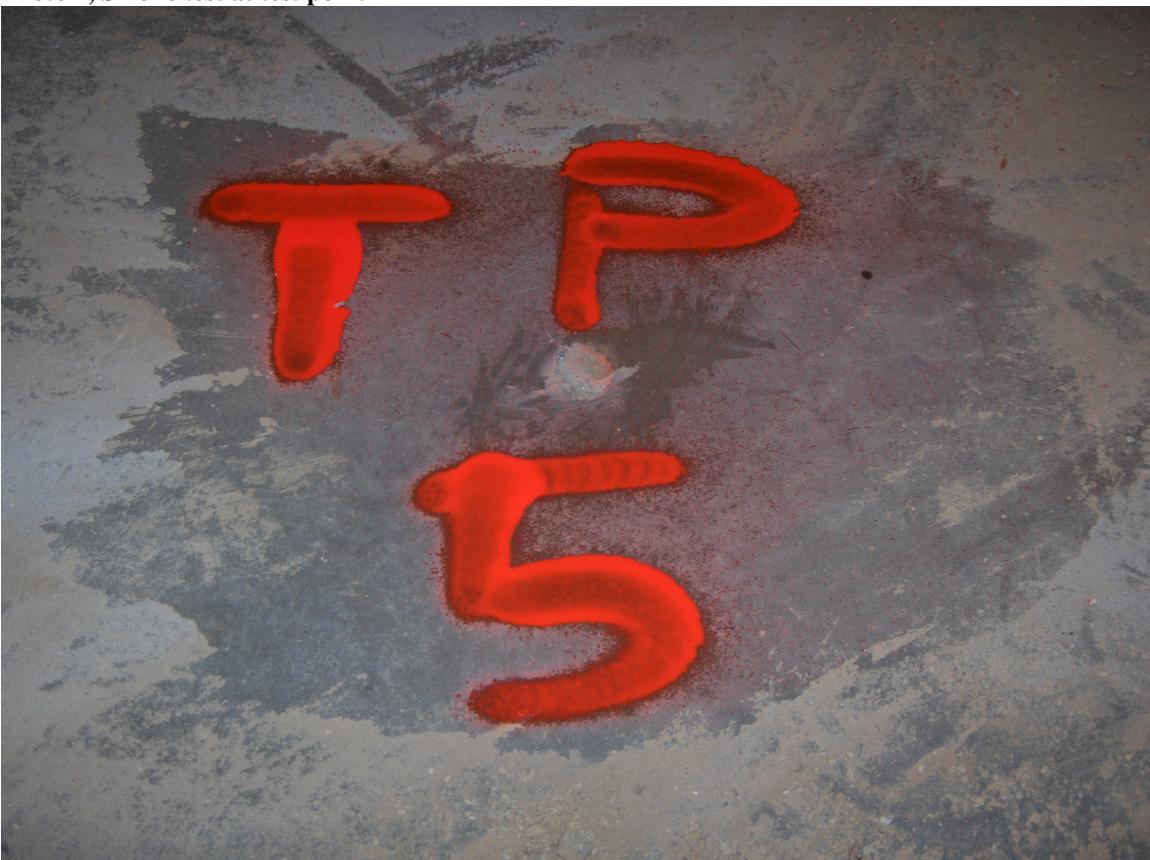
Photo 2, Sealed and labeled test point

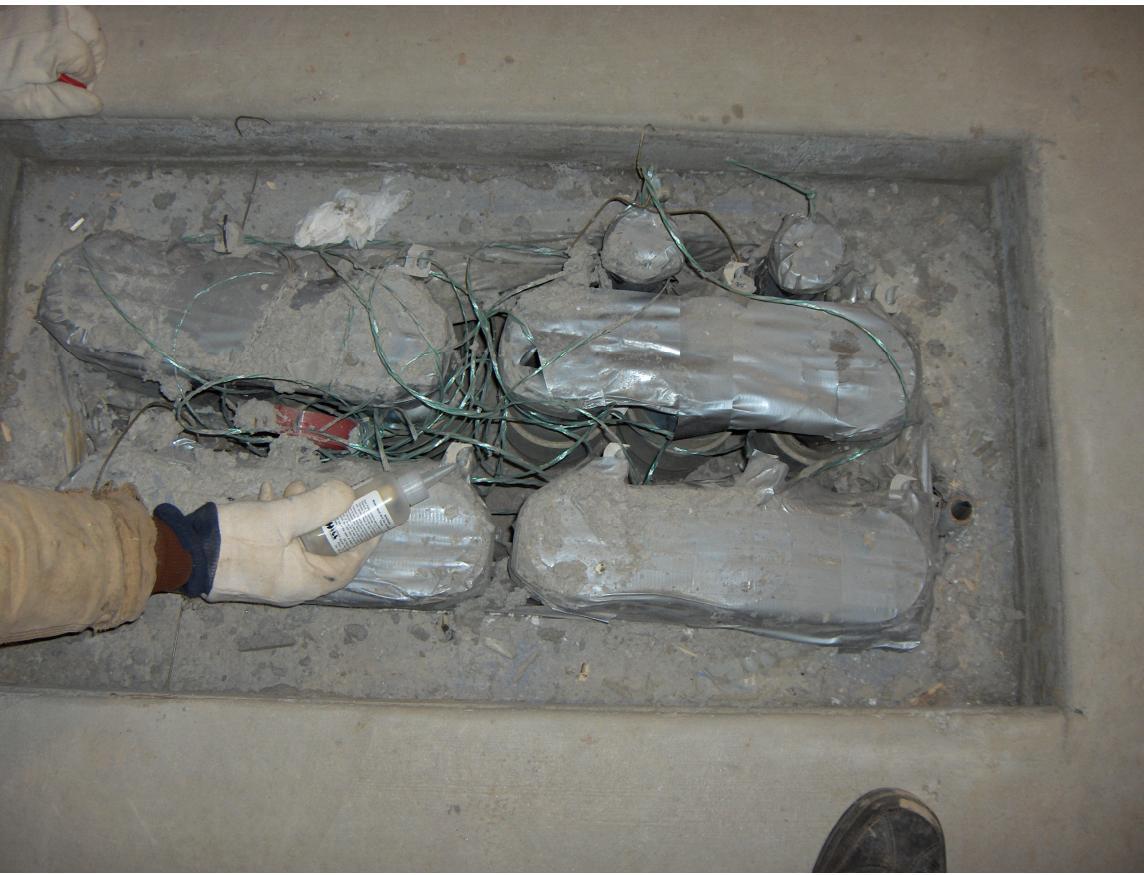
Photo 3, Smoke test of electrical conduits

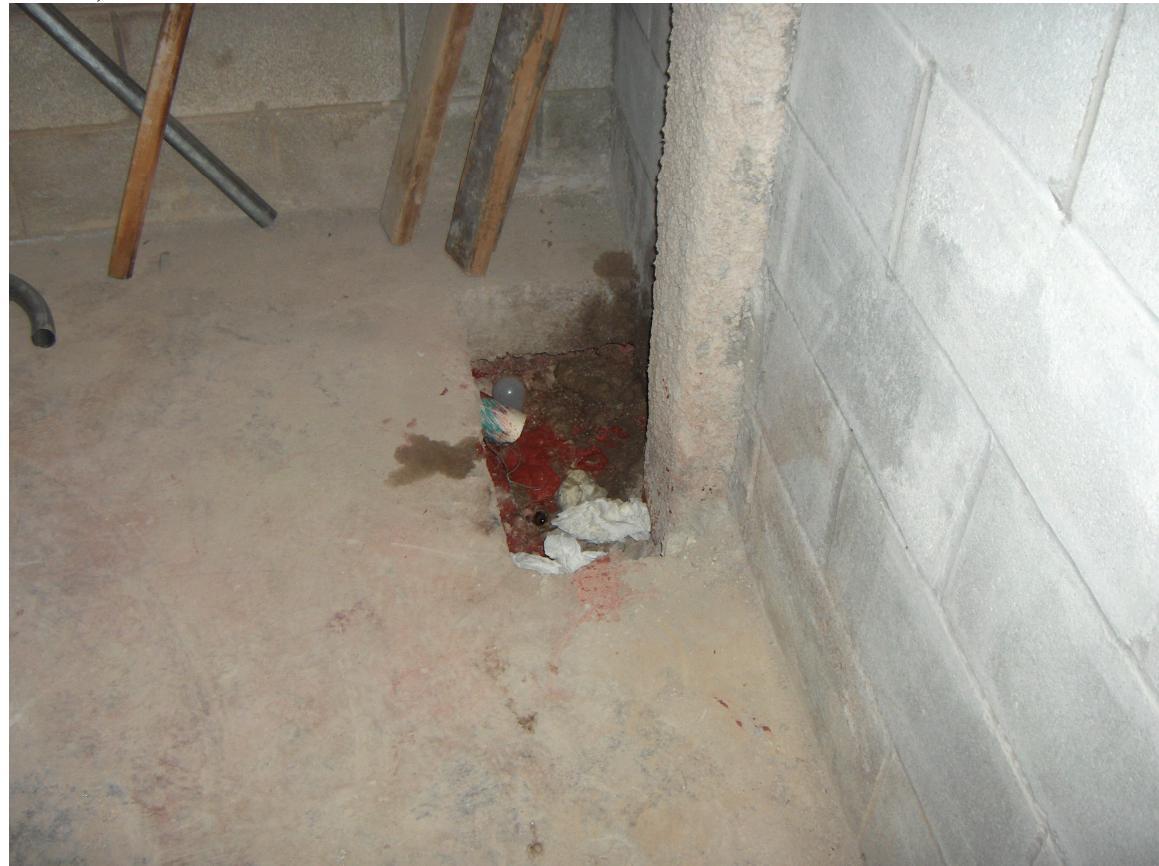
- 1. An inspection of risers and suction pits found all locations complete, with no deficiencies noted.
- 2. A number of deficiencies in the slab were noted near suction pits 6-1 and 6-2. These consisted of non-caulked joints along the parking garage wall in the 6-2 floor and several areas missing a concrete slab in the 6-1 floor. Sewer or drainage sumps noted near 6-1 are not connected with the sub slab, as smoke did not get drawn into openings at grade.
- 3. With the exception of deficiencies noted in the concrete slabs near suction pits 6-1 and 6-2, smoke testing did not observe any drawdown of smoke into the slab along expansion joints, cracks, piping protrusions and other likely points of connection to the sub-slab.

4. A quantitative evaluation of the effectiveness sub-slab system to create a measurable negative pressure field that extends throughout the sub-slab(s) of each building found satisfactory negative pressure fields in slabs treated by suction pits 4-1 and 6-3. The slabs serviced by suction pits 6-1 and 6-2 failed the test. Vacuum measured at the pipe leading into suction pit 6-1 was 0.117 inches of water and was similarly low at 6-2. With a vacuum at the blower specified at 35 inches of water, there was an obvious system malfunction. There was no measurable negative pressure field beyond forty feet from suction pit 6-1. There was no measurable negative pressure field and beyond ninety feet from suction pit 6-2.

Photo 4, unfinished slab in close proximity to Suction Point 6-1

A re-evaluation of the effectiveness of suction pits 6-1 and 6-2 should be completed after repairs have been made to the system blower, valves and/or slab and joints. The actual date of system evaluation will be based on weather conditions favorable to performance of the tests in an environment open to the weather, e.g. in the absence of heavy winds that could affect the results of the evaluation.

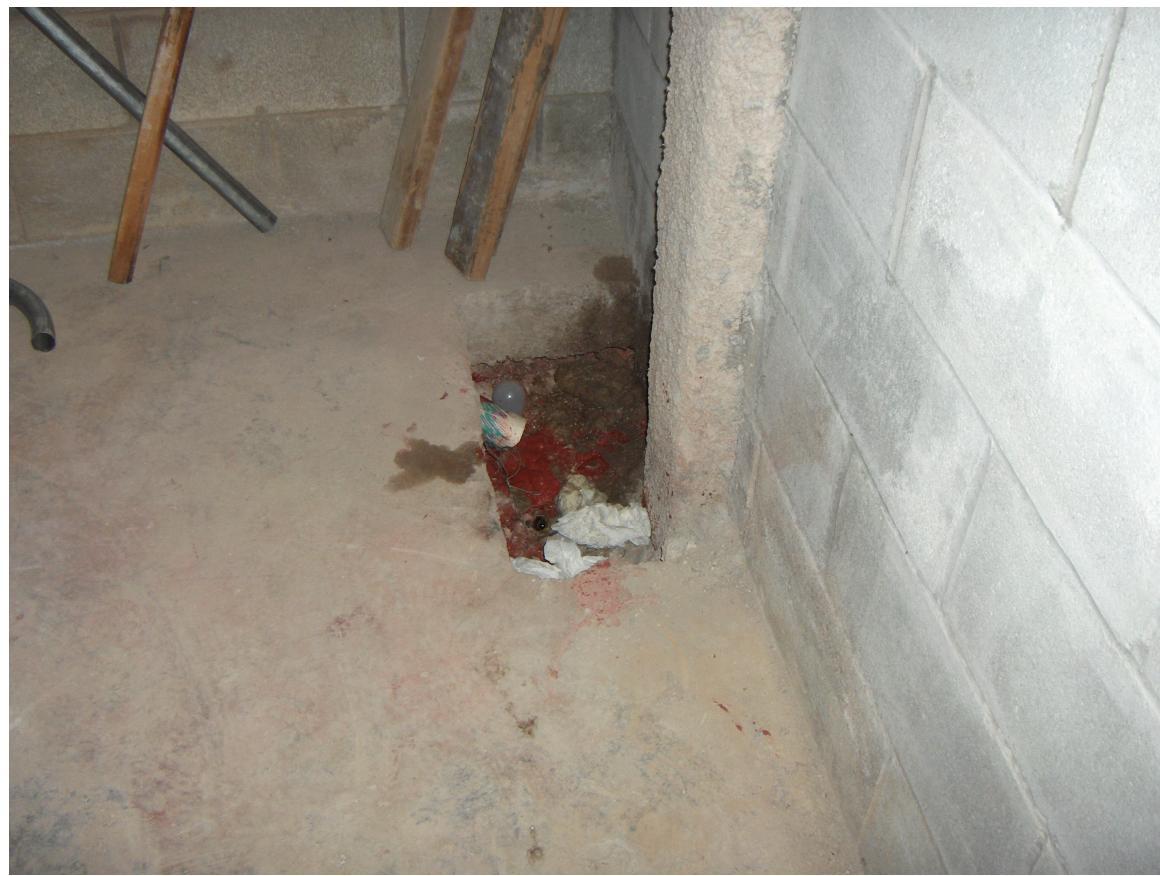
- 1. An inspection of risers and suction pits found all locations complete, with no deficiencies noted.
- 2. One of deficiency in the slab was noted near suction pit 6-1. This consisted of an area missing a concrete slab in the 6-1 floor. This was repaired by Laurel Environmental Associates, Ltd. on April 10, 2006.

Photo 1, unfinished slab in close proximity to Suction Point 6-1

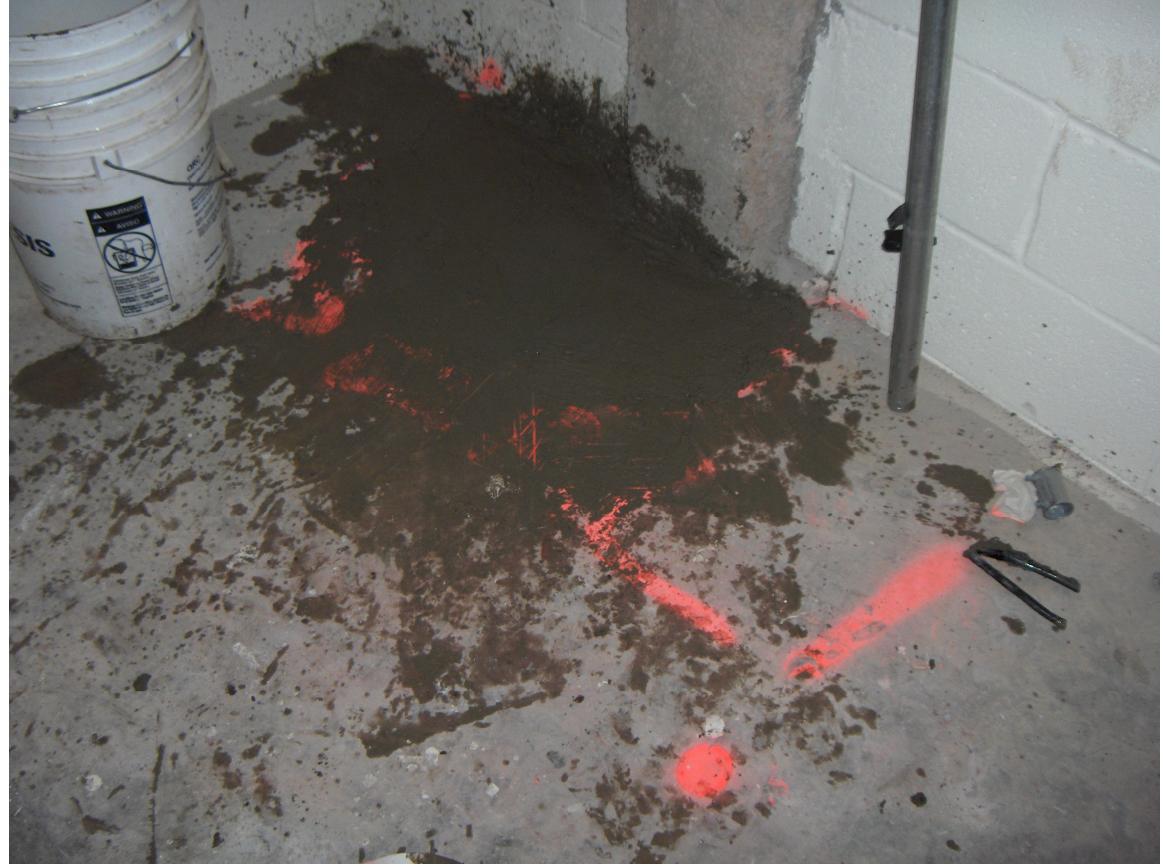
Photo 2, concrete slab adjacent to Suction Pit 6-1sealed by Laurel Environmental 4-12-06
