# APPENDIX O SSDS As-Built Drawings – Building 7

# THE SHOPS AT ATLAS PARK BUILDING 7 SUB-SLAB DEPRESSURIZATION SYSTEM AS-BUILT DRAWINGS QUEENS, NEW YORK

**Re:** Atlas Park Sub-Slab Evaluation and Smoke Test

Buildings 6 & 7, Glendale, Queens, NY

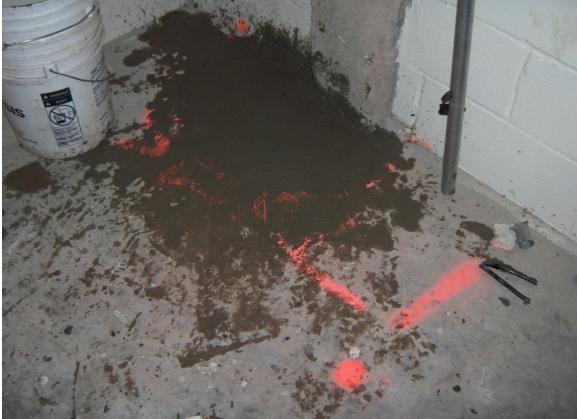
- 1. An inspection of risers and suction pits found all locations complete, with no deficiencies noted.
- 2. One of deficiency in the slab was noted near suction pit 6-1. This consisted of an area missing a concrete slab in the 6-1 floor. This was repaired by Laurel Environmental Associates, Ltd. on April 10, 2006.

Photo 2, concrete slab adjacent to Suction Pit 6-1sealed by Laurel Environmental 4-12-06

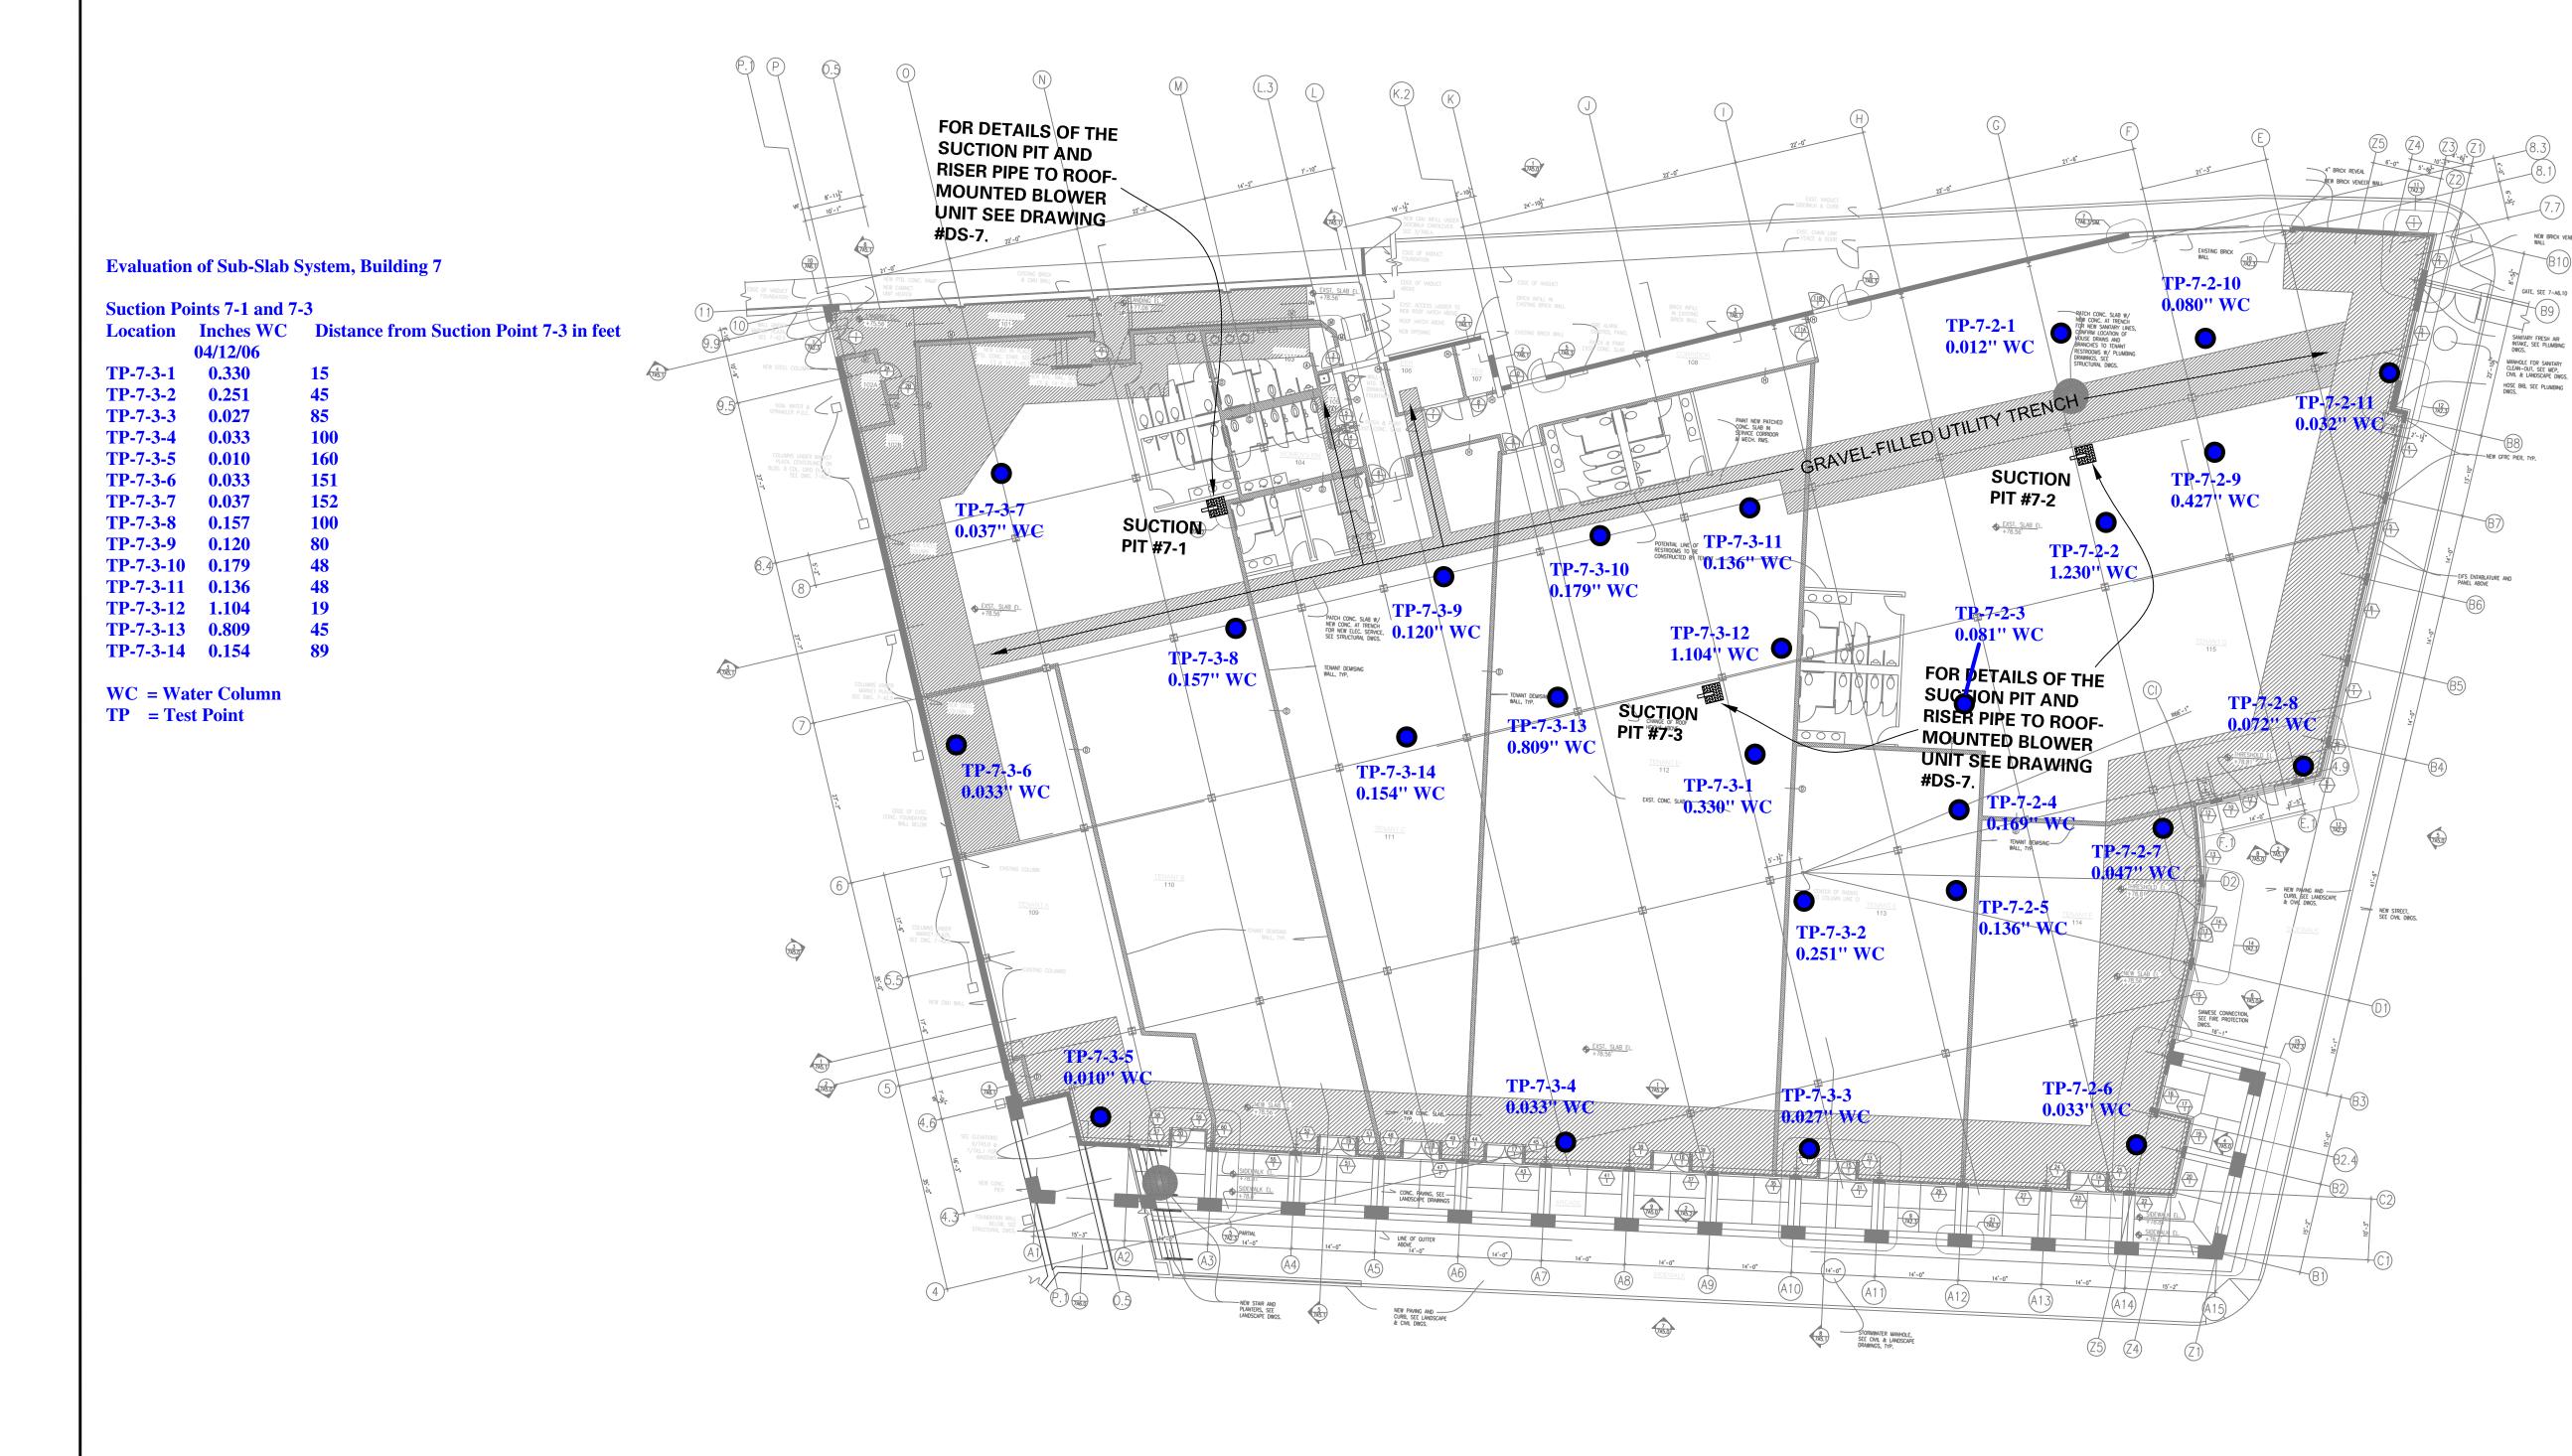
### **Evaluation of Sub-Slab System, Building 7**

### **Location Inches WC Distance from Suction Point in feet** TP-7-2-1 0.012 **TP-7-2-2** 1.230

**TP-7-2-3 TP-7-2-4 TP-7-2-5 TP-7-2-6** 0.033 **TP-7-2-7 TP-7-2-8 TP-7-2-9** TP-7-2-10 0.080 TP-7-2-11 0.032
