**SUPPLEMENTAL REMEDIAL INVESTIGATION  
WORK PLAN**

**211 FRANKLIN STREET  
OLEAN, NEW YORK 14760**

**NYSDEC SITE NUMBER C905038-05-14**

Project No.: 4884S-13

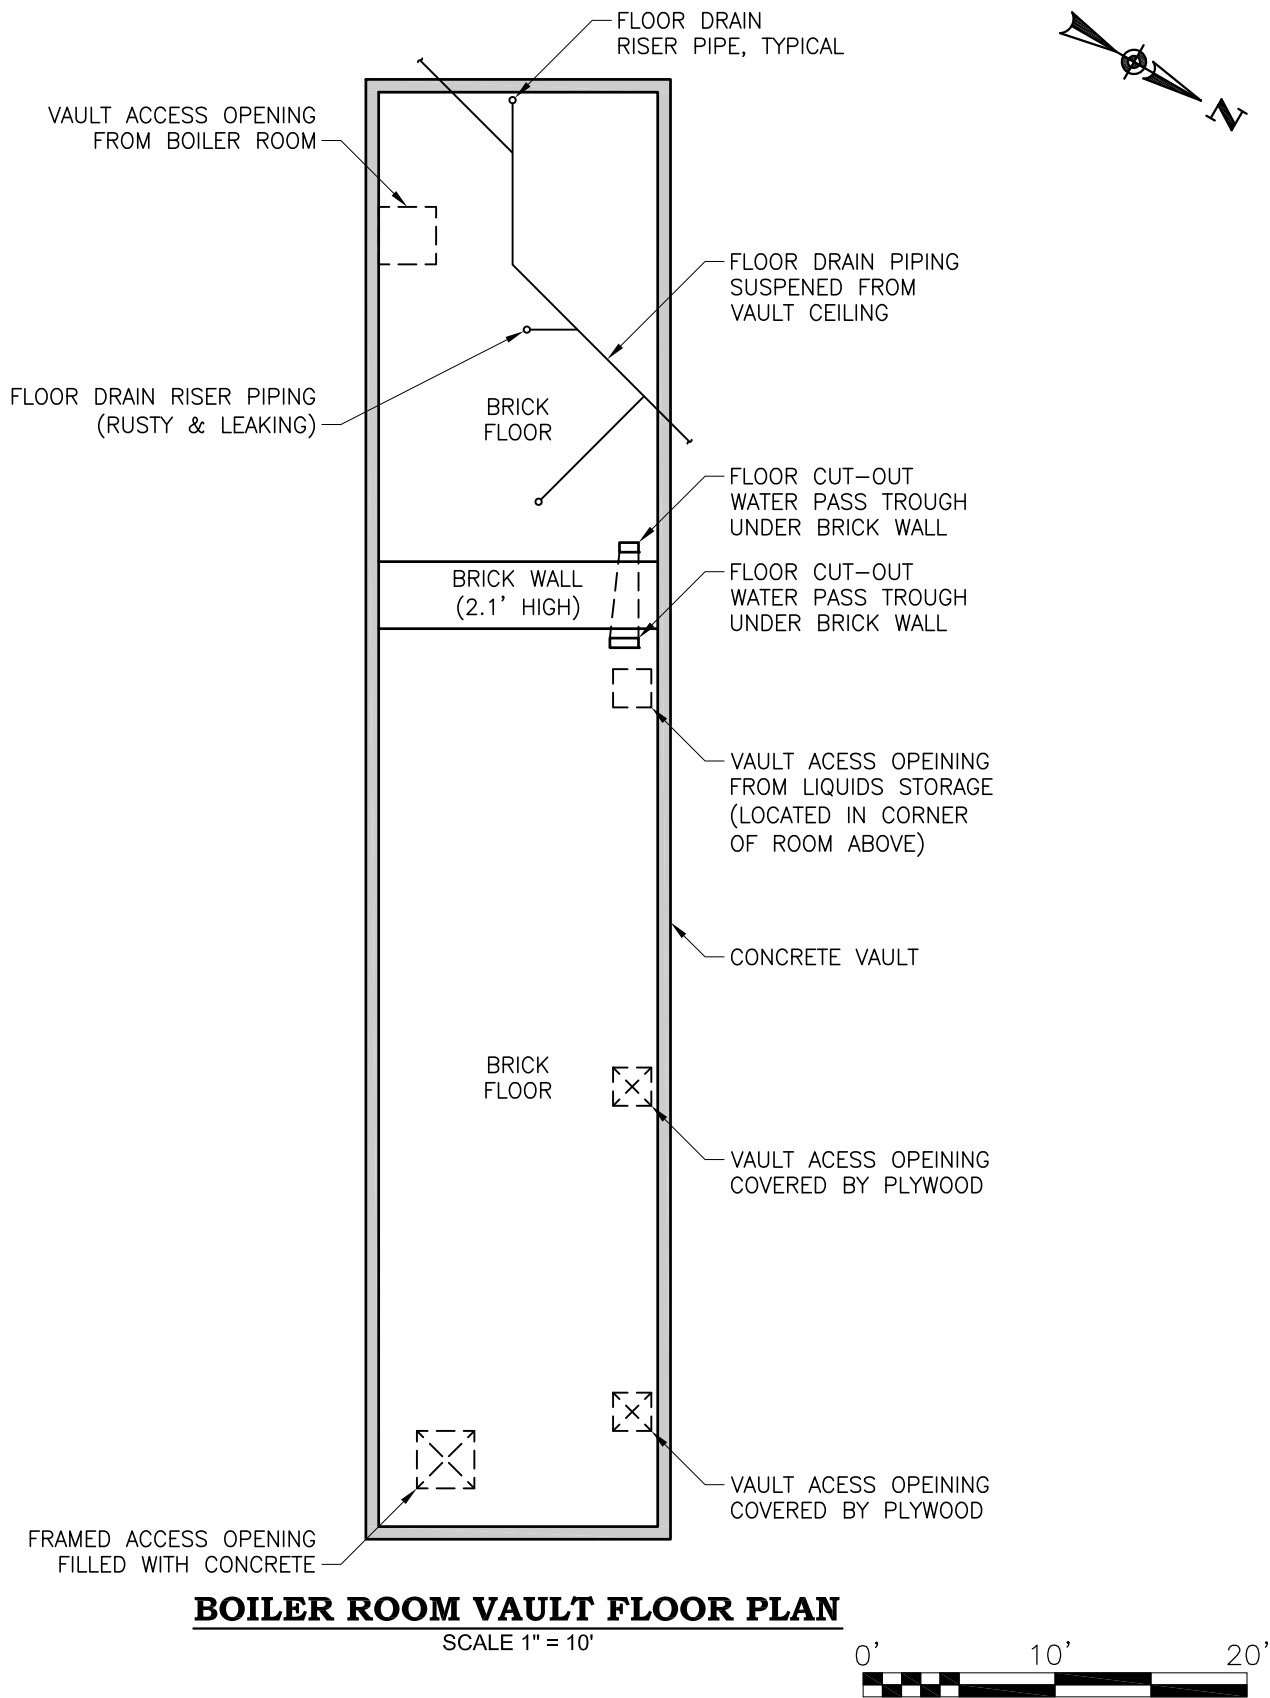
**FIGURE 3**

On May 21, 2014, a sample of the standing water (i.e., as observed in the vault located beneath the boiler room during the 2013 Phase I ESA) was collected and tested for the parameters outlined in the City of Olean Industrial Pretreatment Program Wastewater Discharge Permit No. E-1-12 (these test results are not provided in this Site Observation Report). The facility received permission from the City of Olean to discharge water to the municipal sewer system, and the standing water was subsequently pumped out of the vault and discharged into the sanitary sewer. It is estimated that the vault contained approximately 19,000 gallons of standing water prior to discharge. A sketch of the boiler room vault is provided in Figure 4.

During the basement/vault assessment that was conducted on October 6, 2014, residual standing water was encountered on the floor in portions of the boiler room vault and the depth of this water did not exceed approximately 0.25 feet. A thin layer (i.e., approximately 0.05 feet thick) of sediment was observed across both wet and dry areas of the vault floor. This sediment is fine grained (i.e., silt to clay) and it exhibited a brown color at the surface. A black, inky- type sediment was also observed in areas where the sediment was disturbed (i.e., by foot traffic during the assessment). A faint petroleum-type odor was noted in the vault subsequent to disturbing the sediments.

Based on the patterns of the undisturbed sediment observed, and the observations made on the portions of the floor where sediment was disturbed, the boiler room vault floors were constructed of brick and mortar. A low wall that extended the width of the vault was observed to be capped with apparent clay bricks and cement mortar. It is assumed that the floor bricks and mortar are of the same material as the low wall. Floor cut-outs were observed on either side of the low wall (i.e., one on each side) near the northwest wall of the boiler room vault. The openings of these floor cut-outs measured approximately 0.5 feet by 1.0 feet (northwest side) and 0.5 feet by 1.5 feet (southeast side) and each floor cut-out is approximately 0.5 feet deep. Both floor cut-outs contained approximately 2 inches of sediment. The residual standing water was observed to be approximately the same depth on both sides of the wall, and since the boiler room vault was pumped out from the southwest end, it is assumed that these floor cut-outs are connected via a conduit to allow liquid levels to equilibrate on either side of the low wall. However, a conduit between the floor cut-outs was not observed during the assessment.

The walls of the boiler room vault are constructed of poured concrete, and a layer of apparent tar paper covered portions of the walls. The tar paper had deteriorated and fallen off of the concrete walls in some areas, and dissolved tar paper may have been the source of the black sediment and faint petroleum odors observed at the time of the assessment.

Apparent 4-inch diameter sanitary sewer piping was observed suspended from the walls of the vault in the southwestern portion of the vault, trending from the southwest wall to the northwest wall. Two 2-inch diameter drain pipes protruded through the boiler room vault ceiling, and connected to the apparent sanitary sewer piping. The locations of these drain pipes correlate to the locations of floor drains in the boiler room (i.e., in the room above the vault) which receive boiler blowdown. One drain pipe was observed to be covered with rust, and a steady drip of apparent water from this pipe was observed accumulating on the floor of the boiler room vault. It is assumed that this leaking pipe is the source of the sanding water that accumulated in the boiler room vault.

Sediment samples will be collected from both of the floor cut-outs located adjacent to the low wall in the boiler room vault (refer to Appendix A). The samples will be evaluated and screened with a PID. If the field screening and observations indicate that the samples are similar, one sediment sample (or both, based on this evaluation and screening) will be submitted under chain-of-custody control to the analytical laboratory and tested for the following parameters:

Following the receipt of the test results, the remainder of the standing water in the boiler room vault will be pumped out and, with the permission of the City of Olean, discharged to the municipal sanitary sewer system. The floor cut-outs in the boiler room vault will subsequently be observed to evaluate their integrity. A core will be advanced through the bottom of each floor cut-out using a concrete drill and soil/fill samples (designated VLT-1 and VLT-2 on Figure 3) will subsequently be collected from a depth of approximately 0 to 1 foot below the bottom of the floor cut-outs using hand-operated sampling equipment. Two soil/fill samples will be submitted under chain-of-custody control to the analytical laboratory and tested for the parameters listed above.

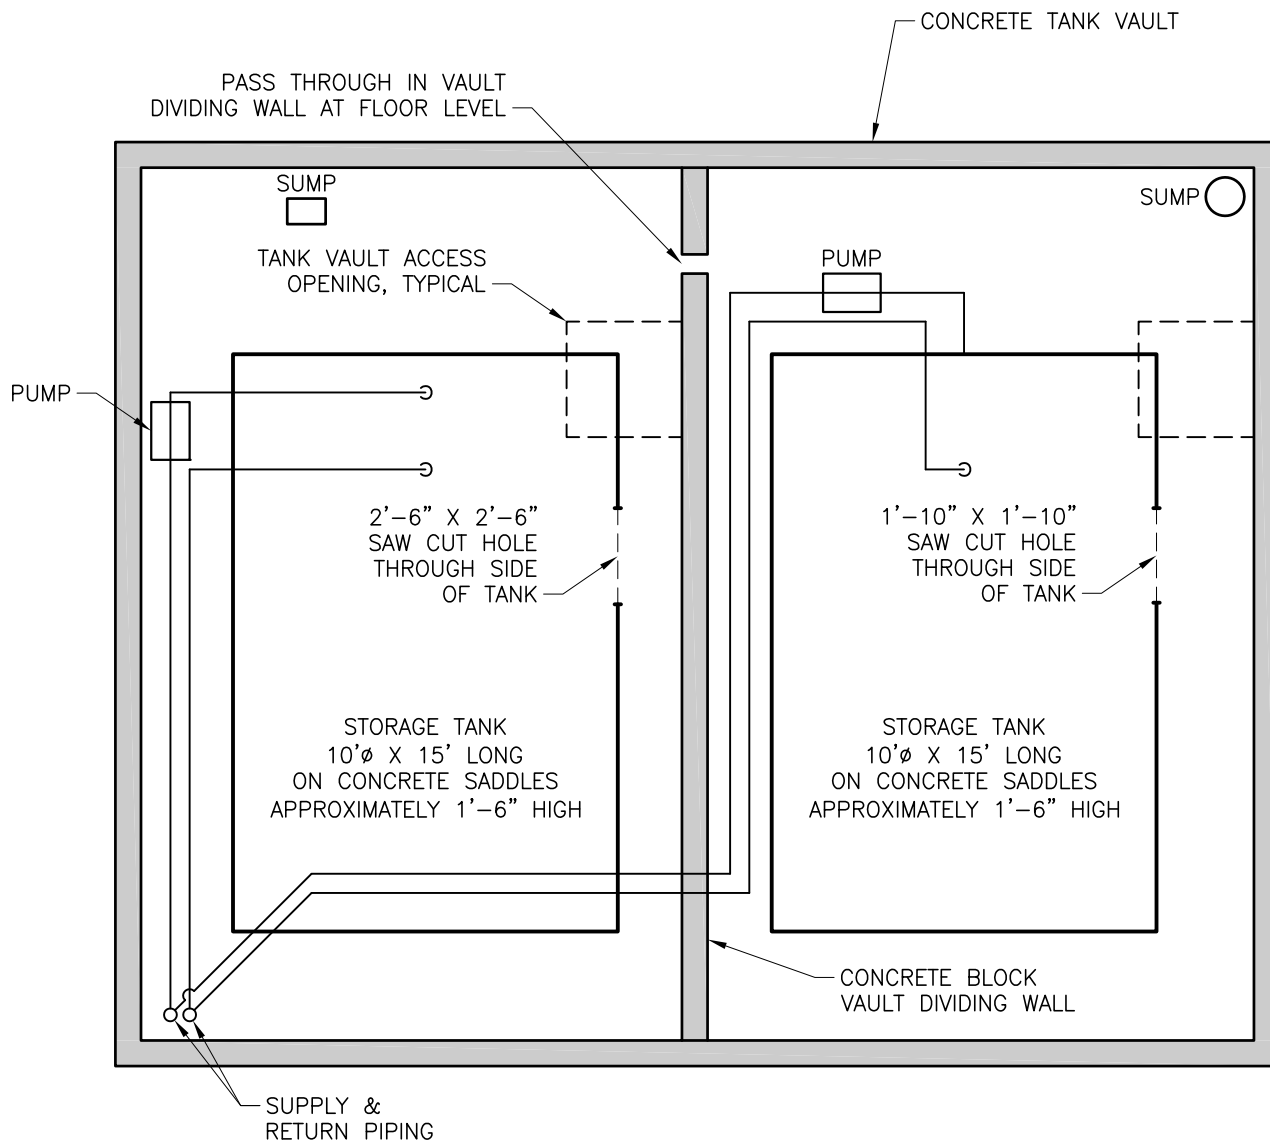
## **EPOXY ROOM TANK VAULT FLOOR PLAN**

The floors of the epoxy room tank vaults are constructed of poured concrete. Black stains, sticky resin, and/or a hardened translucent resin covered portions of the epoxy room tank vault floors at the time of the assessment. A rectangular shaped sump pit was observed in the floor in the southwest epoxy room tank vault, located to the northwest of the storage tank. This sump pit was filled to the level of the floor with a hard, translucent resin material. A circular sump pit was observed in the floor in the northeast epoxy room tank vault, located in the northern corner of the vault. This sump was probed with a hand tool, and an apparent hard bottom was observed approximately 5 inches below the surface of the floor. The sump contained approximately 2 inches of a viscous amber colored liquid.

With the exception of the wall separating the two vaults, the walls of the epoxy room tank vaults were constructed of poured concrete. Slight pitting of the concrete surface was observed in two locations on the northeastern wall of the northeast epoxy room tank vault. Additionally, a portion of the concrete block wall (i.e., separating the two vaults) was missing at the floor level, creating an approximate 0.5-foot square conduit between the two vaults. Black staining (i.e., not indicative of petroleum) was observed on the base of the walls (i.e., starting at the floor surface and extending up the walls approximately 0.5 feet) around the perimeter of both epoxy room tank vaults, and this staining was more pronounced in the northeast vault. Portions of the walls above this perimeter staining were also stained black, and this staining had the appearance of splashed liquid. Black staining was also observed on the ceiling and upper portion of the south wall in the southeast corner of the eastern vault and this staining appeared to originate from cracks in the ceiling.

Product supply and return piping was observed connected to the bottom and top of each tank (respectively), and a pump, connected in-line to the supply piping, was observed adjacent to each tank. The product piping for both tanks was routed to the southwest corner of the western vault, at which location the piping protruded through the vault ceiling.

The sump pits in the epoxy room tank vaults will be cleaned out (to the extent possible) and examined to determine the integrity of the structures (refer to Appendix A). A sample of the material removed from each sump will be retained for subsequent testing, and the remainder of the material will be containerized for disposal.

A core will be advanced through the bottom of each sump using a concrete drill (as necessary, depending on sump construction) and a soil/fill sample (designated VLT-3 and VLT-4 on Figure 3) will subsequently be collected from a depth of approximately 0 to 1 foot below the bottom of each sump using hand-operated sampling equipment. A composite sample of the contents removed from each sump and a soil/fill sample from each location (4 samples total) will be submitted under chain-of-custody control to the analytical laboratory and tested for the parameters listed in Section 3.4.1.

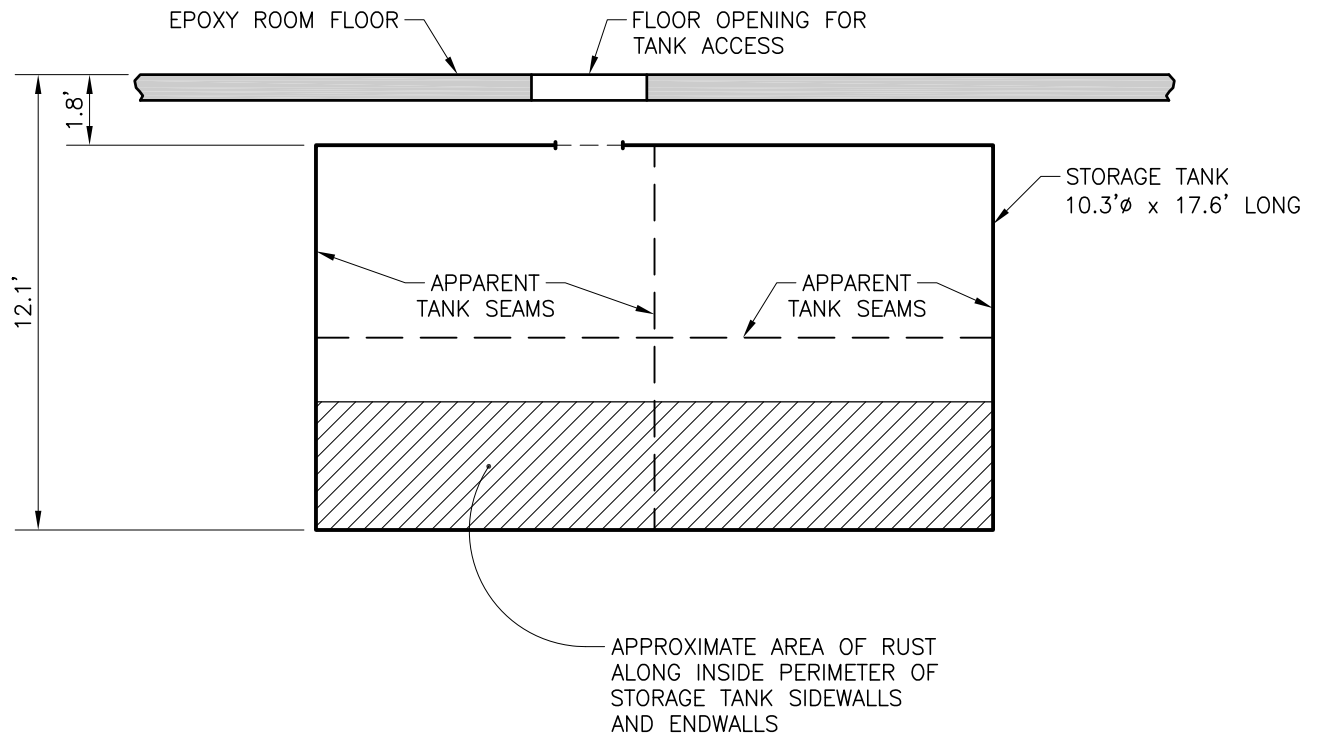
### UNDERGROUND STORAGE TANK SECTION

The interior of the UST was inspected using a video scope and photographed from the vantage point of the access port in the top of the UST. The interior surfaces of the UST were covered in a layer of rust, and this rust was most prominent along the tank invert, where apparent scale was observed. This scale extended along the tank invert to each end wall. The scale observed at the junction of the tank invert and the end walls appeared to be separating from those junctions, and may indicate breaks in the seams of the UST along the invert at the end walls. [Note: On June 19, 2014, a test boring designated TB-118 was advanced approximately 3 feet to the north of the UST to a depth of approximately 34 feet below the floor surface. This test boring was subsequently completed as monitoring well MW-N. Field evidence of impact was not observed in the unsaturated soil or fill at this location. A fill sample collected from approximately 14-16 feet below the floor surface (i.e., approximately 2-4 feet below the bottom of the

A uniform line of rust/discoloration was observed around the perimeter of the UST interior, approximately 3 feet above the tank invert. This may indicate a period of prolonged storage of un-used liquids within the UST.

An apparent product supply pipe was observed extending from just above the tank invert and connected to the north sidewall/top of the UST via a pipe flange. The extent of the product supply piping outside of the UST is not known. An additional pipe was observed protruding from the northeast end wall, and was closed near the surface of the end wall with an apparent threaded pipe cap. The extent of this pipe outside of the UST is not known.

Based on the location of the UST (i.e., beneath the building floor and under room divider walls), the following method for documenting the integrity of the UST is proposed.

- Two test borings will be advanced through the bottom of the UST. It is anticipated that one test boring will be advanced near the northeast end wall of the UST, and the other test boring will be advanced as close to the southwest end wall as is possible with the equipment utilized. It is anticipated that 3-inch diameter holes will be cored through the floor at each test boring location and test borings will be completed using a direct-push drill-rig capable of advancing a 2.25-inch diameter macro core sampler to an approximate depth of 20 feet below the floor (i.e., approximately 8 feet below the bottom of the UST).
