Mr. Chad Staniszewski
Mr. Eugene Melnyk
New York State Department of Environmental Conservation
270 Michigan Avenue
Buffalo, NY 14203
OU-2 Additional Cover Areas
NYSDEC Site No. C915201C

Elk Street Commerce Park, LLC
600 Elk St., Buffalo, NY

OU2
COVER AREAS
Project 3617-16-7397
Figure 1

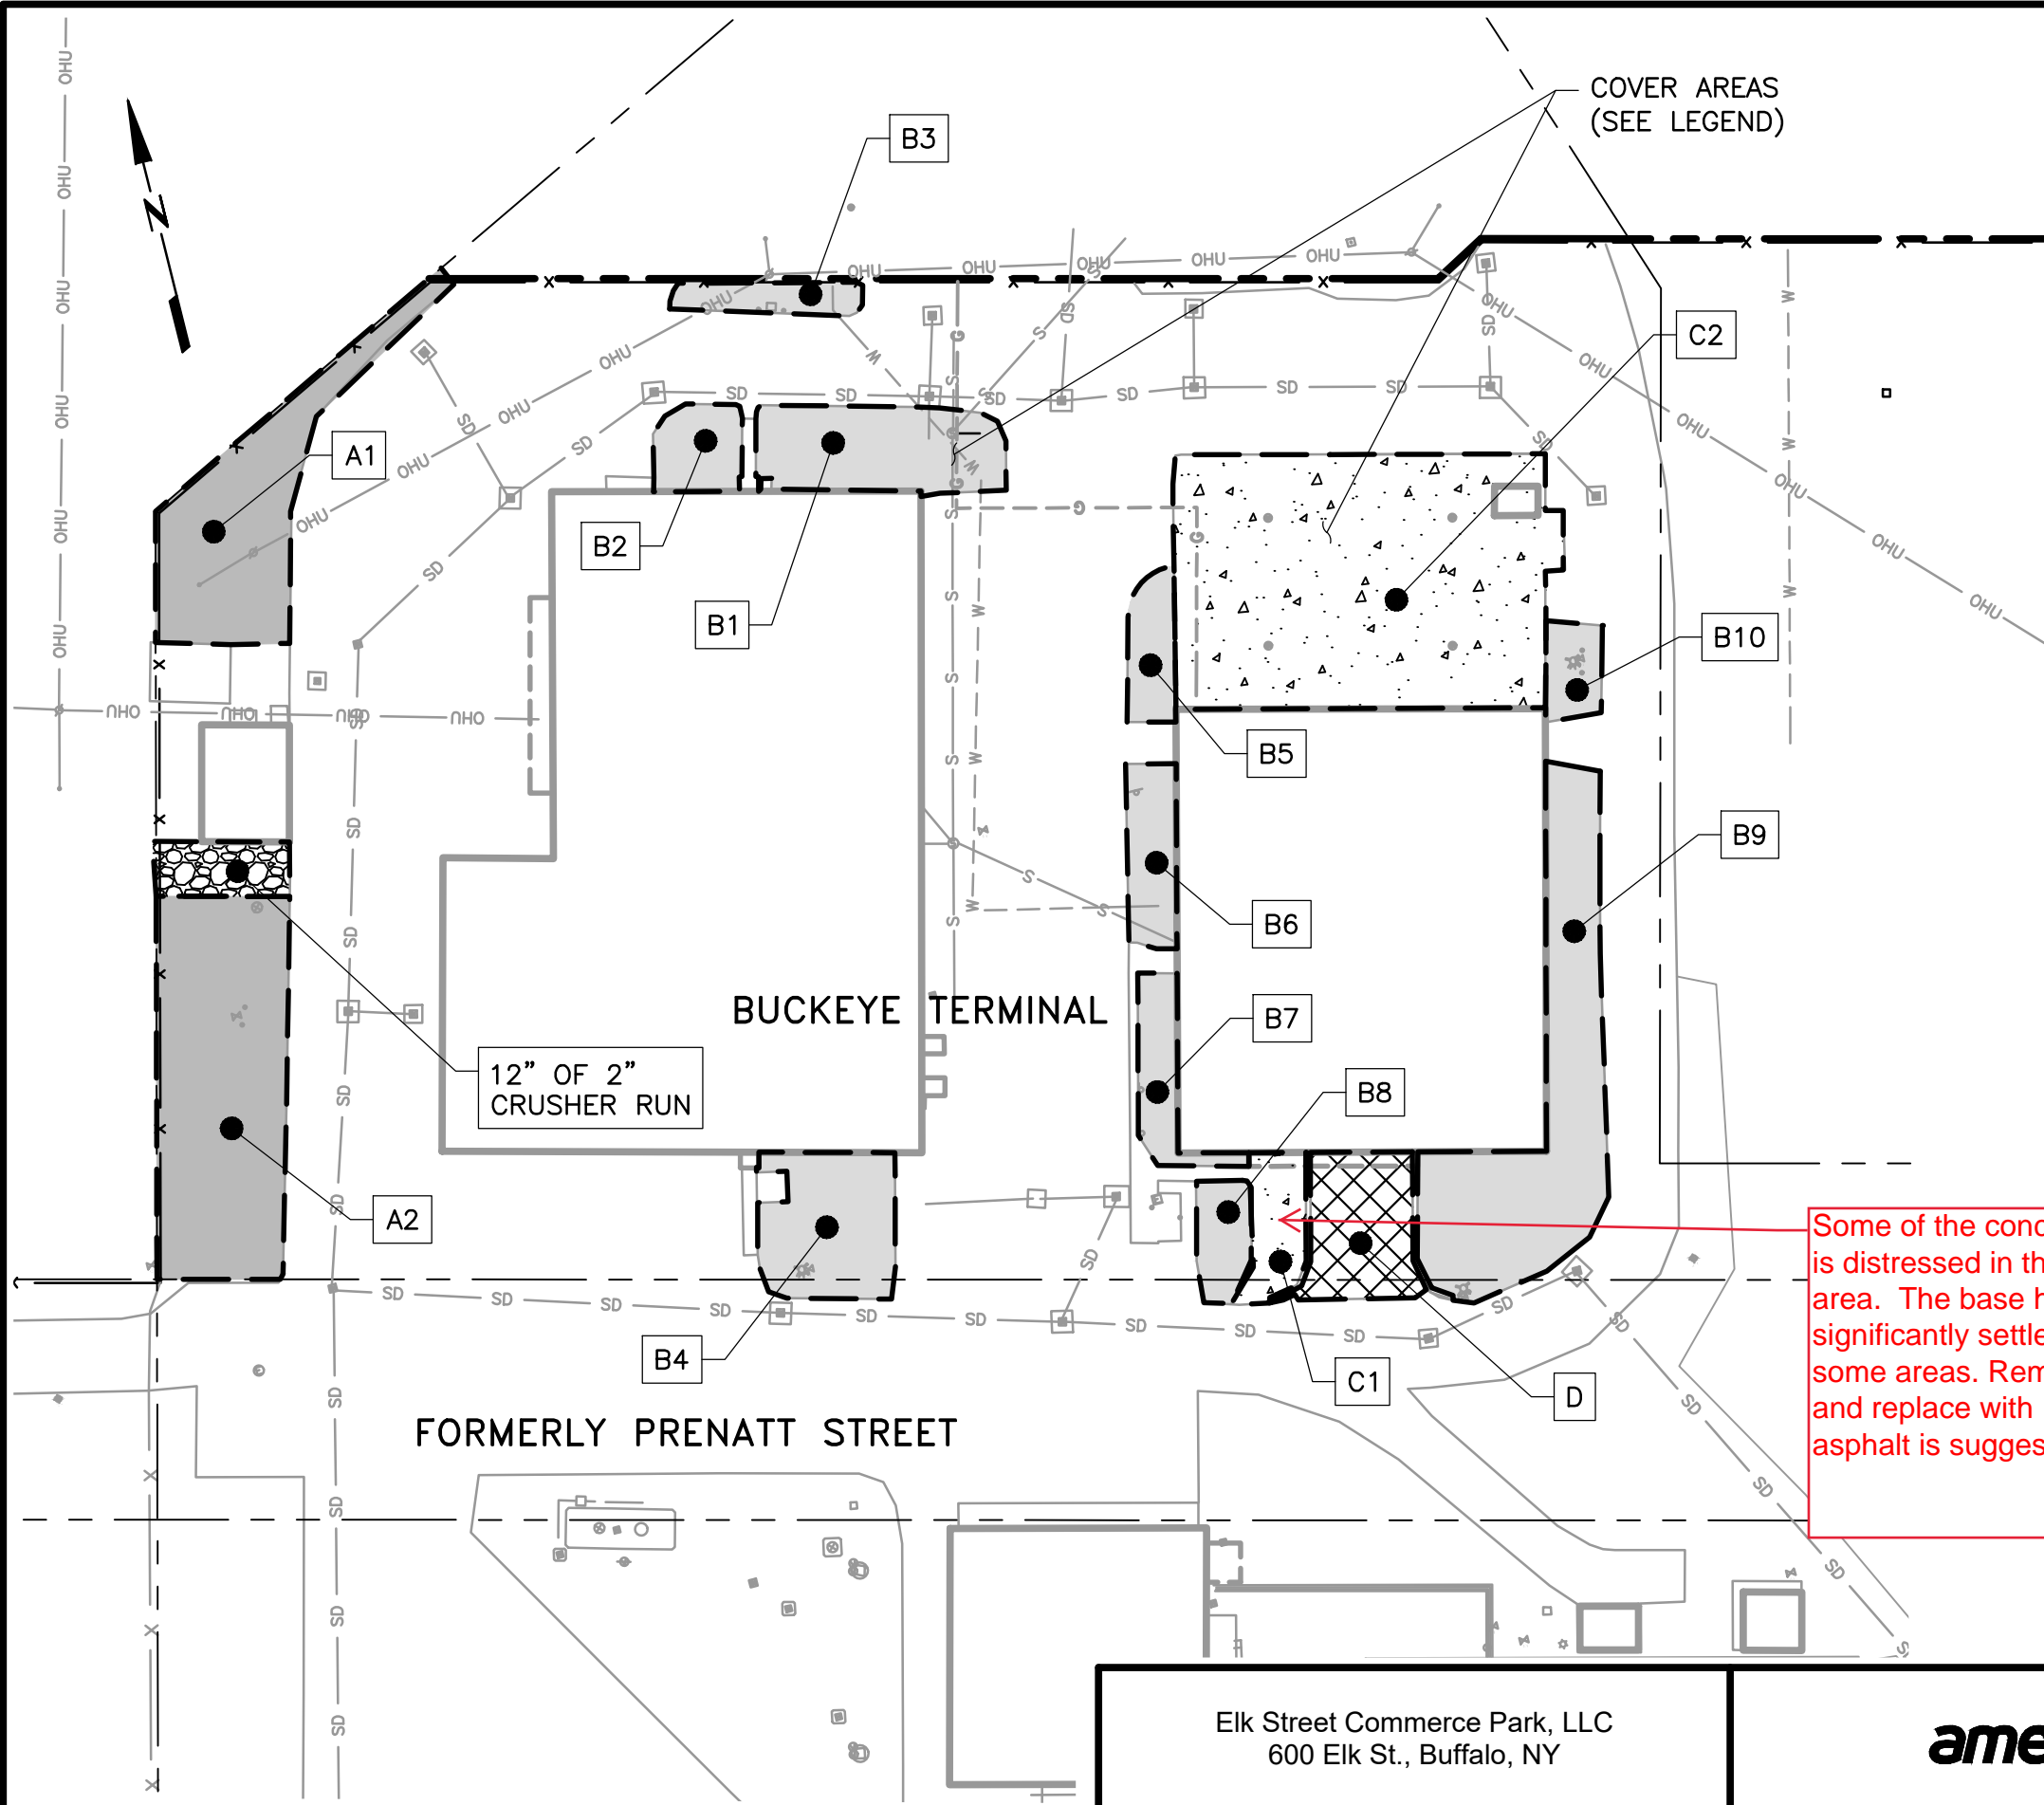
On July 30, 2019 representatives from Elk Street Commerce Park, LLC (ESCP), Amec E&E PC (Amec) and the New York State Department of Environmental Conservation (NYSDEC) conducted a comprehensive site walk of Operable Units 2 (OU2) and Operable Unit 3 (OU3). The NYSDEC indicated that several areas around the OU2 warehouses and power station currently have cover systems that do not adequately meet the requirements of the OU2 Decision Document. The specific areas are shown on the attached Figure 1 and include the areas of stone cover to the north and south of the power station building, vegetated and stone areas around the warehouses, the former concrete building slab north of the eastern warehouse and the former concrete ramp on the south side of the eastern warehouse.

see comments on concrete on the
south side of eastern warehouse
as noted on figure 1

- The stoned areas to the north and south of the power station will receive an asphalt pavement comprised of 2.5-inches of binder course and 1.5-inches of top course. Existing stone cover will be removed as necessary for grading purposes. The remaining stone will be prepared for use as subbase material for the pavement. The area immediately adjacent to the door of the substation will be left without pavement as existing pavement grades are above the bottom of door elevation. A thin strip will be excavated and replaced with 12-inches of clean cover to accommodate the door.
- Material will be removed from the vegetated and stone areas around the warehouse as needed to install asphalt pavement comprised of 2.0-inches of binder course and 1.0-inches of top course.

repair areas with
spalled concrete as
discussed in the
field on 8/26/2019

- The former concrete building ~~slab~~ directly north of the eastern warehouse will be inspected and repaired as necessary to establish a competent hardscape surface.
- Sediment and debris within the envelop of the concrete ramp will be removed and disposed of offsite. The concrete slab will be broken to allow for drainage of infiltrated stormwater. The ramp will be backfilled with site material and paved to drain away from the building.
