From: Jesse Alt-Winzig <JAltWinzig@cscos.com>
Sent: Wednesday, June 19, 2024 1:42 PM
To: Melnyk, Eugene W (DEC)
Cc: Daniel G. Keane; Nicole Kane; Caprio, Andrea (DEC)
Subject: RE: 1803 Elmwood Avenue BCP (C915394) - RI Progress and PCB Concrete Sampling
Attachments: Figure 1 - Proposed Slab Sampling.pdf; 1803 Elmwood Avenue BCP - Concrete Sampling Figure.pdf

Figure 1 | Proposed Concrete Sampling
1803 Elmwood Avenue BCP

FOCUSED PHASE II ENVIRONMENTAL SITE ASSESSMENT

1803 ELMWOOD AVENUE
BUFFALO, NEW YORK

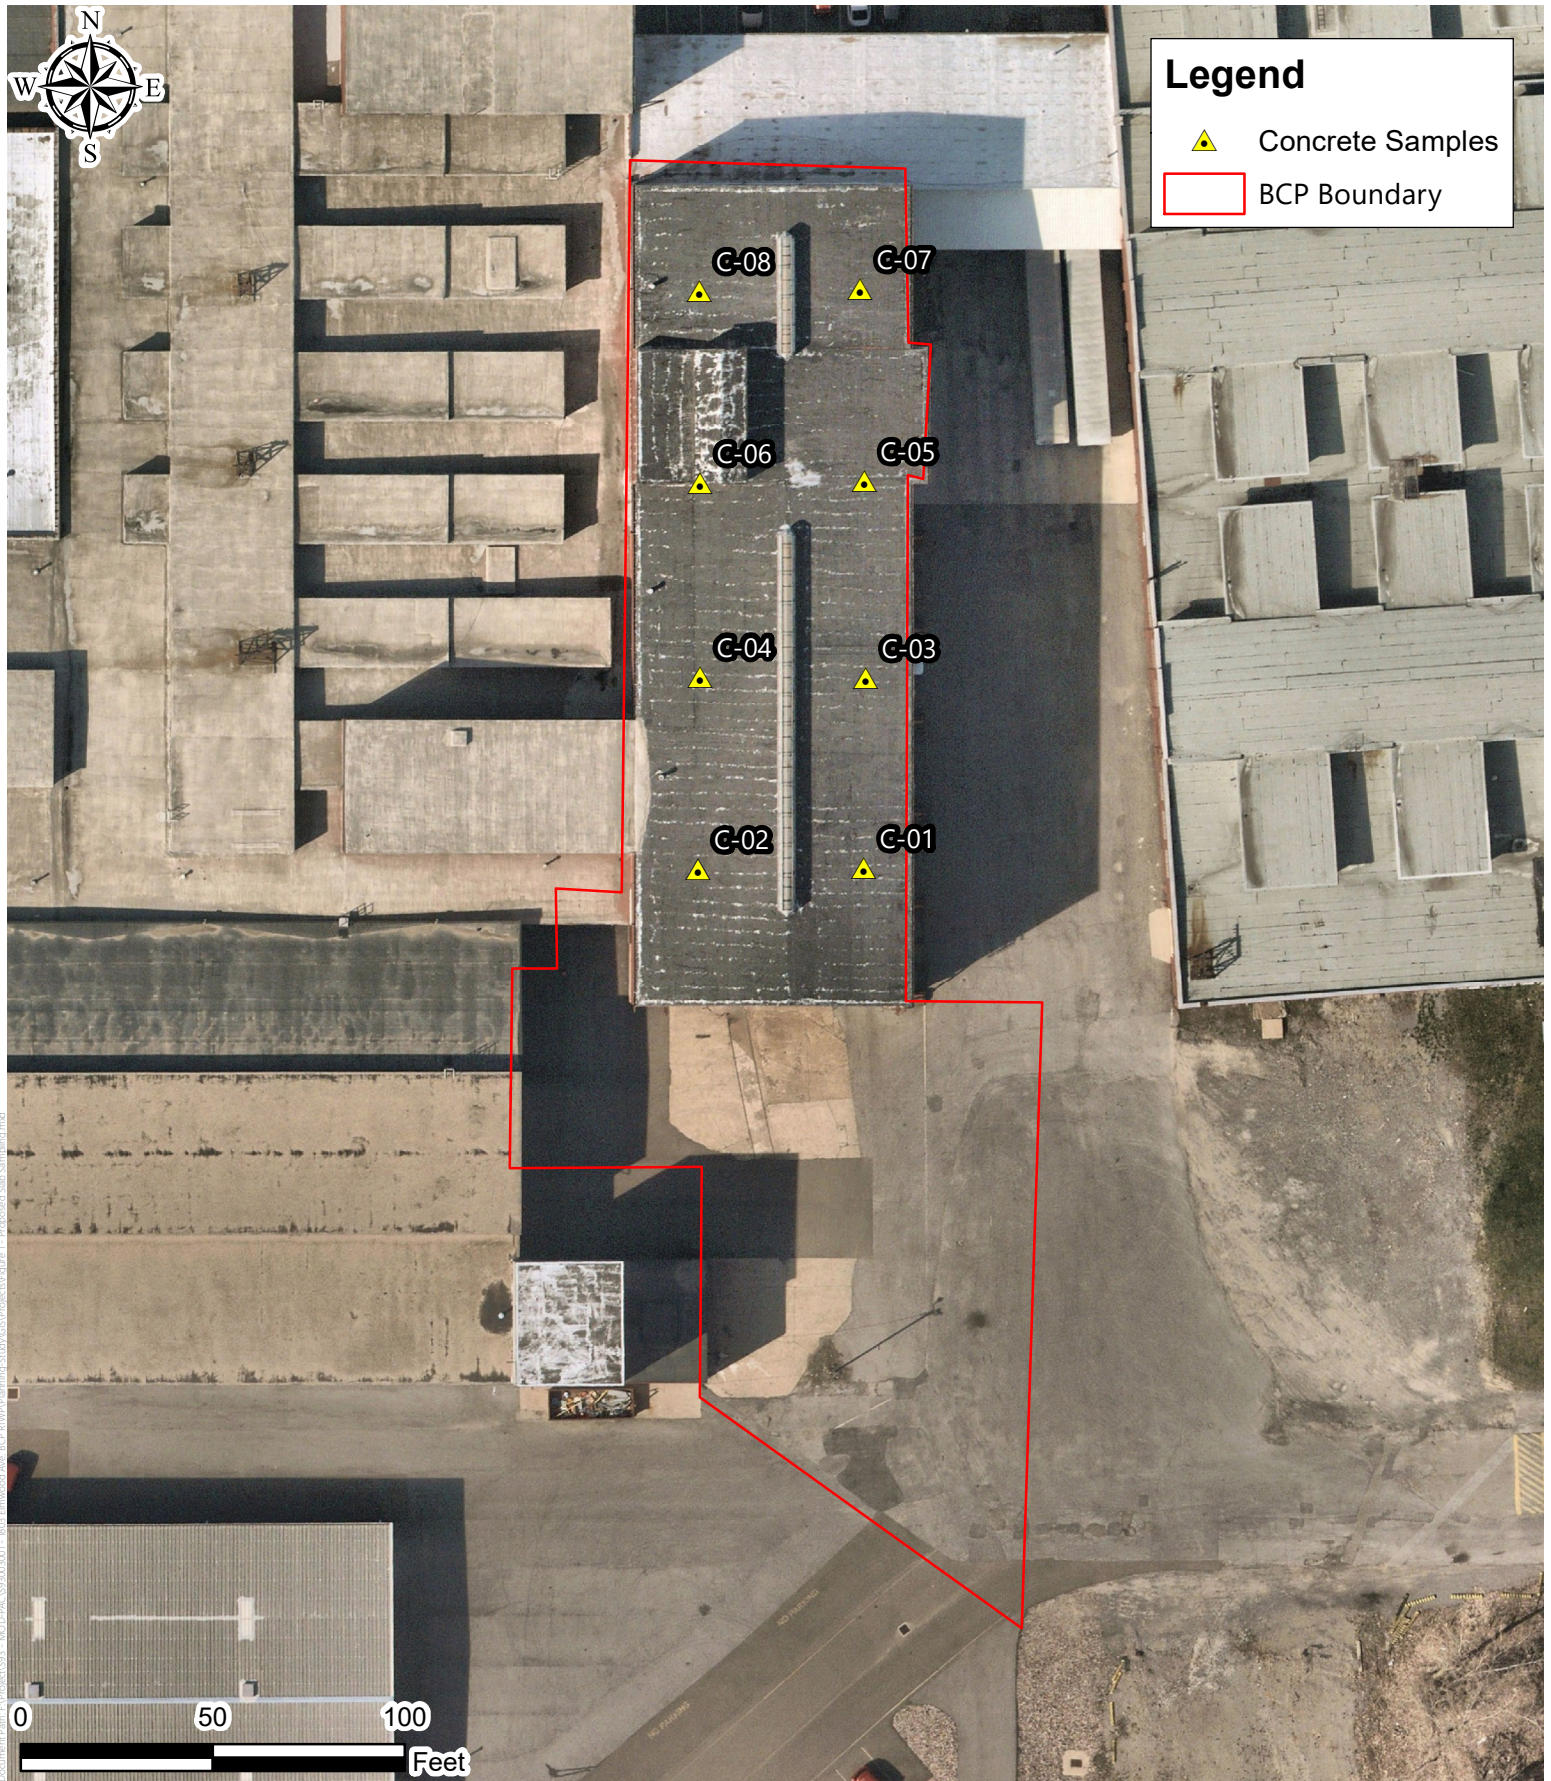
The Project Team intends to follow up with this by collecting eight (8) concrete samples from the warehouse slab in order to identify the presence of PCB contamination; and if it is discrete to one location, or throughout the entire slab. The work plan is described below.

C&S will collect eight samples of the concrete slab within the Site warehouse.

- The slab will be chipped in eight discrete locations using a hammer drill to an approximate depth of 2 centimeters below slab surface.
- Any drilling equipment that has the potential to come in contact with the sampled media will either be decontaminated prior to each use or will disposable, dedicated materials.
- C&S will place the samples for analysis in pre-cleaned bottles provided by the laboratory with a decontaminated stainless-steel spoon or by gloved hand.
- C&S will submit eight samples under standard chain-of-custody procedures for laboratory analyses using United States Environmental Protection Agency (USEPA) methods.
- QA/QC samples will include one field duplicate and one MS/MSD sample.
- The sample will be analyzed for 6 NYCRR Part 375 PCBs per EPA method 8082 with detection level of 100 parts per billion (ppb).

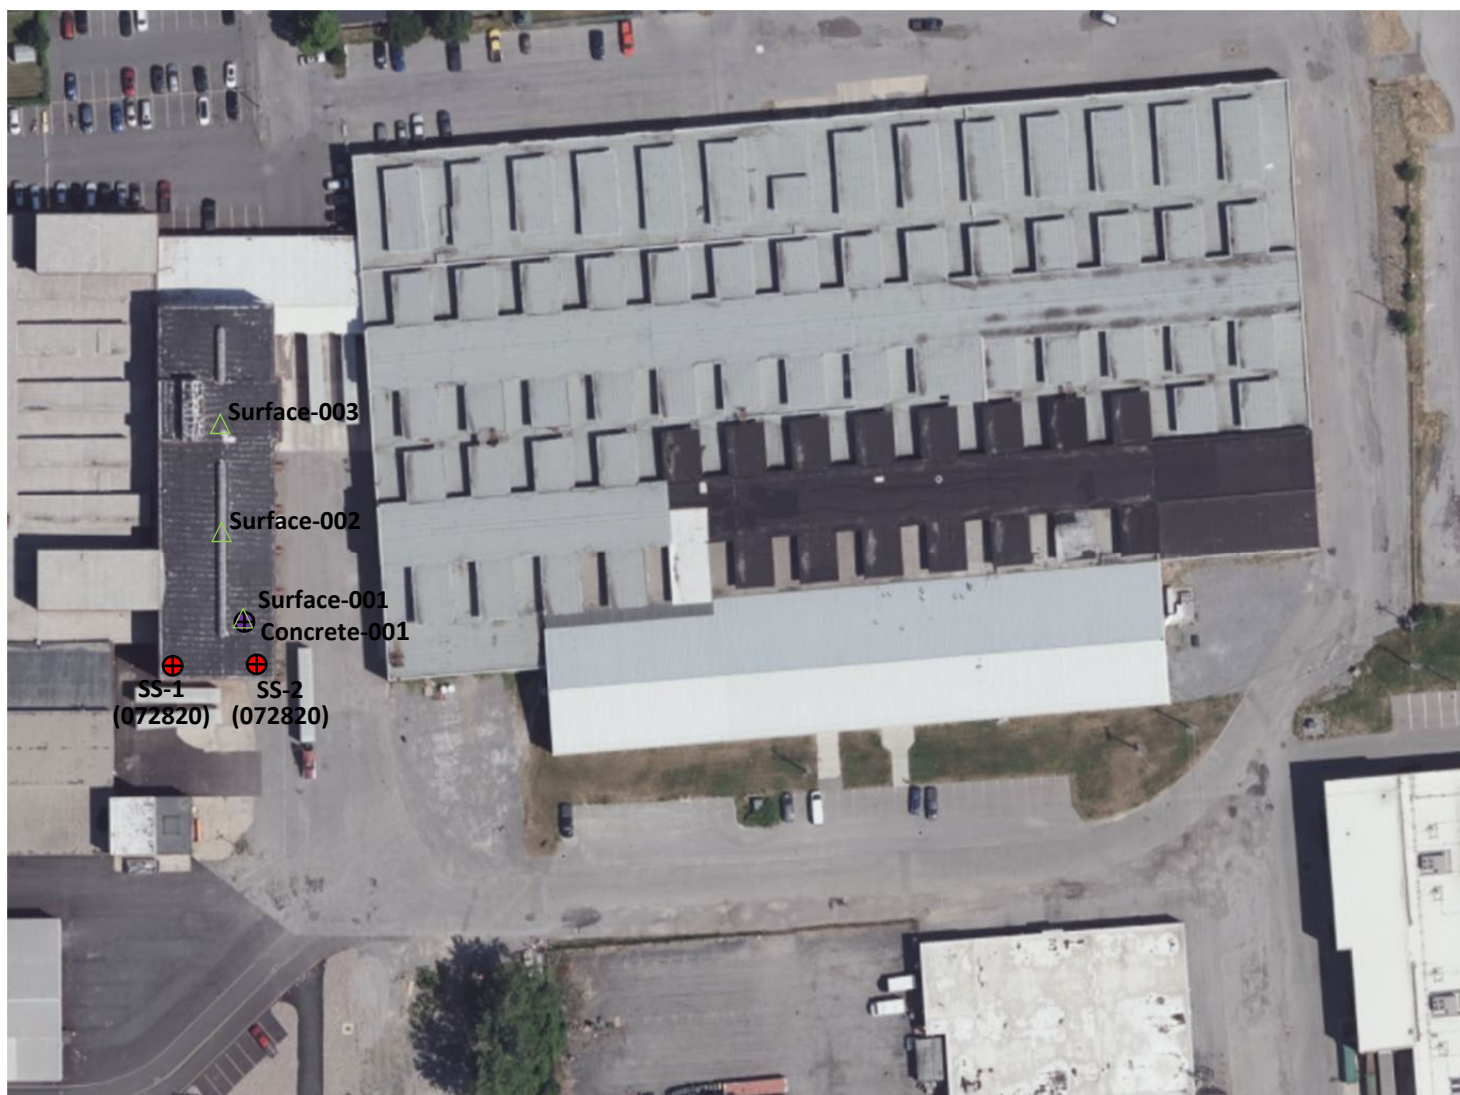
FIGURE NO: 3

After some discussions with the project team, we were able to locate documentation regarding PCB sampling that has already occurred. Three oily residue samples on the concrete slab were collected and analyzed for PCBs with DEXSIL Clor-N-Soil BCP Screening Kits. The results are reported in Section 3.2 (pg. 6 of report, pg. 9 of PDF) and locations shown on figure 3 (pg. 82 of the PDF). I have attached Figure 3 separately for your records. The PCB results are also summarized below:

- Surface-001: >50 ppm
- Surface-002: ~35 ppm
- Surface-003: ~40 ppm

As reported in Section 3.2 of the report, the concrete floor was scraped clean at location Surface-001. One concrete sample (Concrete-001) was then collected in the location of Surface-001. The analytical results identified three (3) PCB Aroclors at concentrations above method detection limits in the one (1) concrete sample

collected. Total PCBs were 1.75 ppm in concrete sample Concrete-001 which is in exceedance of the CUSCO. The Alpha Report (L2031763) is included on page 167 of the PDF.
