February 4, 2025

Re: Nassau Metals, OU-2
Voluntary Cleanup Program Site No. V00159
Corrective Actions Work Plan Addendum, **ASR Project #A22-115**

158 Page Avenue Work to be Performed

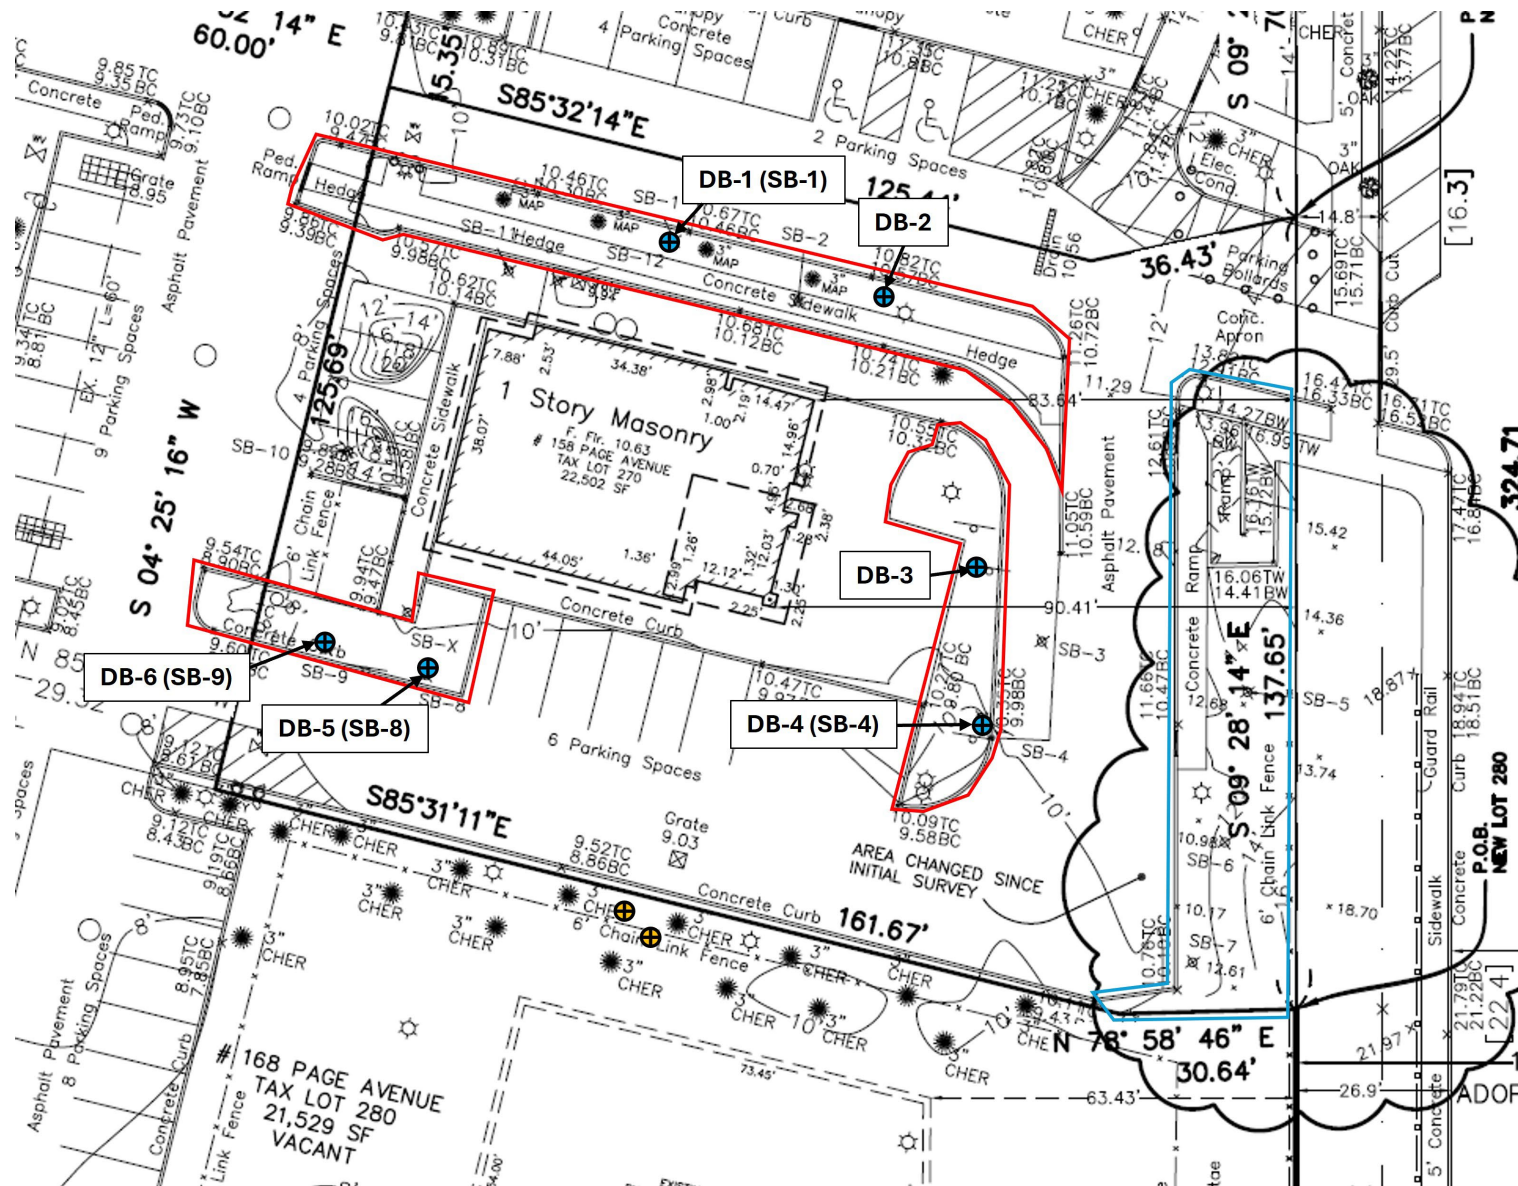
FIGURE 1.0

The subsurface investigation identified elevated levels of heavy metals, specifically copper and lead, within the topsoil and mulch composite samples collected from 158 Page Avenue. The topsoil and mulch were reportedly imported to the Site by Mammoth, Inc., around November 2022. To delineate this condition, **ASR** proposes to conduct six (6) delineation borings (designated DB-1 through DB-6) as shown in Figure 1, with two (2) borings advanced per approximately 500-square foot area of landscaping. The proposed soil borings will allow for discrete soil samples to be collected in each of the previously composited locations (e.g., DB-1 performed at historical SB-1 location), effectively determining what fractions of the composite sample contributed to the documented contamination.

The subsurface investigation determined that the geosynthetic composite layer (“GCL”) capping system east of 158 Page Avenue had been damaged during construction activities. Based on publicly available satellite imagery, this area was disturbed in 2015 during construction of a pedestrian ramp and driveway, and again visibly disturbed in July 2022 during renovations to the building at 158 Page Avenue.

To further investigate this issue, **ASR** proposes to hand excavate the area to determine the lateral extent of the missing GCL; test pits will be hand dug throughout the blue highlighted area on Figure 1 at 10-foot intervals in north/south and east/west cardinal directions. The GCL will be considered “damaged” if the demarcation barrier is not covered by at least 12-inches of material as specified in Appendix I of the Remedial Completion Report for the Site. The corresponding GCL design detail has been appended to this work plan as Attachment 1.

After the extent of the damaged GCL has been delineated, a new GCL cap with a minimum 1-foot thickness will be installed above the existing ground surface. An appropriately designed retaining wall may need to be installed to support the proposed remedy. Any imported material will be sampled as required by the SMP and the NYSDEC notified in advance of any import as required by the SMP.

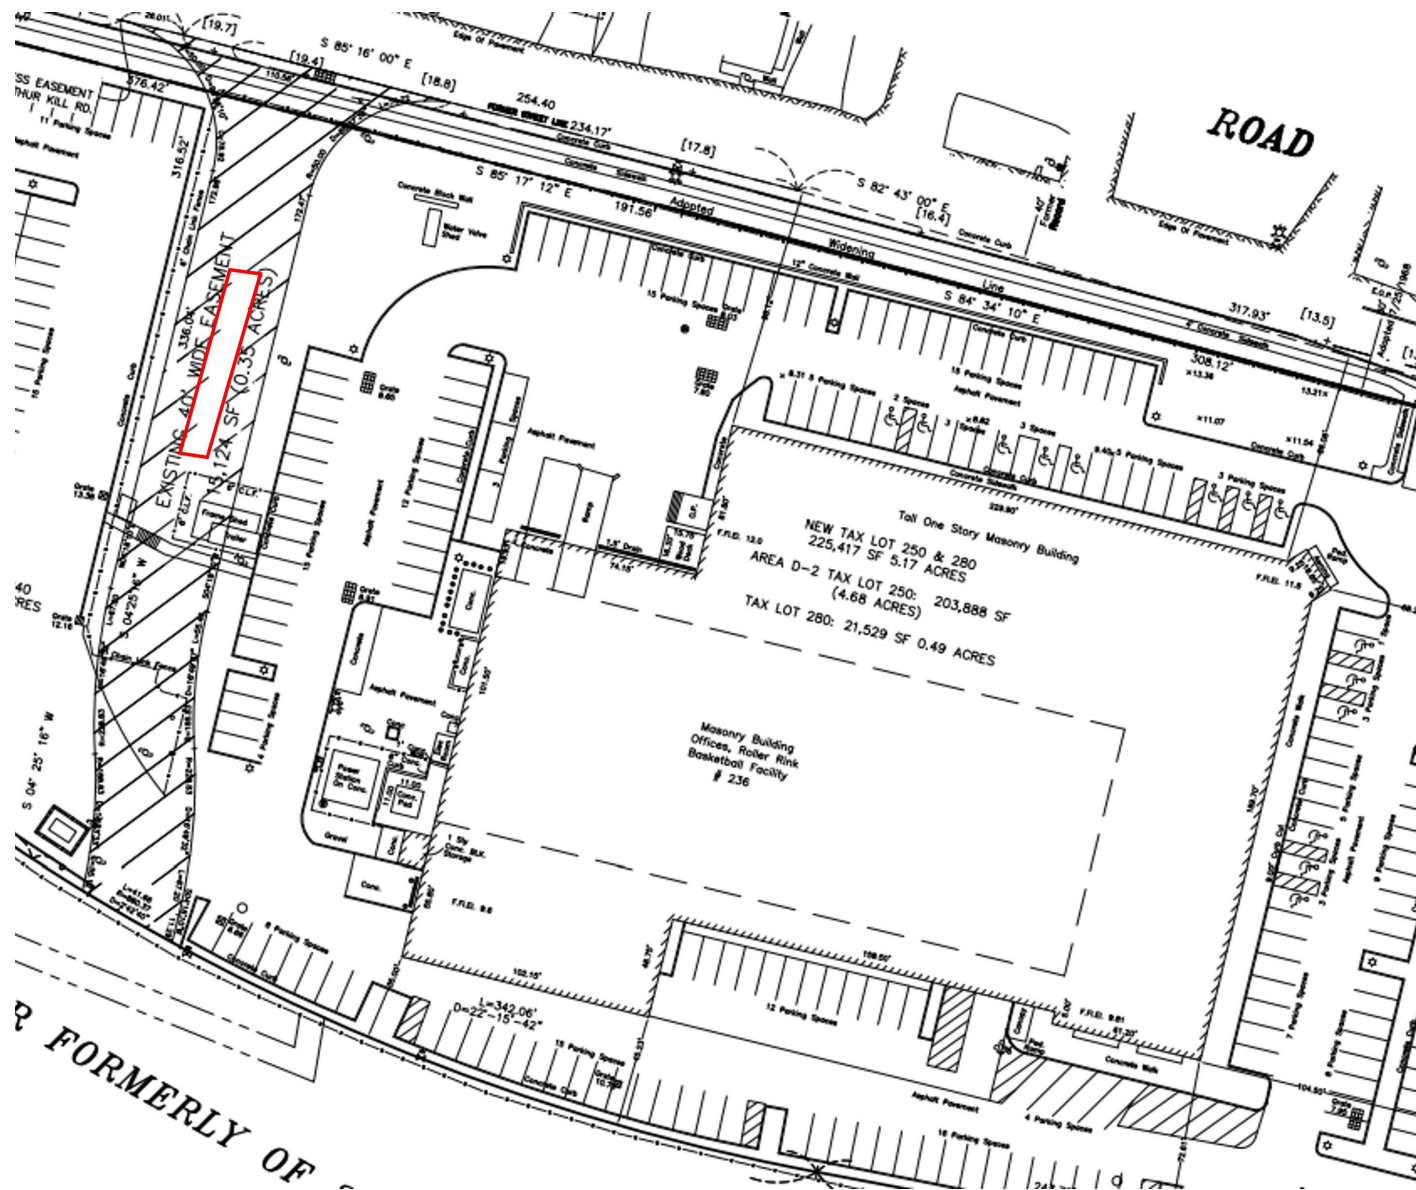
FIGURE 3.0

During implementation of the Corrective Actions Work Plan, it was noted that construction and demolition (“C&D”) debris had been illegally dumped west of the building at 236 Richmond Valley Road over an indeterminate period of time. *ASR* will sample this material for waste characterization parameters and arrange for disposal at an appropriate facility. The area of dumped material is shown in Figure 3.
