**Re: Corrective Measures Plan, November 6, 2020
711 North Road (Cooper Vision), Scottsville
Monroe County, Site No.: V00175**

Subject: Corrective Measures Plan
CooperVision Facility Site #V00175-8
711 North Street
Scottsville, New York

SSDS PLAN

FIGURE 2

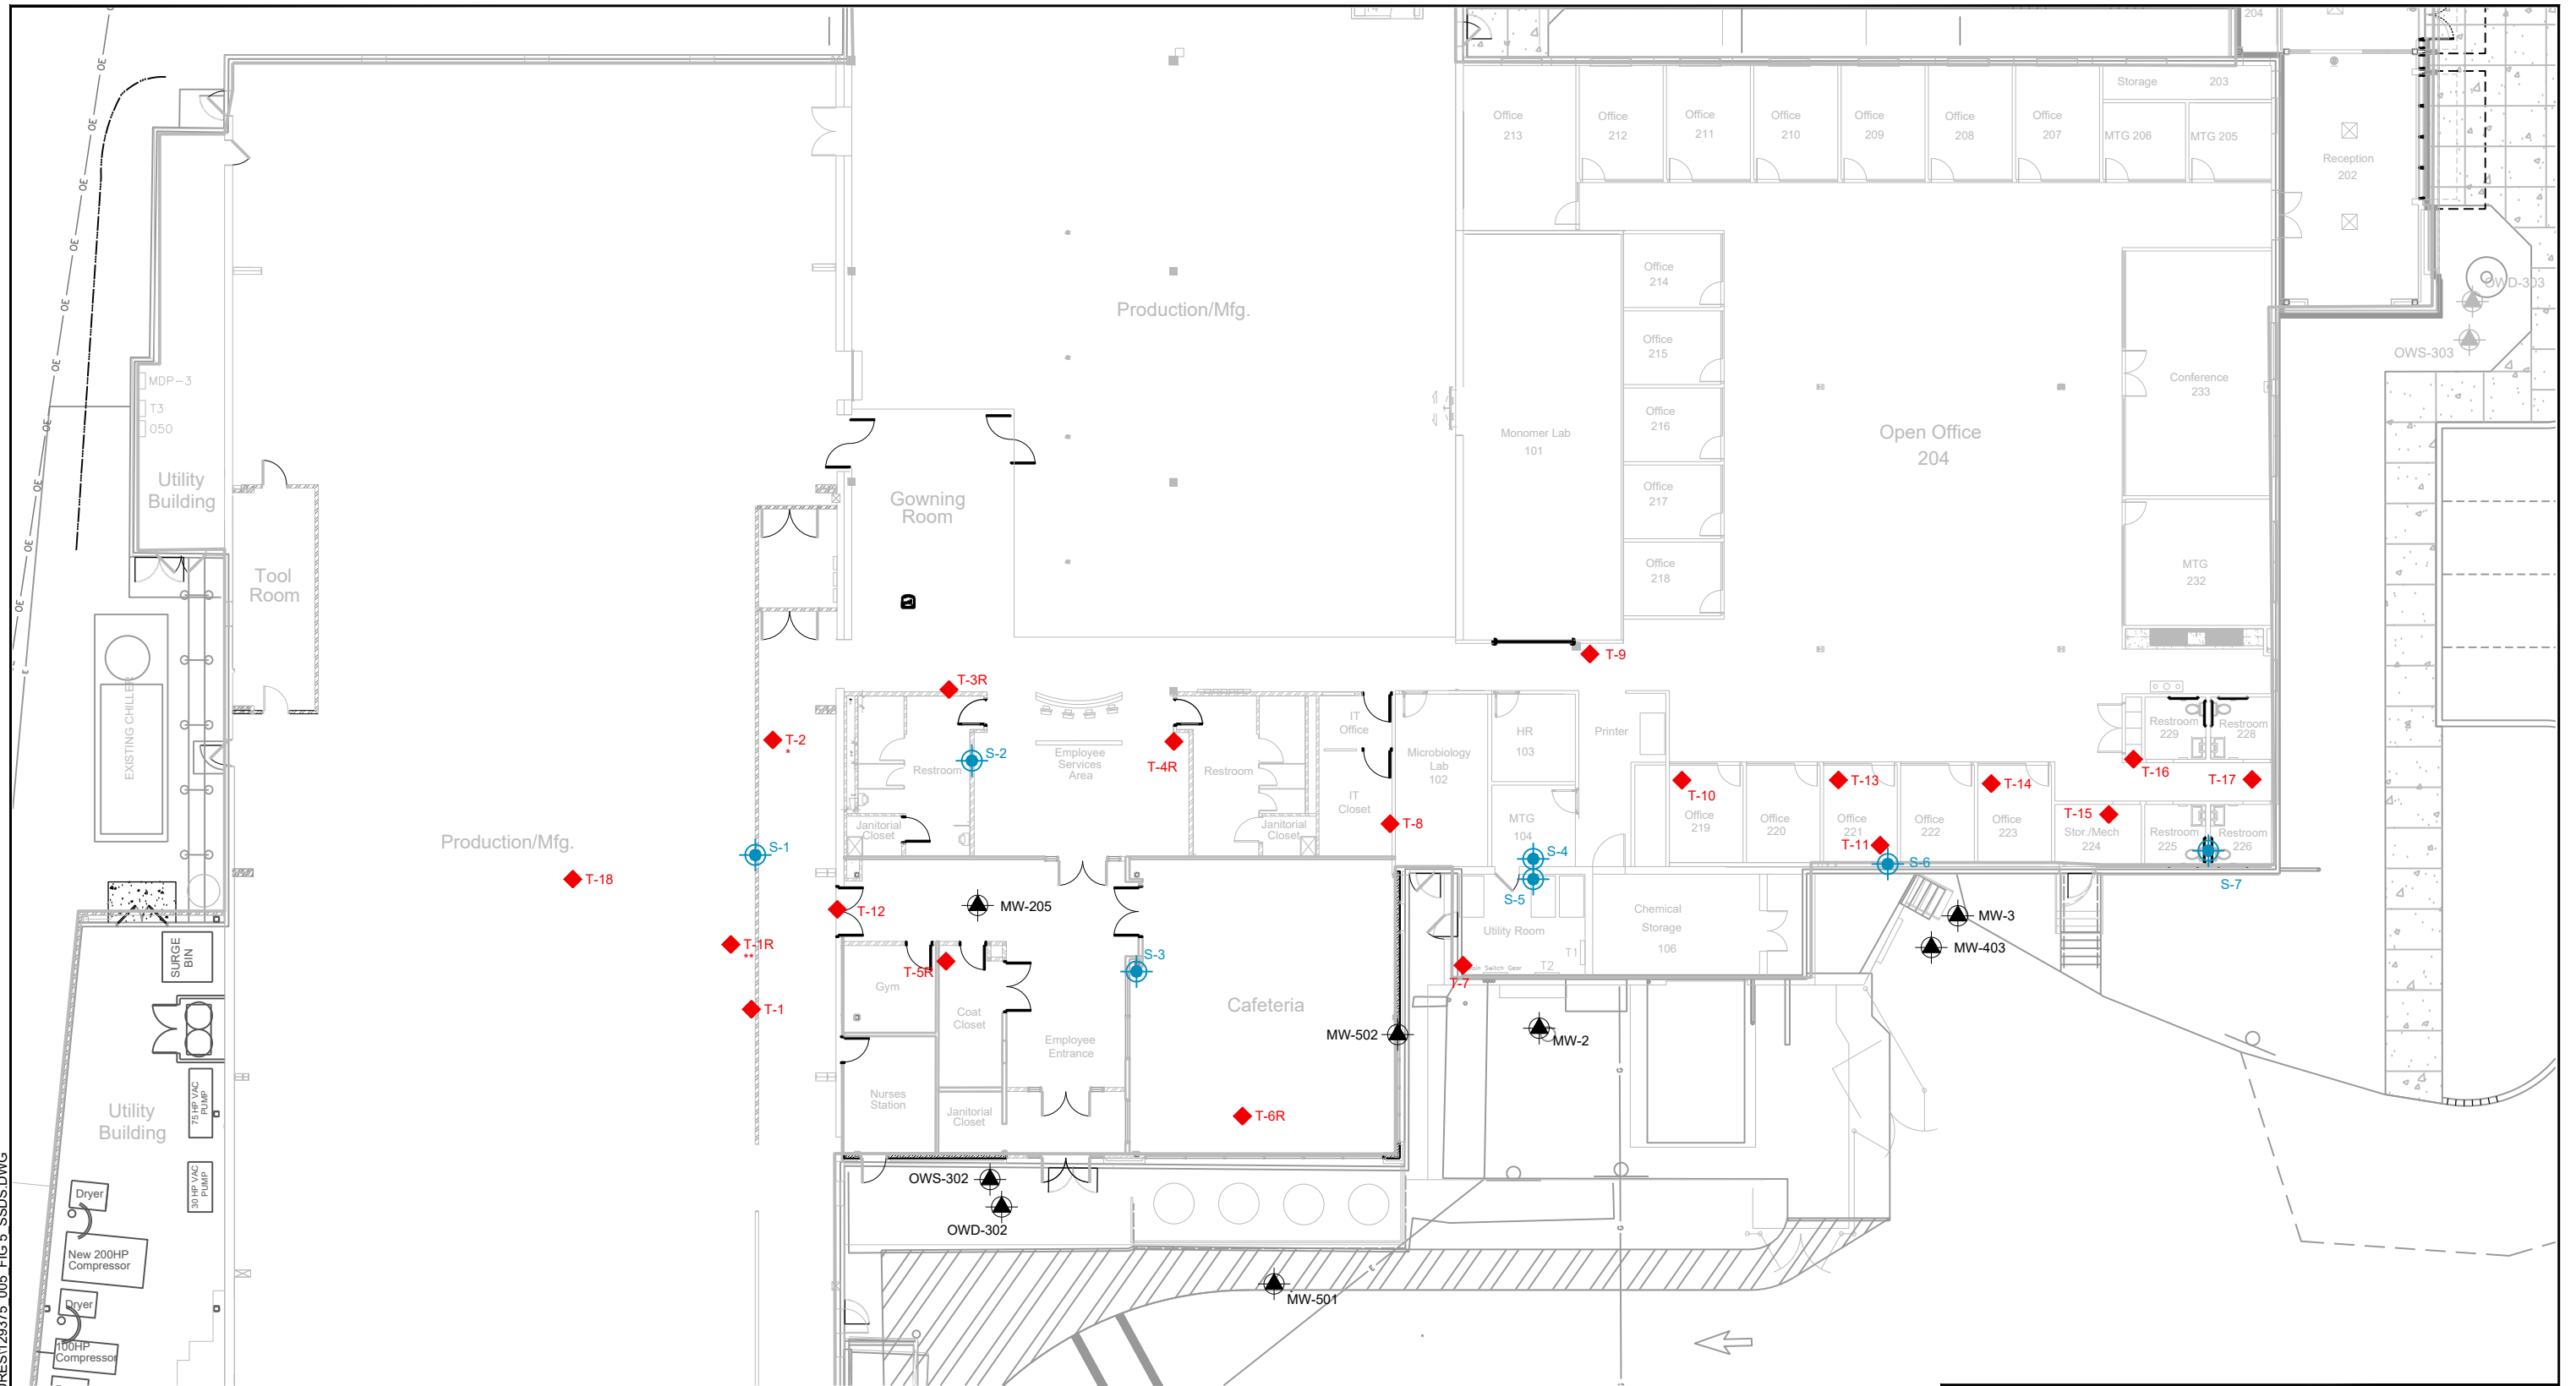
Response: Haley & Aldrich subcontracted Mitigation Tech to evaluate the sub-slab depressurization system at Suction Pit 1 on 22 September 2020. Please refer to Figure 2. Mitigation Tech inspected the suction pit and found that the integrity of the floor penetration had been compromised. Mitigation Tech increased the suction pit cavity volume and improved the seal between the pipe and the floor slab for optimal system performance. The existing Radonaway GP-501 fan was removed and replaced with a Radonaway HS-5000 unit to increase vacuum at the suction pit. Following these improvements, vacuum at test points T-1, T-12 and T-18 improved and were above the design criteria of 0.002 inches of water column. See Table 1 for updated Vacuum readings.

- GENERAL NOTES**
- T-2 IS NOT A VALID TEST POINT
 - T-1R IS A TEMPORARY LOCATION FOR DIAGNOSTIC INSPECTION PURPOSES. IT WILL BE DECOMMISSIONED AT A LATER TIME

Suction Pit S-1 had an HS-5000 fan installed.
