Re: Richter Metalcraft VCA Site # V-00327-3 2022 Annual Site Certification Letter Village of Wallkill, Ulster County, New York LaBella Project No. 2224549

On behalf of Richter Metalcraft, LaBella Associates, DPC (LaBella) is pleased to submit this annual certification letter report describing the condition of two engineering controls established as part of the cleanup remedy. This letter report has been prepared as required by Section 3 of the *Site Management Plan* (SMP) dated March 2007.

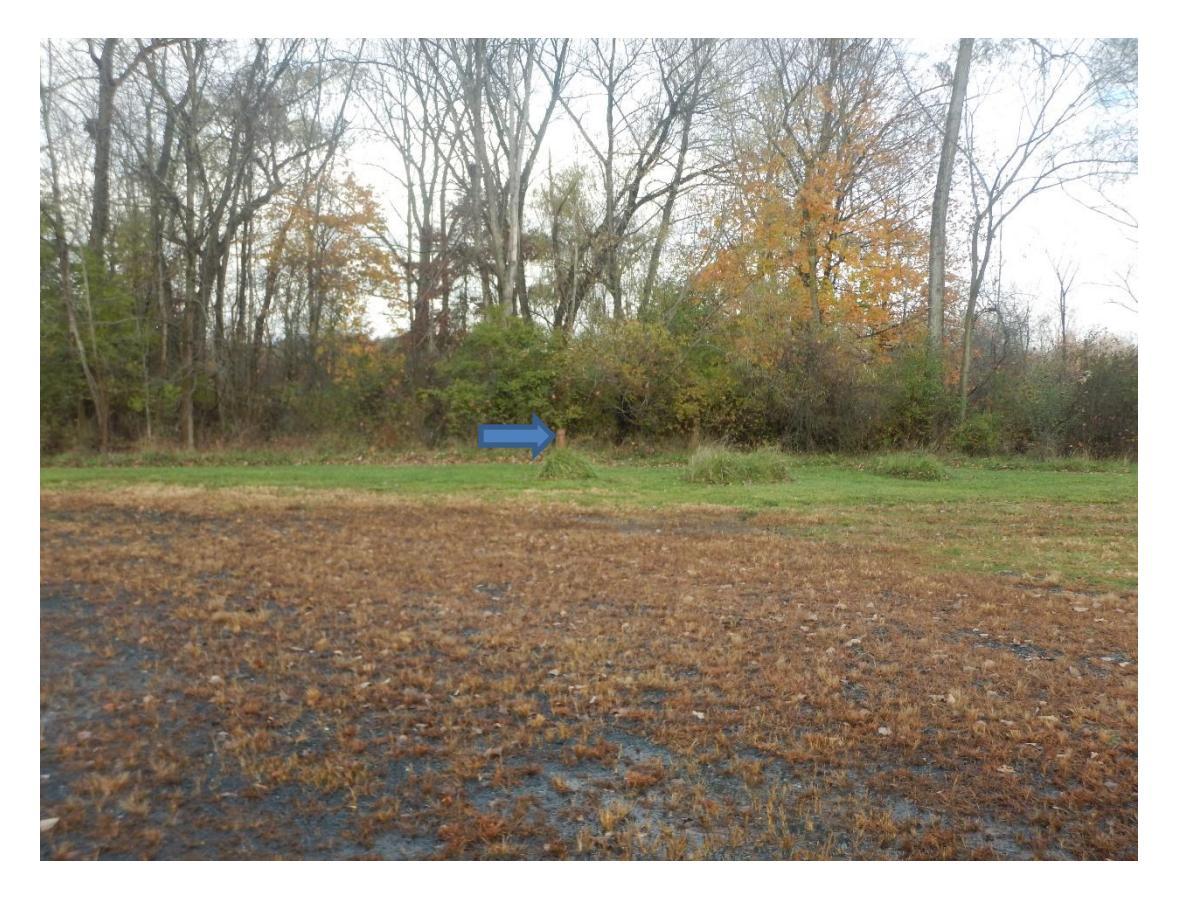
Photo 1: Taken November 1, 2022. AOC-1 Monitoring Well MW-5 (blue arrow): No observed issues.

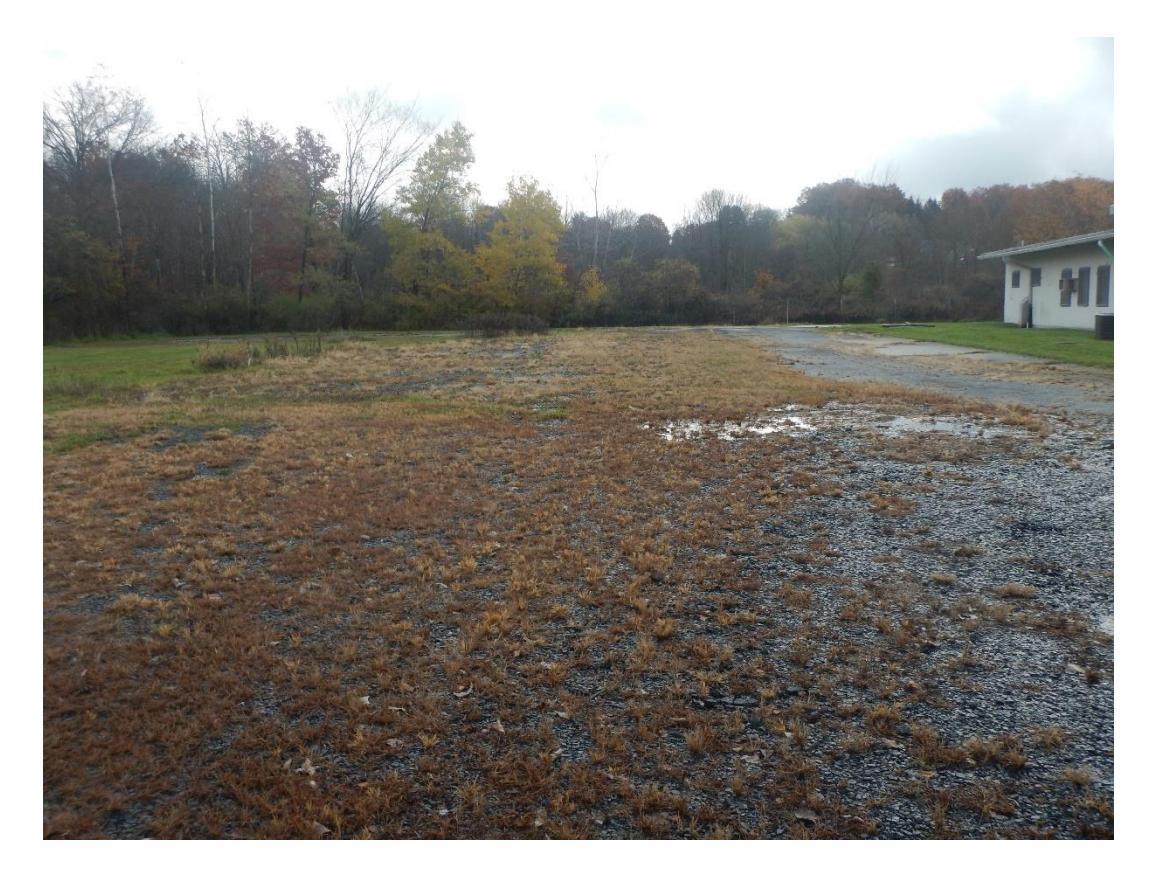
Photo 2: Taken November 1, 2020. AOC-2: No observed issues.

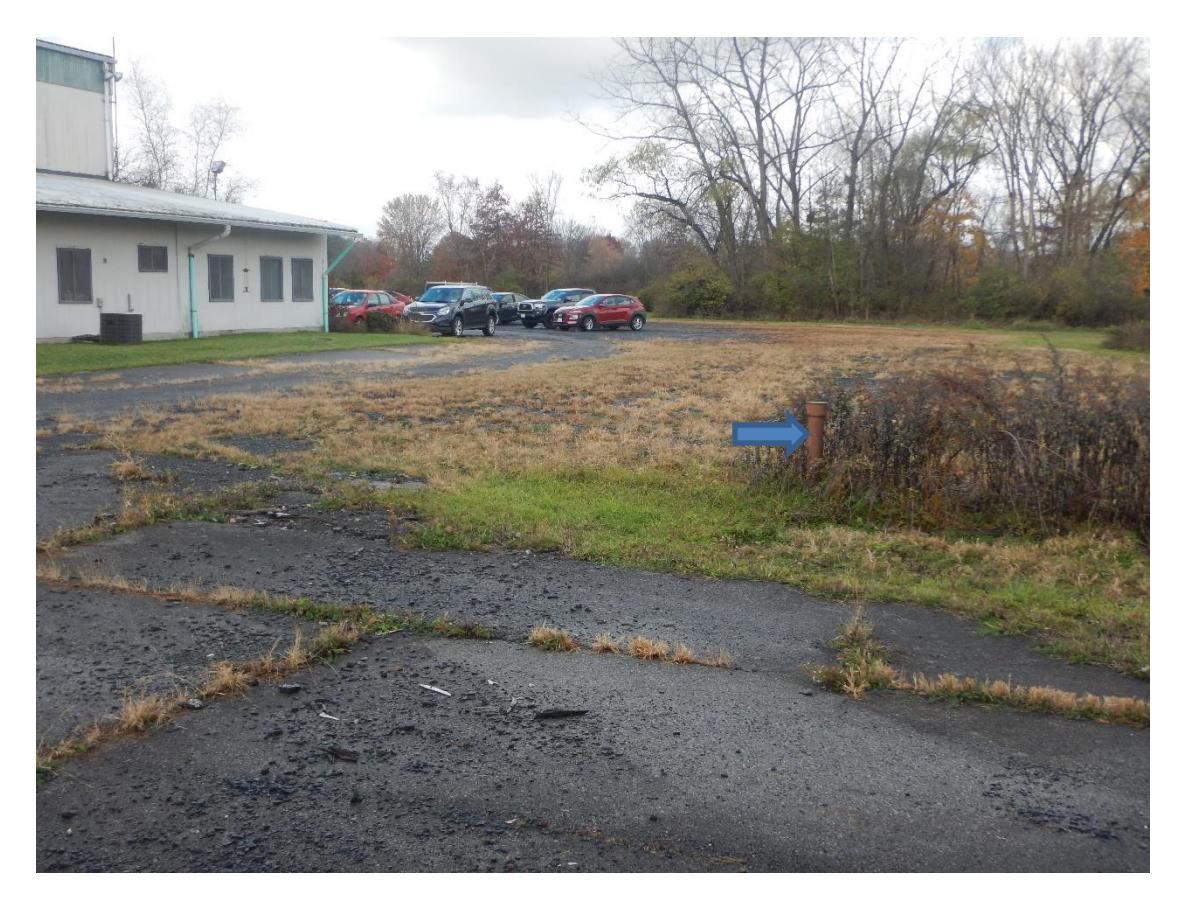
Photo 3: Taken November 1, 2022. AOC-2 Monitoring Well MW-6 (blue arrow): No observed issues.

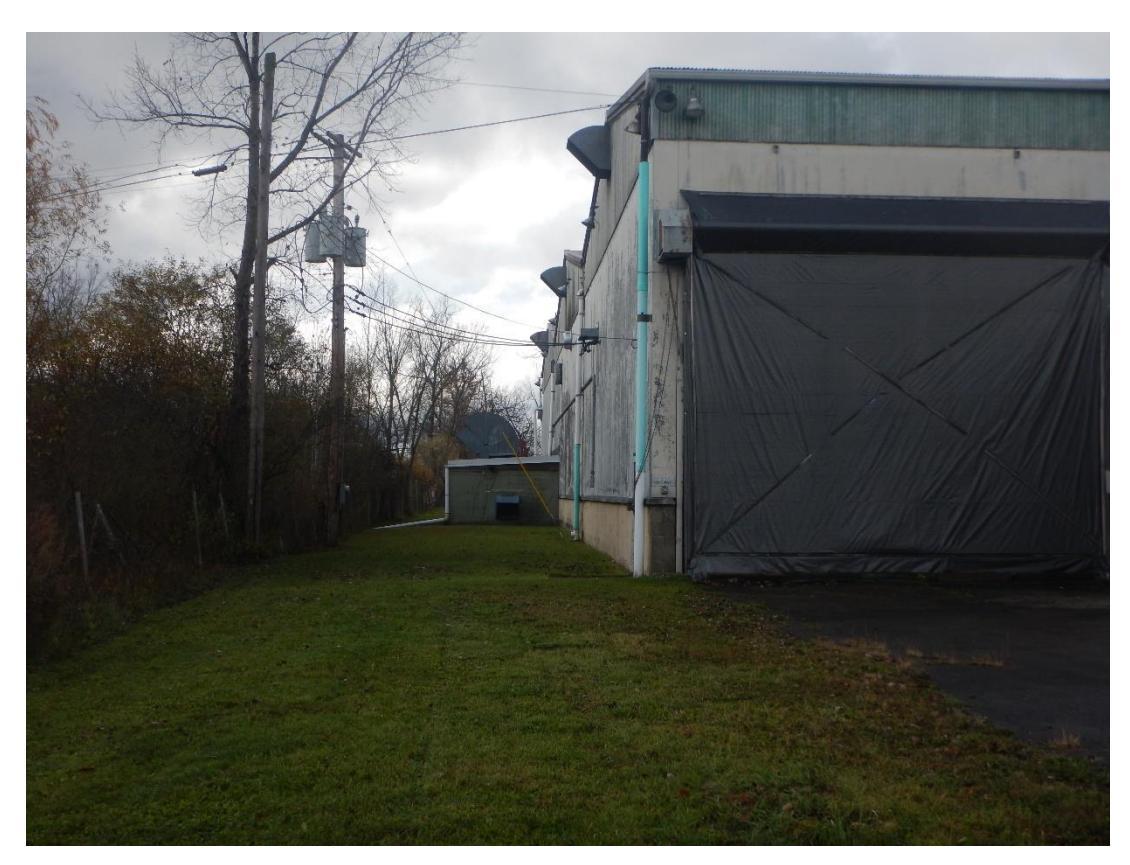
Photo 4: Taken November 1, 2022. AOC-3: No observed issues.

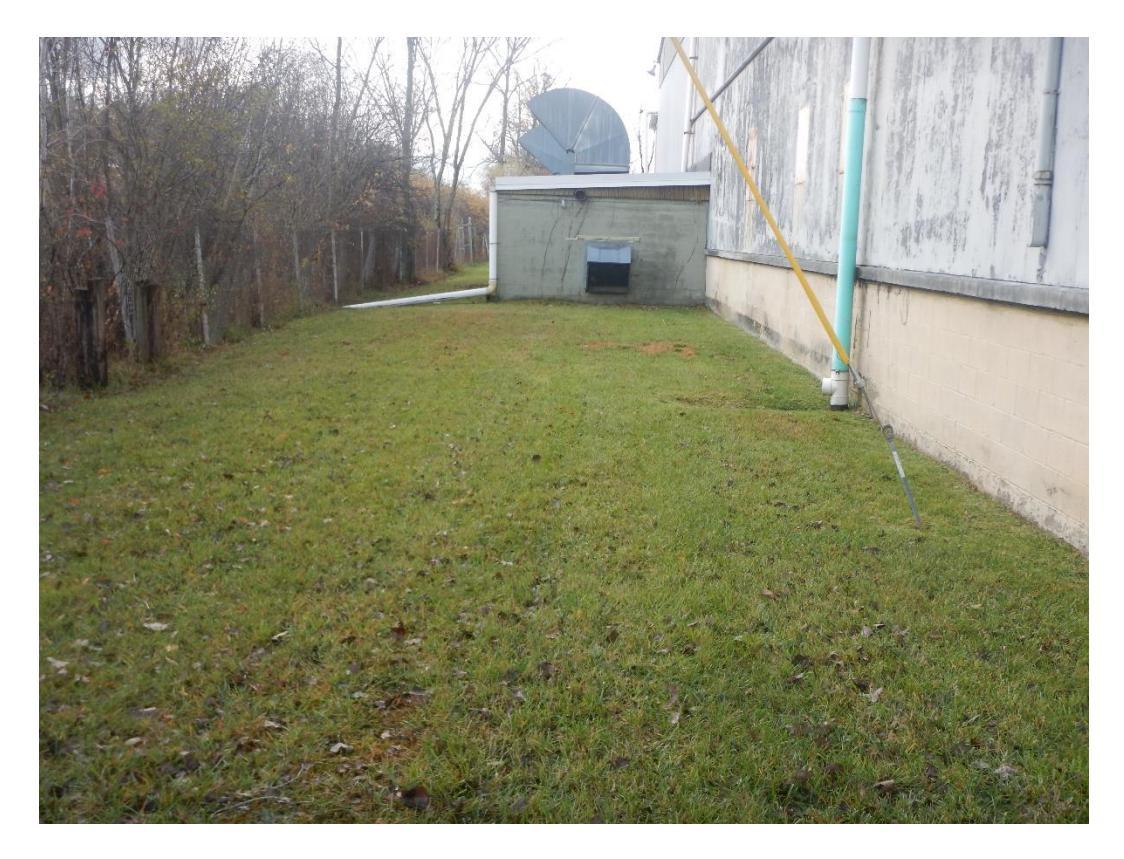
Photo 5: Taken November 1, 2022. AOC-3: No observed issues.

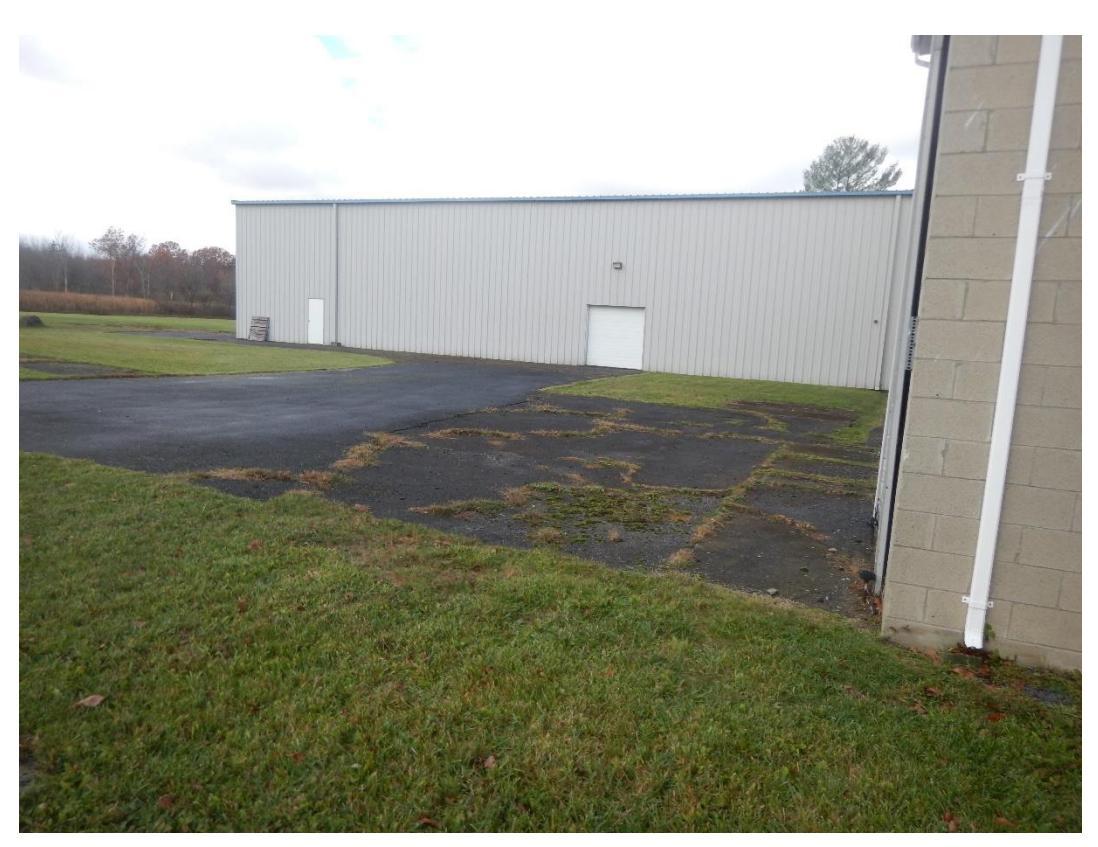
Photo 6: Taken November 1, 2022. AOC-4 and AOC-5: No observed issues.

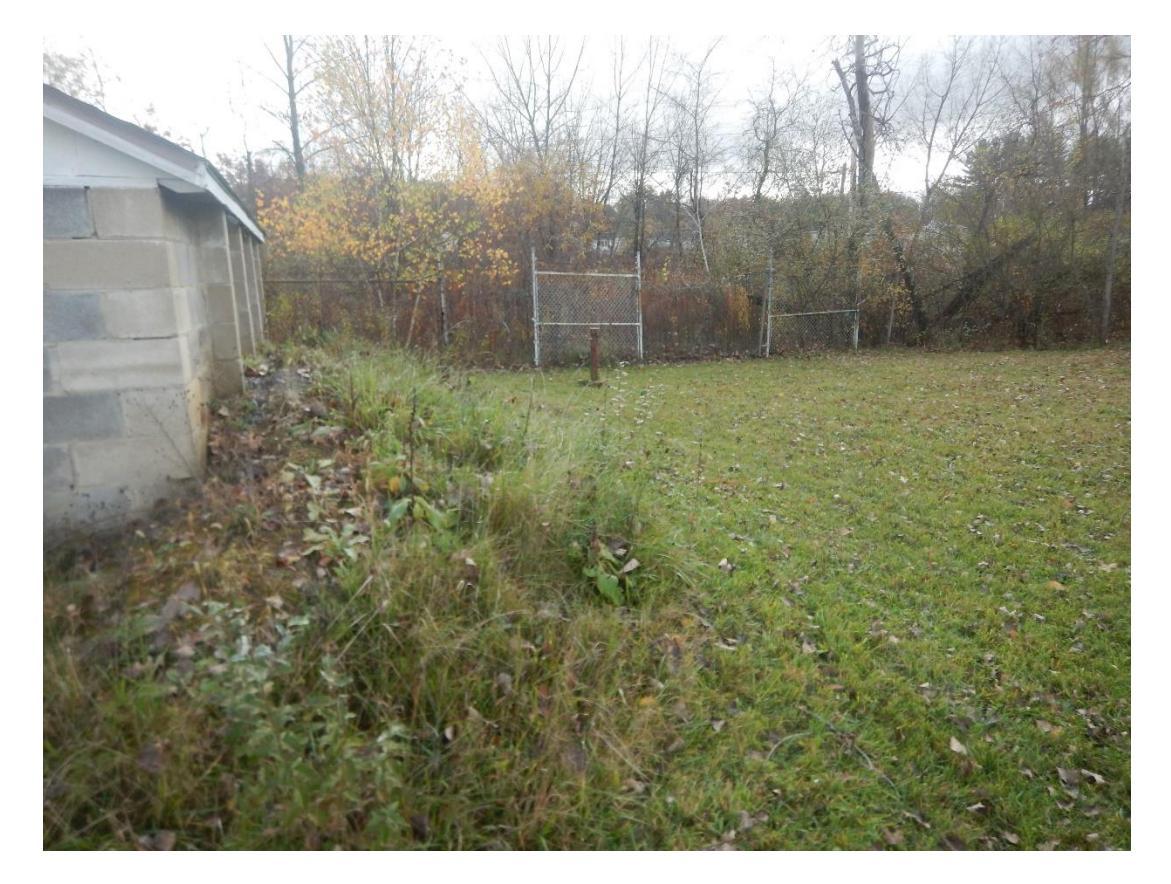
Photo 7: Taken November 1, 2022. AOC-4 and AOC-5 Monitoring Well MW-1: No observed issues.

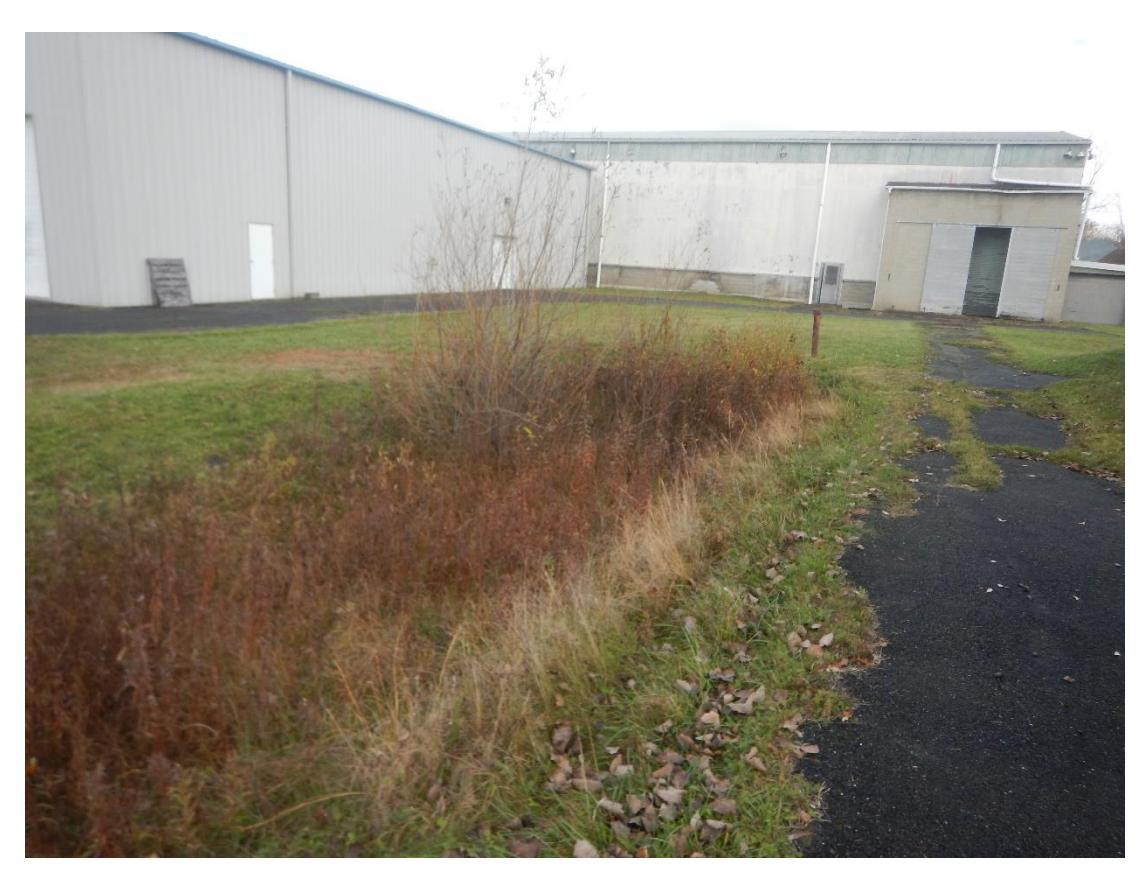
Photo 8: Taken November 1, 2022. AOC-4 and AOC-5 Monitoring Well MW-2: No observed issues.

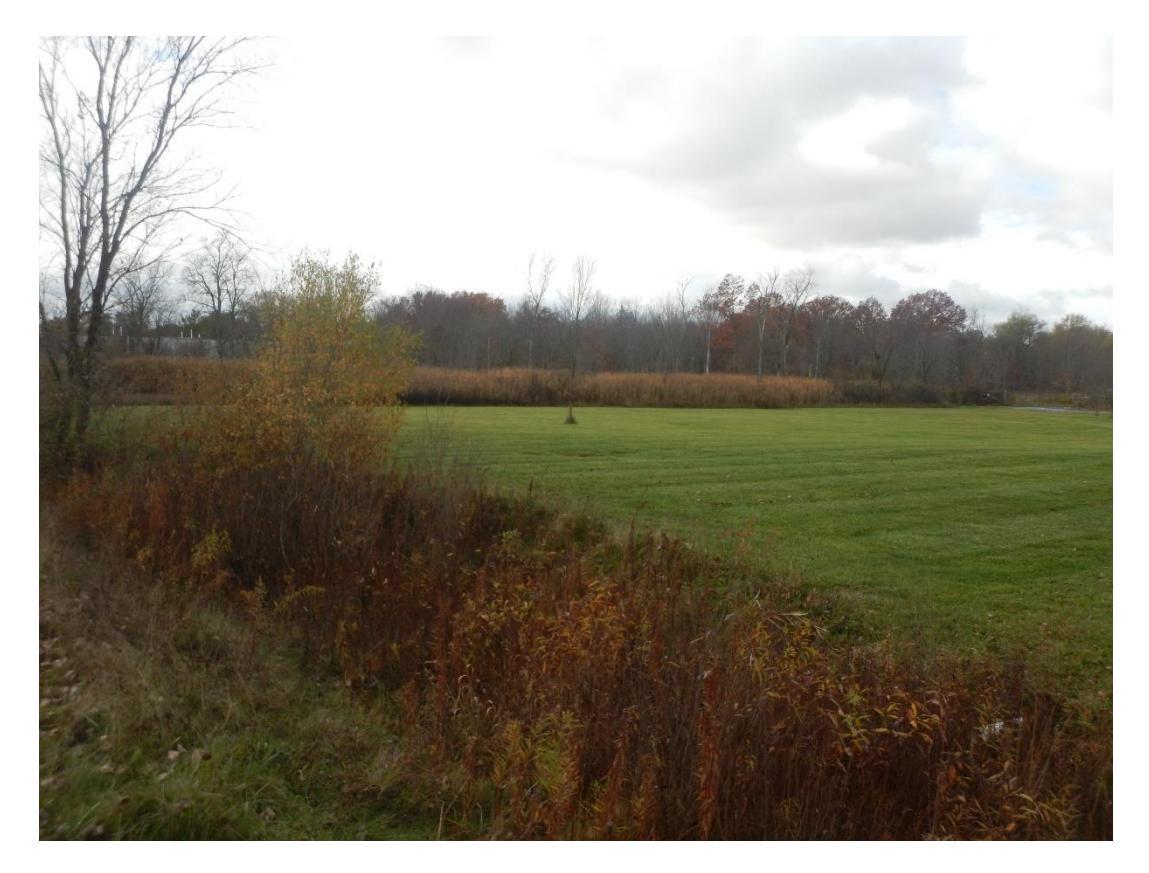
Photo 9: Taken November 1, 2022. AOC-5 and Monitoring Well MW-3 (middle of frame): No observed issues.

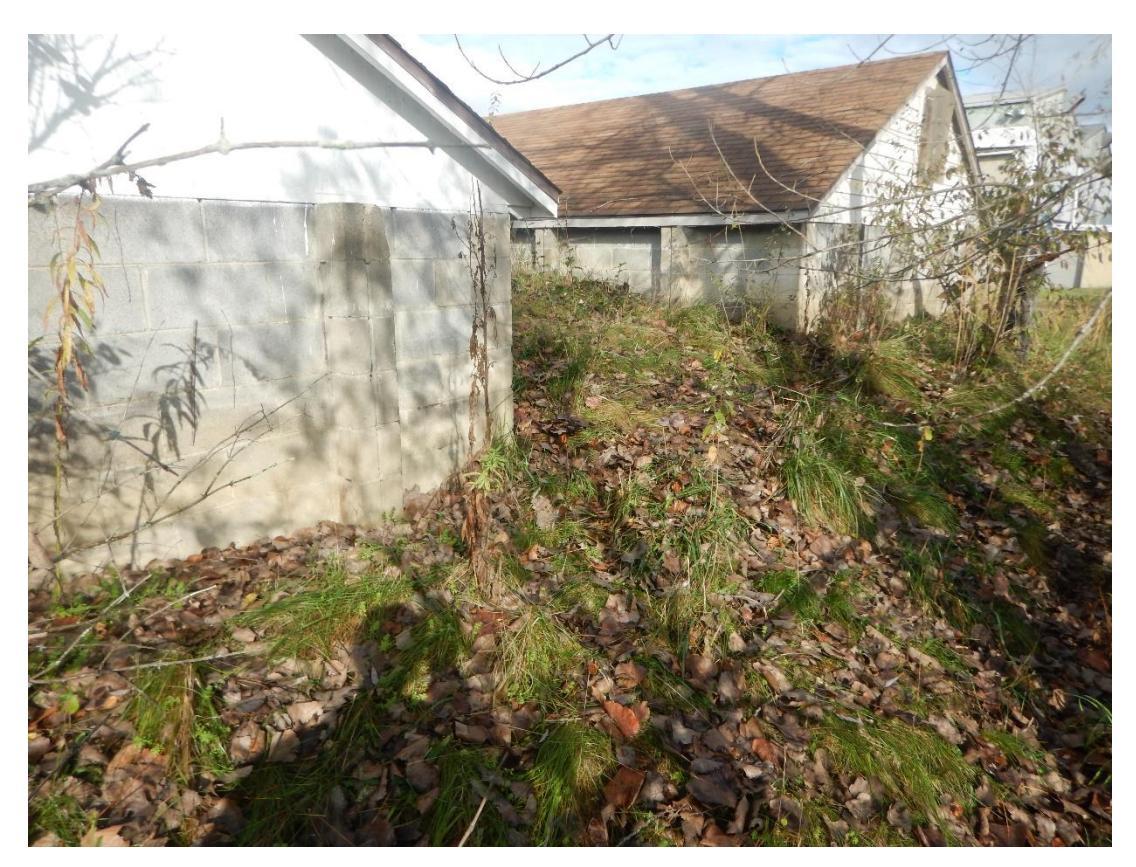
LaBella noted areas which had been recently regraded and sodded within AOC-4. RM management indicated that burrows had been noted in this area which they had repaired by replacing displaced soil into the burrows, compacting affected areas, and installing fresh sod at grade. The repairs appeared satisfactory to LaBella.

Photo 10: Taken November 1, 2022. AOC-4: Conditions generally acceptable. Shallow rodent burrows present along building edge (patched by RM management prior to LaBella inspection).

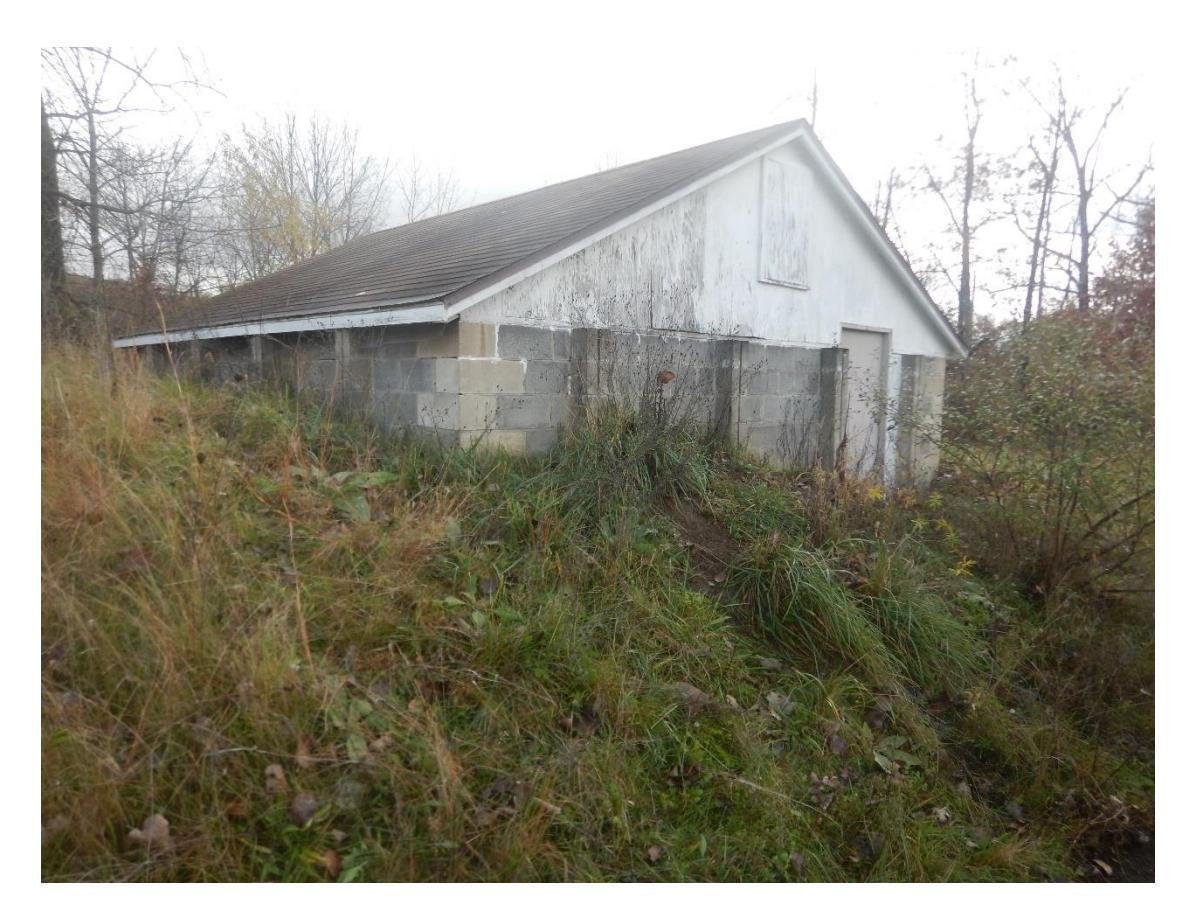
Photo 11: Taken November 1, 2022. AOC-4: Following burrow repairs, no other observed issues.

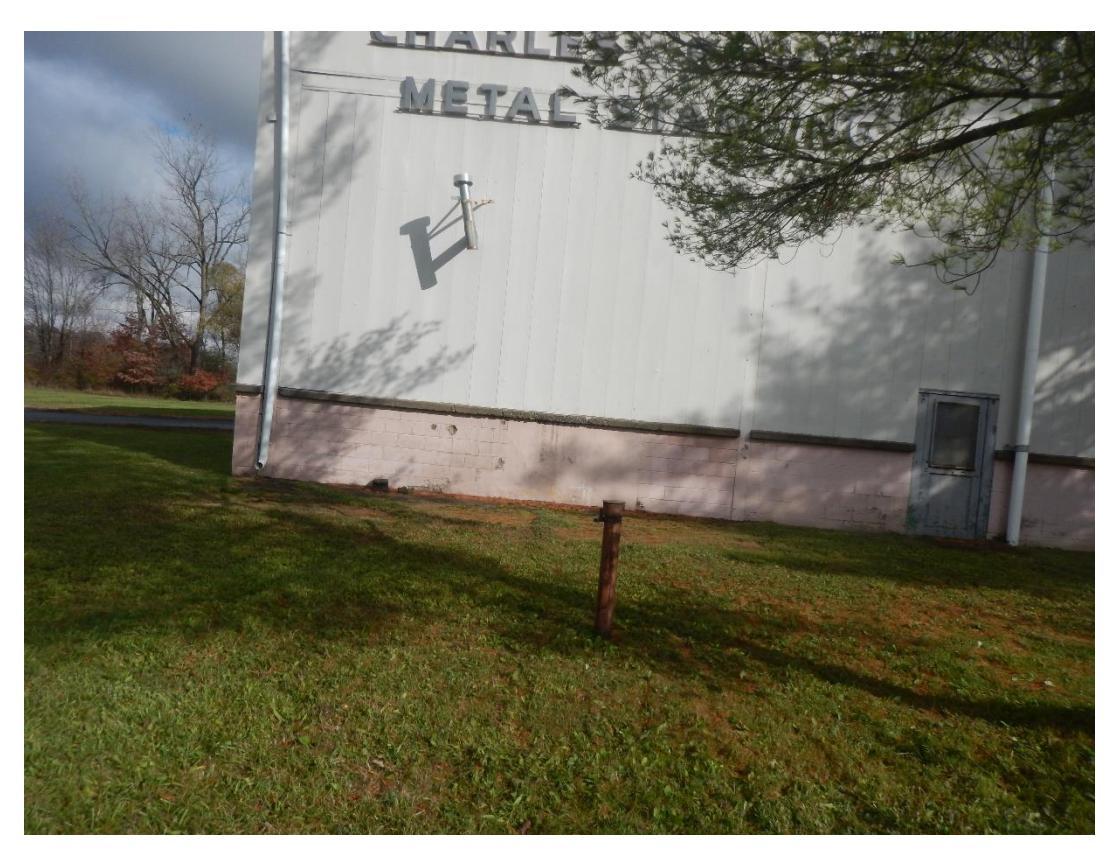
Photo 12: Taken November 1, 2022. Monitoring Well MW-4: No observed issues.

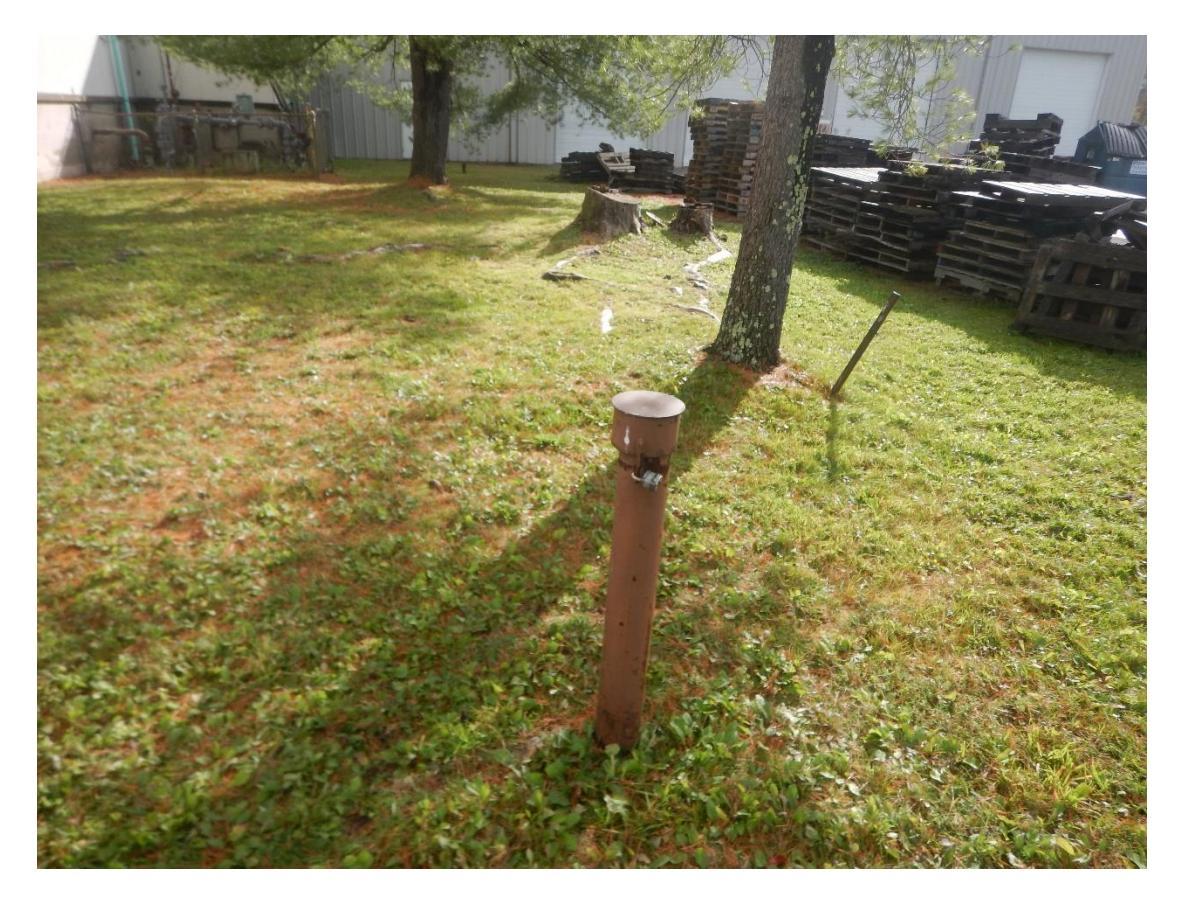
Photo 13: Taken November 1, 2022. Monitoring Well MW-4: No observed issues.

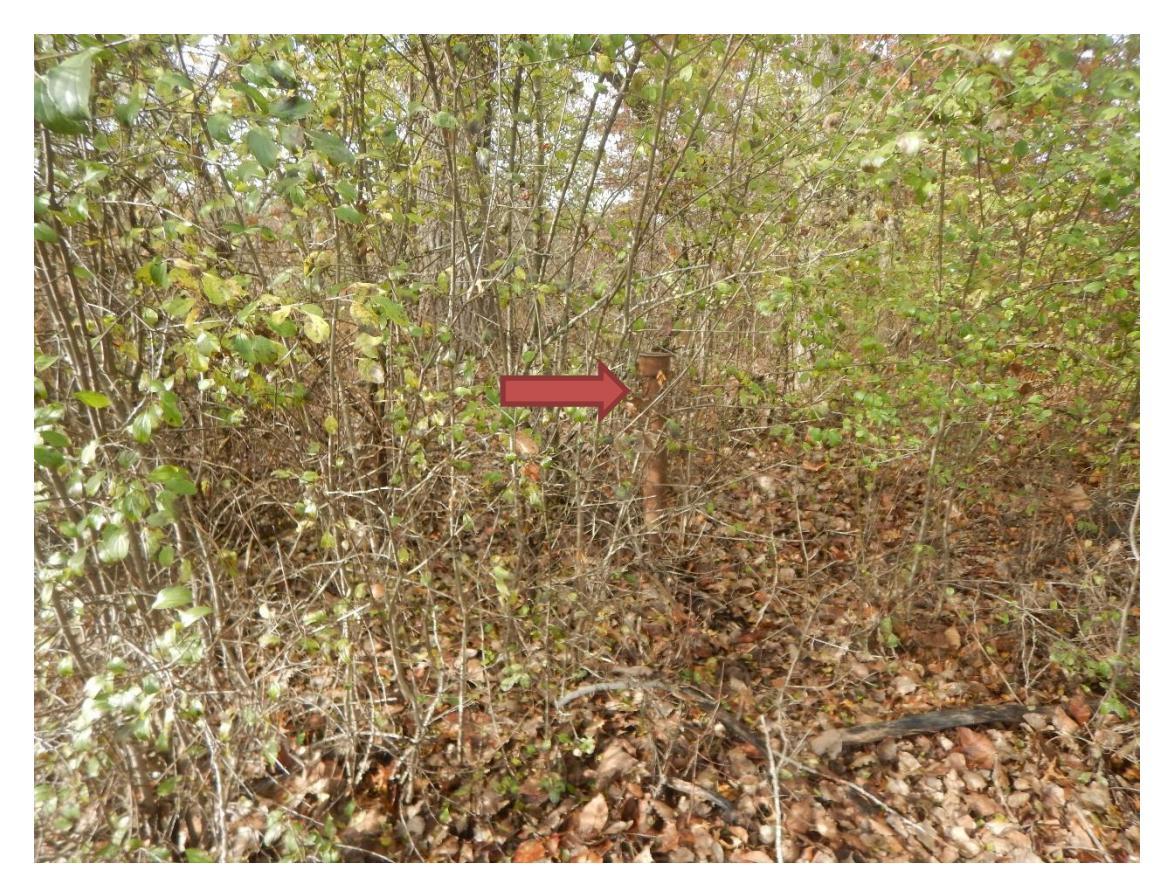
Photo 14: Taken November 1, 2022. Monitoring Well MW-7 (red arrow): No observed issues.
