**T-1 of Stoddard Creek Trout Evaluation**  
Scott Cornett, Region Nine Fisheries

9/12/19

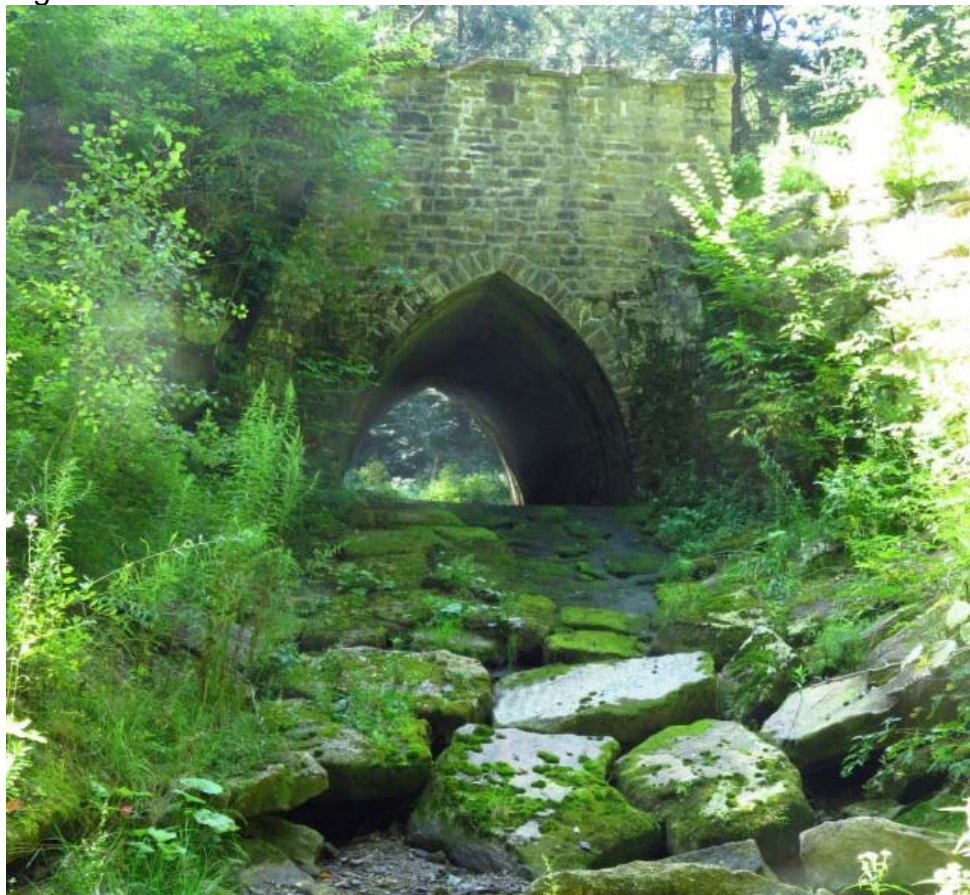
Tributary #1 of Stoddard Creek, flowing through Allegany State Park had never previously been surveyed by fisheries staff, although the author has caught wild brook trout while fishing in this stream. A hand-built stone culvert with a concrete drop apron, falling at a steep angle for approximately 15 vertical feet, is located 0.2 miles above the mouth and likely acts as a significant or total barrier to trout movement (Figure 1). No stocking records exist for this stream, however Stoddard Creek itself was stocked with brook trout fingerlings in the 1920s and 1930s. In order to document the presence of wild brook trout in this stream and to determine if brook trout exist upstream of the culvert on ASP Route #1, we sampled the stream at two sites on August 5<sup>th</sup>, 2019. Our lower site was located 250 feet below the culvert and the upper site began just above the culvert. At the time of the survey, both sites had very little water flow, with much of the stream going subsurface between pools.

Figure 1. Stone road culvert on ASP Route #1.

While adult trout habitat was actually much better at the survey site above the culvert than below, the density of wild adult brook trout was much higher below the culvert, as were the number of young-of-year trout observed. This likely indicates that the culvert is mostly or totally impassable to adult brook trout and fish cannot move upstream to find higher quality habitat. It is not clear whether the brook trout population upstream of the culvert has resulted from fish that were able to, at some point in the past, get past this culvert or whether these fish are decedents of trout existing in the upper portion of the stream prior to this culvert being installed (likely by the CCC in the 1930s). Fisheries staff will work with park staff to determine if there is any way to alter the outlet of the road culvert to better facilitate brook trout movement upstream to reconnect this brook trout population. No changes in management or regulations are currently recommended, pending updates to the state-wide inland trout management plan.
