SLR
 231 MAIN STREET
 SUITE 102
 NEW PALTZ, NY 12561
 845.633.8153

HRA #2 - WHITESIDE DAM (1964 AERIAL IMAGE)
 GREAT CHAZY RIVER FLOOD & ICE JAM STUDY
 SD119
 CLINTON COUNTY
 NEW YORK

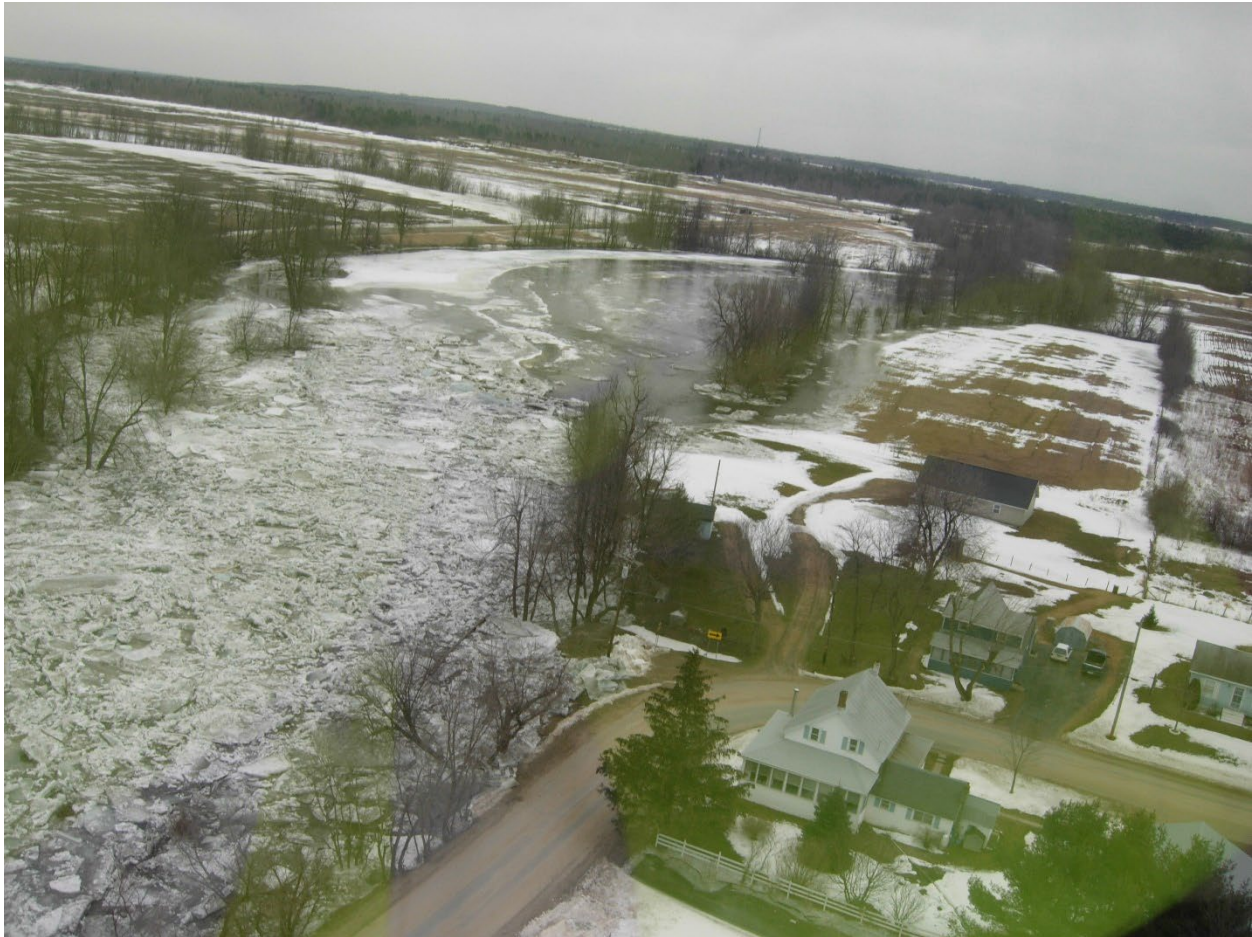
Figure 4-23: Break-up ice accumulates at the solid ice that forms in the tailwaters of Whiteside Dam – note transition at image center. View is to the east, looking downstream; Dubois Road is in foreground. Image is provided by Clinton County Department of Emergency Services.

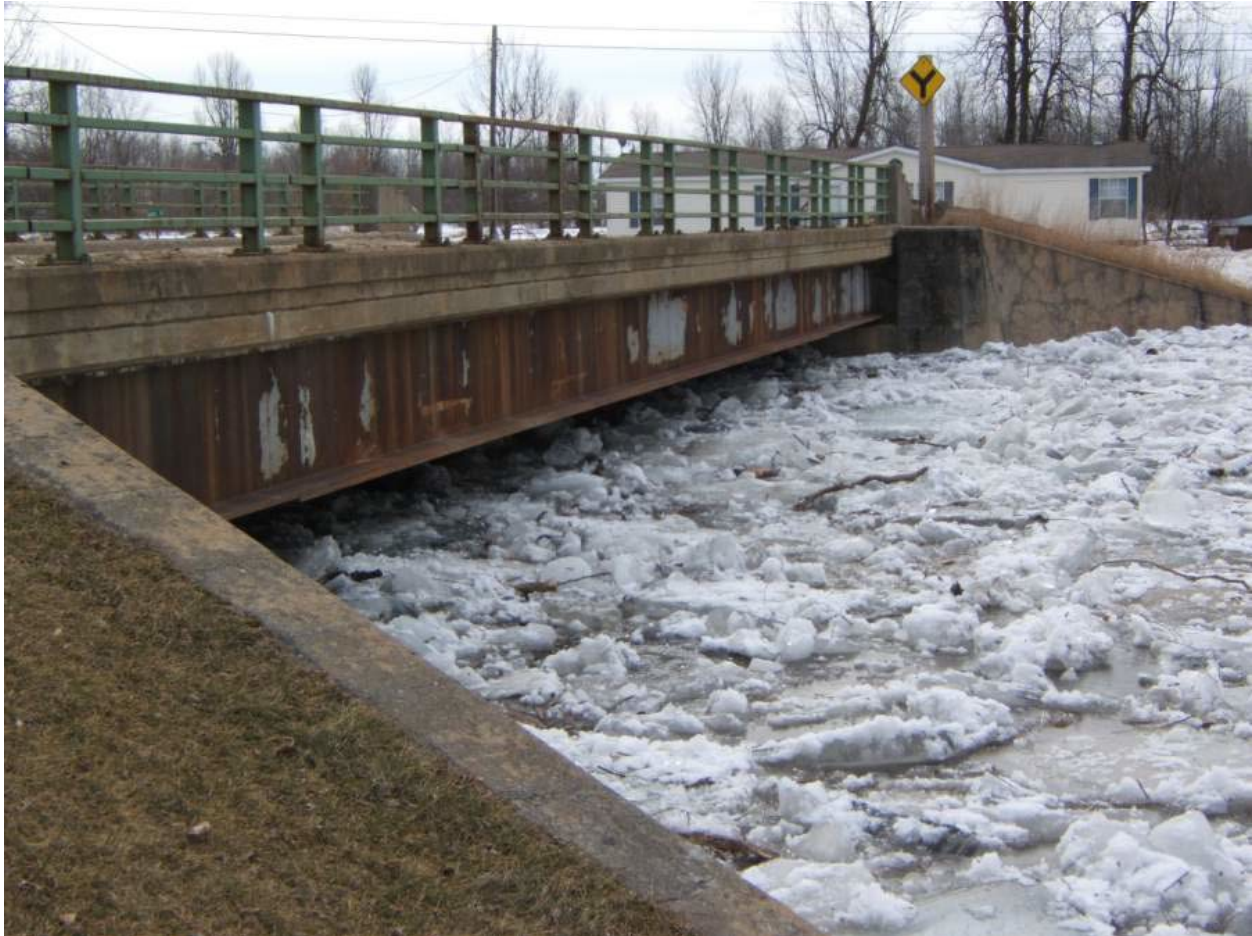
Figure 4-26: Break-up ice jamming in March 2007 at the Creek Road bridge in Perry Mills. View is up upstream face of bridge; flow is right to left in image. Image is provided by Clinton County Department of Emergency Services.

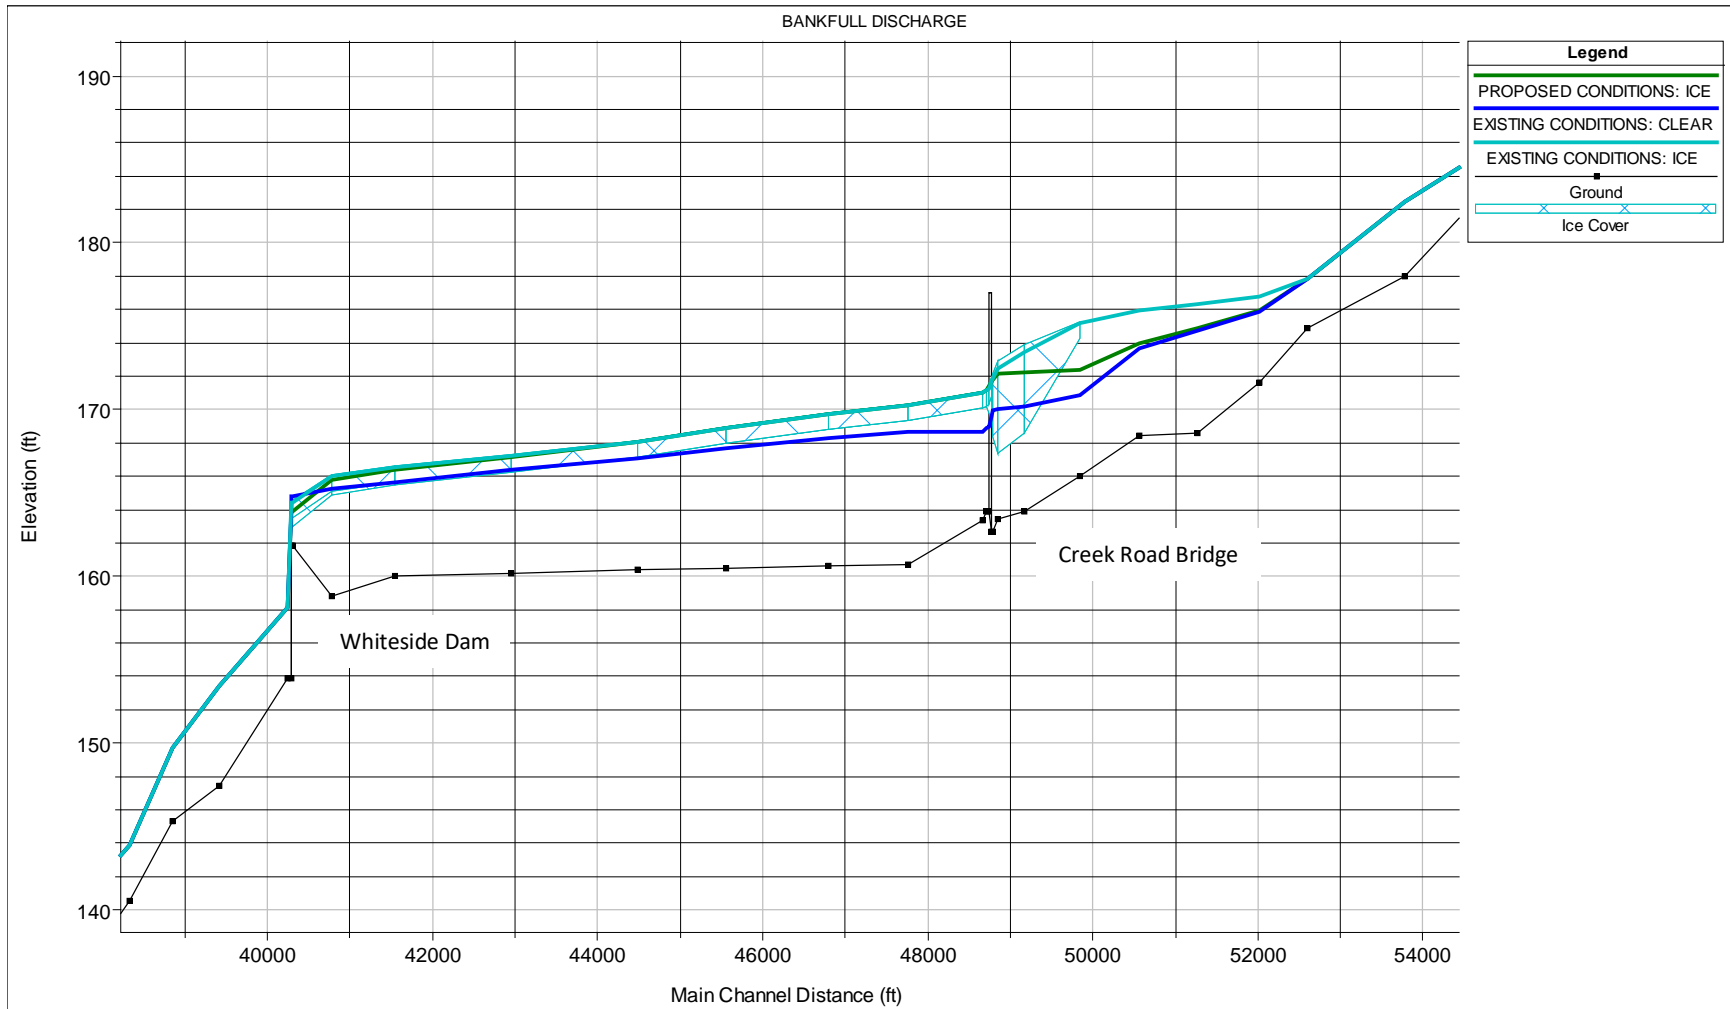
Figure 4-27: Profile of Modeled Bankfull Flow Through Perry Mills Under Ice Jamming Scenarios Comparing Existing Conditions and Proposed Conditions, with Whiteside Dam Removed and No Ice Accumulation.

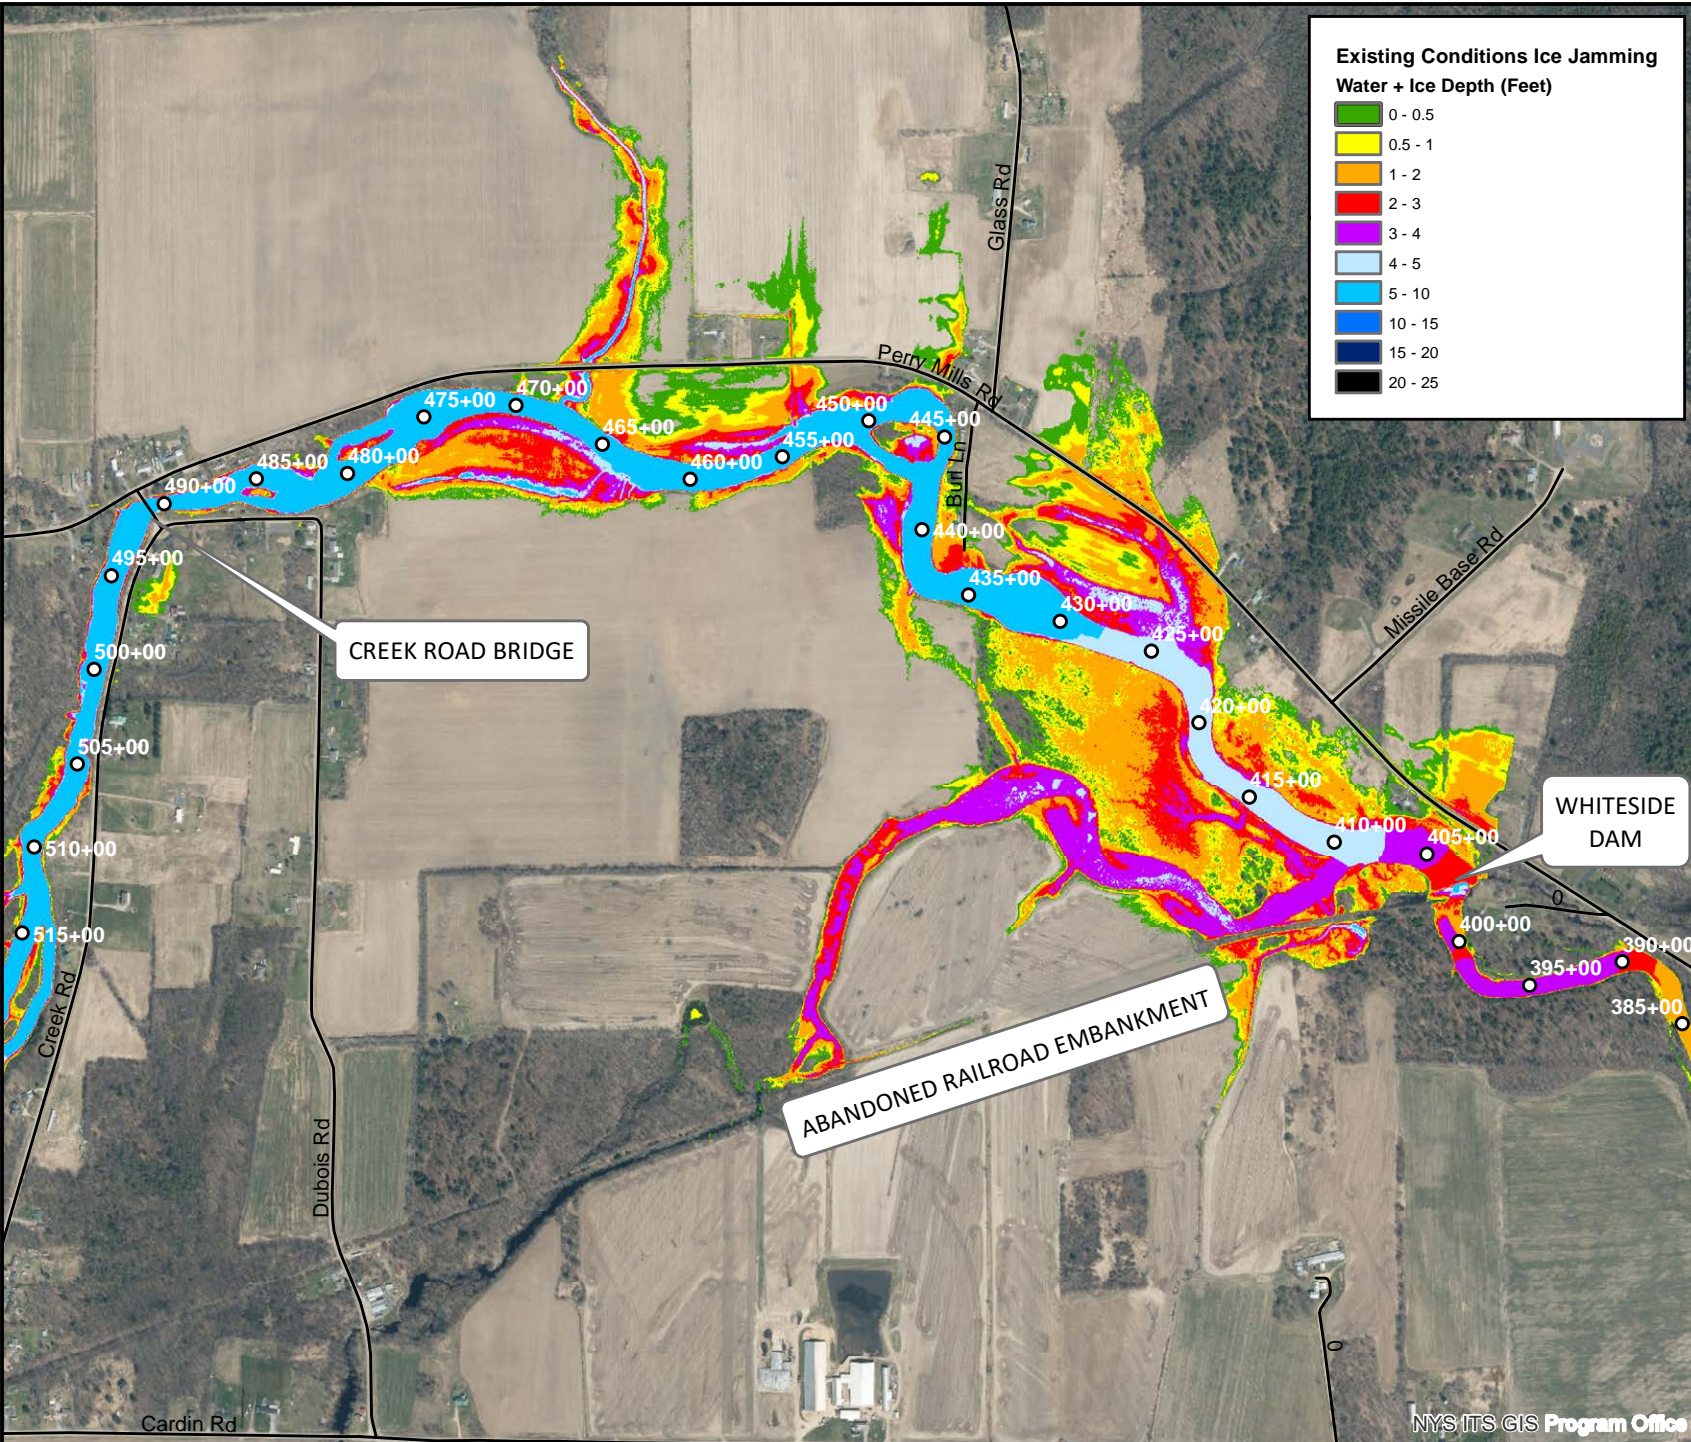
SLR
 231 MAIN STREET
 SUITE 102
 NEW PALTZ, NY 12561
 845.633.8153

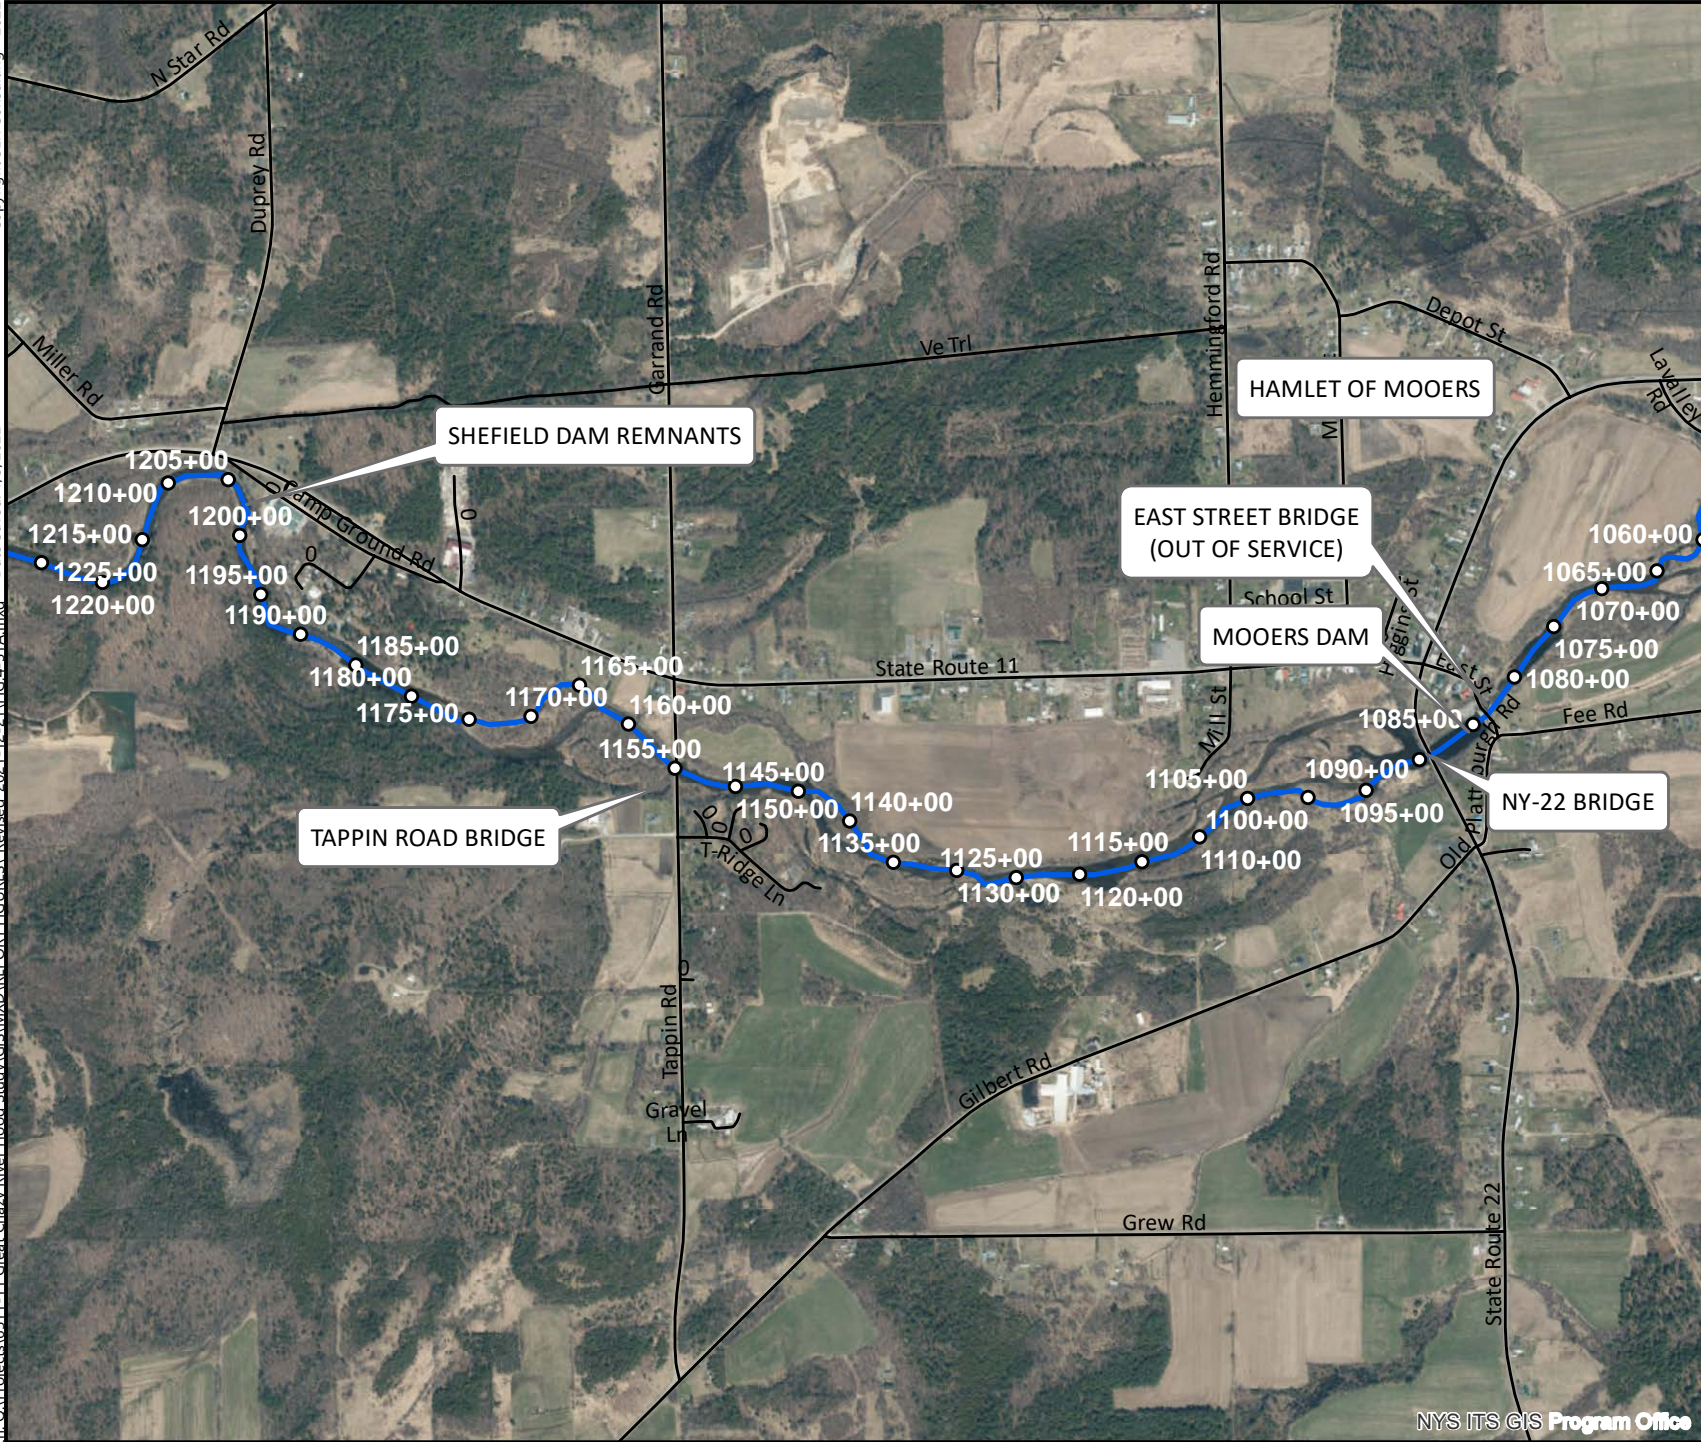
SLR
 231 MAIN STREET
 SUITE 102
 NEW PALTZ, NY 12561
 845.633.8153

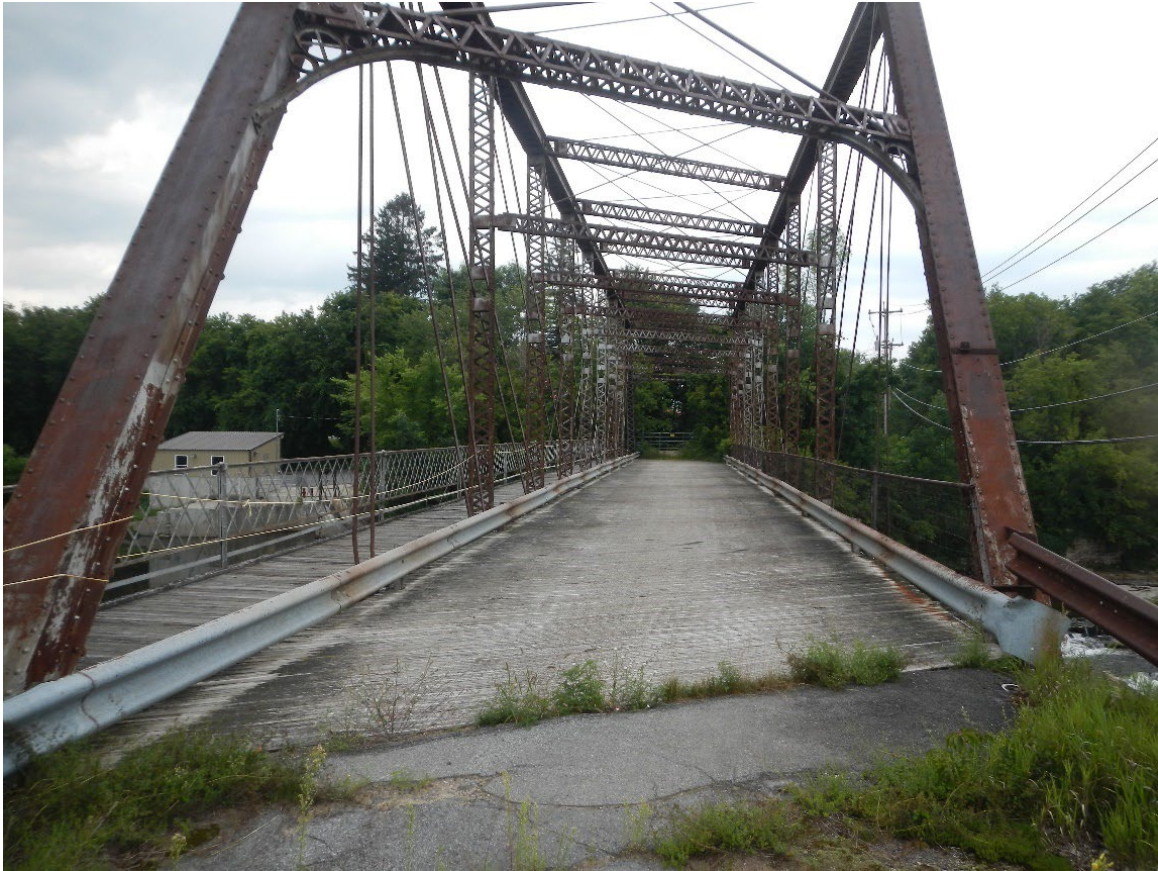
Figure 4-32: Out-of-service East Street bridge in the Hamlet of Mooers. Note deterioration of protective paint on the steel trusses and signs of corrosion.

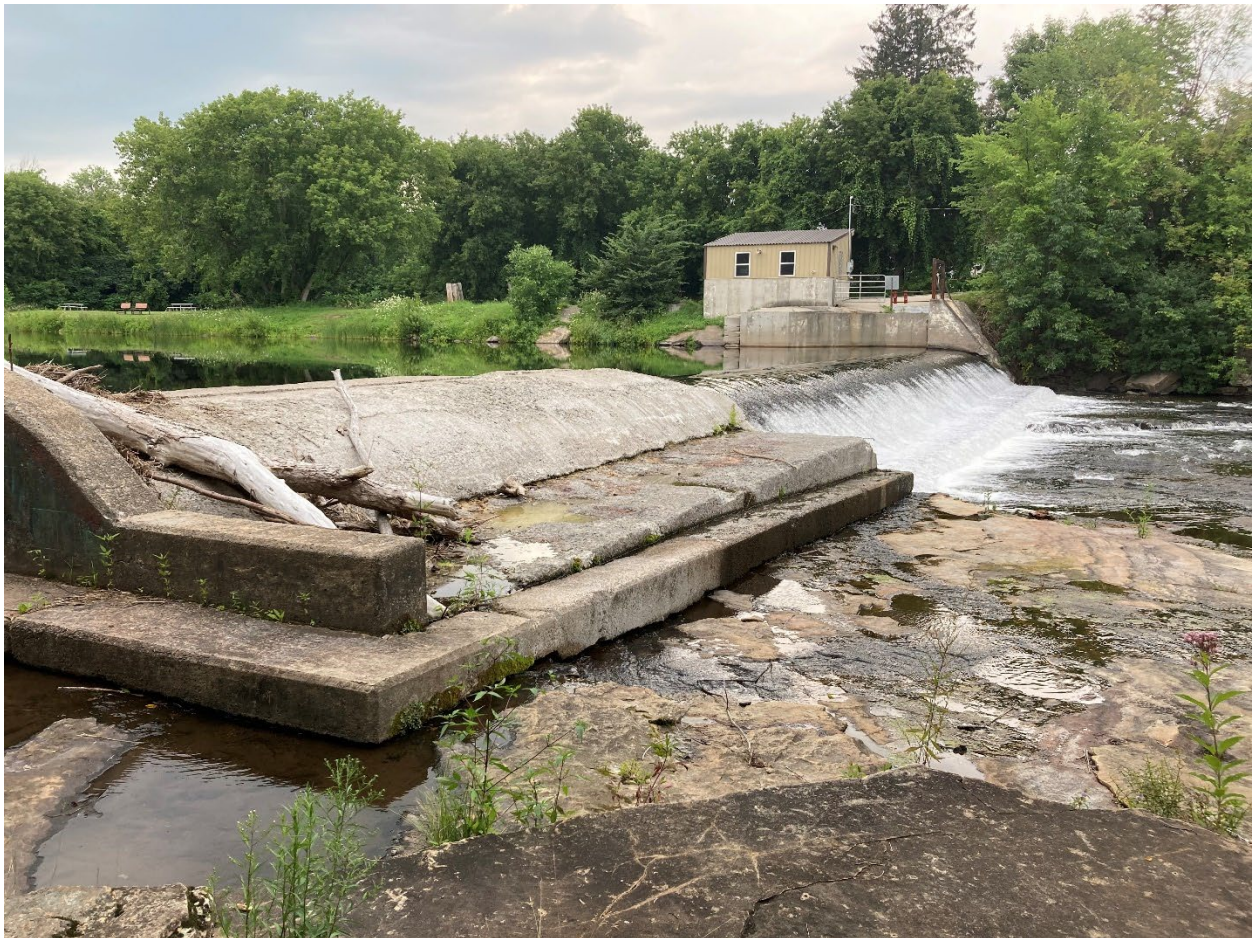
Figure 4-33: Mooers Dam. Fire suppression pump station is in background. Note seeps along concrete apron contact with bedrock in foreground.

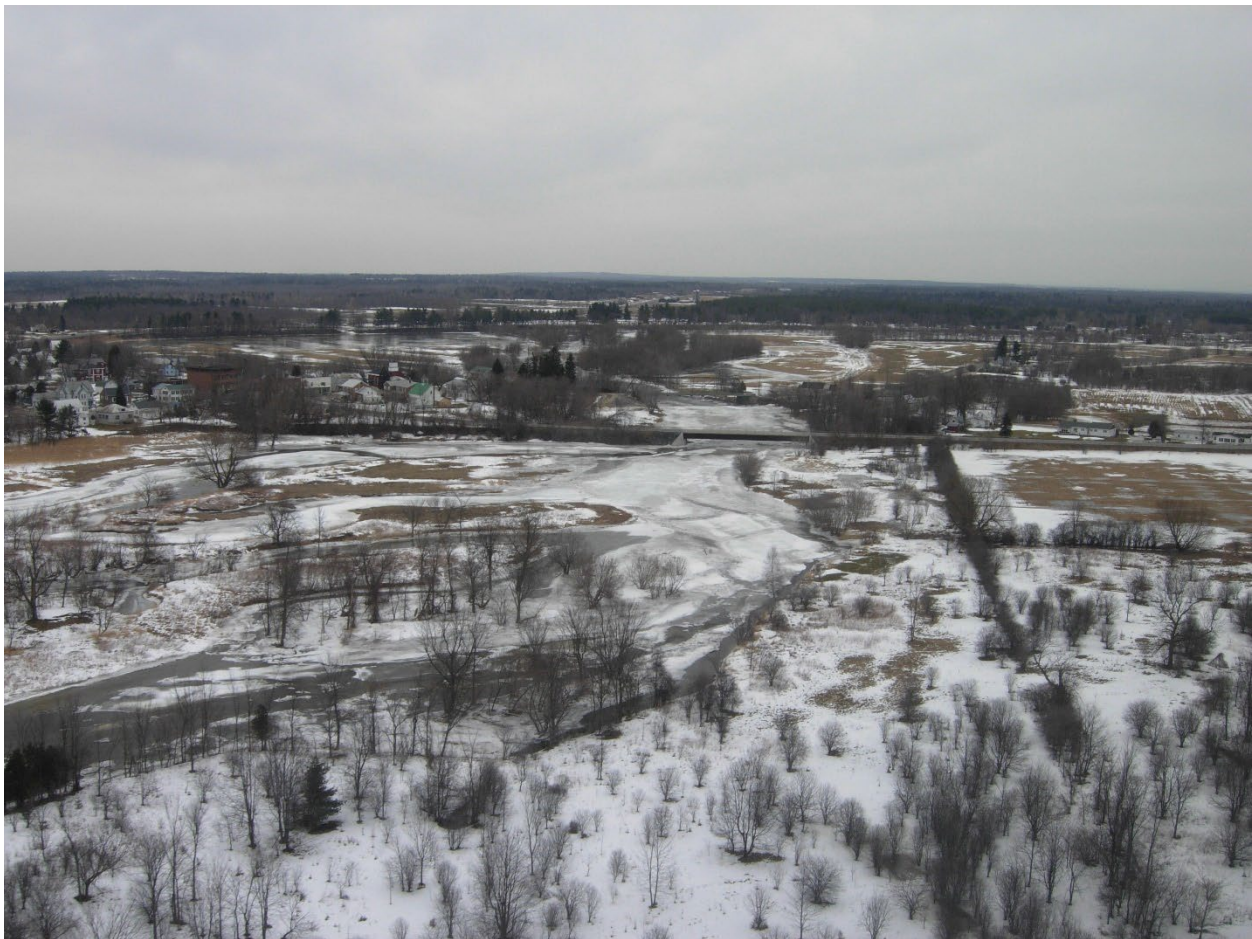
Figure 4-34: Solid ice formed in the Mooers Dam impoundment reaches upstream past the NY-22 bridge. The crest of the dam and the bridge are in the center of the image, which is oriented to the east, looking downstream. Image is from March 2007 provided by Clinton County Department of Emergency Services.

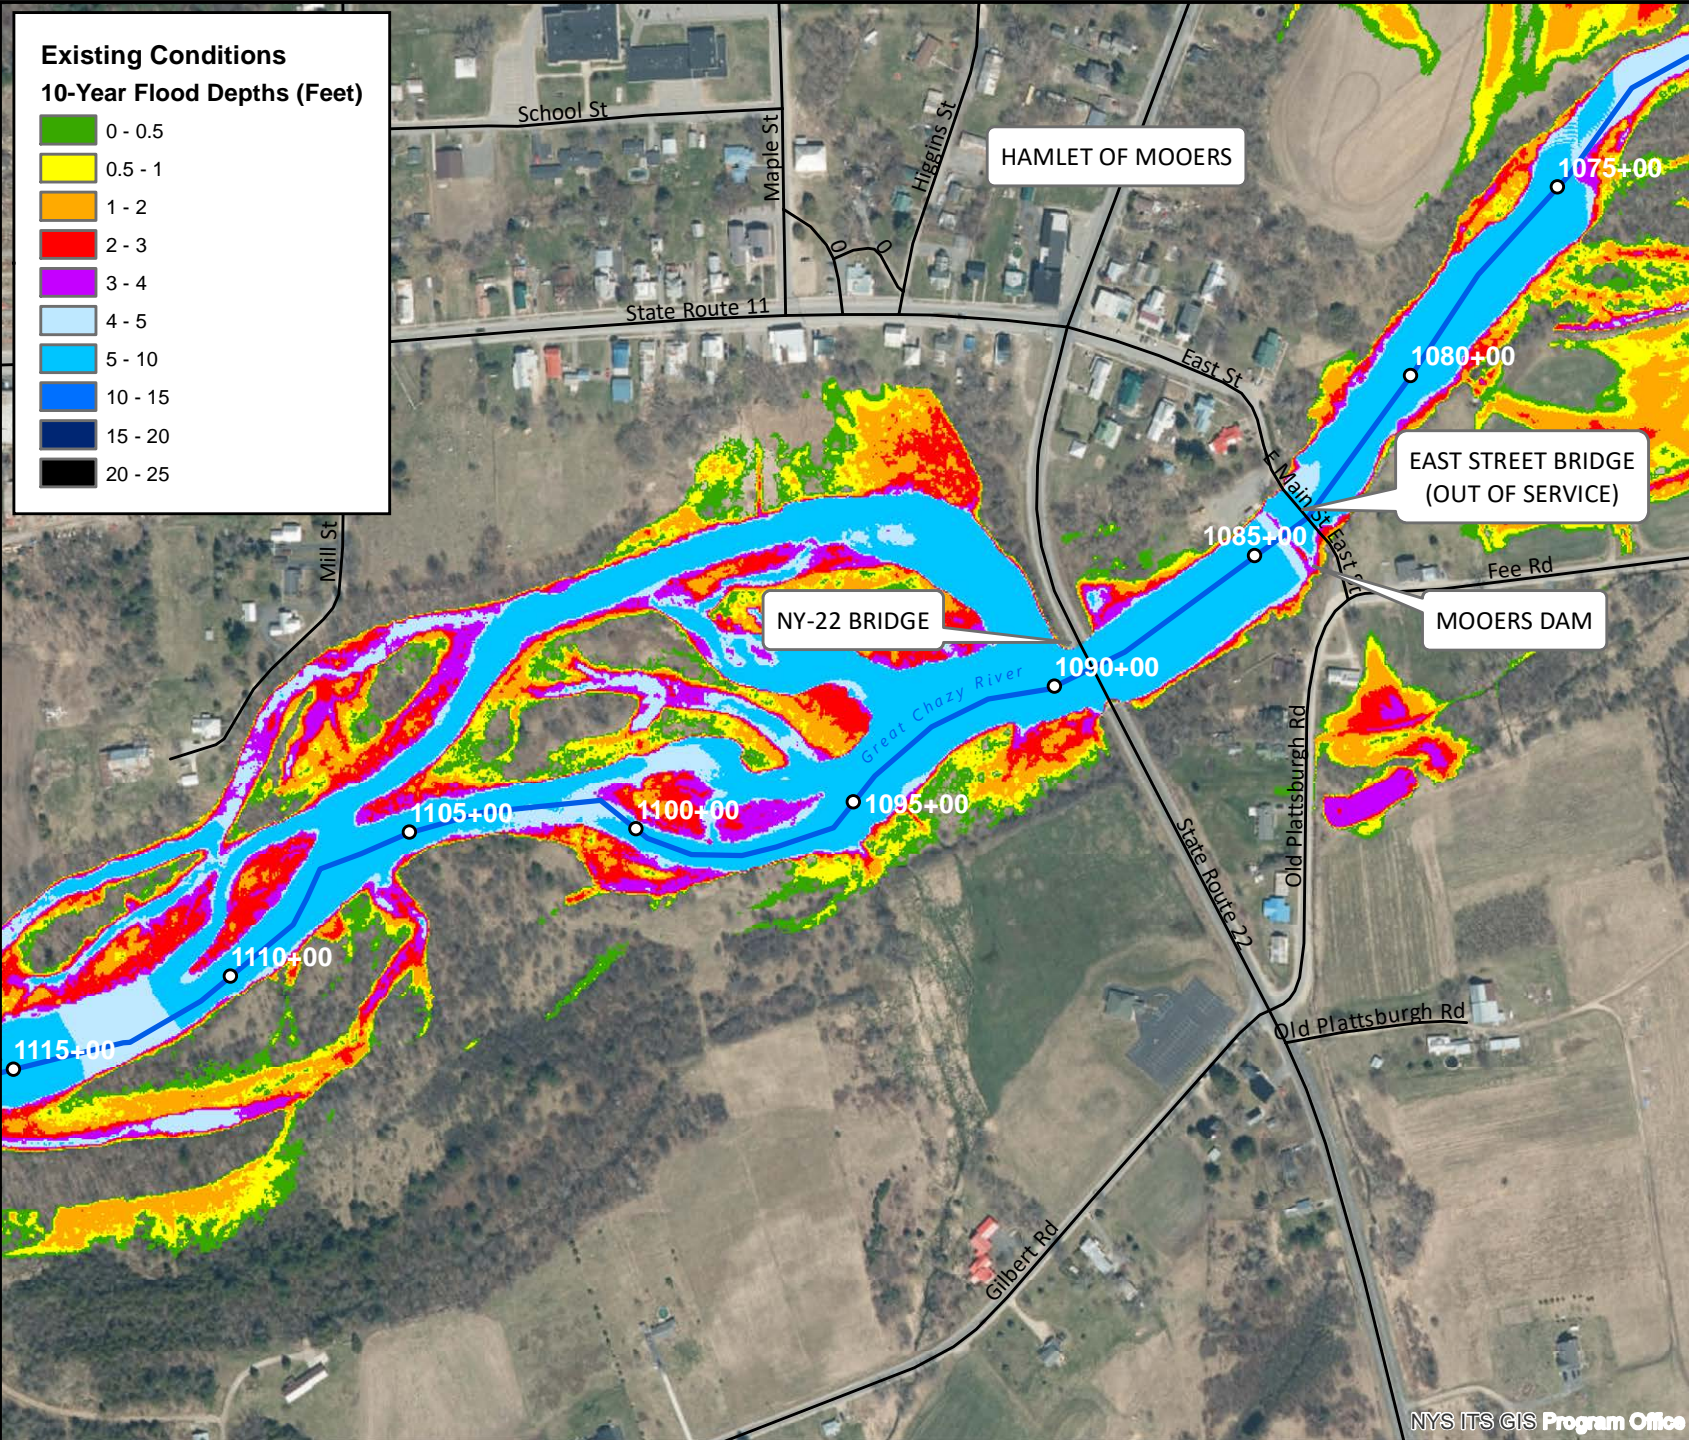
Existing Conditions
10-Year Flood Depths (Feet)

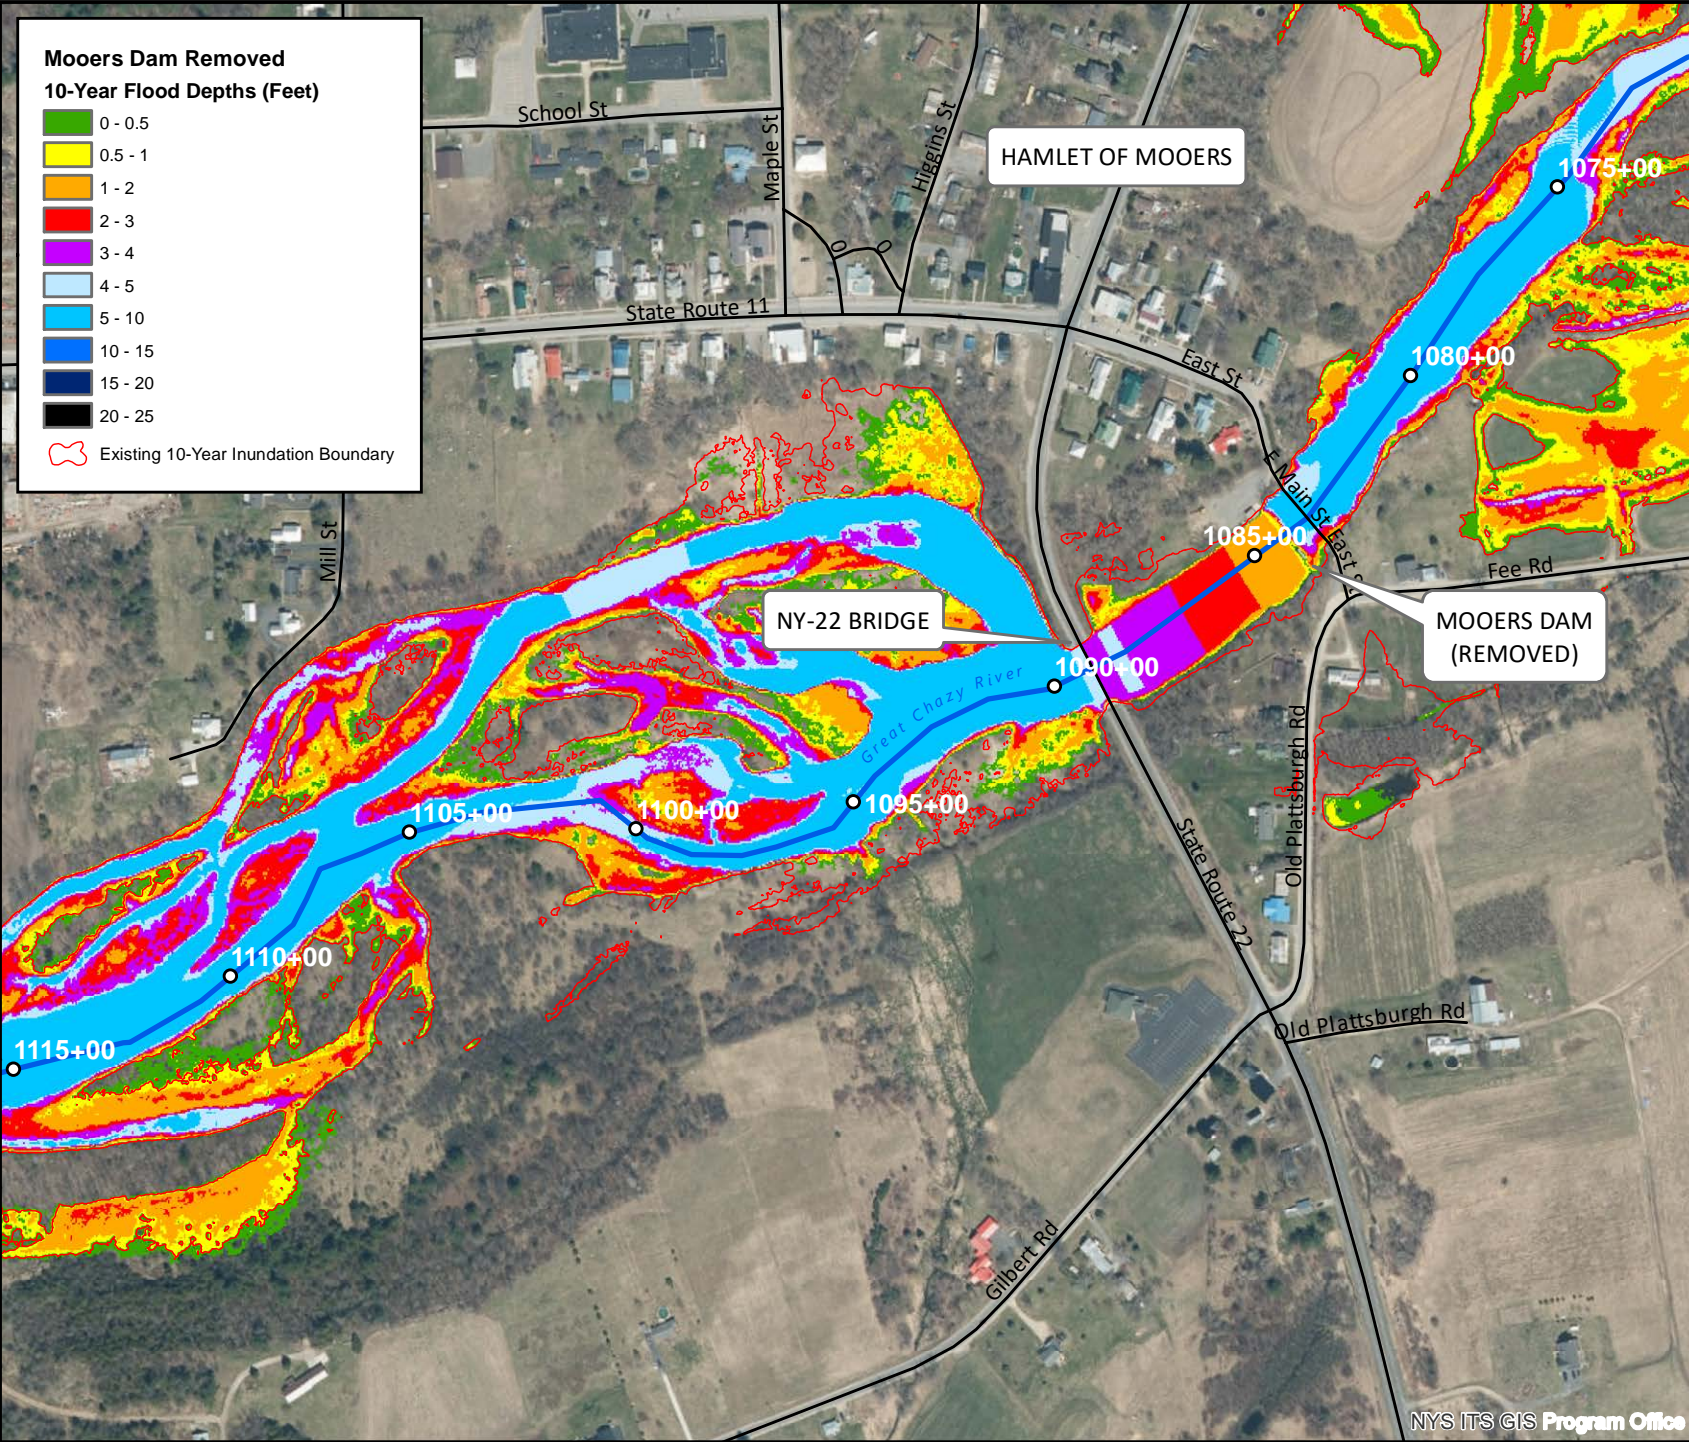
SLR
231 MAIN STREET
SUITE 102
NEW PALTZ, NY 12561
845.633.8153

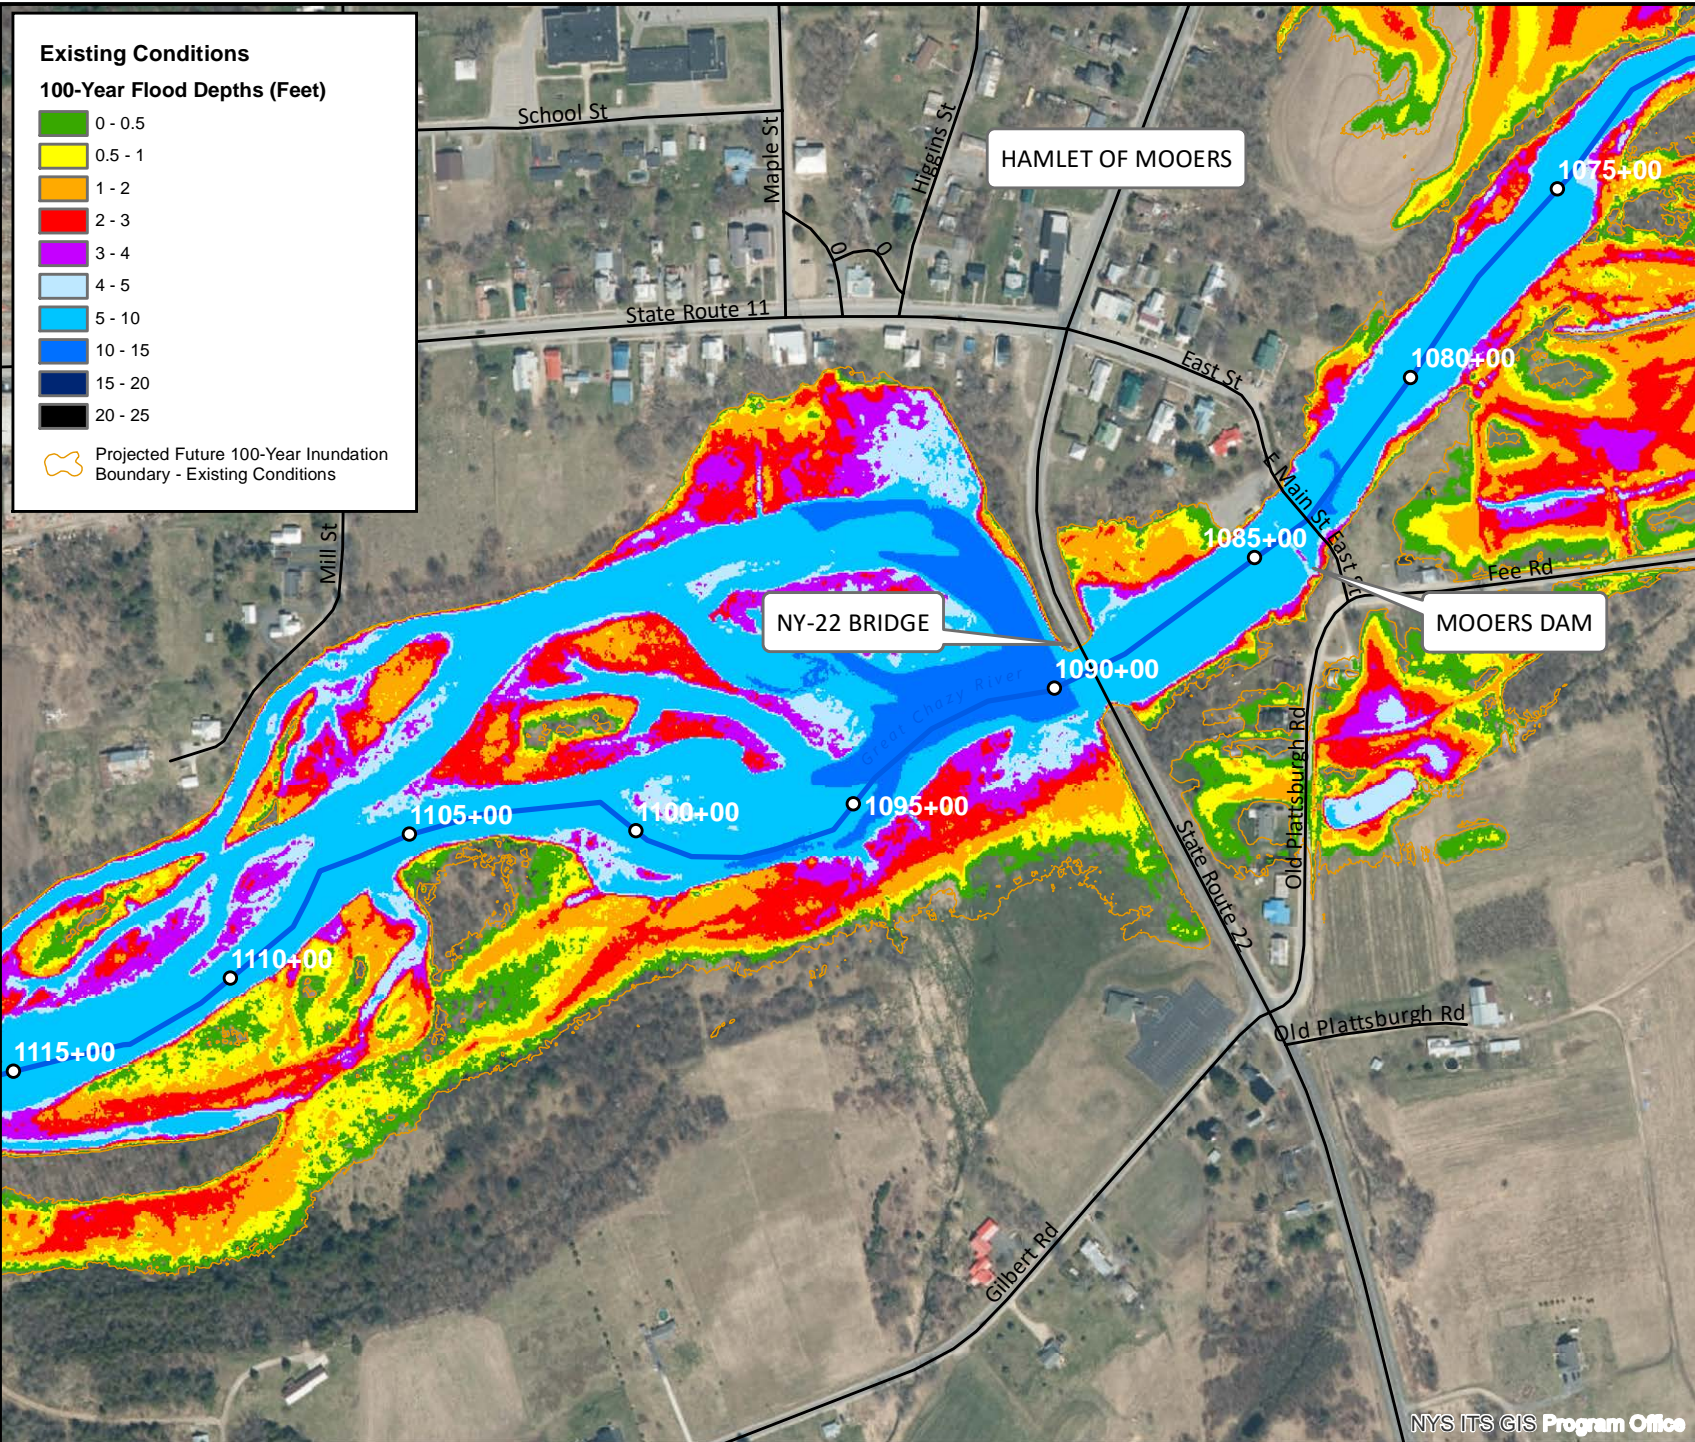
SLR
 231 MAIN STREET
 SUITE 102
 NEW PALTZ, NY 12561
 845.633.8153

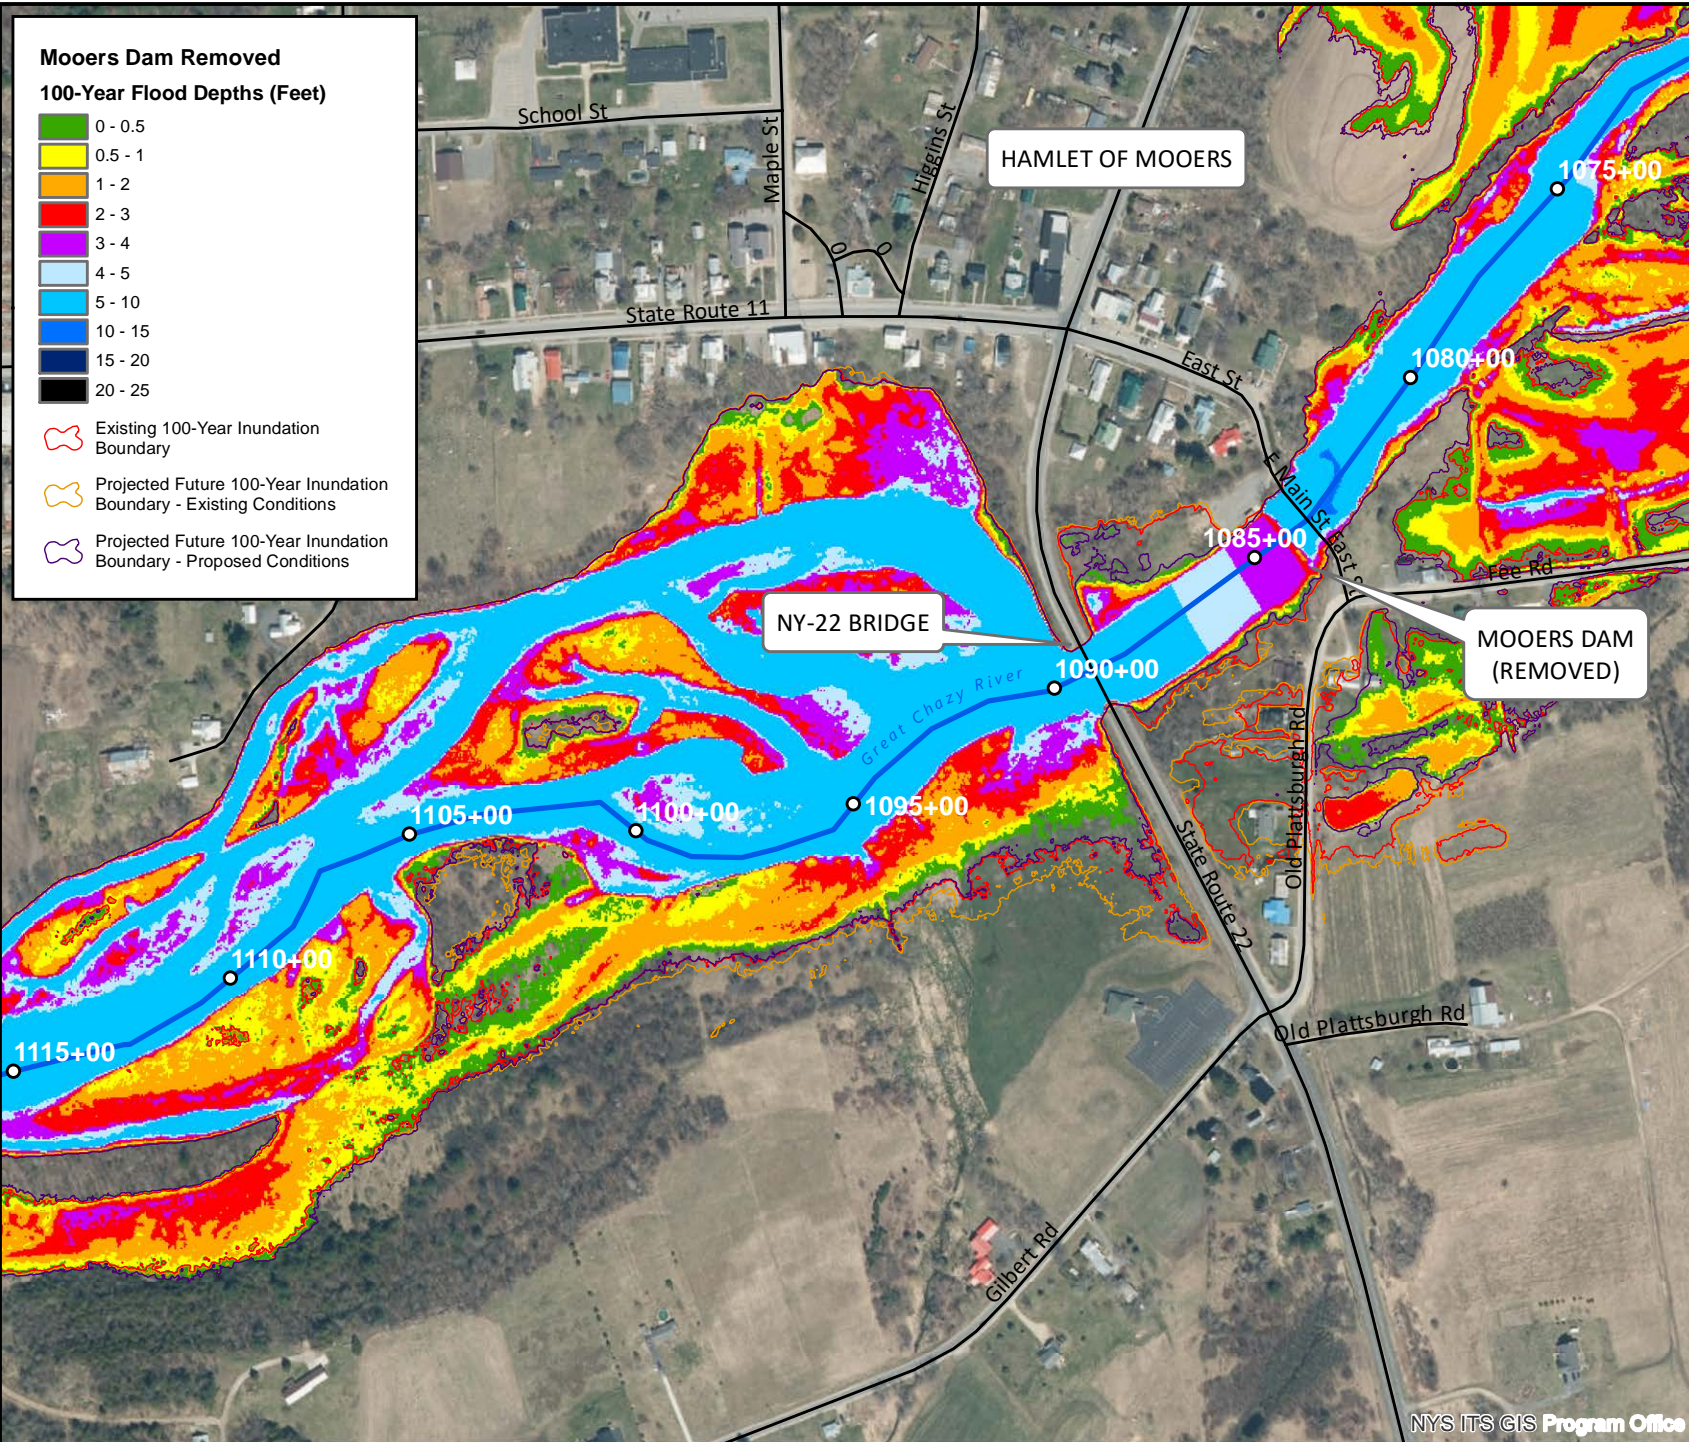
SLR
 231 MAIN STREET
 SUITE 102
 NEW PALTZ, NY 12561
 845.633.8153
