SLR
 231 MAIN STREET
 SUITE 102
 NEW PALTZ, NY 12561
 845.633.8153

HRA #2 - WHITESIDE DAM (1964 AERIAL IMAGE)
 GREAT CHAZY RIVER FLOOD & ICE JAM STUDY
 SD119
 CLINTON COUNTY
 NEW YORK

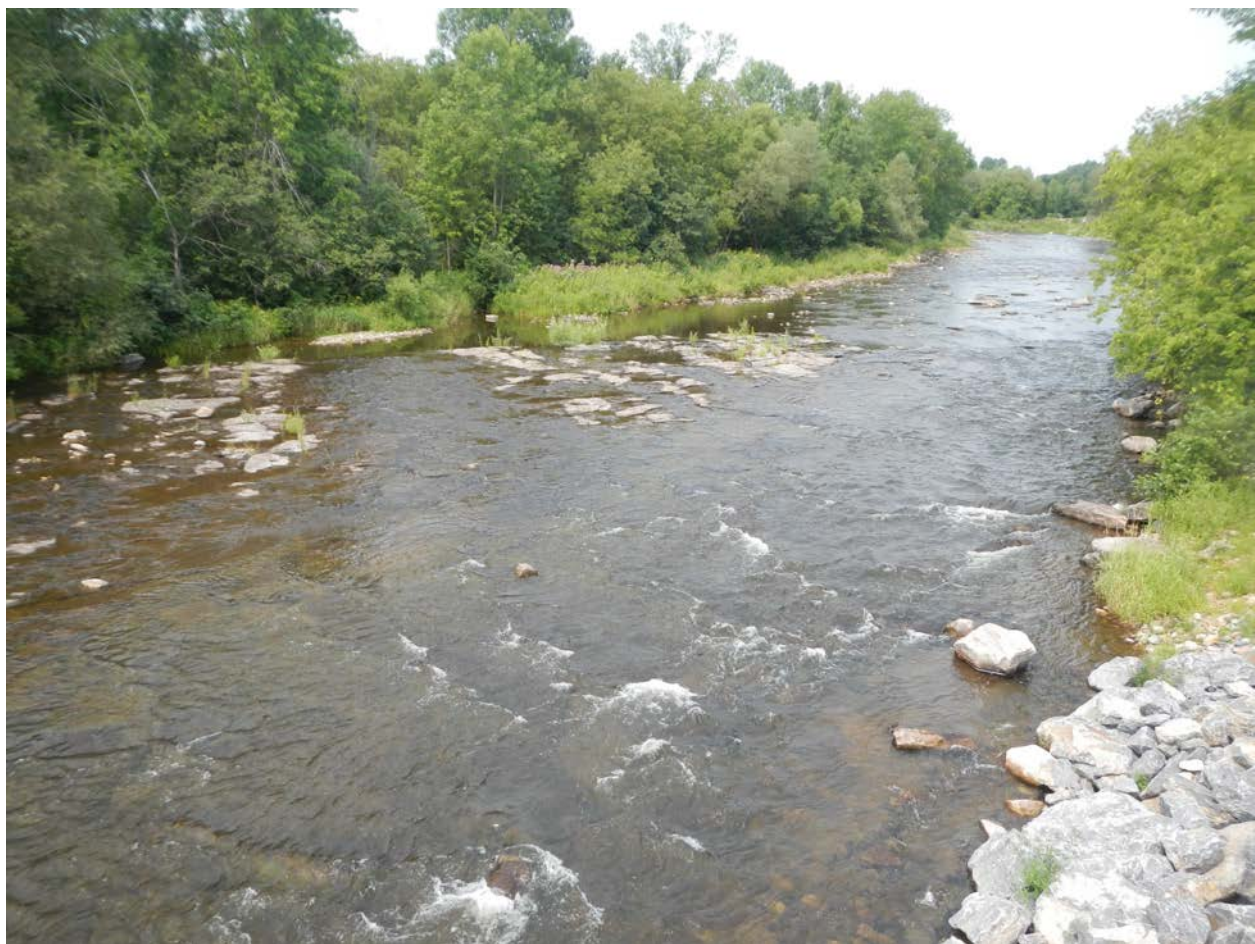
Figure 4-40: View looking upstream from the new Tappin Road bridge.

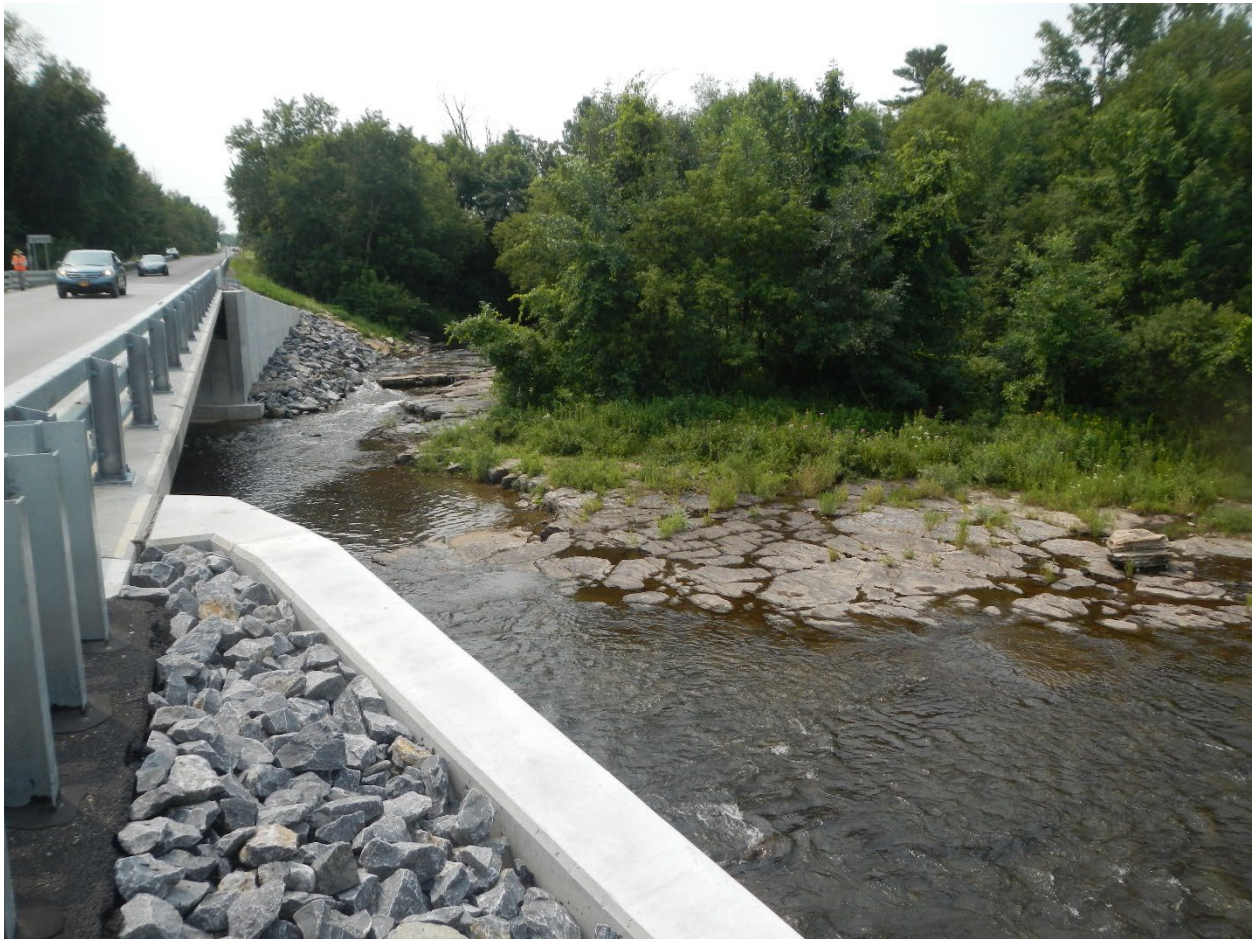
Figure 4-41: Upstream face of the new Tappin Road bridge; view is to the south. Flow is right to left in the image.

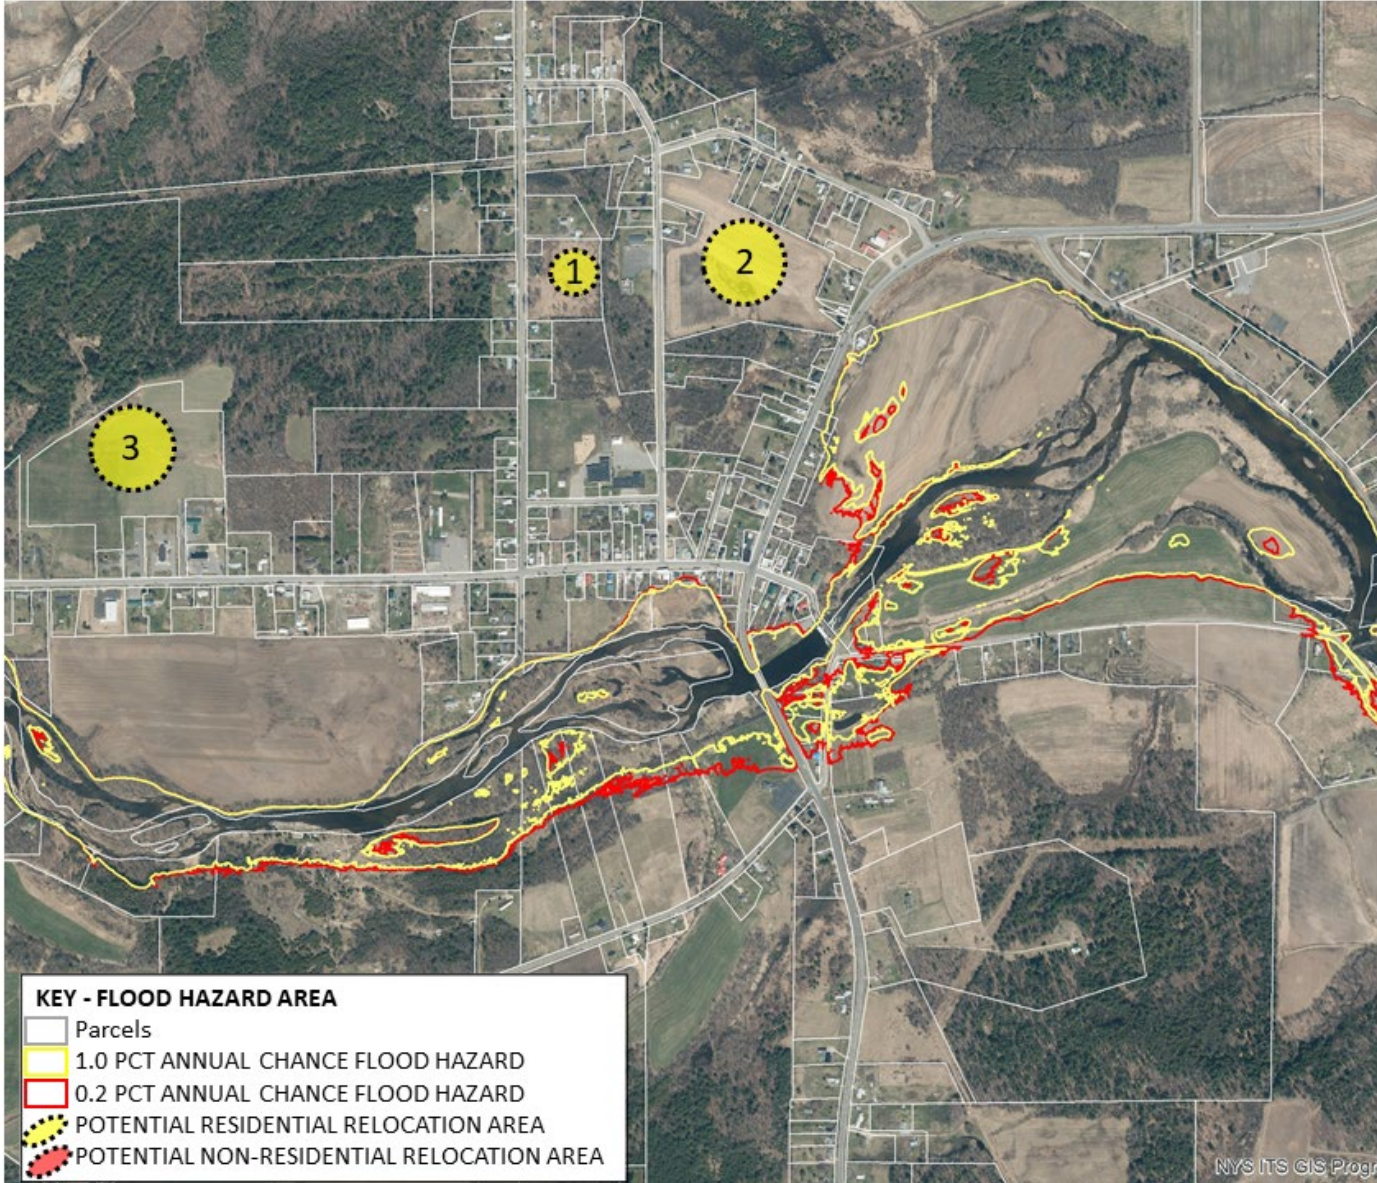
Figure 4-43 Conceptual redevelopment location mapping for HRA 3. See inset on previous page for descriptions.

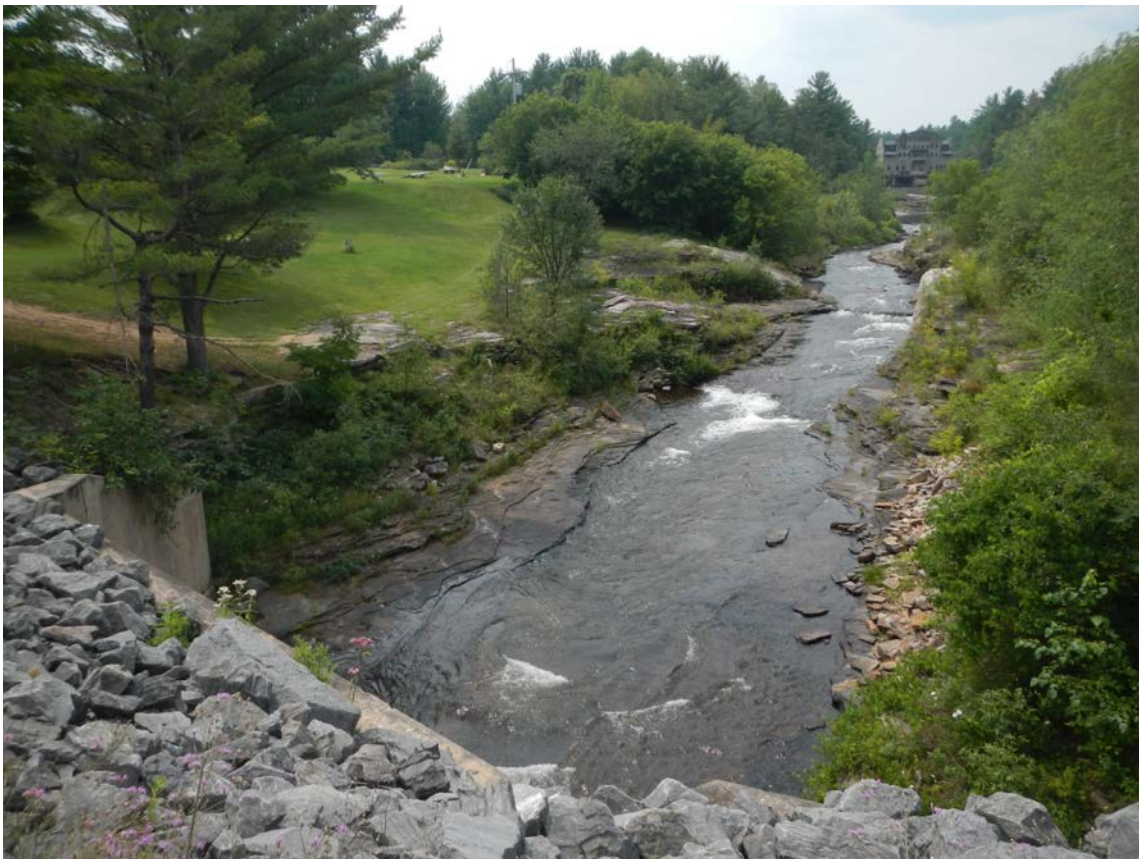
Figure 4-44: Devil's Den Road culvert crossing of the Great Chazy River. View is looking upstream from the culvert.

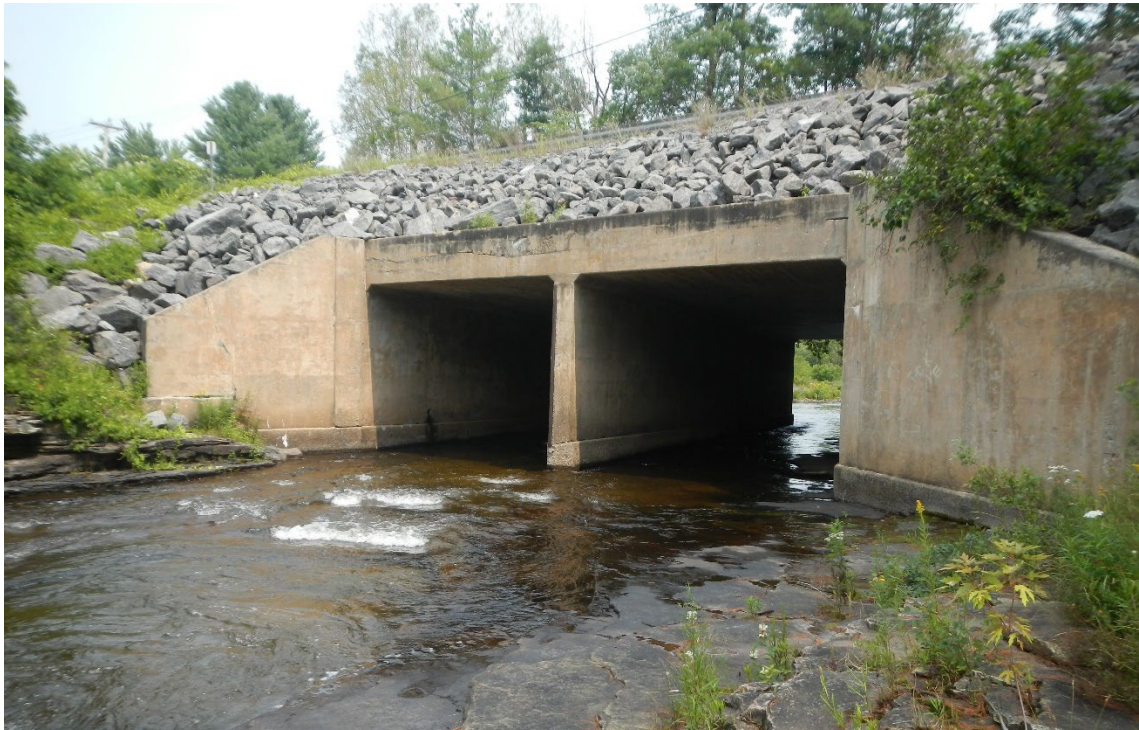
Figure 4-45: Devil's Den Road culvert crossing of the Great Chazy River. View is looking downstream from upstream right bank.

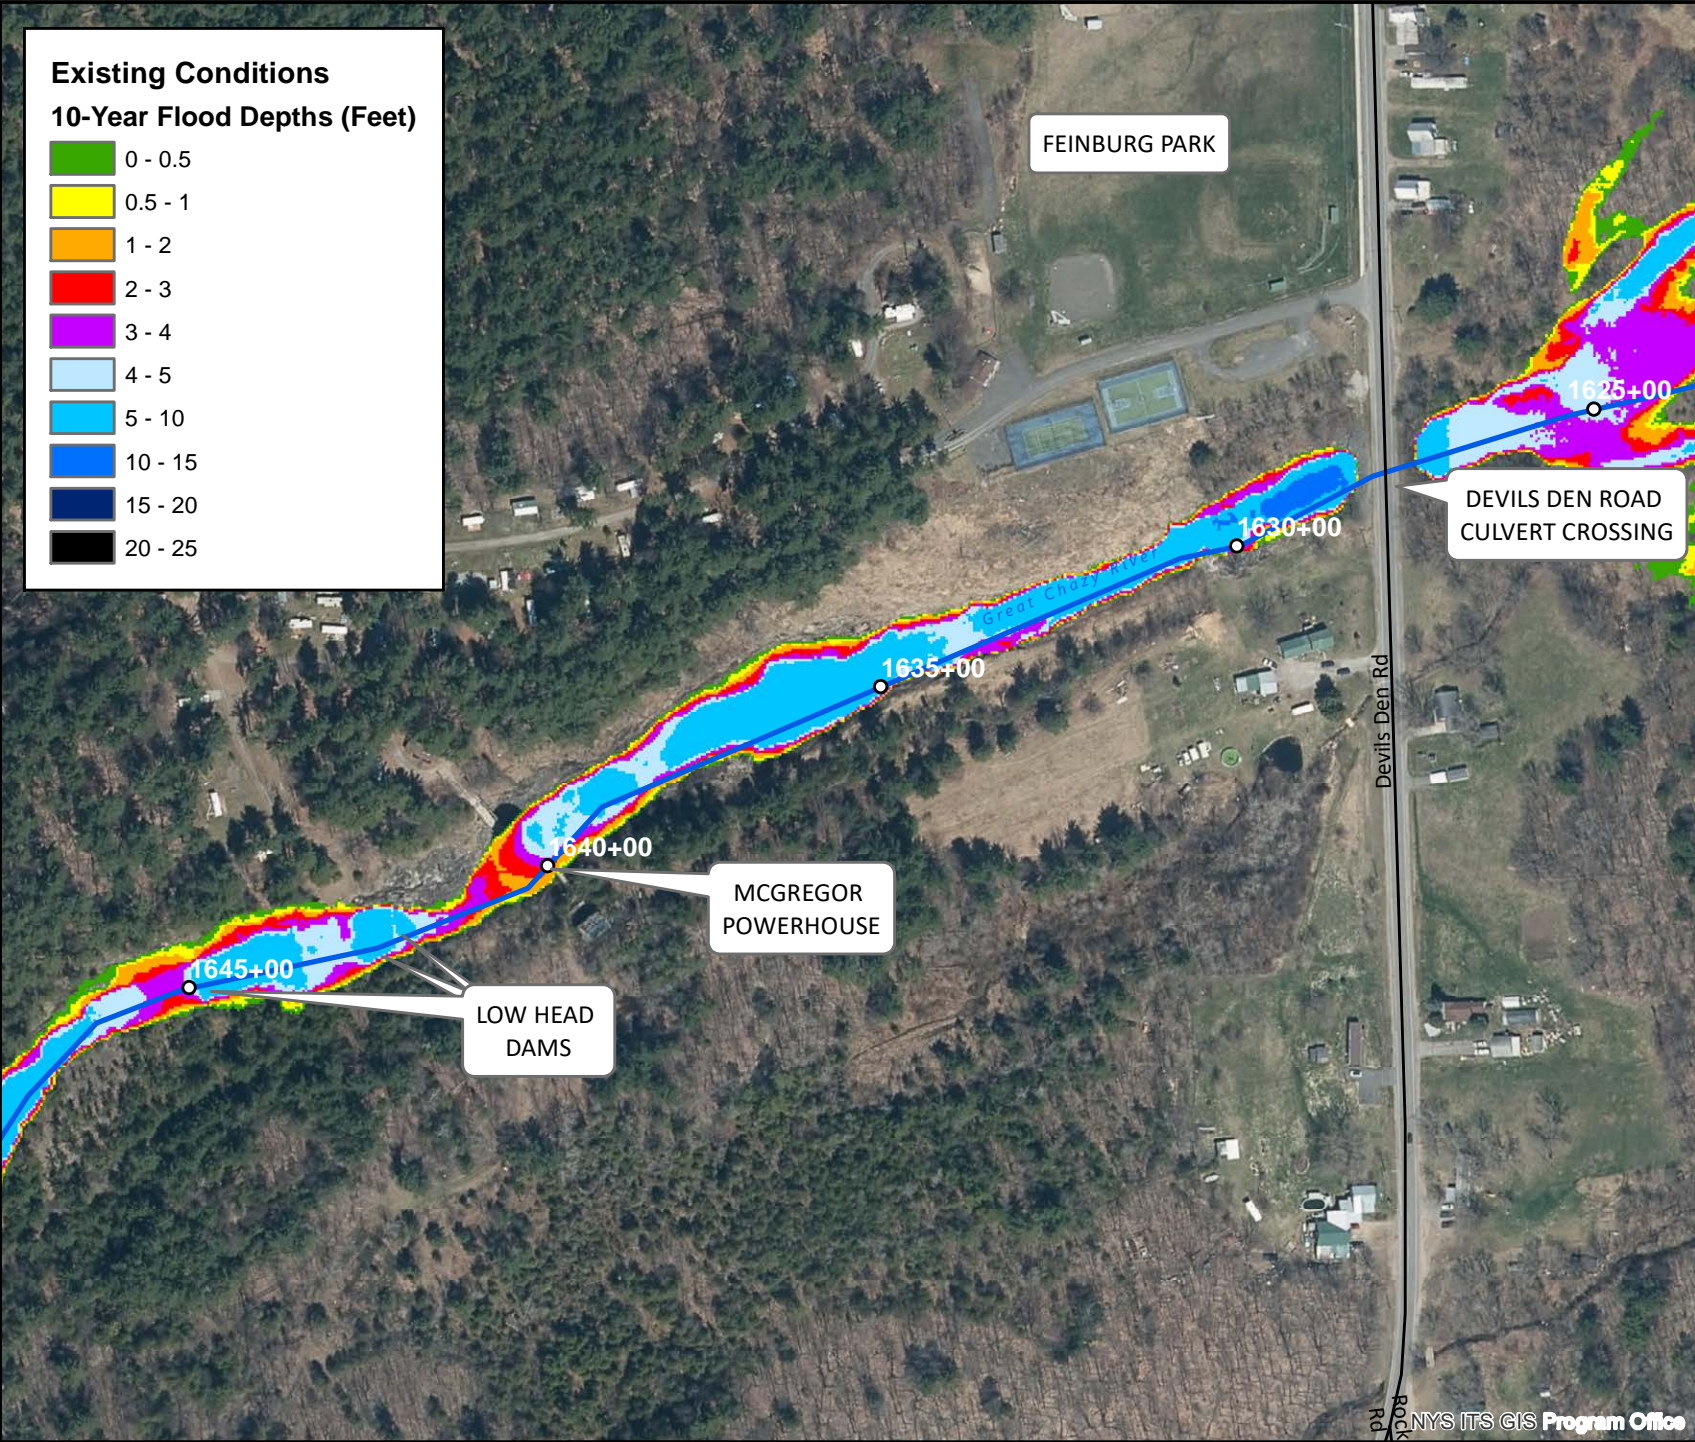
Existing Conditions
10-Year Flood Depths (Feet)

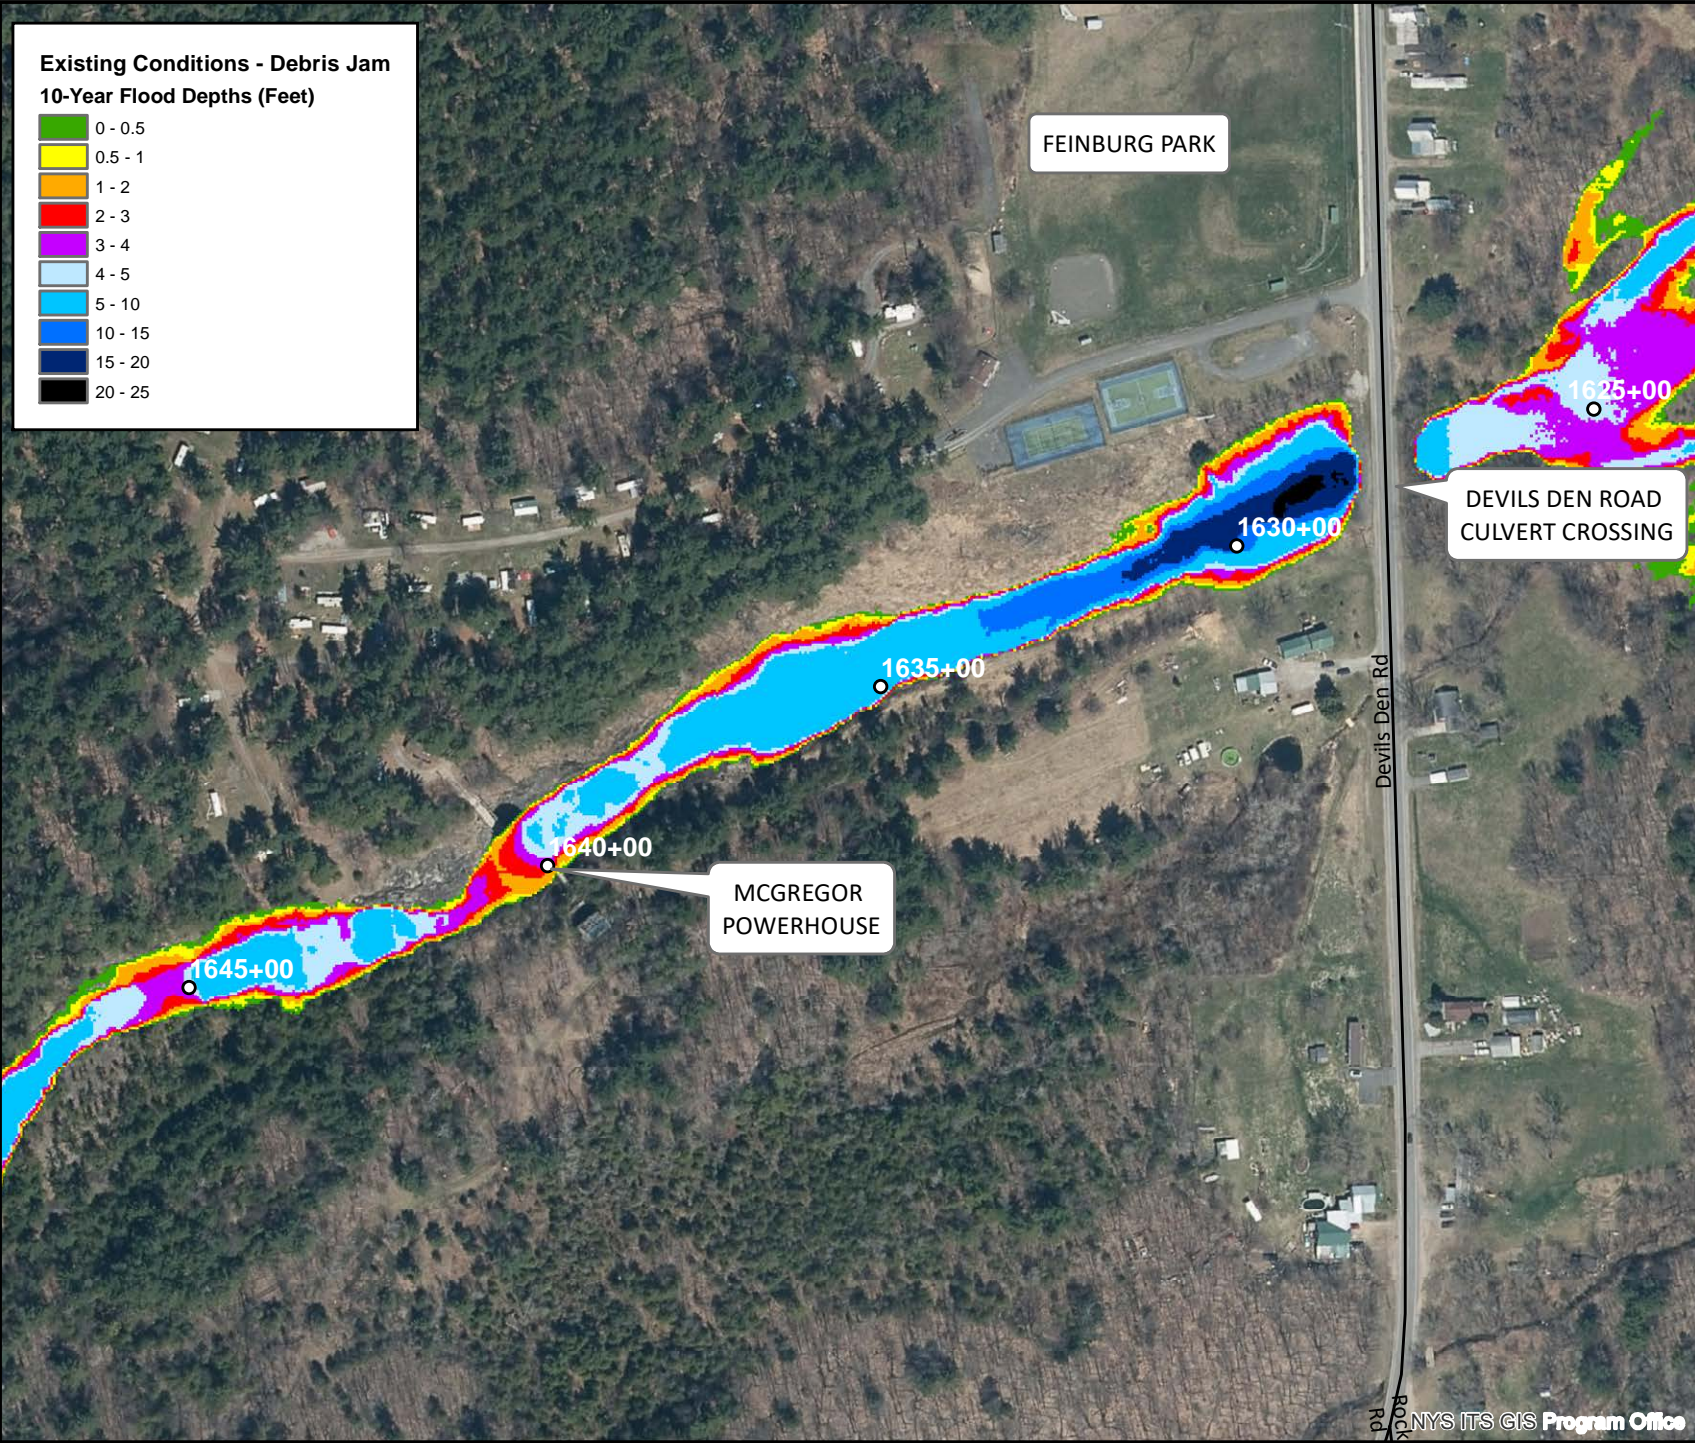
**Existing Conditions - Debris Jam
10-Year Flood Depths (Feet)**

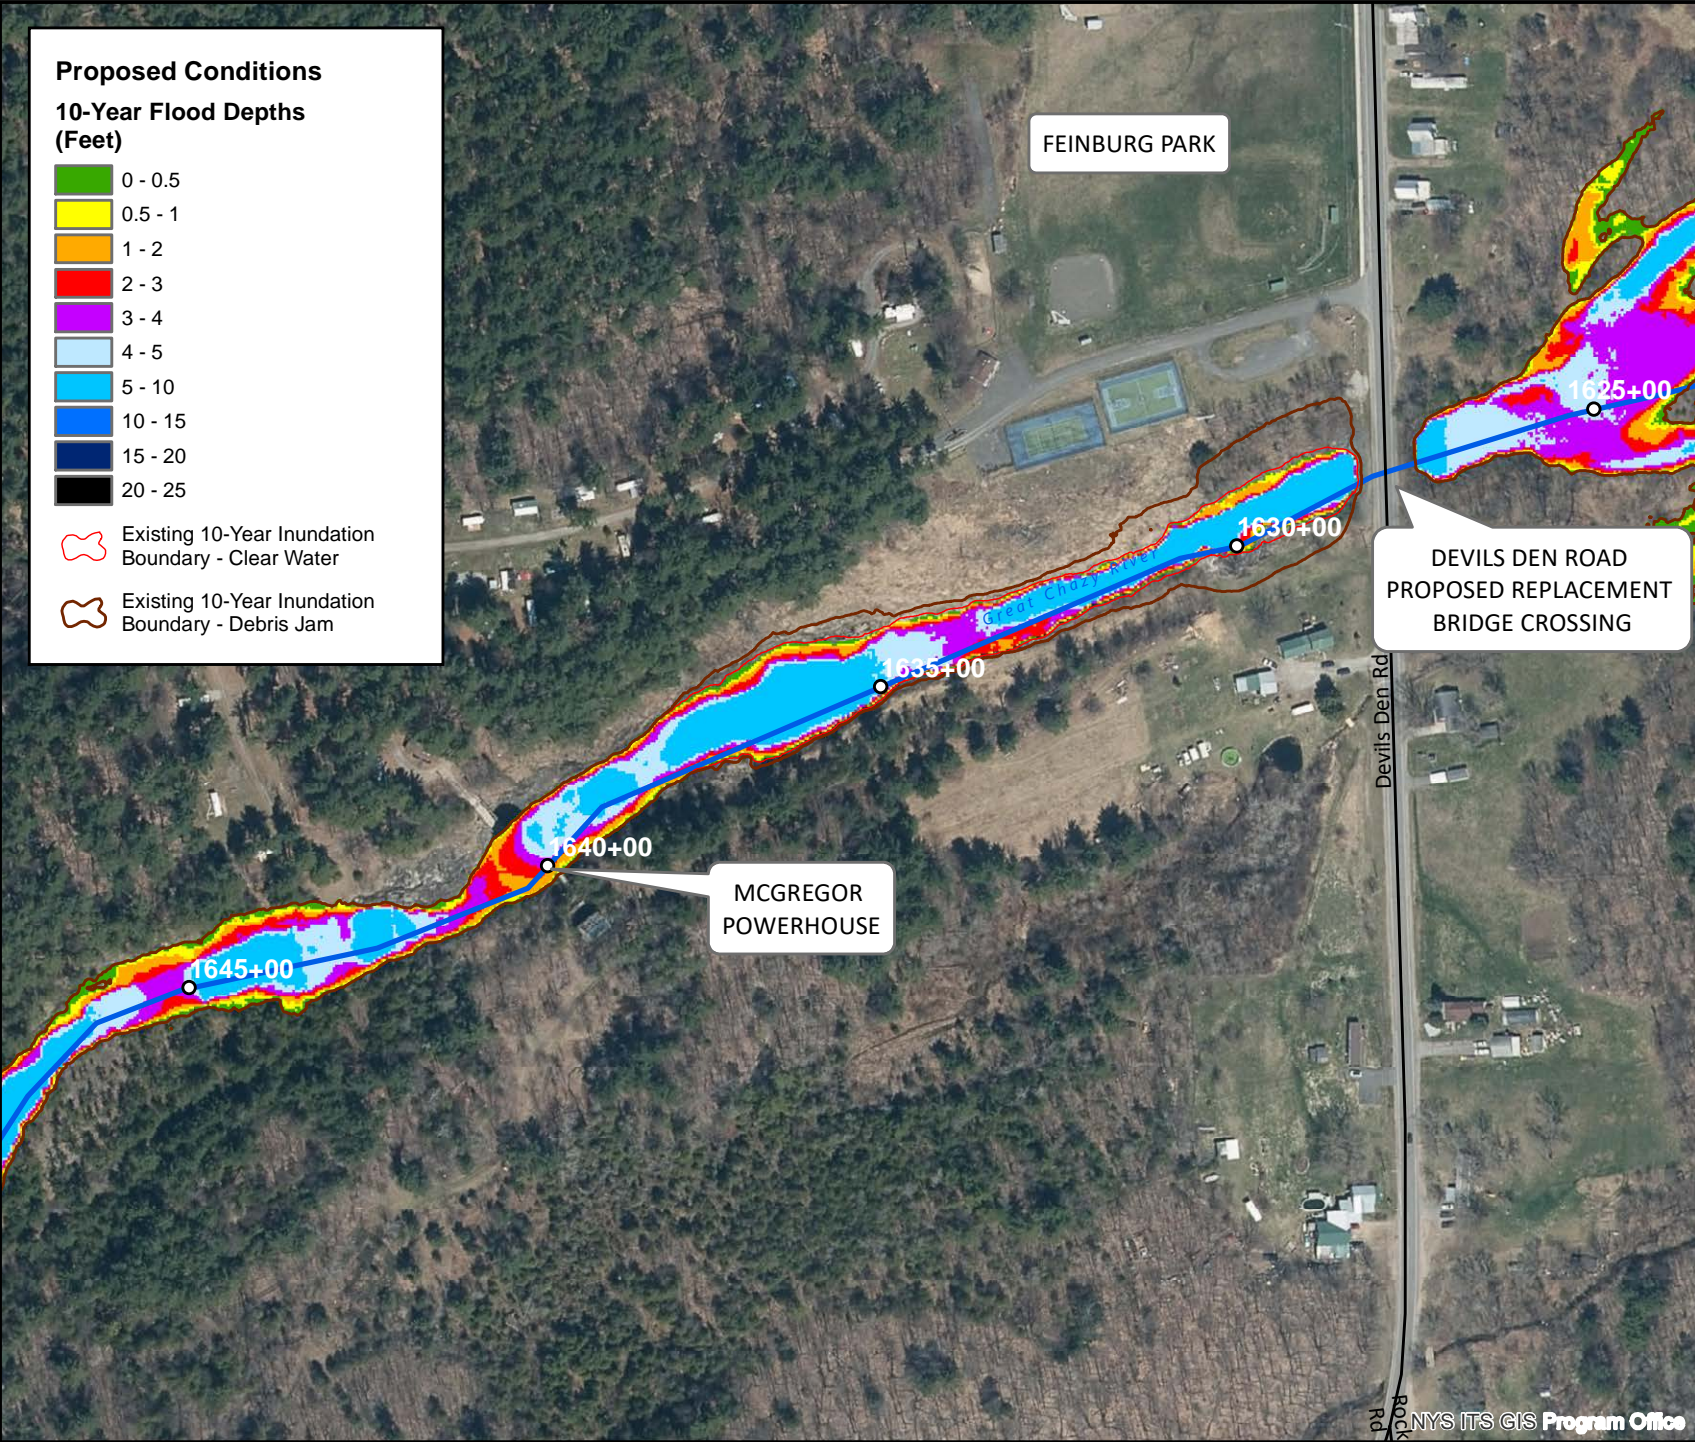
Proposed Conditions
10-Year Flood Depths (Feet)

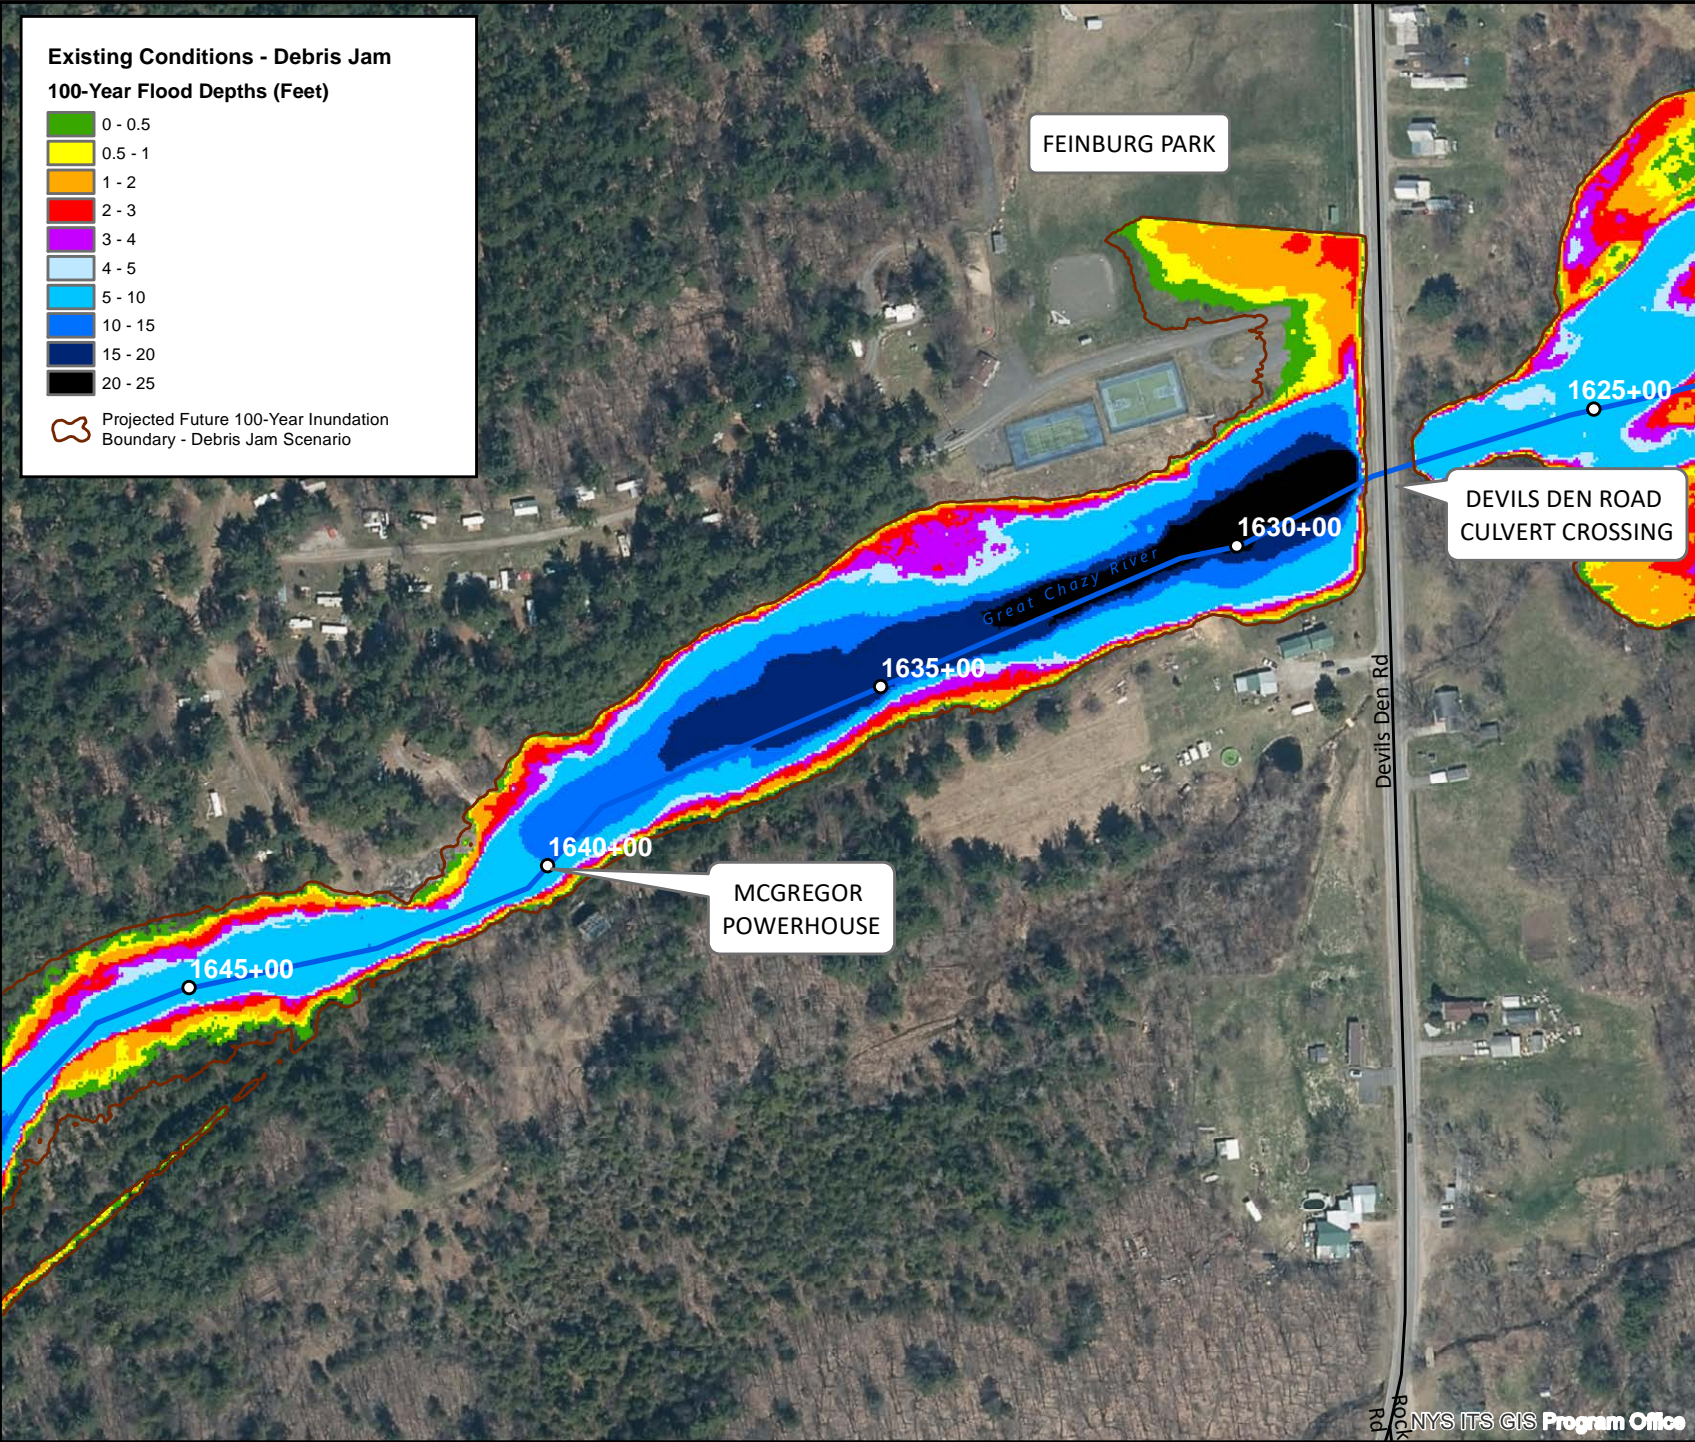
Existing Conditions - Debris Jam

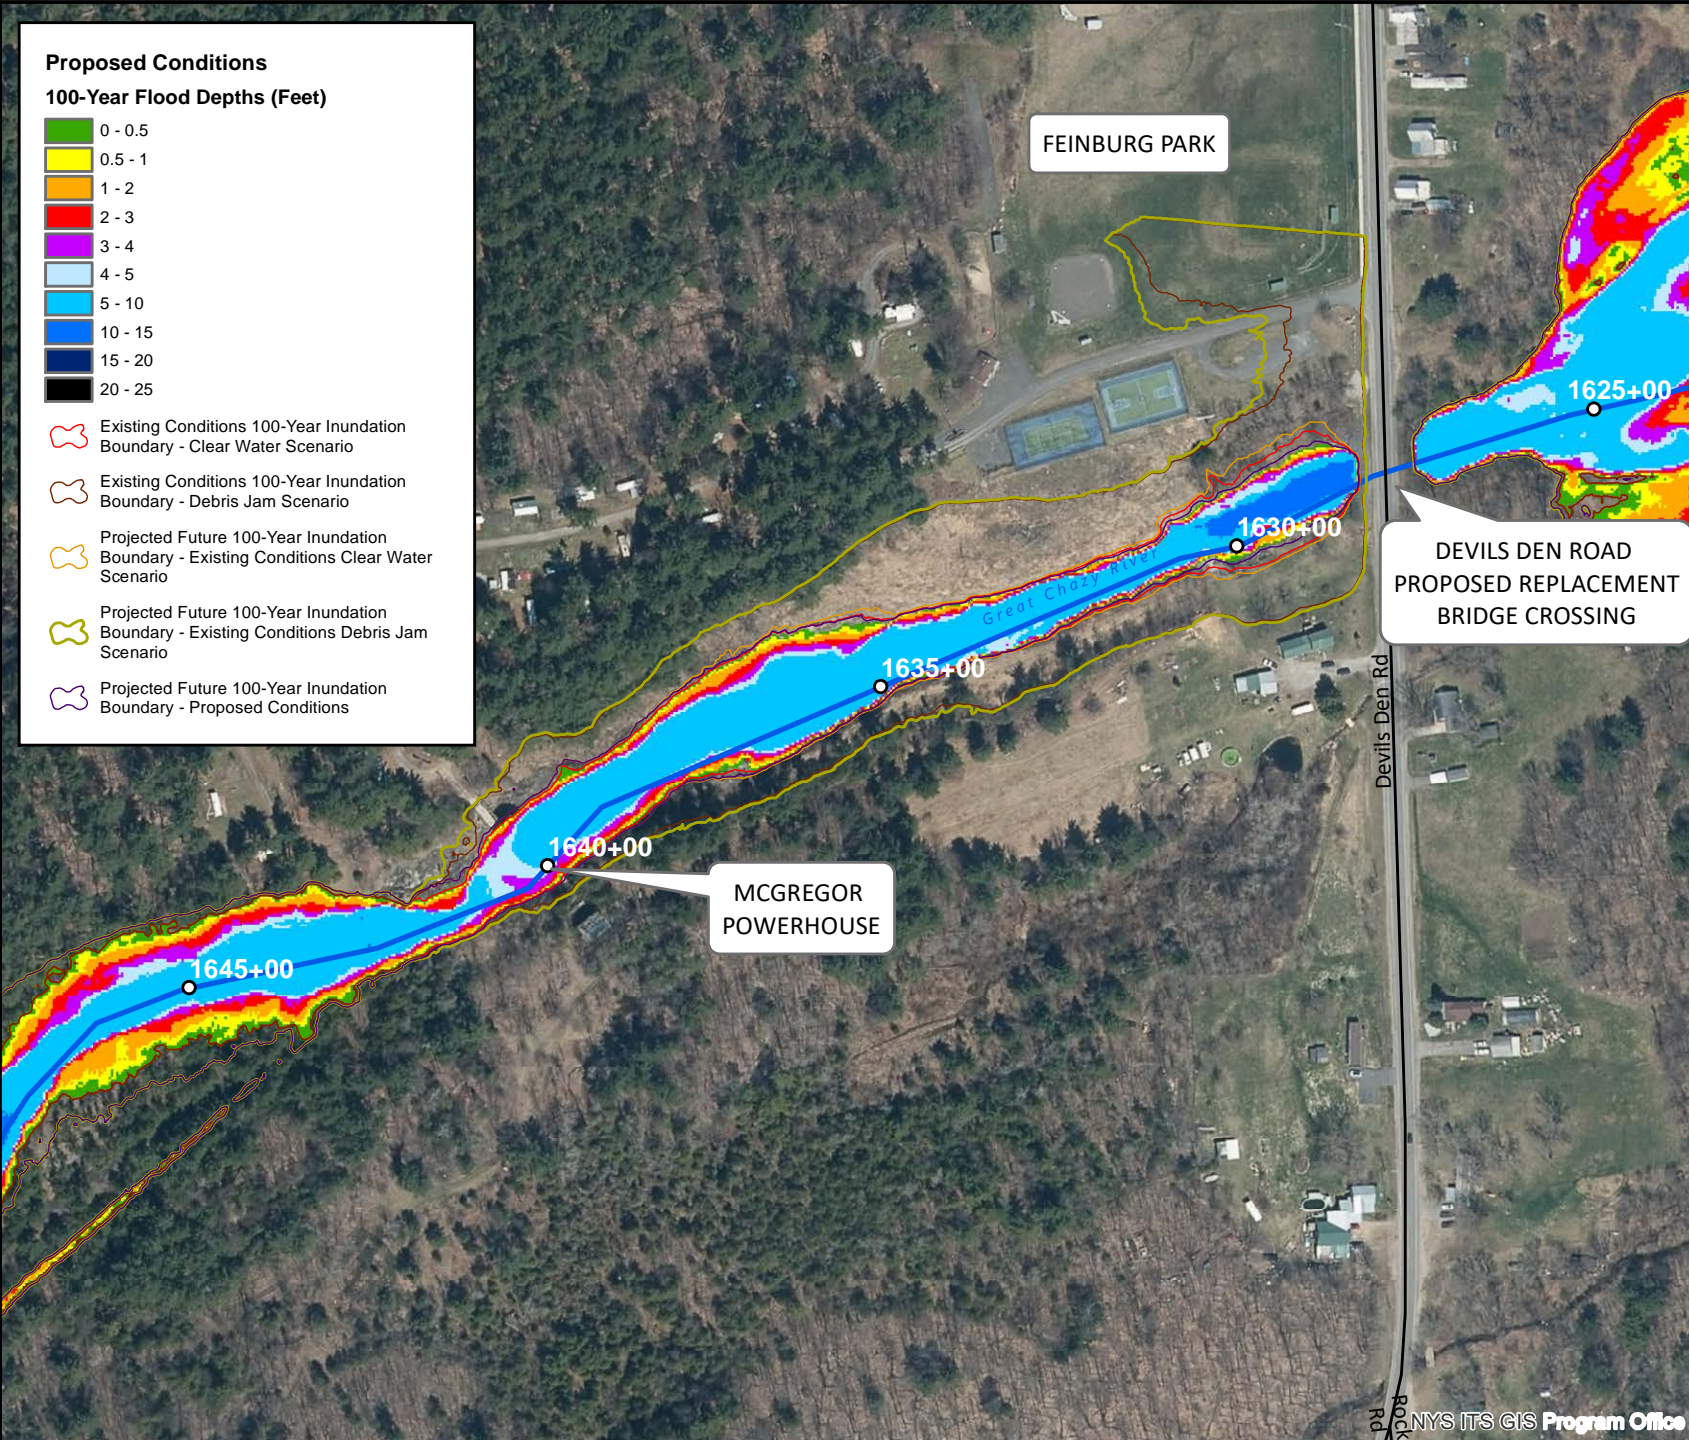
Proposed Conditions
100-Year Flood Depths (Feet)

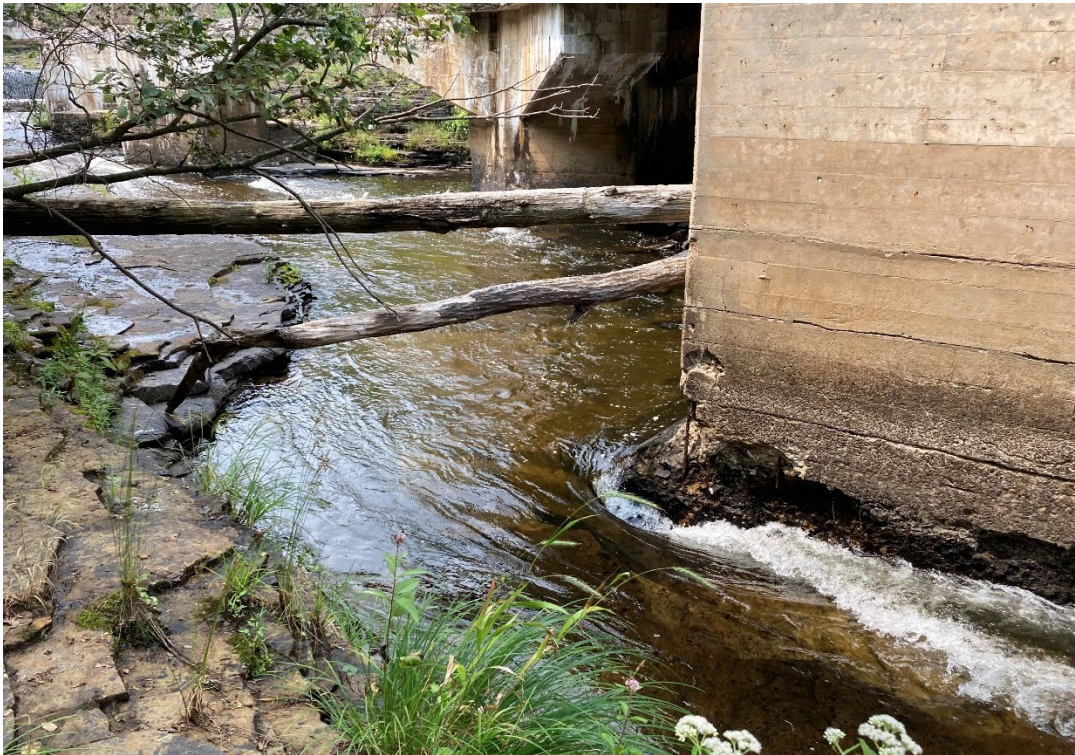
Figure 4-54: Upstream corner of McGregor Powerhouse. Note erosion of concrete and snagged woody debris.

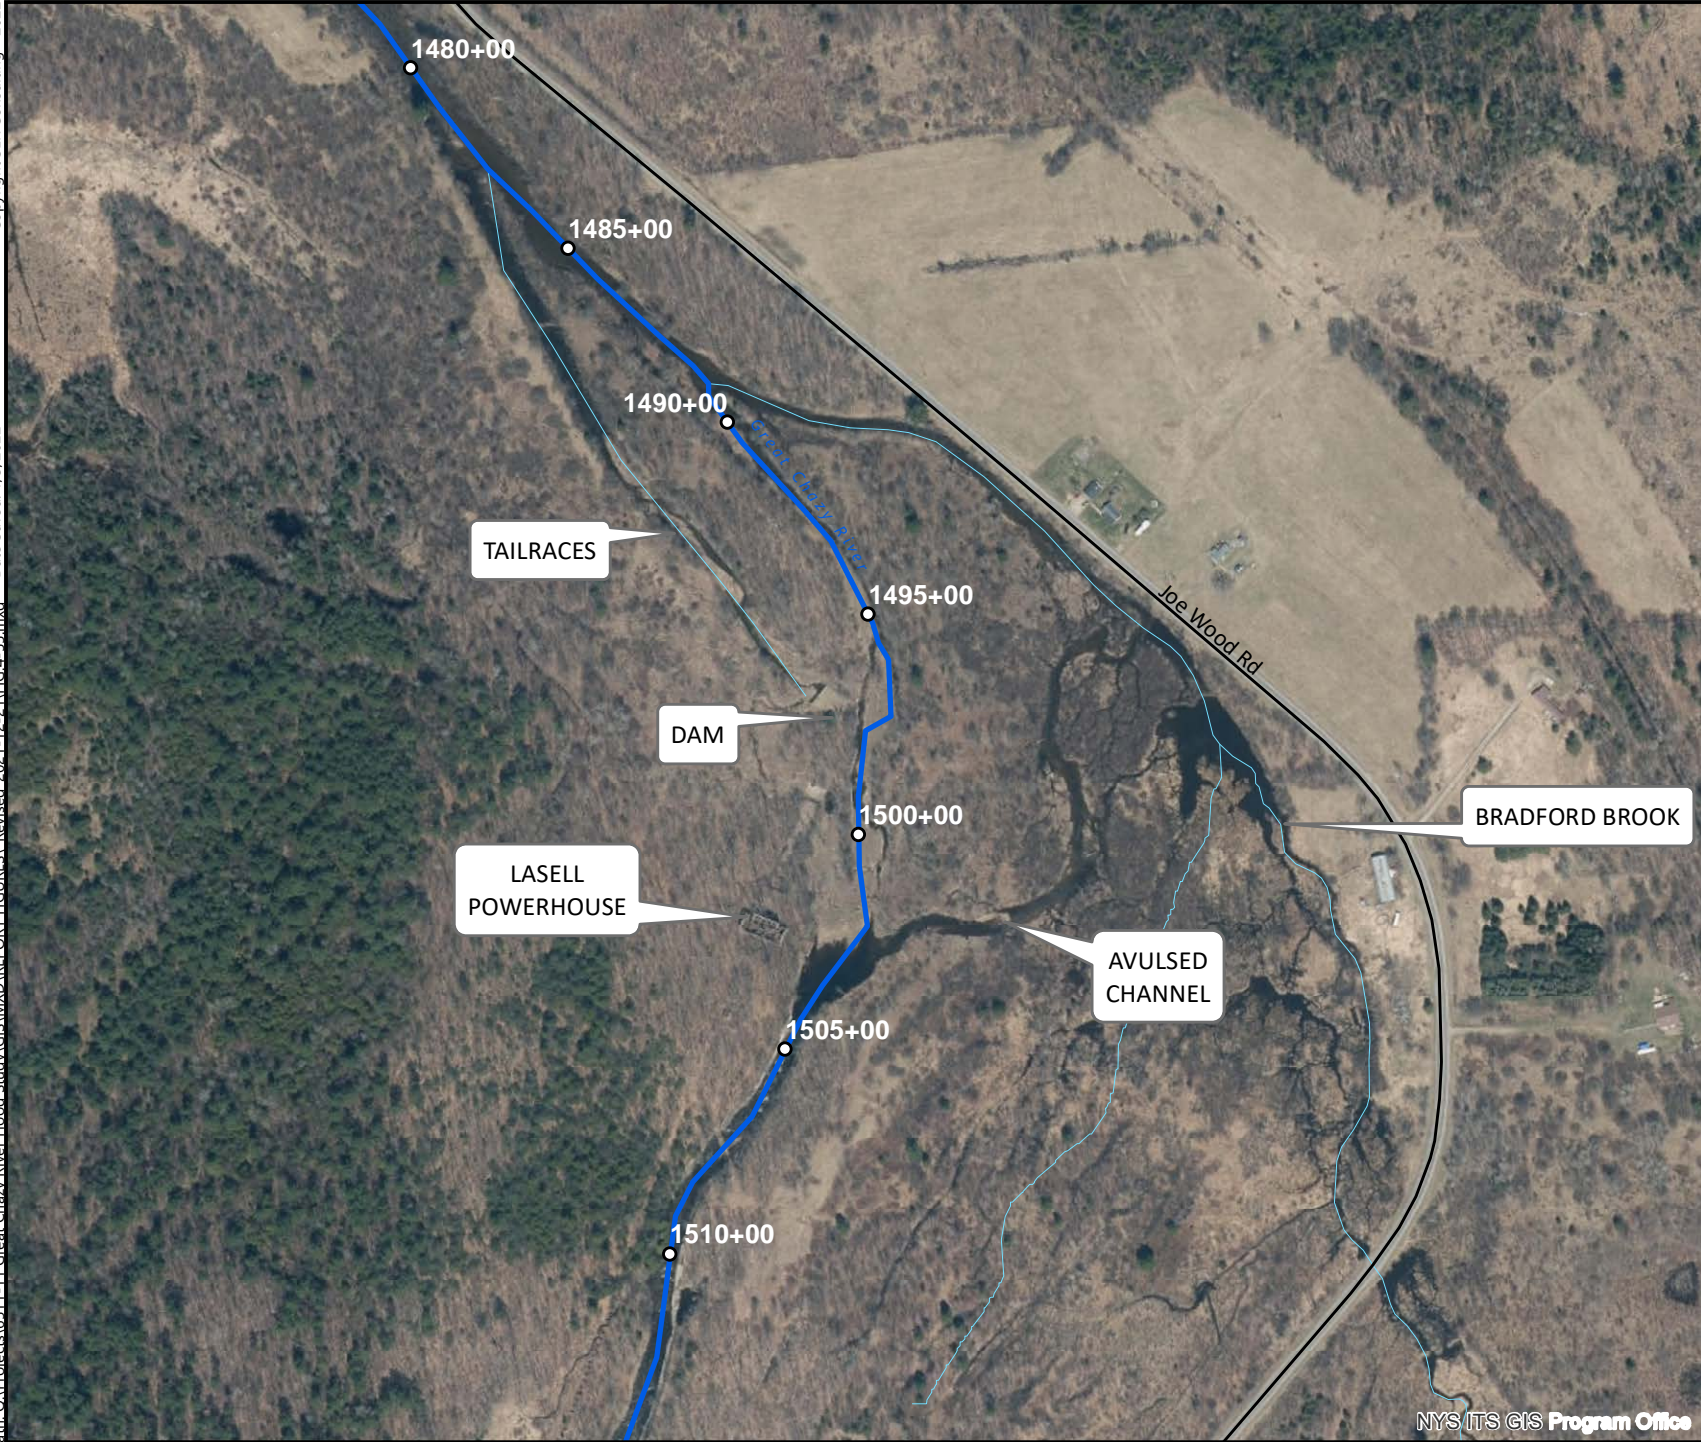
NYS ITS GIS Program Office

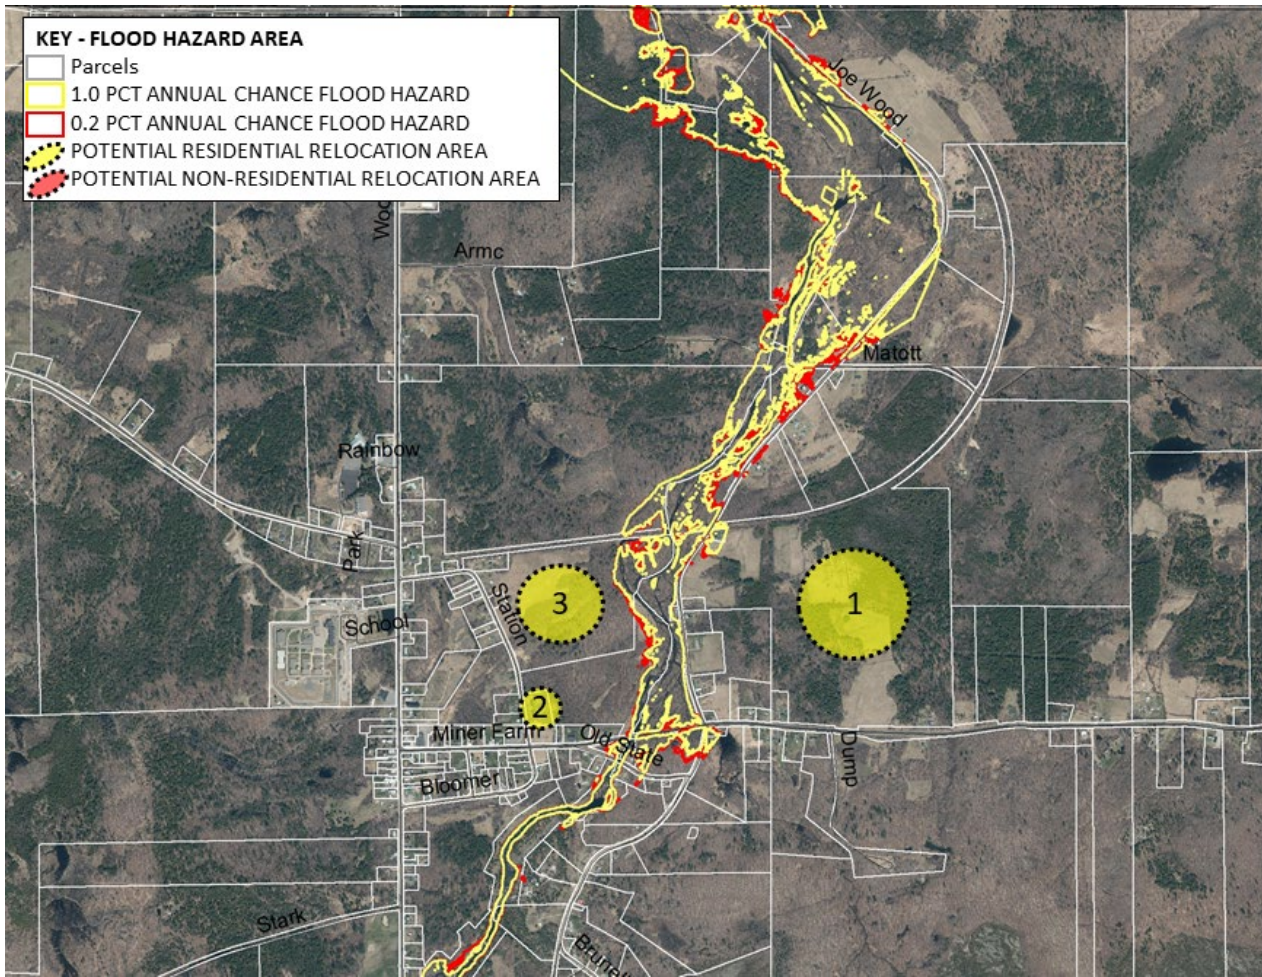
Figure 4-56: Conceptual relocation map for hamlet of Altona. See inset on previous page for descriptions.
