SLR
 231 MAIN STREET
 SUITE 102
 NEW PALTZ, NY 12561
 845.633.8153

HRA #2 - WHITESIDE DAM (1964 AERIAL IMAGE)
 GREAT CHAZY RIVER FLOOD & ICE JAM STUDY
 SD119
 CLINTON COUNTY
 NEW YORK

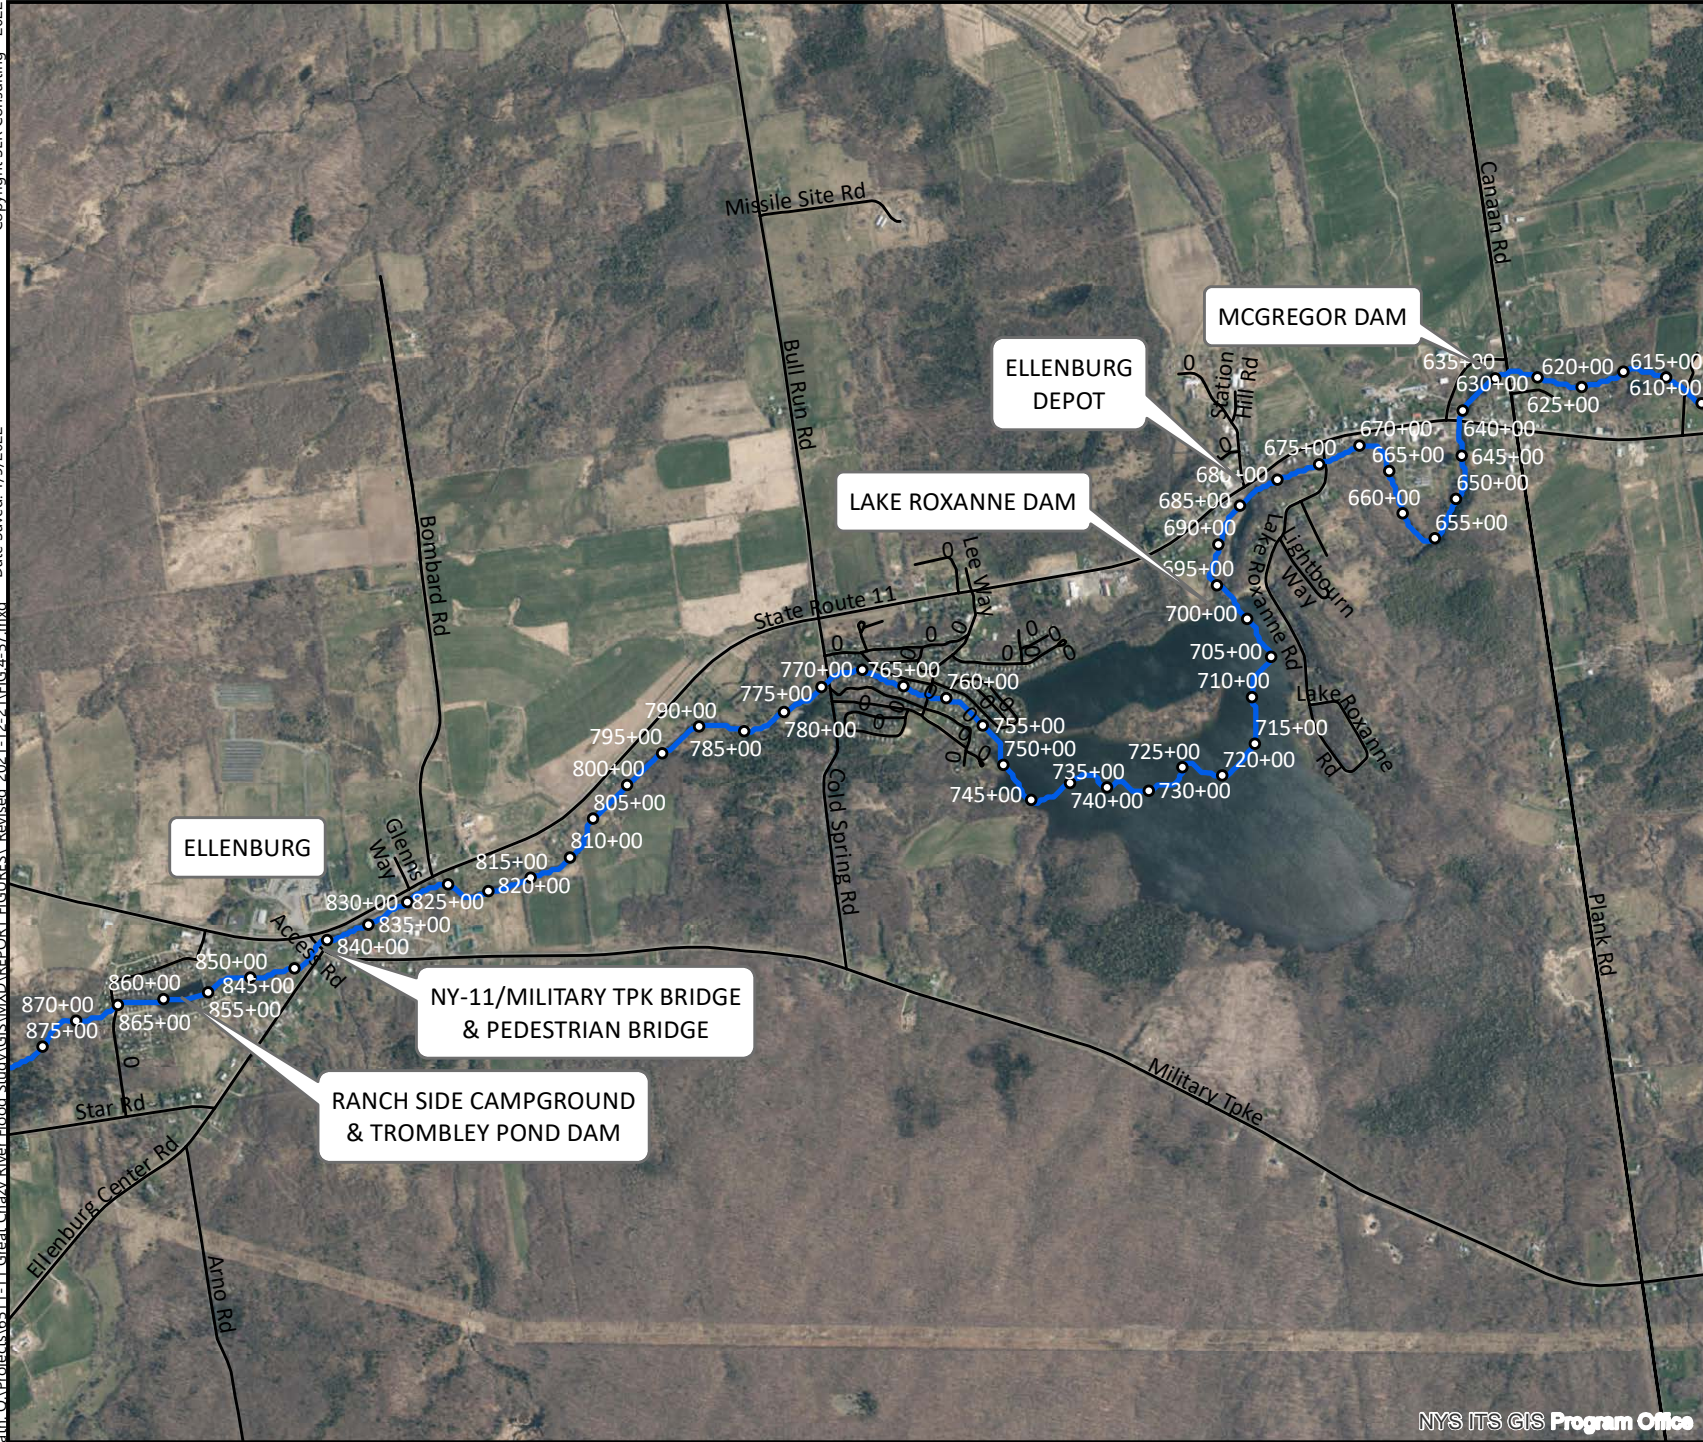
SLR
 231 MAIN STREET
 SUITE 102
 NEW PALTZ, NY 12561
 845.633.8153

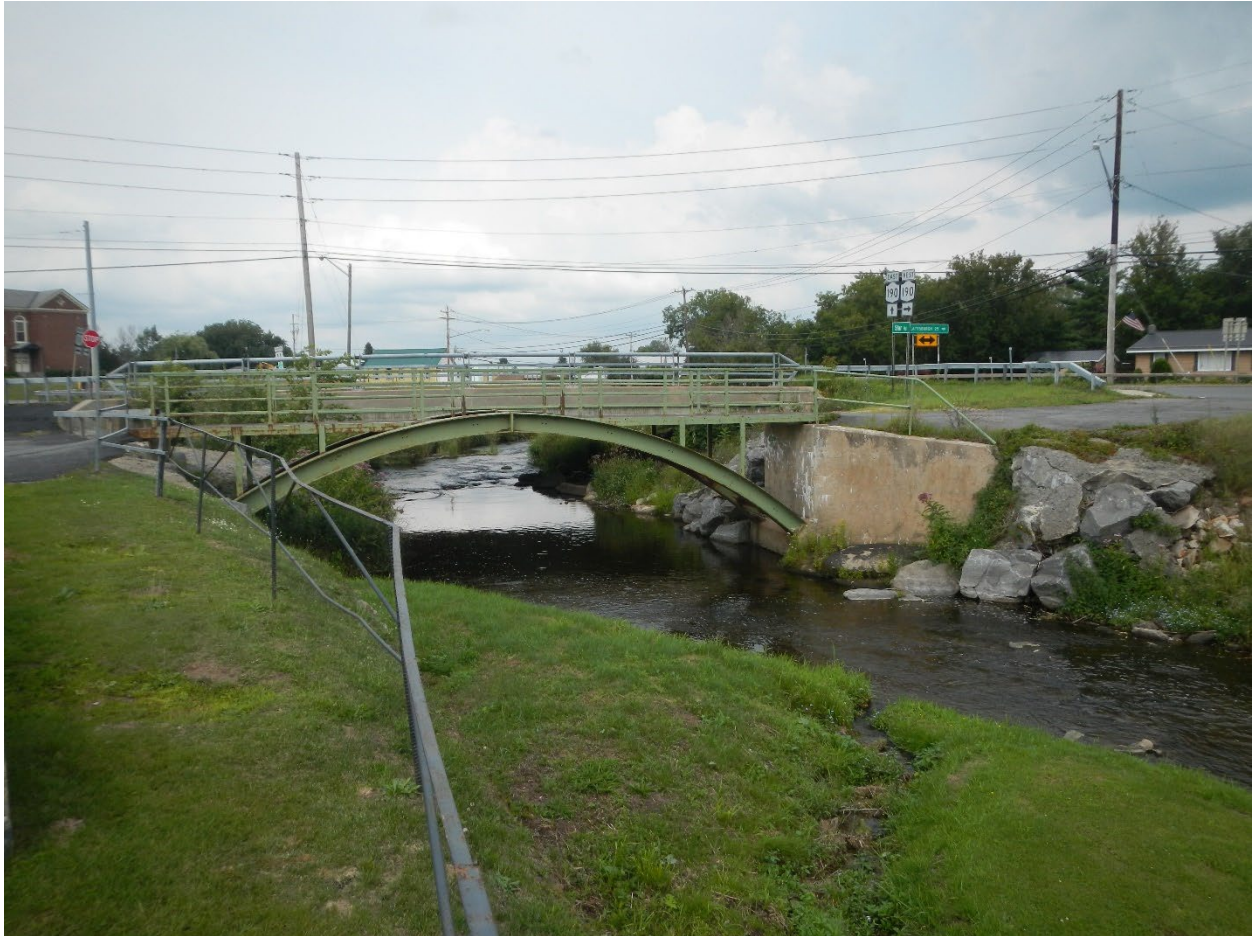
Figure 4-58: Steel Arch Pedestrian Bridge with NY-11/Military Turnpike Intersection Bridge in Background

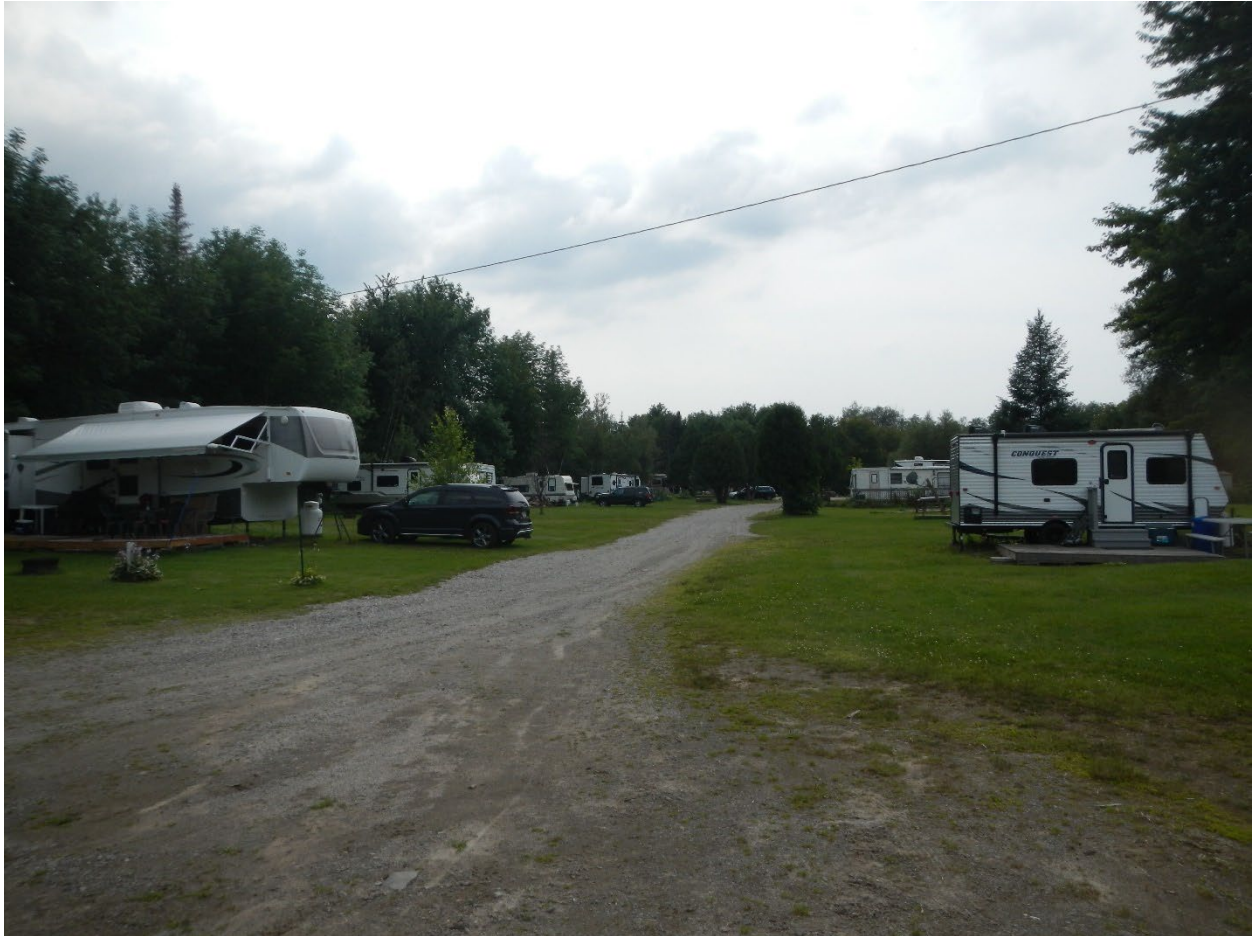
Figure 4-59: Campers and RVs in the North Branch Great Chazy River's right bank floodplain in the Ranch Side Campground. River is out of frame just to the right.

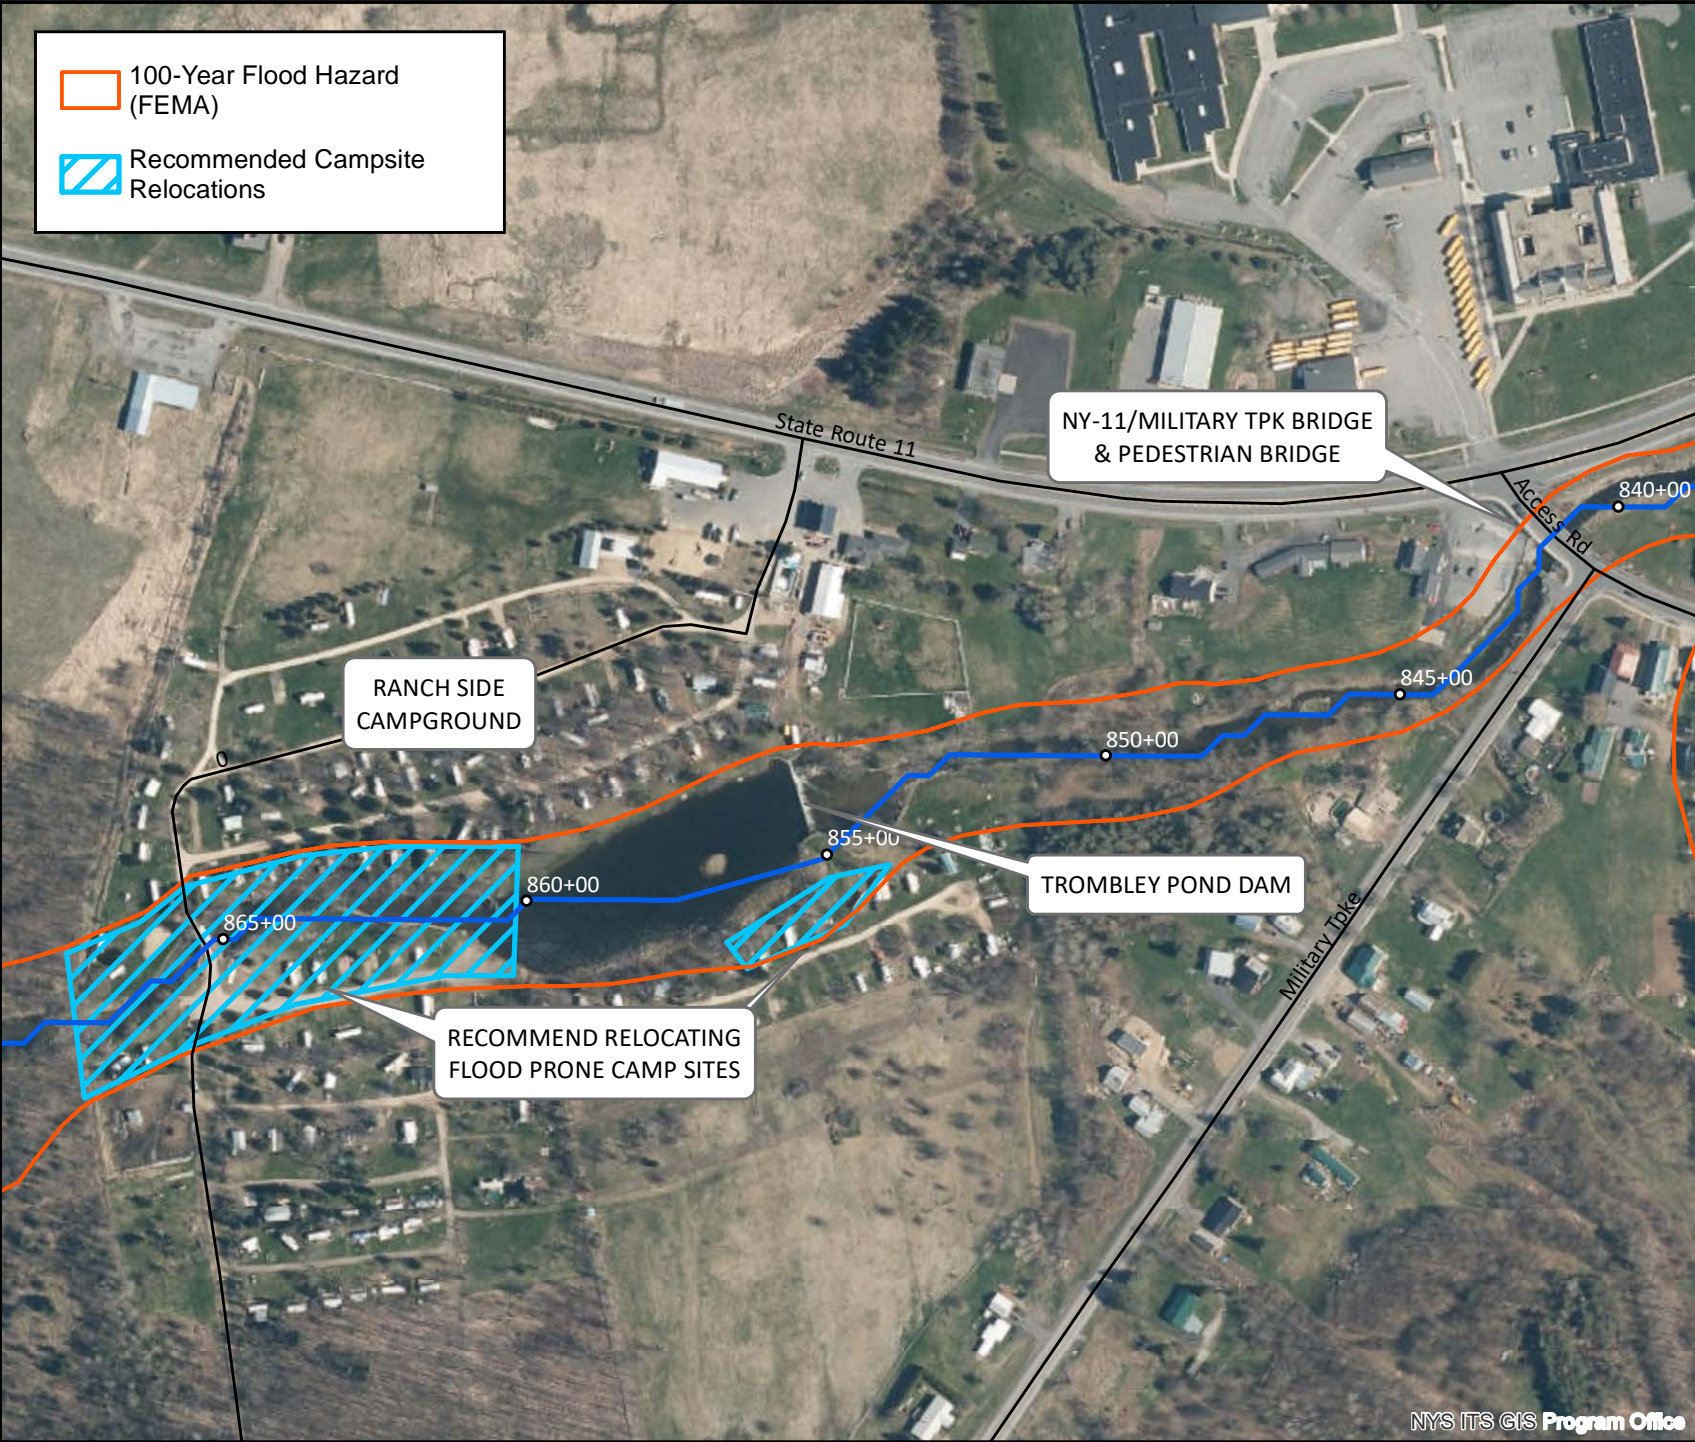
100-Year Flood Hazard (FEMA)
 Recommended Campsite Relocations

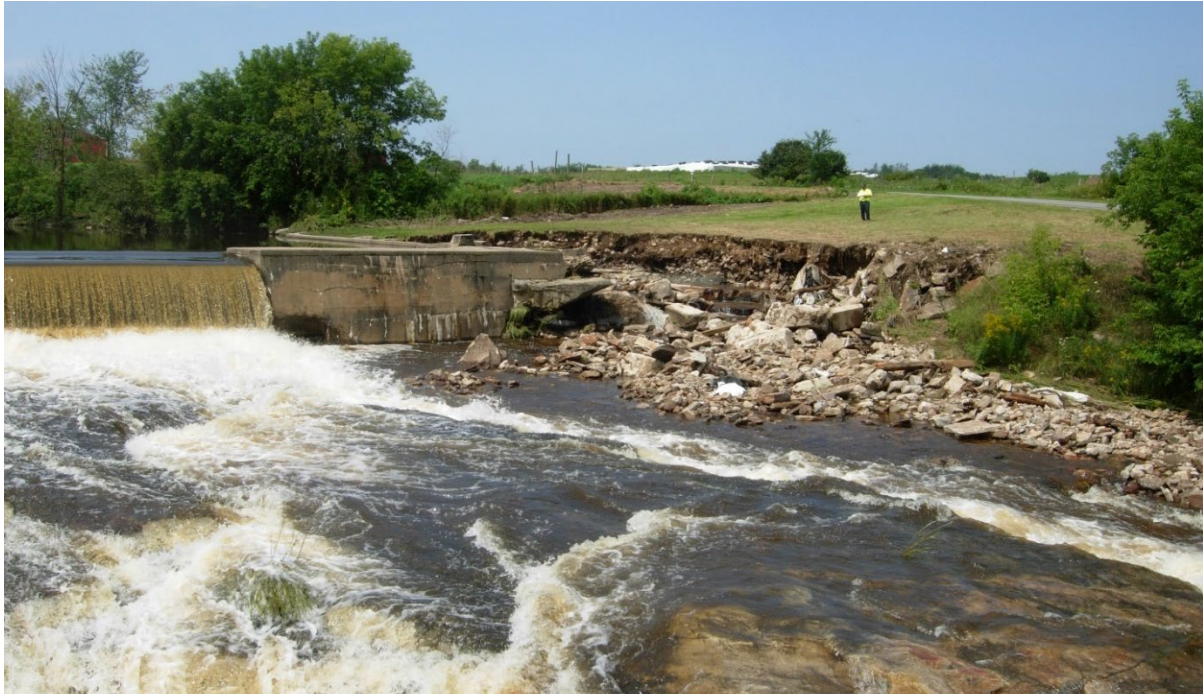
Figure 4-61: Overtopping during flooding in August 2010 caused washout of left embankment and undermining of abutment of McGregor Dam near the Canaan Road bridge in Ellenburg Depot. Photo is provided by Clinton County Emergency Services.

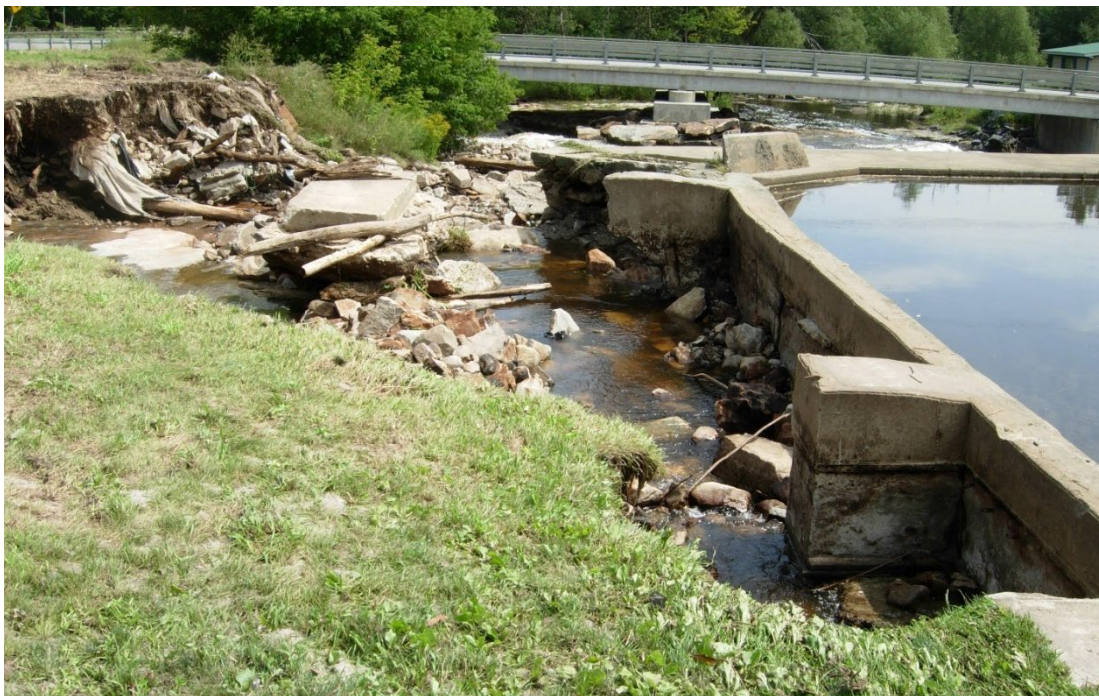
Figure 4-62: Damage to McGregor Dam on North Branch Great Chazy River due to overtopping in August 2010. Canaan Road bridge is in background. Photo is provided by Clinton County Emergency Services.

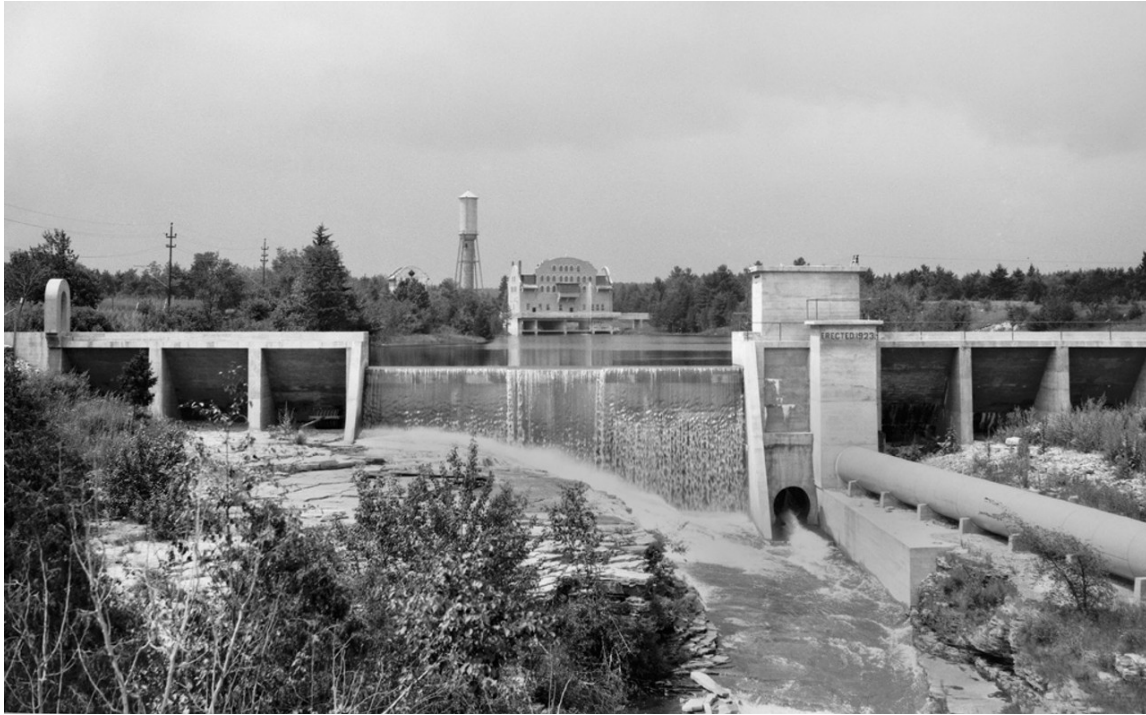
Figure 4-63: LaSell Dam on the Great Chazy River in the 1920s. McGregor Powerhouse is in background.

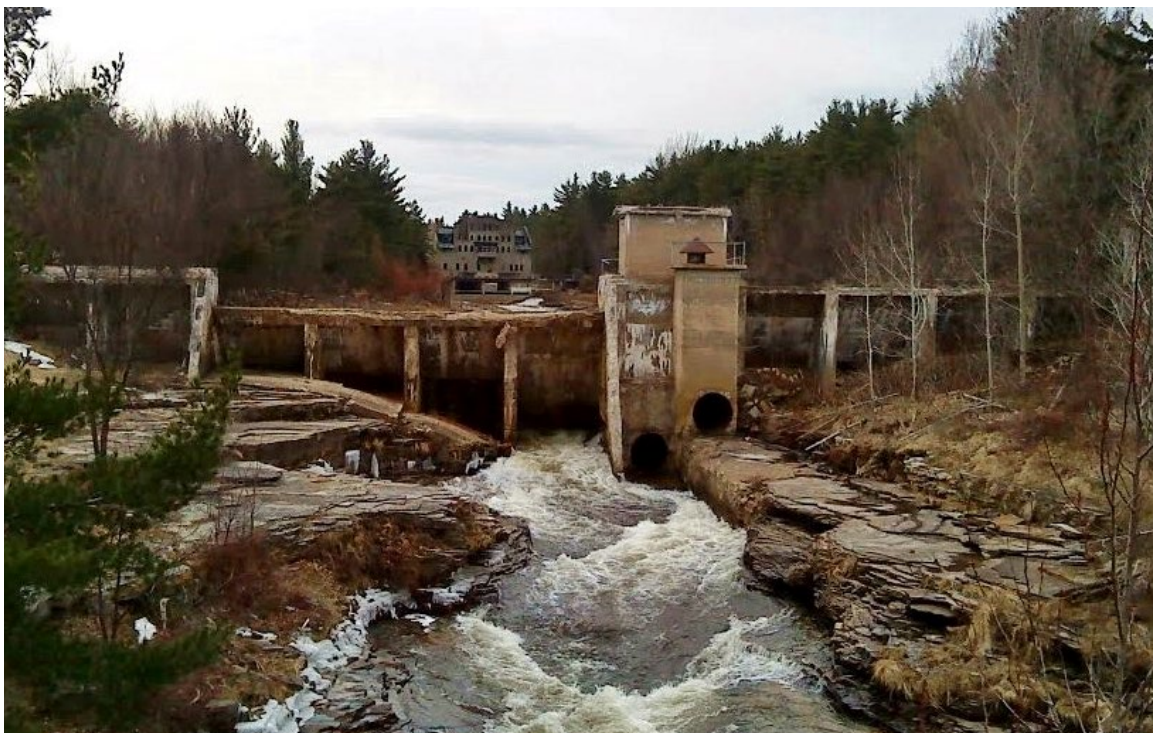
Figure 4-64 – LaSell Dam in 2007. The hydroelectric project was abandoned in the late 1950s – early 1960s and the penstocks and turbines sold for scrap. Note severe deterioration and evidence of alkali-silica reaction in the structural concrete and that one of the slabs in the primary spillway section had failed.

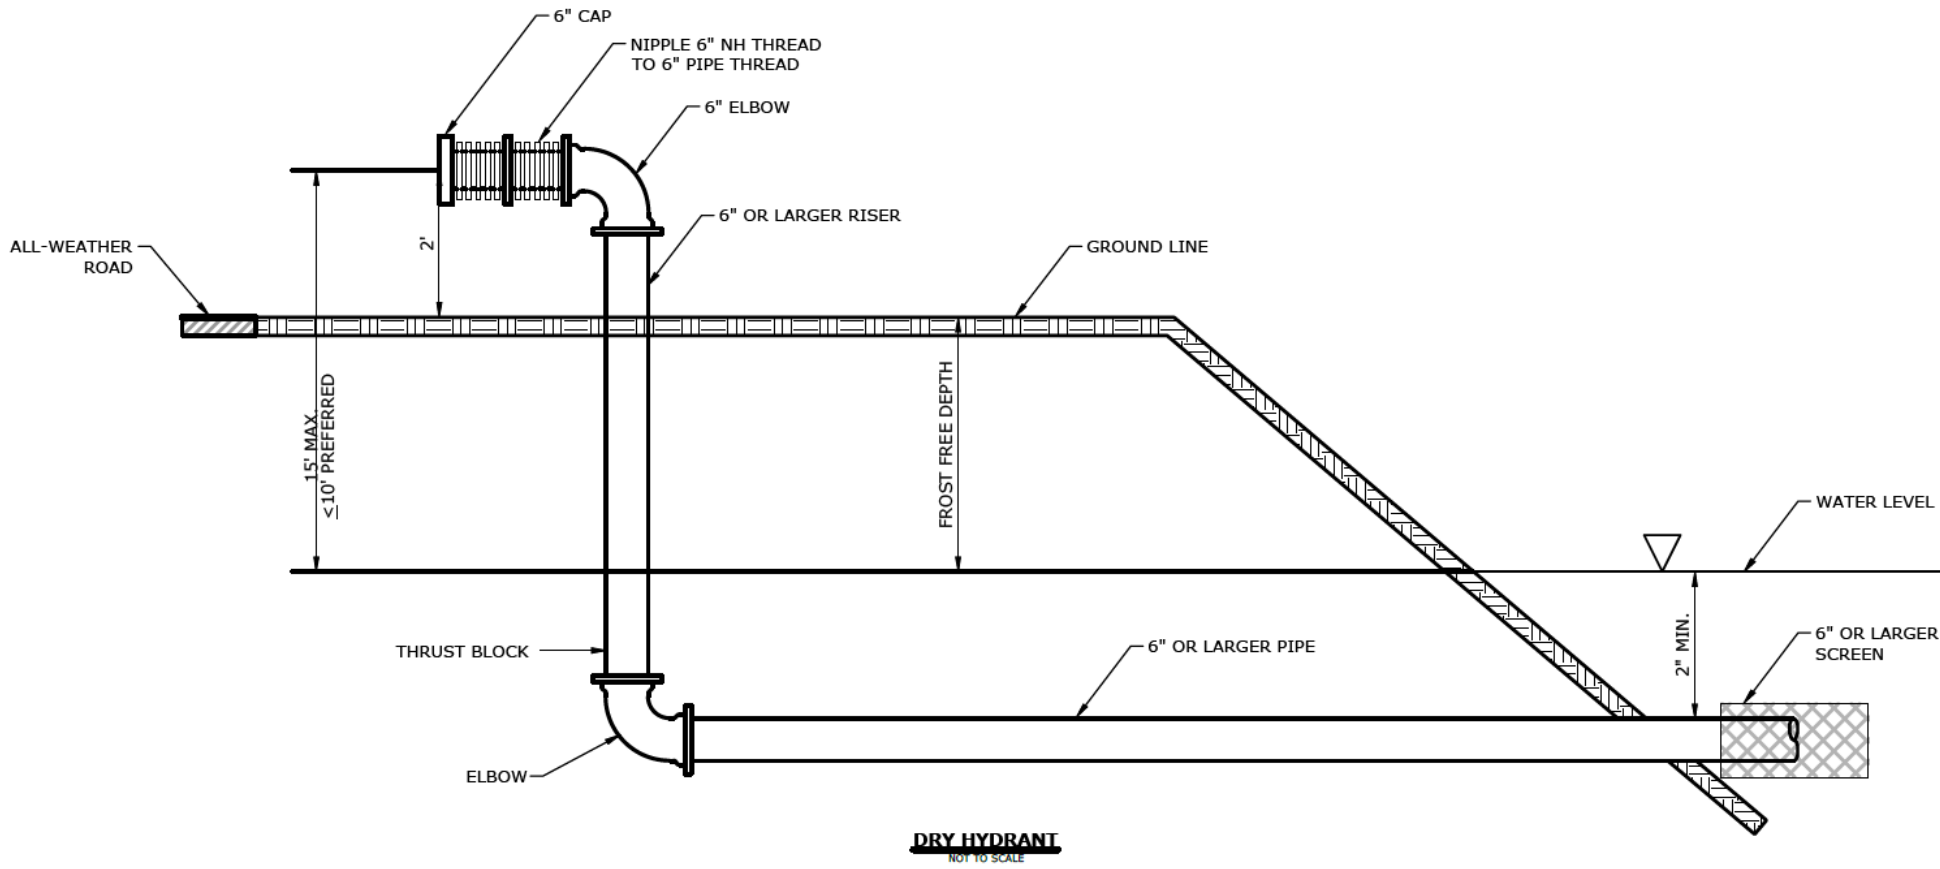
Figure 4-65: Typical Dry Hydrant Detail

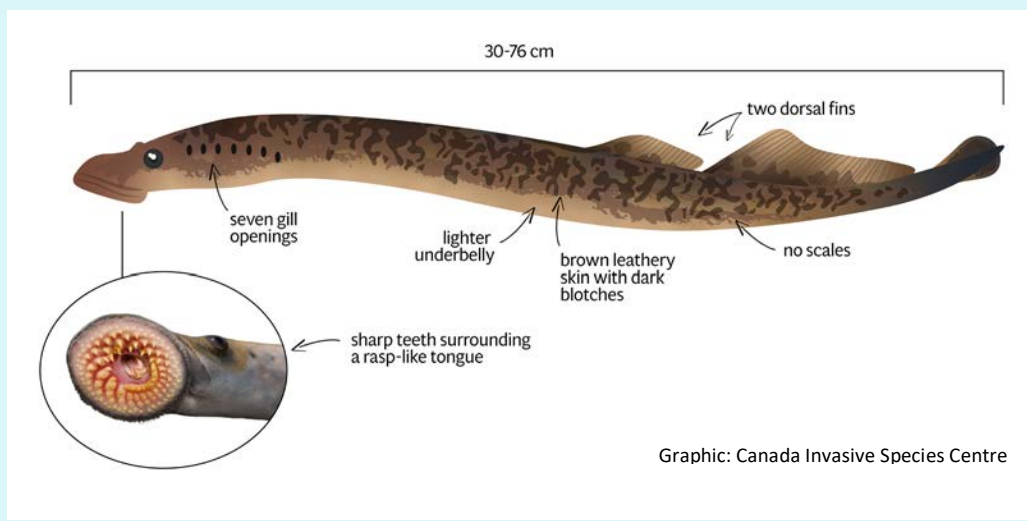
4.7 OTHER STRUCTURES IN THE GREAT CHAZY WATERSHED

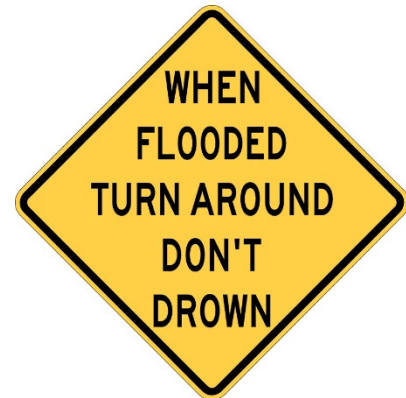
One way to reduce the risks associated with the flooding of roadways is their closure during flooding events, which requires effective signage, road closure barriers, and consideration of alternative routes.

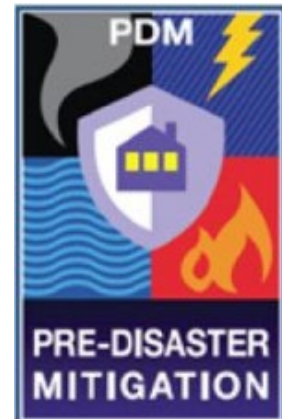
FEMA Hazard Mitigation Grant Program (HMGP)

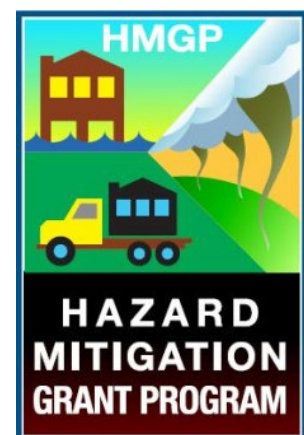
The HMGP is one of the FEMA programs with the greatest possible fit to potential projects recommended in this report. However, it is available only in the months subsequent to a federal disaster declaration in the State of New York. Because the state administers the HMGP directly, application cycles will need to be closely monitored after disasters are declared in New York.

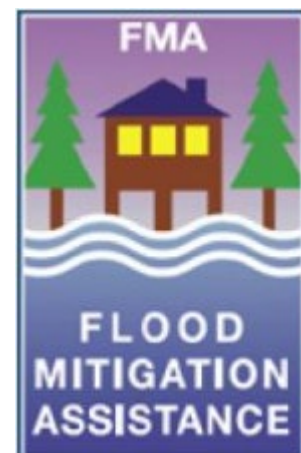
The Biggert-Waters Flood Insurance Reform Act of 2012 eliminated the Repetitive Flood Claims (RFC) and Severe Repetitive Loss (SRL) programs and made the following significant changes to the FMA program:
