REMEDIAL COMPLETION REPORT

Service Station #10954 (17-HMB)

138-50 Hillside Avenue

NYSDEC Spill No. 01-01410

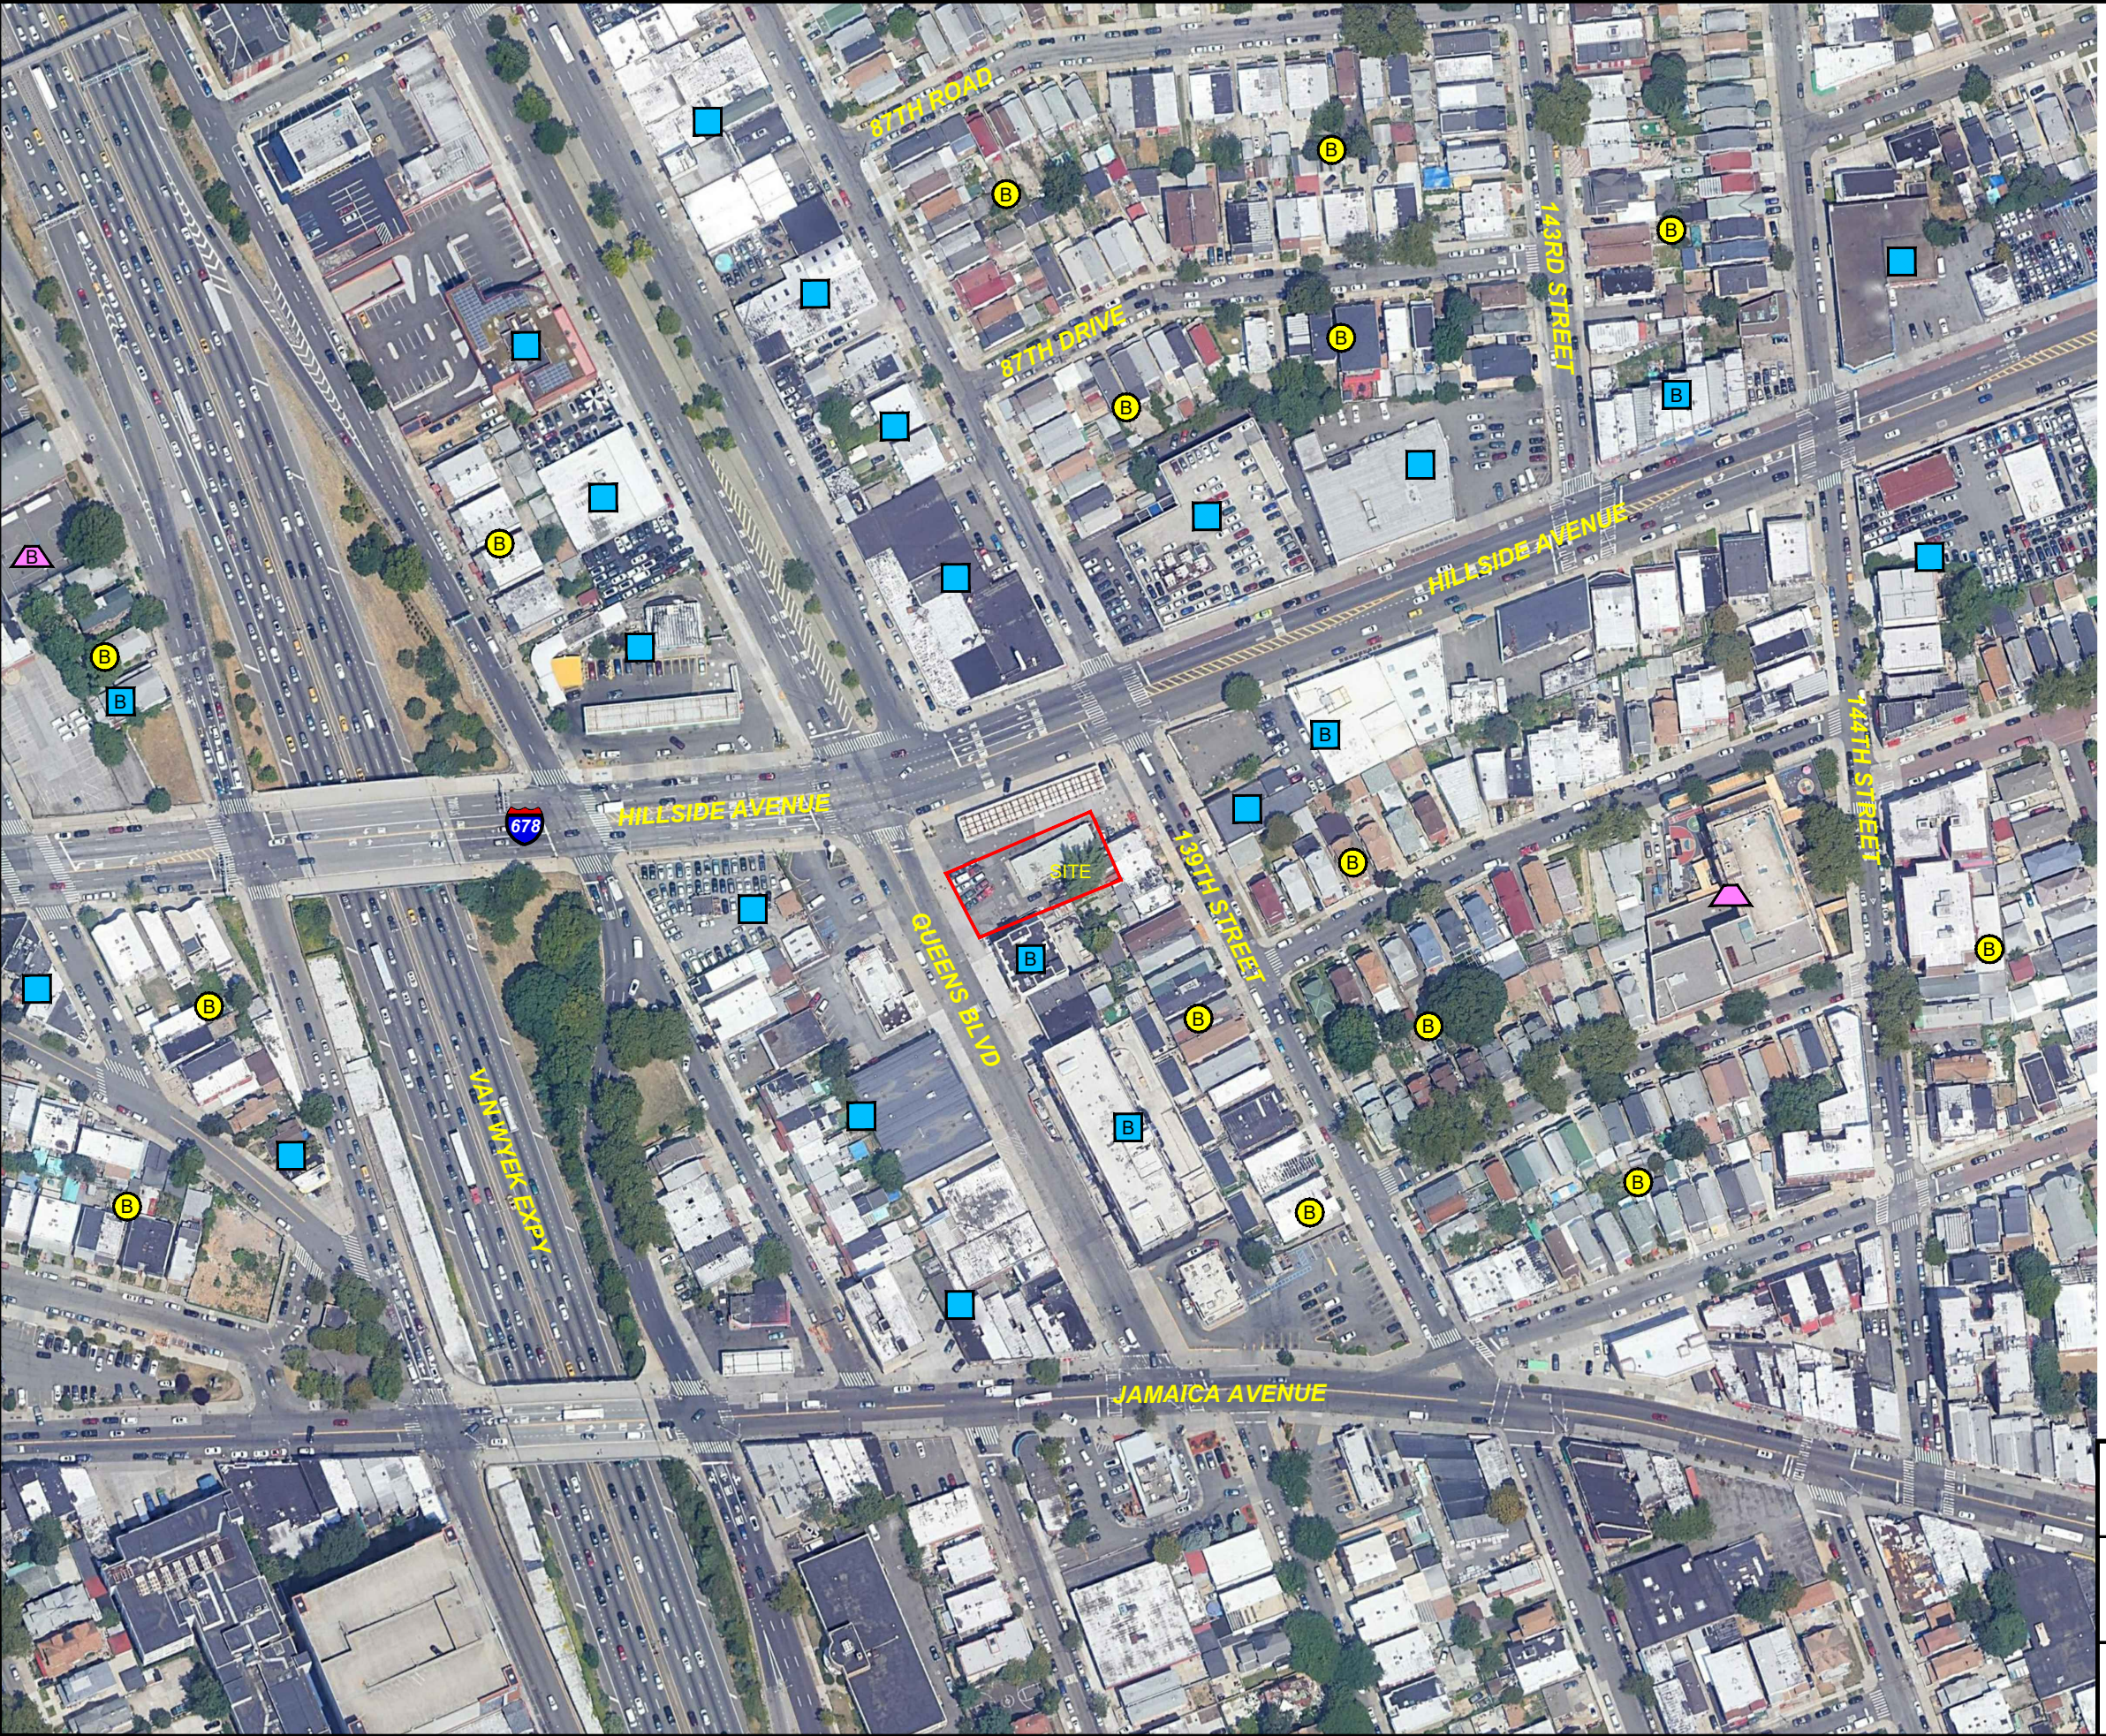
SURROUNDING LAND USE MAP

Figure 3. Surrounding Land Use Map

The 0.5-acre site is an active petroleum filling station with an automobile repair facility and a convenience store located at 138-50 Hillside Avenue, Jamaica, New York. The approximate geographical coordinates for the site are 40 degrees, 42 minutes, and 13.8 seconds North (Latitude) by 73 degrees, 48 minutes, and 55.3 seconds West (Longitude) and the approximate ground surface elevation is 61 feet above mean sea level (amsl) (Kleinfelder 2008; GES 2010; Arcadis 2012). The surrounding area consists of commercial businesses and residential properties with basements (Figure 3).

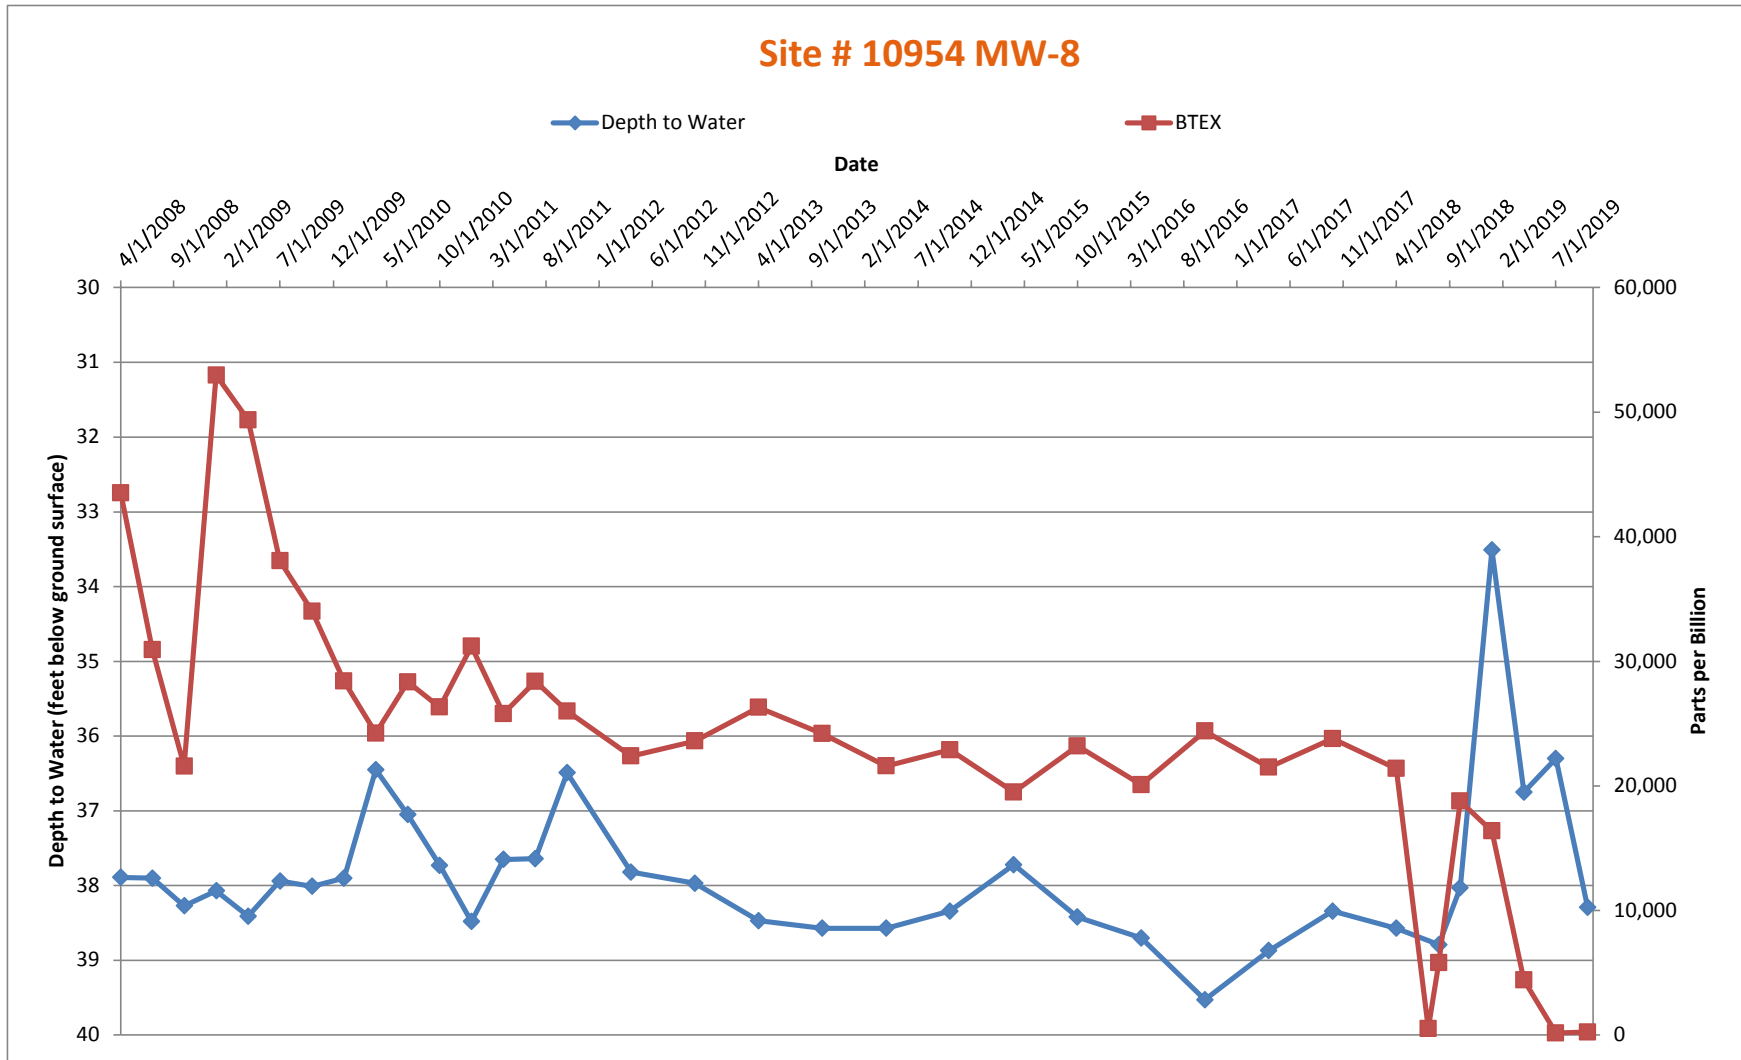
Figure 12
 MW-8 Hydrograph
 April 30, 2008 through October 28, 2019

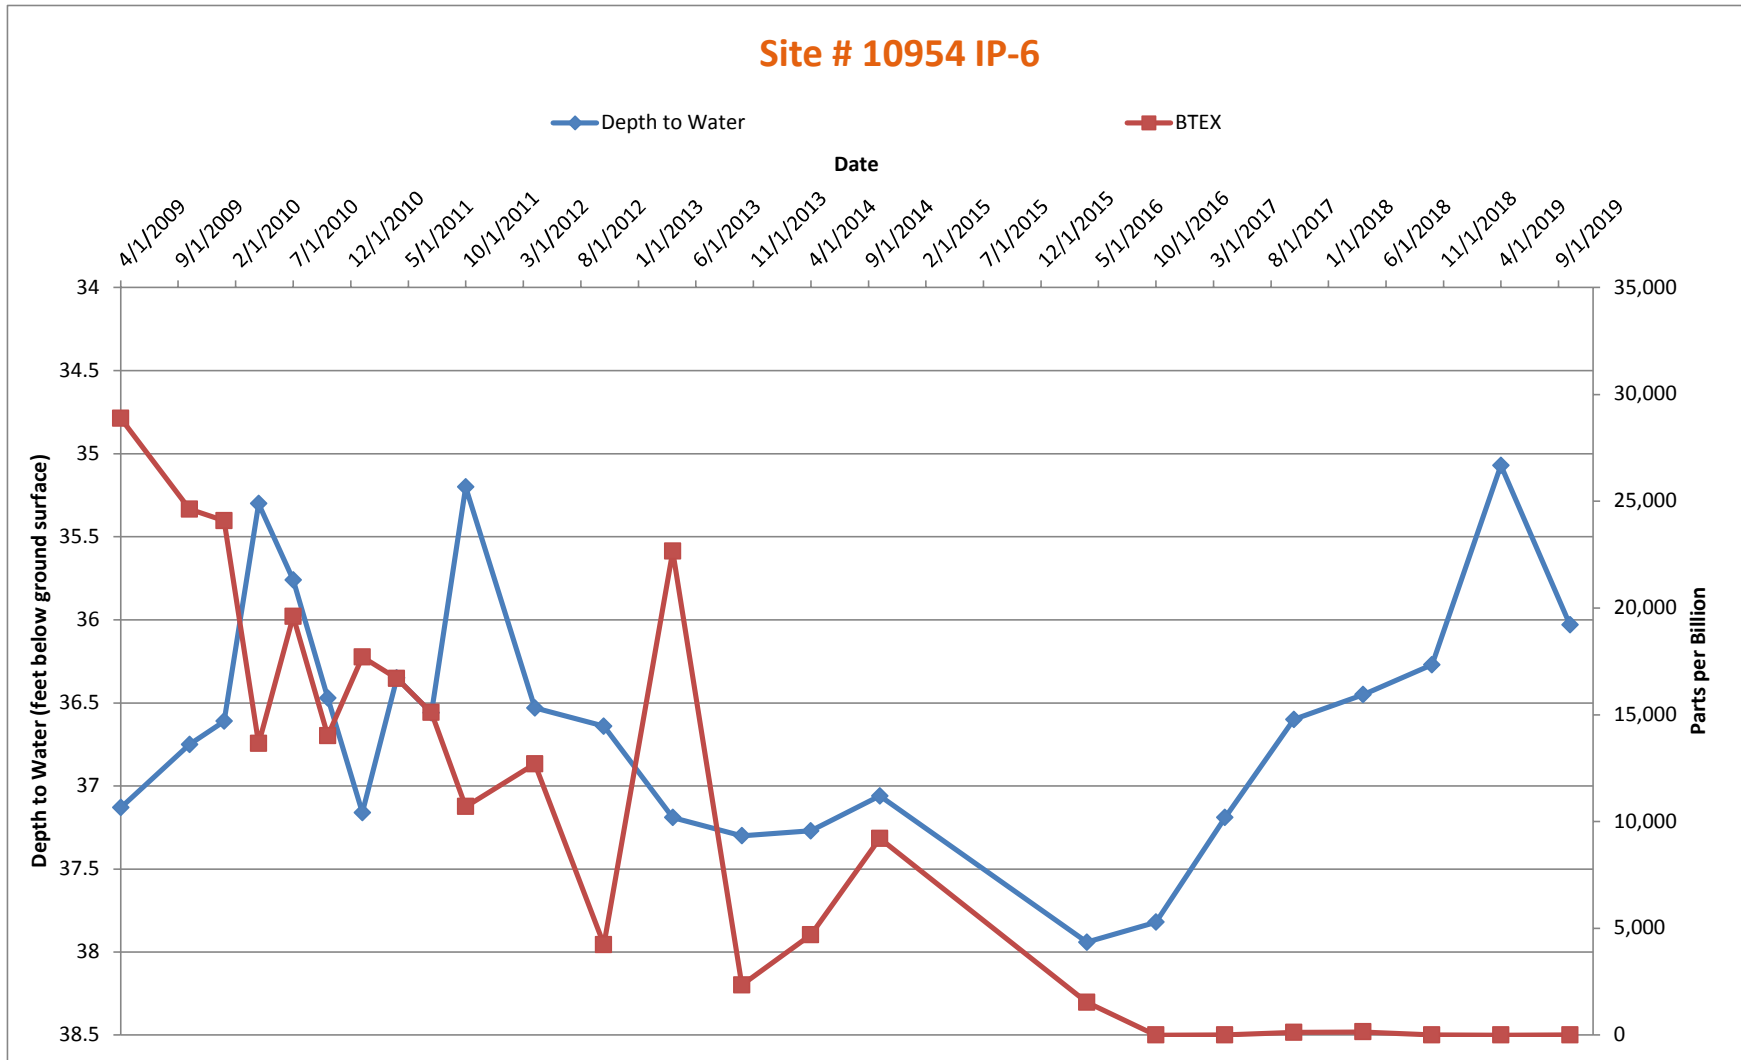
Figure 16
 IP-6 Hydrograph
 April 8, 2009 through October 28, 2019
