**SUPPLEMENTAL INFORMATION  
PURSUANT TO ASTM STANDARDS  
NEW YORK STATE  
SITE REGISTRY DELISTING PETITION  
789 SOUTH BROADWAY,  
HICKSVILLE, NEW YORK**

SUPPLEMENTAL INFORMATION PURSUANT TO ASTM STANDARDS  
NEW YORK STATE SITE REGISTRY DELISTING PETITION  
789 SOUTH BROADWAY (LINDEN TREE SITE)  
HICKSVILLE, NEW YORK

DVIRKA AND BARTILUCCI CONSULTING ENGINEERS  
SYOSSET, NEW YORK

APRIL 1994

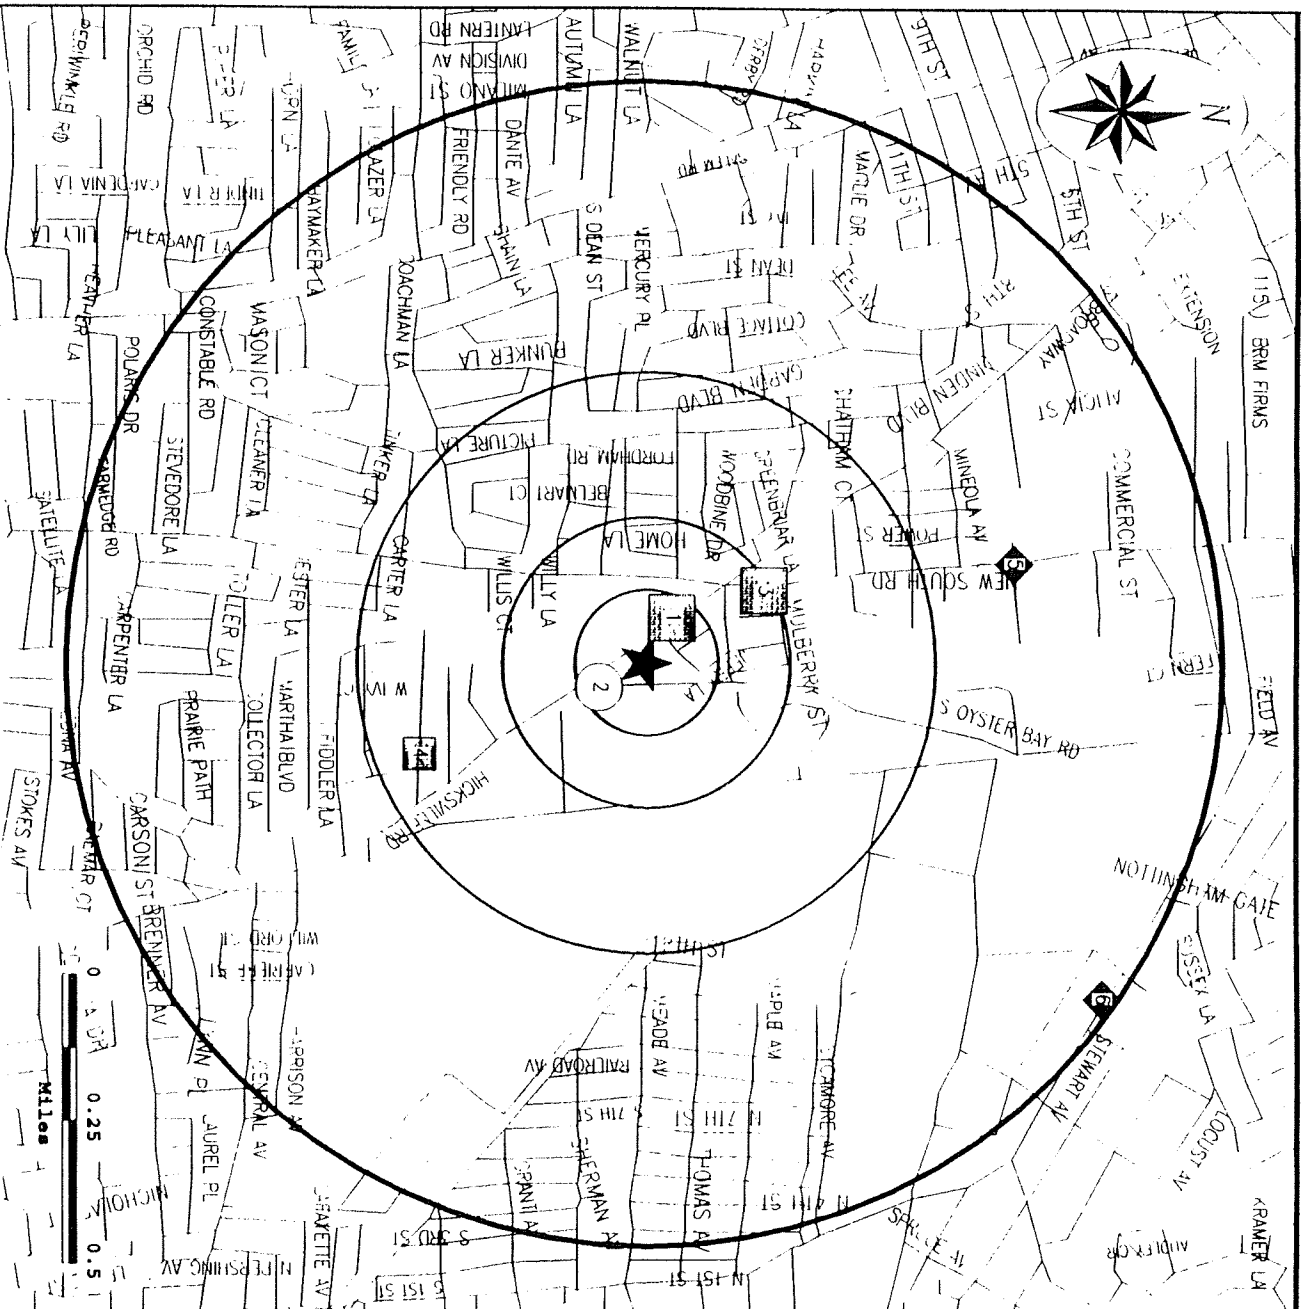
## Map of Risks Within One Mile

Subject Site      Databases Searched to:

★      Single Sites

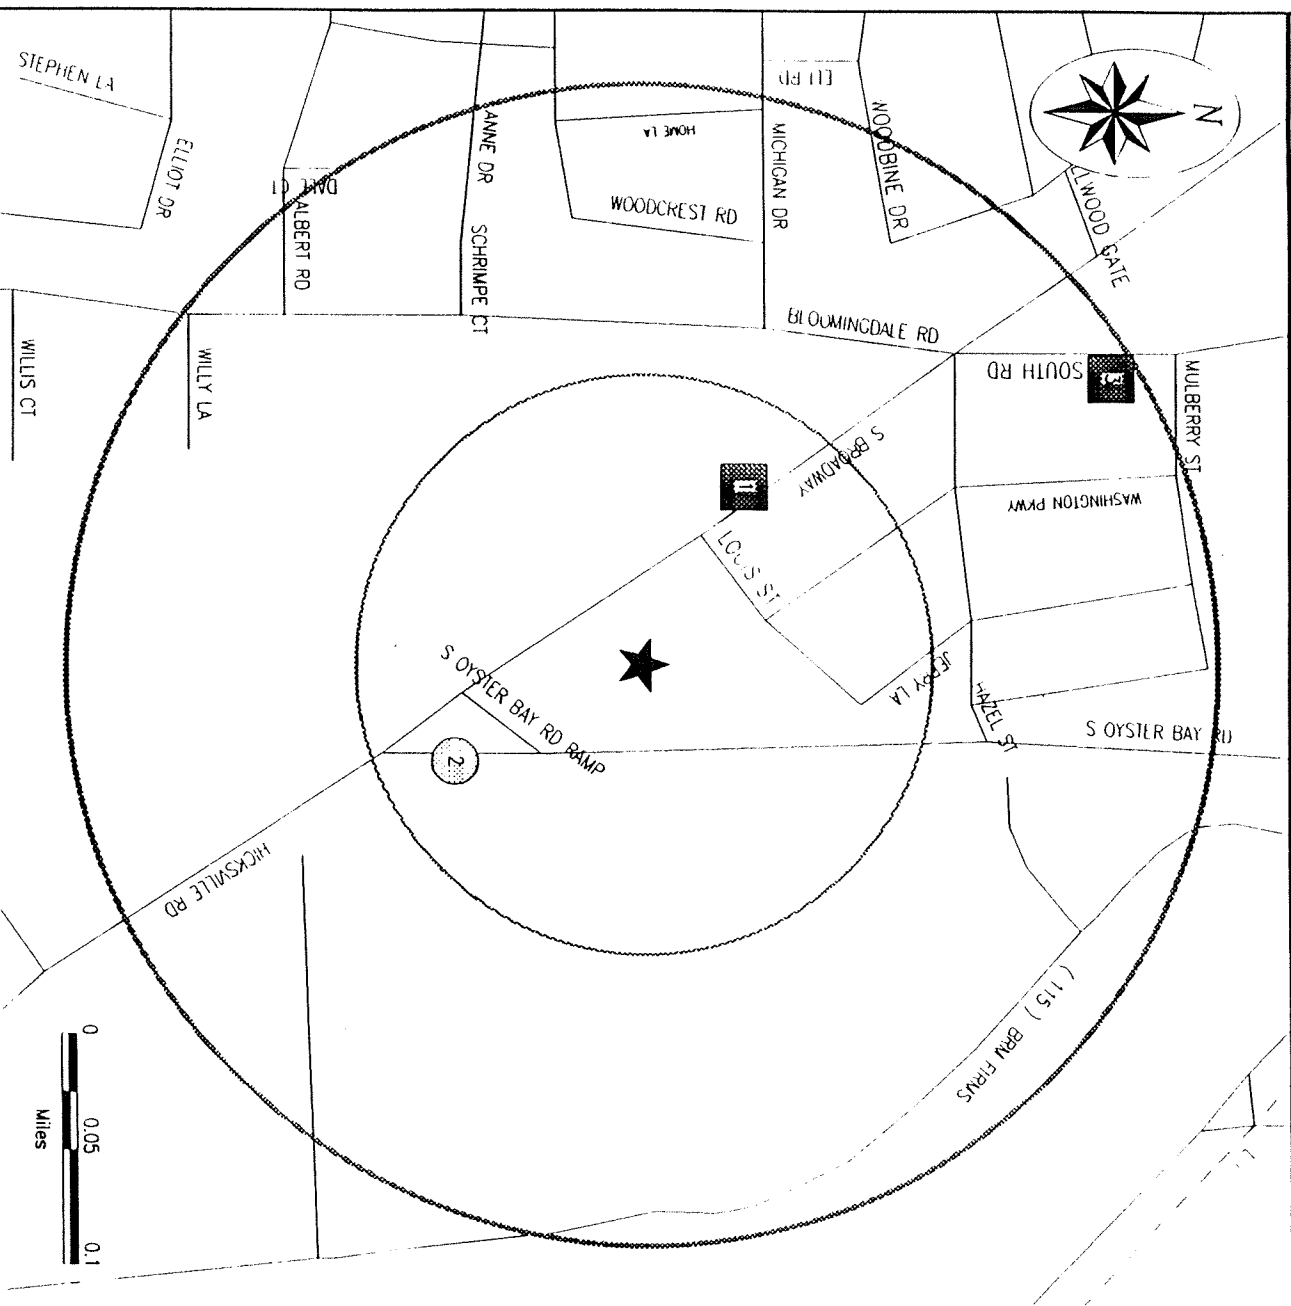
## Map of Risks Within Quarter Mile

★ Subject Site	Category:			
	Databases Searched to:	1 mi.	1/2 mi.	1/4 mi.
★	Single Sites	◆	■	▲
	Multiple Sites	◆	■	▲
Roads Highways Railroads Rivers or Water Bodies Utilities	NPL, SPL, SCL, TSD	CERCLIS, LUST, SWLF	UST	ERNS, GENERATORS
