**PHASE I SITE ASSESSMENT
BUILDING 30**

GRUMMAN AEROSPACE CORPORATION
BETHPAGE, NEW YORK

JANUARY 1996

Re: Phase I Site Assessment
Building 30
Bethpage, NY
D&B No. 1167-N

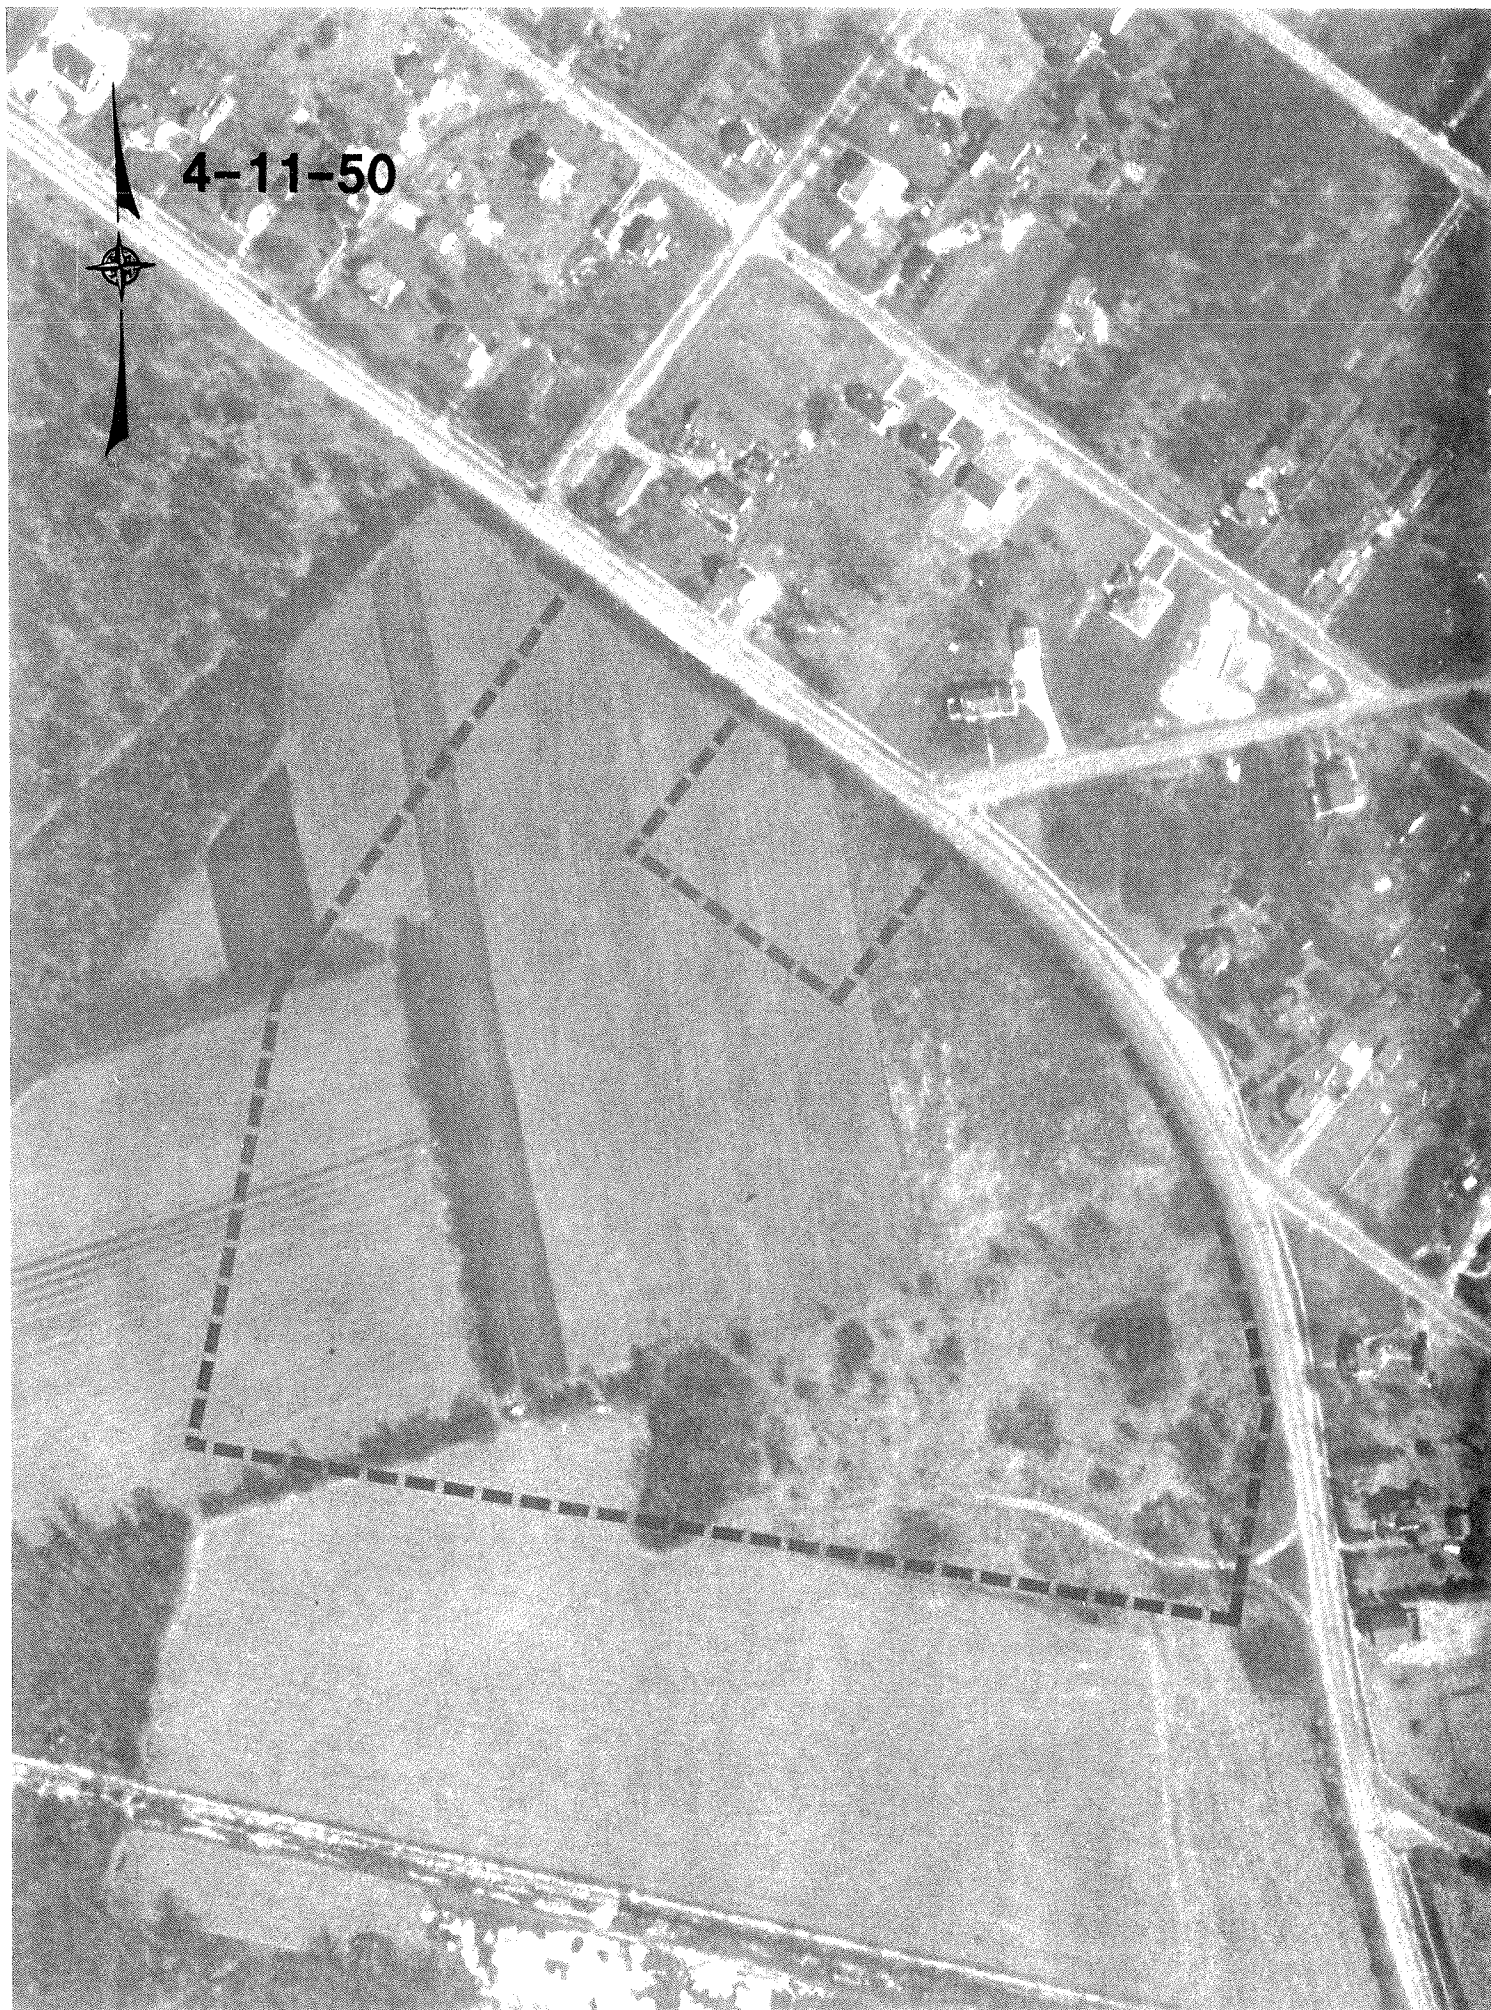
4-11-50

A review of aerial photographs shows that the site was undeveloped, with the exception of agricultural activity in the western portion from 1950 through 1962. The eastern portion of the site appears undeveloped as well, with the exception of unpaved roadways. An enlarged aerial photograph (i.e., 1" = 100' scale) was obtained of this area for the year 1957 (see Appendix B) in an attempt to further define the use of this area; however, nothing noteworthy was observed at this increased scale. Properties north and east of the site appear residentially developed during this time frame, while areas west and south appear undeveloped. The 1957 aerial shows a building had been constructed adjacent to the northern boundary of the site.

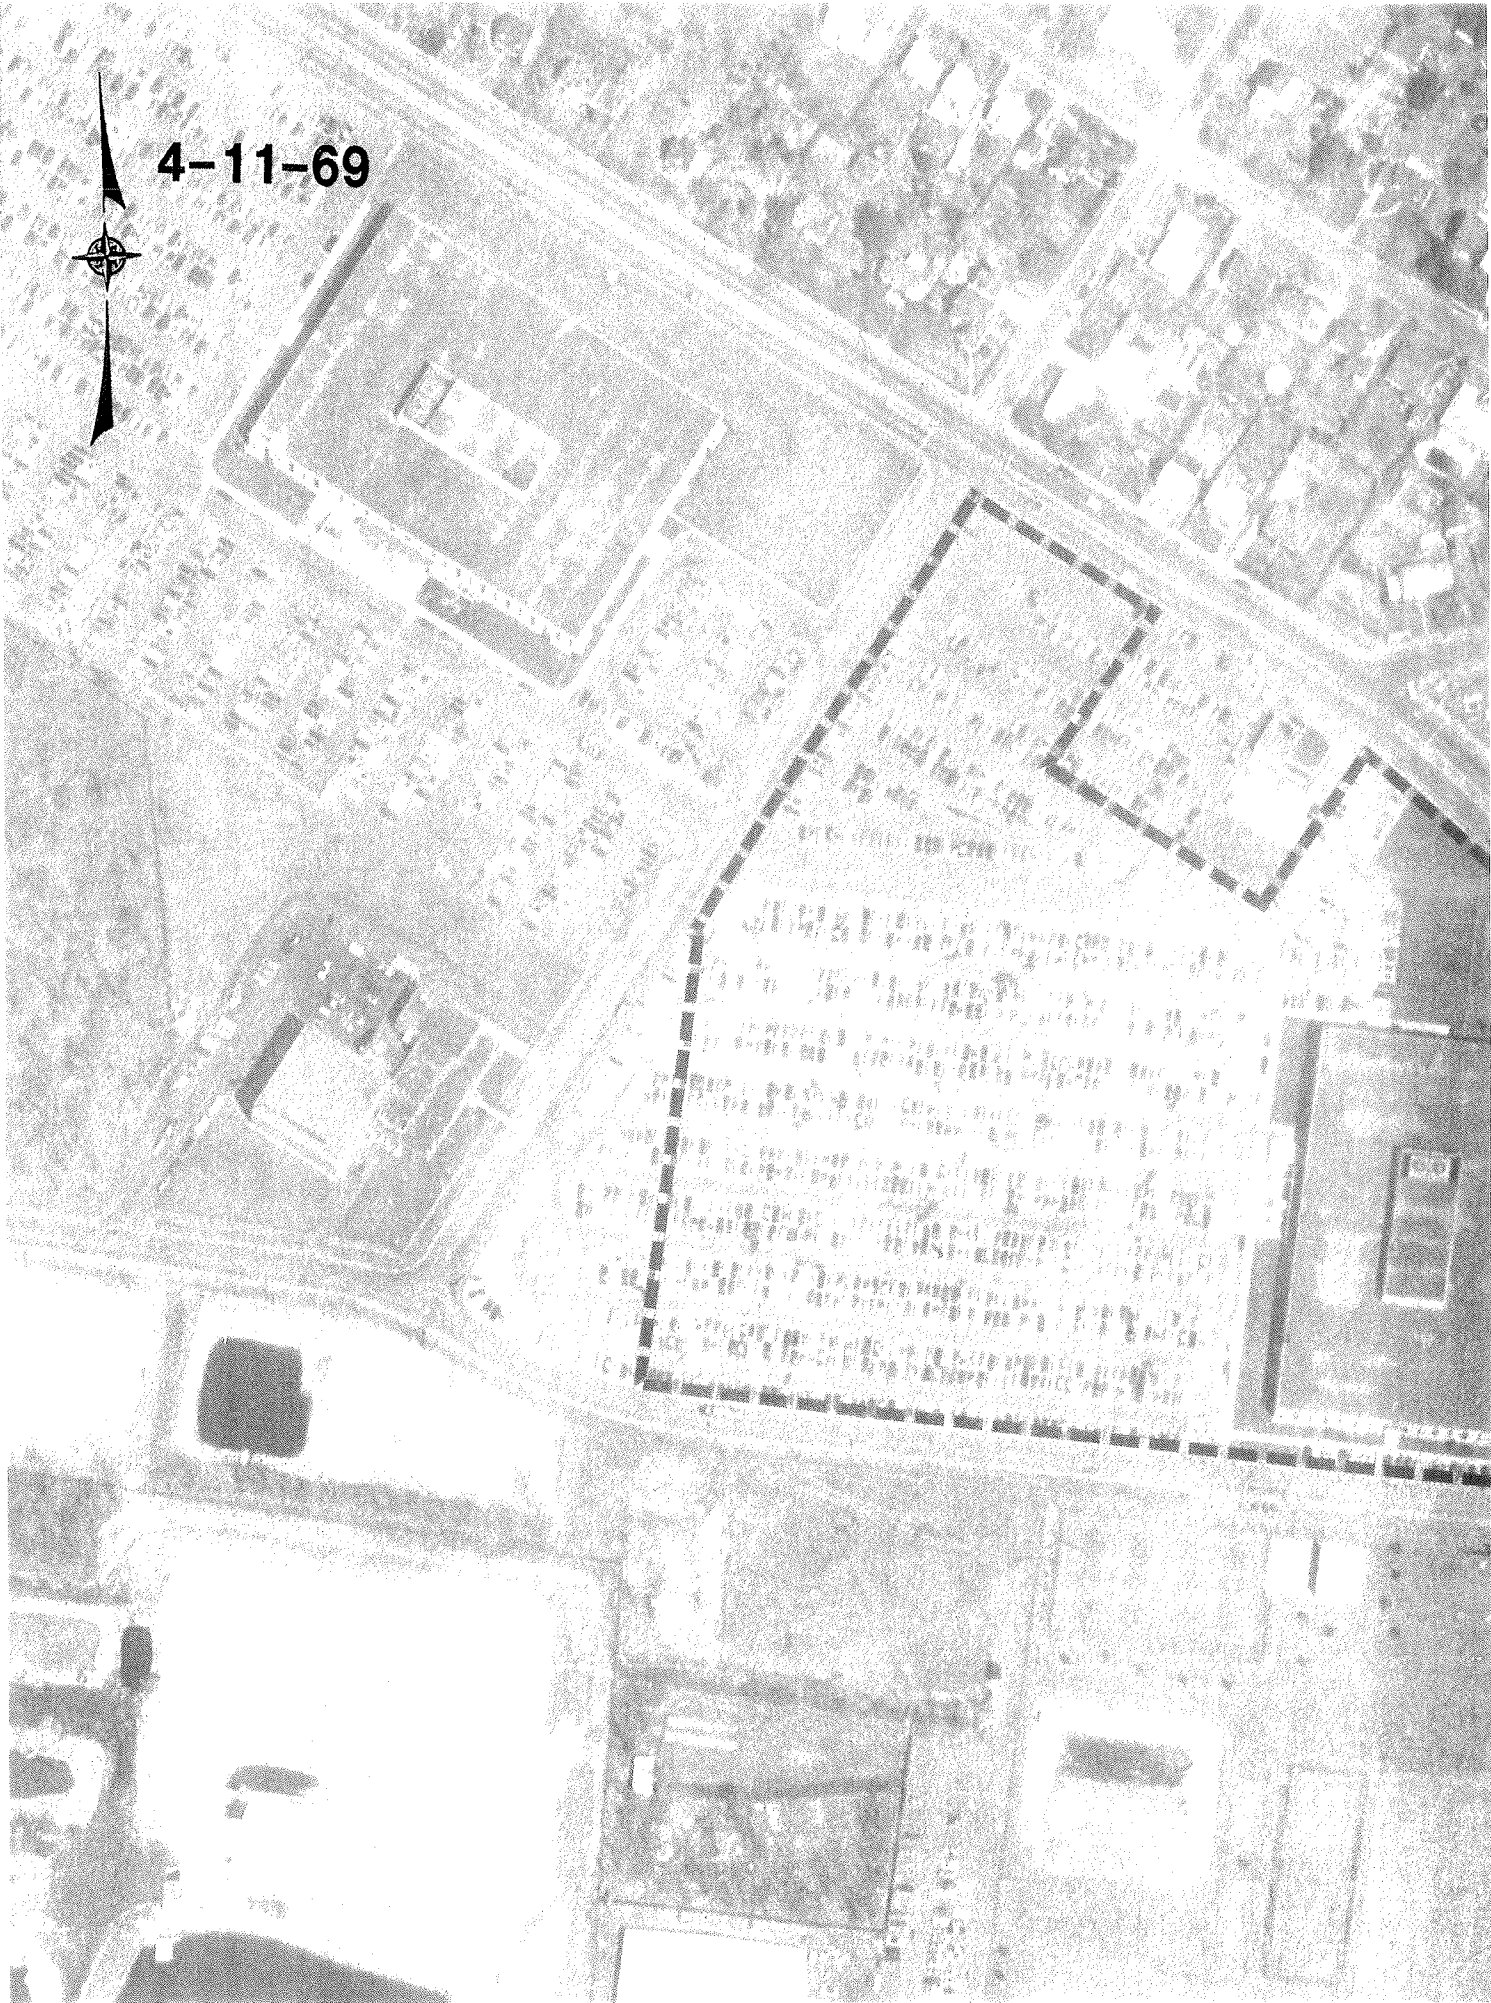
4-30-72

A parking area is noted to the east of the building in the 1972 aerial. Between 1969 and 1972, another building had been constructed adjacent to the northern boundary line of the site. According to Grumman Utility Quadrangle maps, a small white square noted off the northeast corner of the building, close to Stewart Avenue, in the 1972 and 1988 aerials was identified as a vault utilized to house a backflow preventer for the connection to the Bethpage water supply.
