**PHASE I  
ENVIRONMENTAL  
SITE ASSESSMENT**

**PLANT 17,  
NORTH WAREHOUSES**

**GOCO FACILITY  
BETHPAGE, NEW YORK**

Subject: Final Phase I Environmental Site Assessment  
Plant 17, North Warehouses  
Radian Project No. 002704-2006

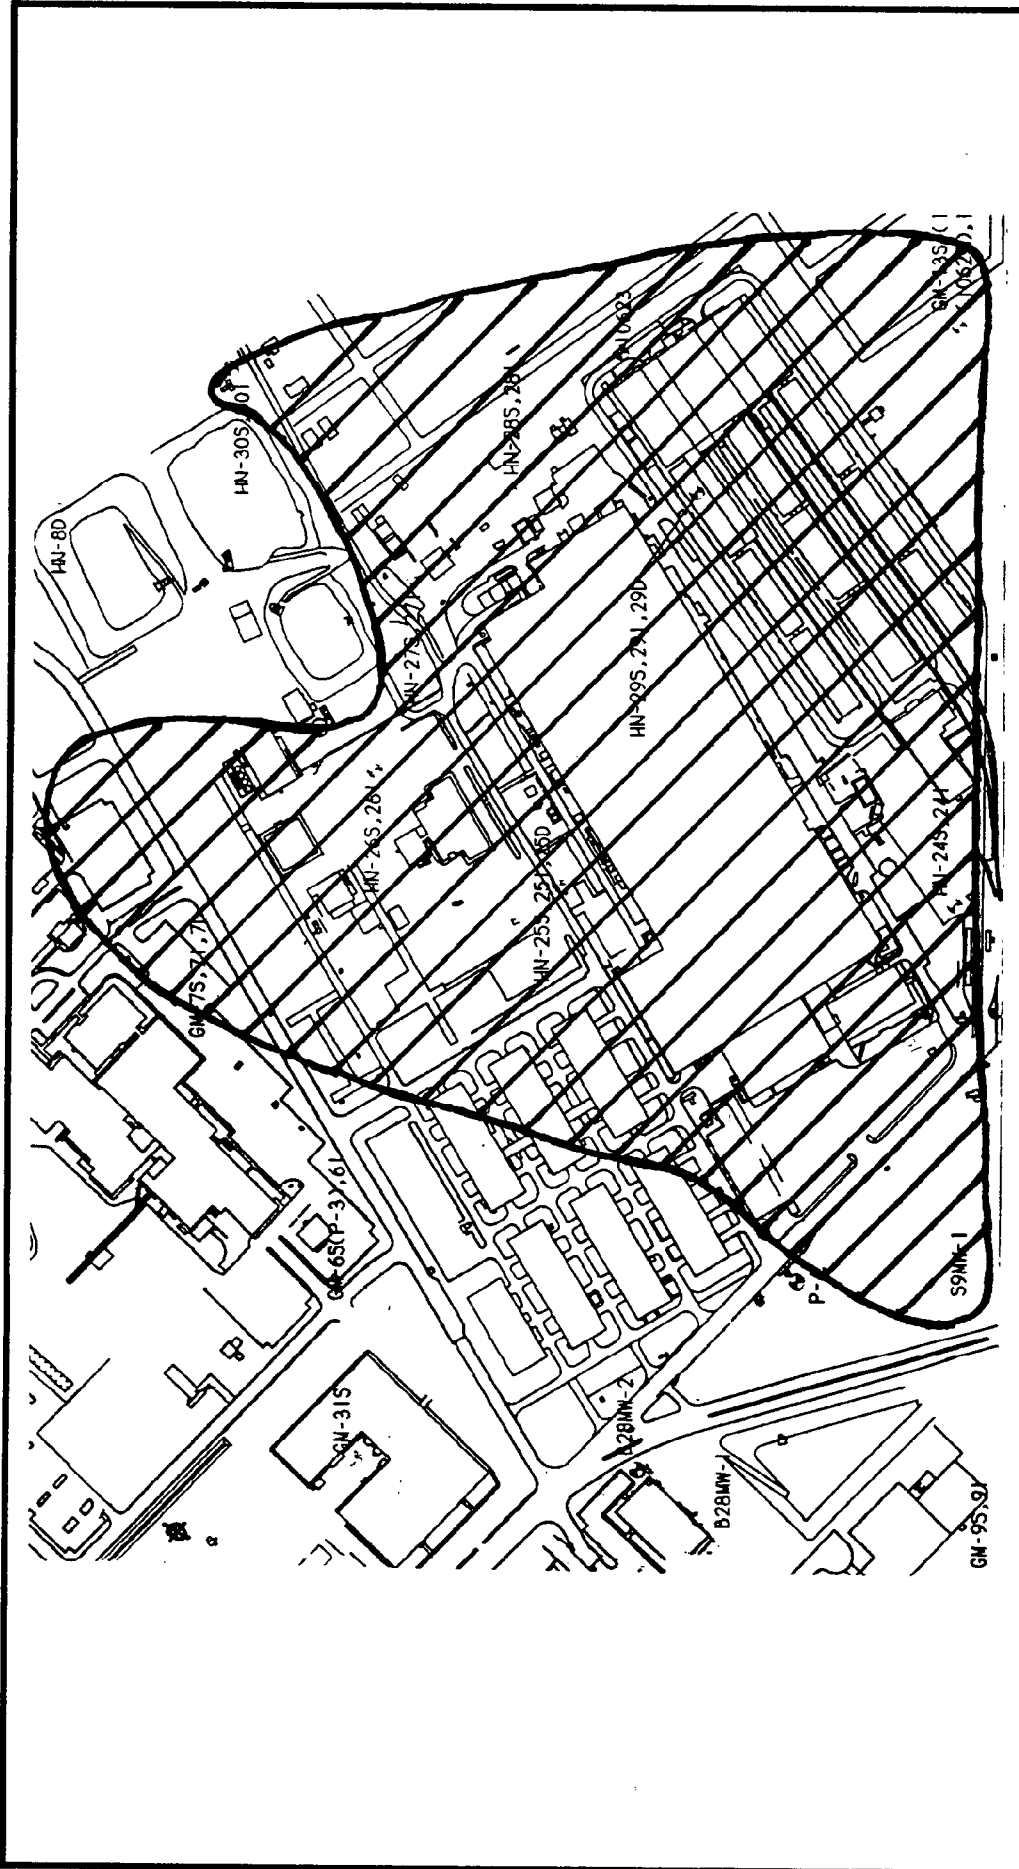
<p>CLIENT: NORTHROP GRUMMAN CORP. BETHPAGE, LONG ISLAND, NY</p>	<p>DWG. TITLE: IMPACTED AREA OF GROUNDWATER CONTAMINATION: GOCO FACILITY</p>									
<p>REFERENCE: GERAGHTY &amp; MILLER, INC. GENERALIZED AREAS OF IMPACTED GROUNDWATER</p>

To the south of the Northrop Grumman facility, contaminants are present in groundwater at varying depths, however, the concentrations of contaminants do not indicate that a discrete plume or plumes are present. The pumping and recharge of groundwater on the Northrop Grumman facility, as well as the pumping by the Bethpage Water District, is likely responsible for the observed contamination downgradient of the Northrop Grumman facility.
