**PHASE I  
ENVIRONMENTAL  
SITE ASSESSMENT  
for the  
PRODUCT  
MANUFACTURING  
PLANT 3 SITE**

**GOCO FACILITY  
BETHPAGE, NEW YORK**

**NORTHROP GRUMMAN  
CORPORATION  
South Oyster Bay Road  
Bethpage, New York**

**April 11, 1997**

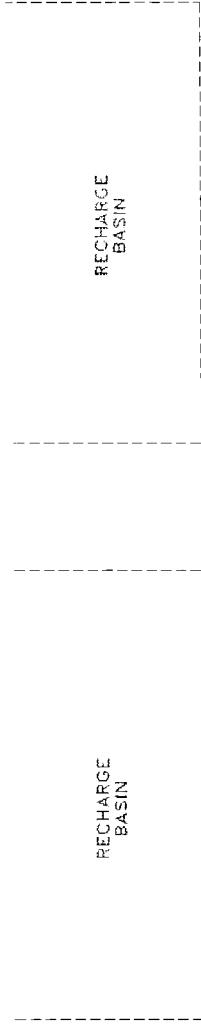
AOC 22 USTs NO. 03-13-1, 03-13-2, & 03-13-3

CLIENT: NORTHROP GRUMMAN CORP. BETHPAGE, LONG ISLAND, NY	DWG. TITLE: USTs AND ASTs AT ROADS AND GROUNDS BUILDING
<b>RADIAN</b> INTERNATIONAL LLC PARTELET, NEW JERSEY	DRAWN BY: BTD
	DATE: MAR 1997
PROJECT No.: 012704-3006	SCALE: NONE
	FIGURE: 16
	FILE NUMBER: 2704330T
