Addendum to Pre-Design Sampling and Remedial Technology Evaluation Report for VOC Source Area, Operable Unit 3 (Former Grumman Settling Ponds), Bethpage, New York

**BETHPAGE COMMUNITY PARK  
VOC SOURCE AREA  
AND SAMPLING LOCATIONS**

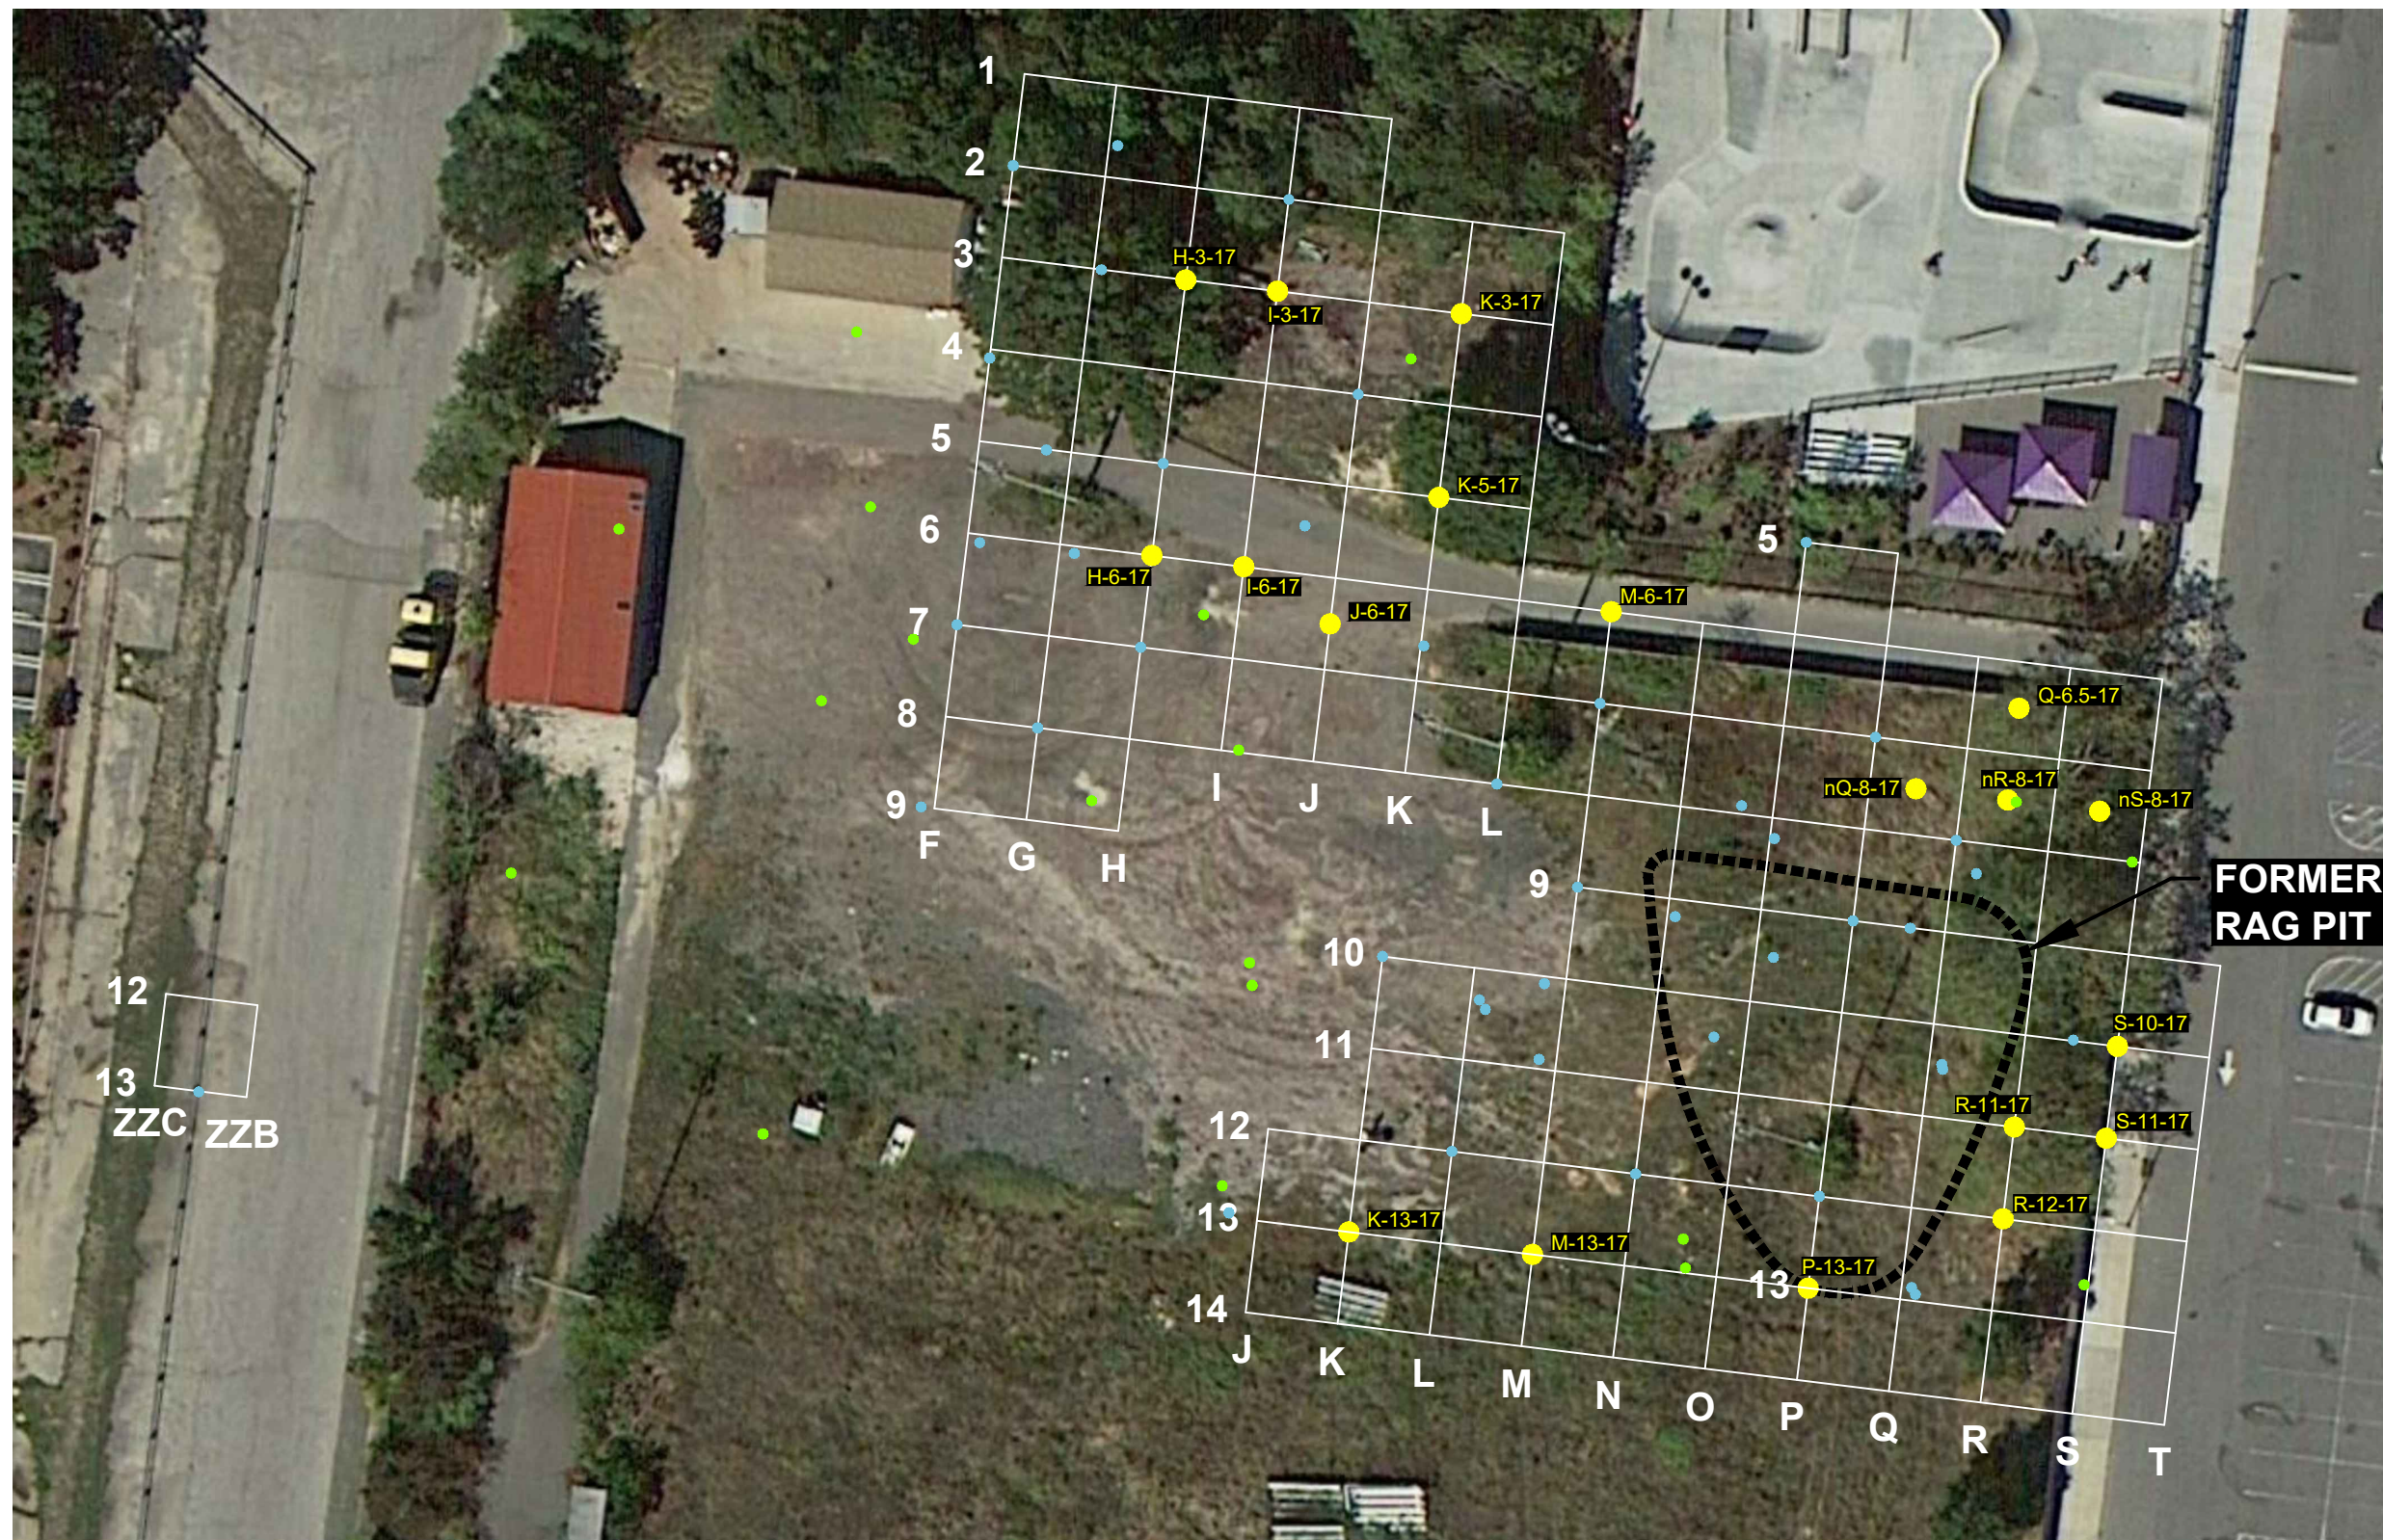
FIGURE  
**3**

A total of 19 soil borings were sampled; sampling locations are shown on **Figure 3** and the sample depths and location coordinates are listed in **Table 1**. The soil borings were field located using a handheld Global Positioning System (GPS) unit. Soil samples were collected using direct-push drilling equipment with Dual-Tube or Macro-Core ® samplers (depending on sample depth). Soil cores were
