### **Weekly Progress Summary for ISTR Construction Northrop Grumman Systems, Corp. Operable Unit 3, Bethpage, NY Reporting Period: June 22-27, 2020**

## PHOTOGRAPH LOG – June 23, 2020

Northrop Grumman  
OU3 VOC Source Area Remedy  
Bethpage Community Park

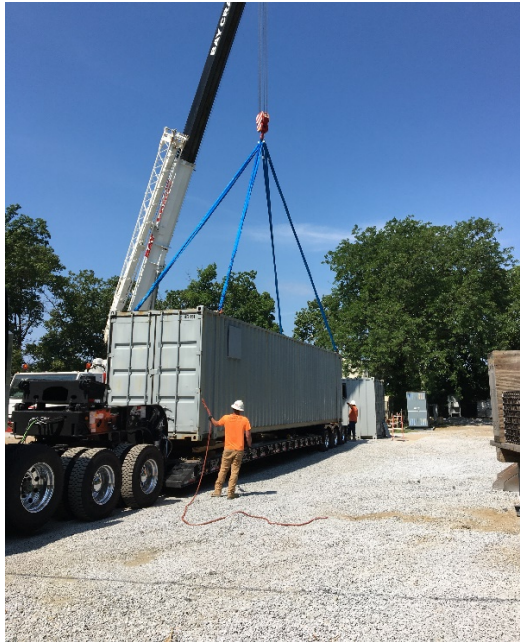
### Photograph: 1

**Description:** Bay Crane offloading  
Tier 1 treatment trailer

**Location:**  
McKay Field

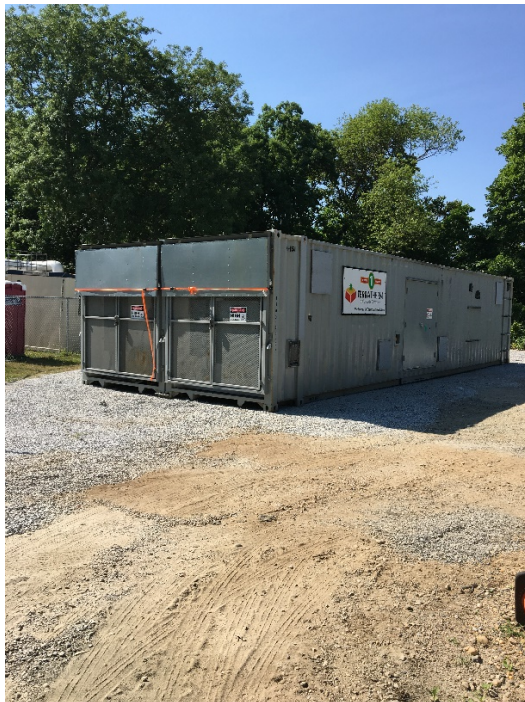
### Photograph: 2

**Description:** Two Tier 1  
equipment trailers

**Location:**  
McKay Field

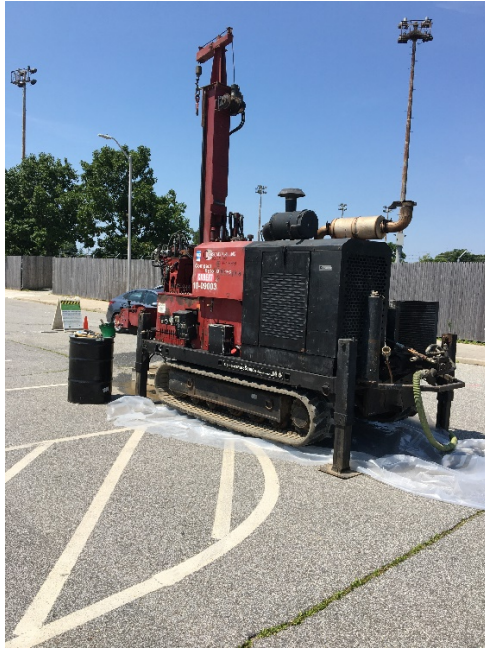
### Photograph: 3

**Description:** ADT installing  
TPMP-6

**Location:**  
Parking lot

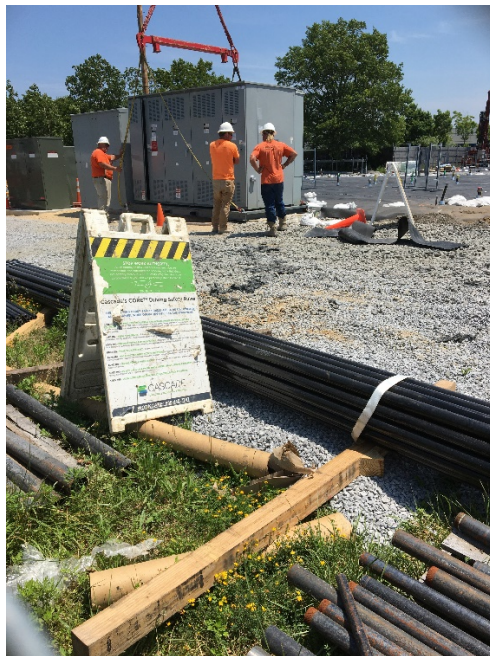
### Photograph: 4

**Description:** Bay Crane offloading  
MSWB Unit

**Location:**  
Wellfield

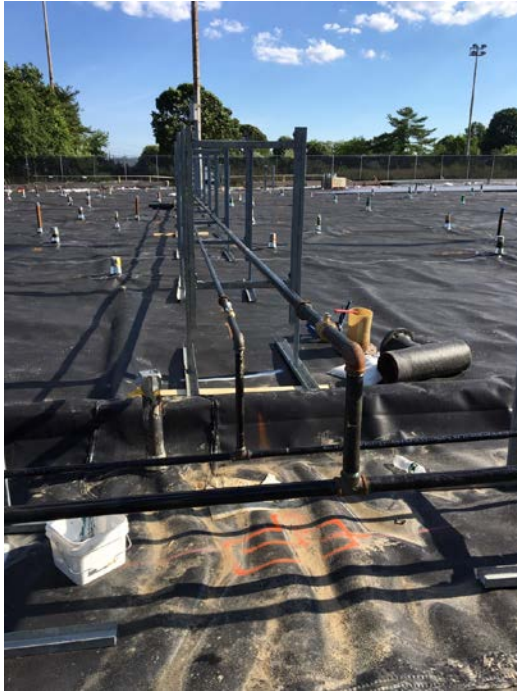
### Photograph: 1

**Description:** Air and water piping

**Location:**  
Wellfield looking south

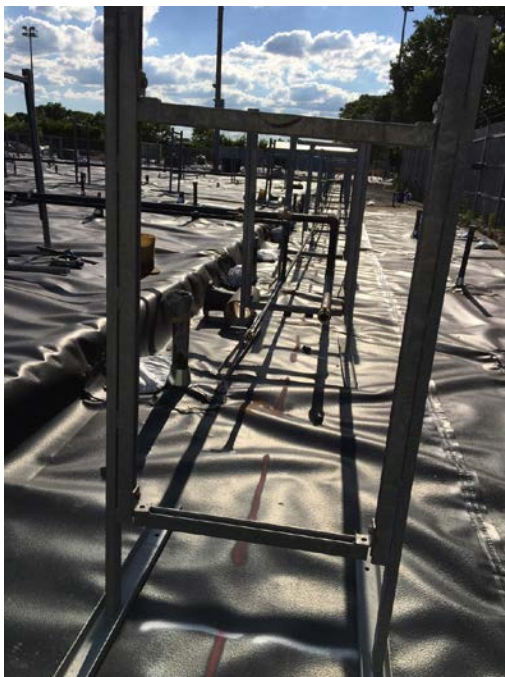
### Photograph: 2

**Description:** Air and water piping

**Location:**  
Wellfield looking west

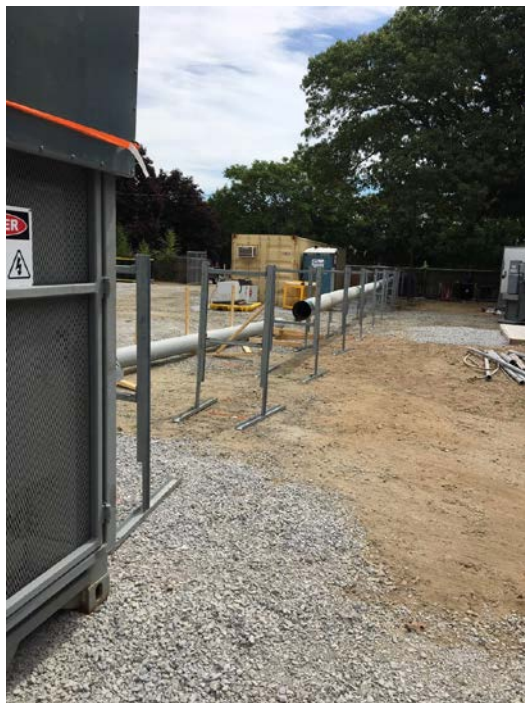
### Photograph: 1

**Description:** Vapor piping being installed

**Location:**  
McKay Field looking east

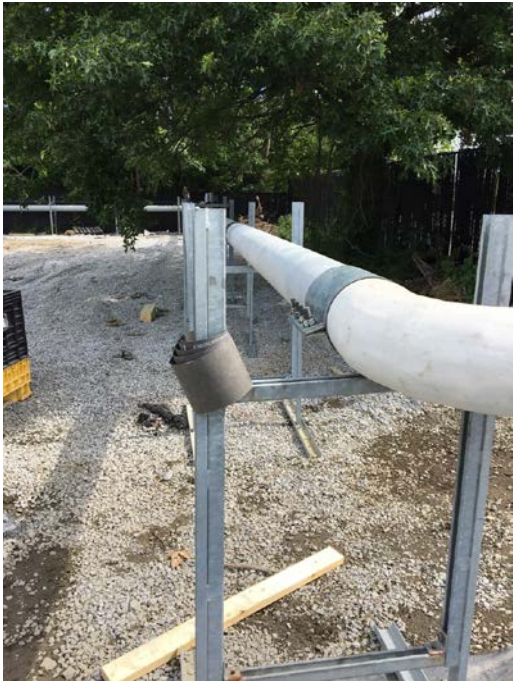
### Photograph: 4

**Description:** Vapor piping being installed

**Location:**  
Wellfield looking north

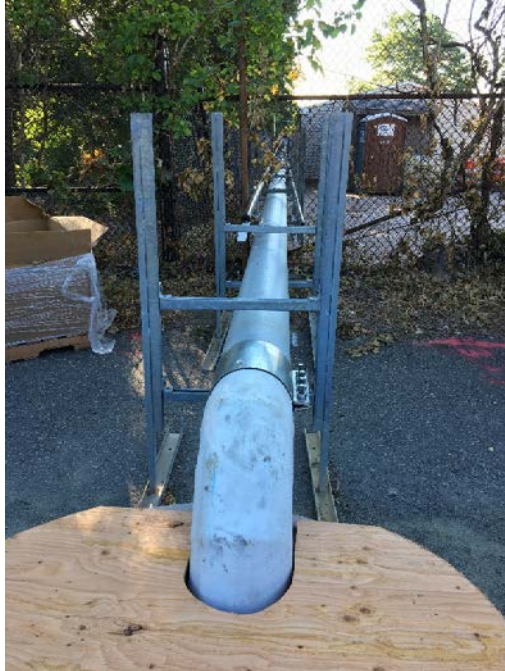
### Photograph: 1

**Description:** 10-inch FRP vapor line through fence and into manhole to connect with subsurface piping across McKay Field Access Road

**Location:**  
McKay field Access Road,  
looking east into the wellfield area

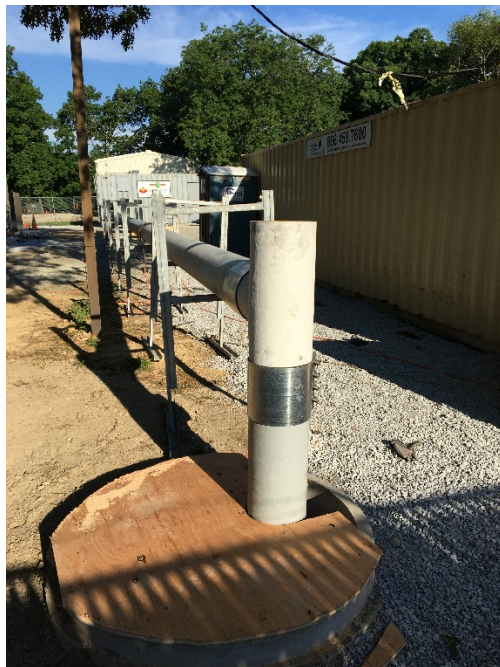
### Photograph: 2

**Description:** 10-in FRP vapor line transitioning to the surface at McKay Field

**Location:**  
McKay Field looking west

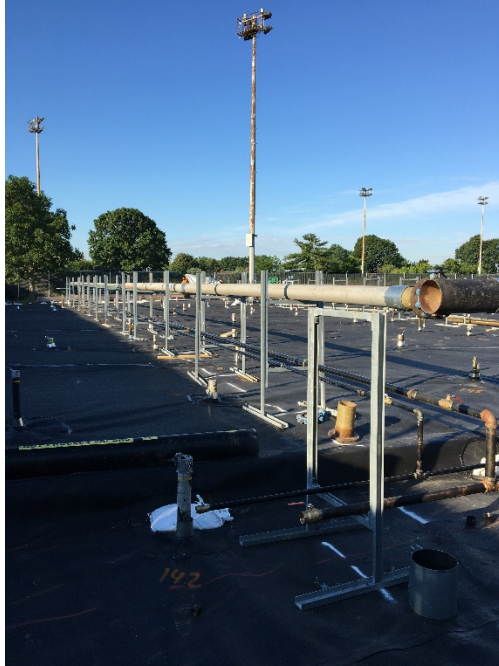
### Photograph: 3

**Description:** Process piping (10-in FRP vapor, 2-in CS air, and 1-in CS liquid)

**Location:**  
Northeast corner of the wellfield looking south

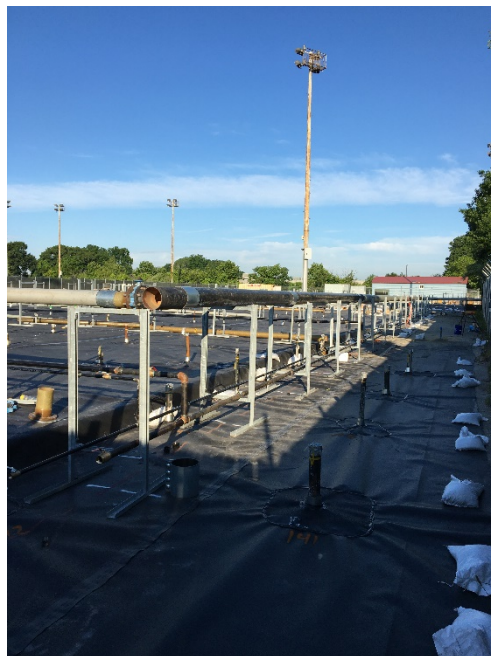
### Photograph: 4

**Description:** Process piping (10-in FRP vapor, 2-in CS air, and 1-in CS liquid)

**Location:**  
Northeast corner of the wellfield looking west

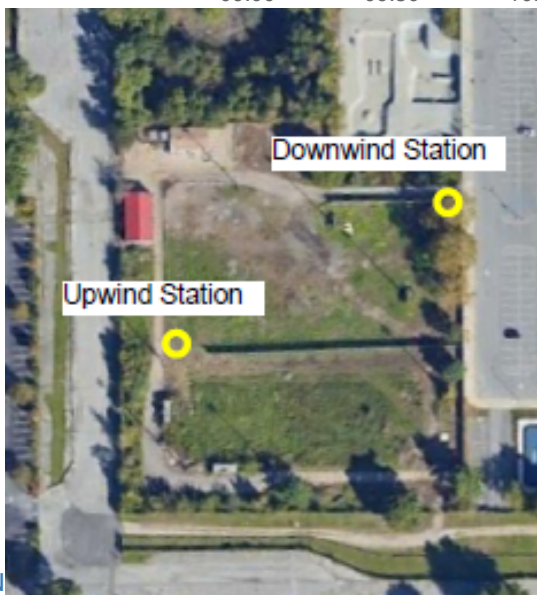
Mass Conc. Total mg/m <sup>3</sup> DustTrak-8530 RS232(C)			VOC ppm miniRAE 3000 RS232(A)		
MIN	AVG	MAX	MIN	AVG	MAX
-0.007	-0.002	0.011	0	0	0

NYSDEC DER-10 CAMP action levels:

- Particulates (DustTrak reading, shown as orange line and orange y-axis scale): 0.1 mg/m<sup>3</sup> (15-minute average)
- TVOCs (miniRAE PID reading, shown as red line and red y-axis scale): 5 ppm (15-minute average)

Short-term peaks of DustTrak and miniRAE readings are common during instrument setup at the beginning of the workday, and during manual calibration/detection checks throughout the day.

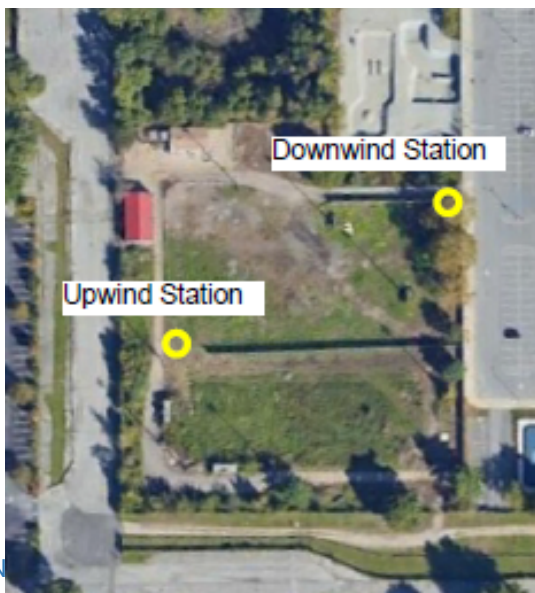
**Name** 41147 - Upwind  
**S/N** 0B357066  
**Location** Bethpage Community Park, 1001 Stewart Ave, Bethpage, NY 11714, USA

Mass Conc. Total mg/m <sup>3</sup> DustTrak-8530 RS232(C)			VOC ppm miniRAE 3000 RS232(A)		
MIN	AVG	MAX	MIN	AVG	MAX
0.01	0.014	0.024	0	0	0

NYSDEC DER-10 CAMP action levels:

- Particulates (DustTrak reading, shown as orange line and orange y-axis scale): 0.1 mg/m<sup>3</sup> (15-minute average)
- TVOCs (miniRAE PID reading, shown as red line and red y-axis scale): 5 ppm (15-minute average)

Short-term peaks of DustTrak and miniRAE readings are common during instrument setup at the beginning of the workday, and during manual calibration/detection checks throughout the day.

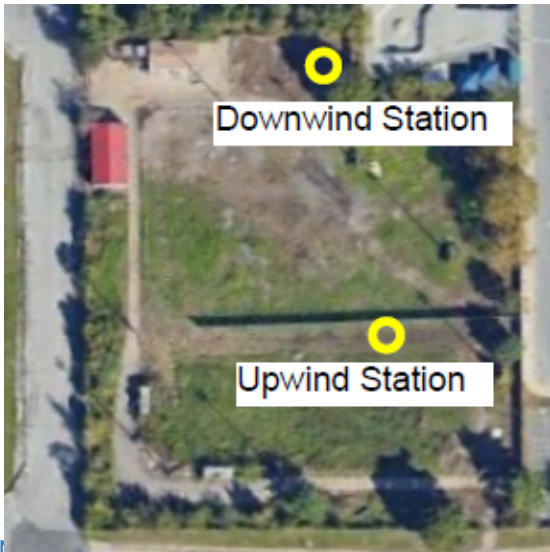
**Name** 39875 - Downwind  
**S/N** 0B333738  
**Location** 789 Stewart Ave,  
Bethpage, NY 11714,  
USA

Mass Conc. Total mg/m <sup>3</sup> DustTrak-8530 RS232(C)			VOC ppm miniRAE 3000 RS232(A)		
MIN	AVG	MAX	MIN	AVG	MAX
-0.03	-0.017	0.229	0	0	0

NYSDEC DER-10 CAMP action levels:

- Particulates (DustTrak reading, shown as orange line and orange y-axis scale): 0.1 mg/m<sup>3</sup> (15-minute average)
- TVOCs (miniRAE PID reading, shown as red line and red y-axis scale): 5 ppm (15-minute average)

Short-term peaks of DustTrak and miniRAE readings are common during instrument setup at the beginning of the workday, and during manual calibration/detection checks throughout the day.

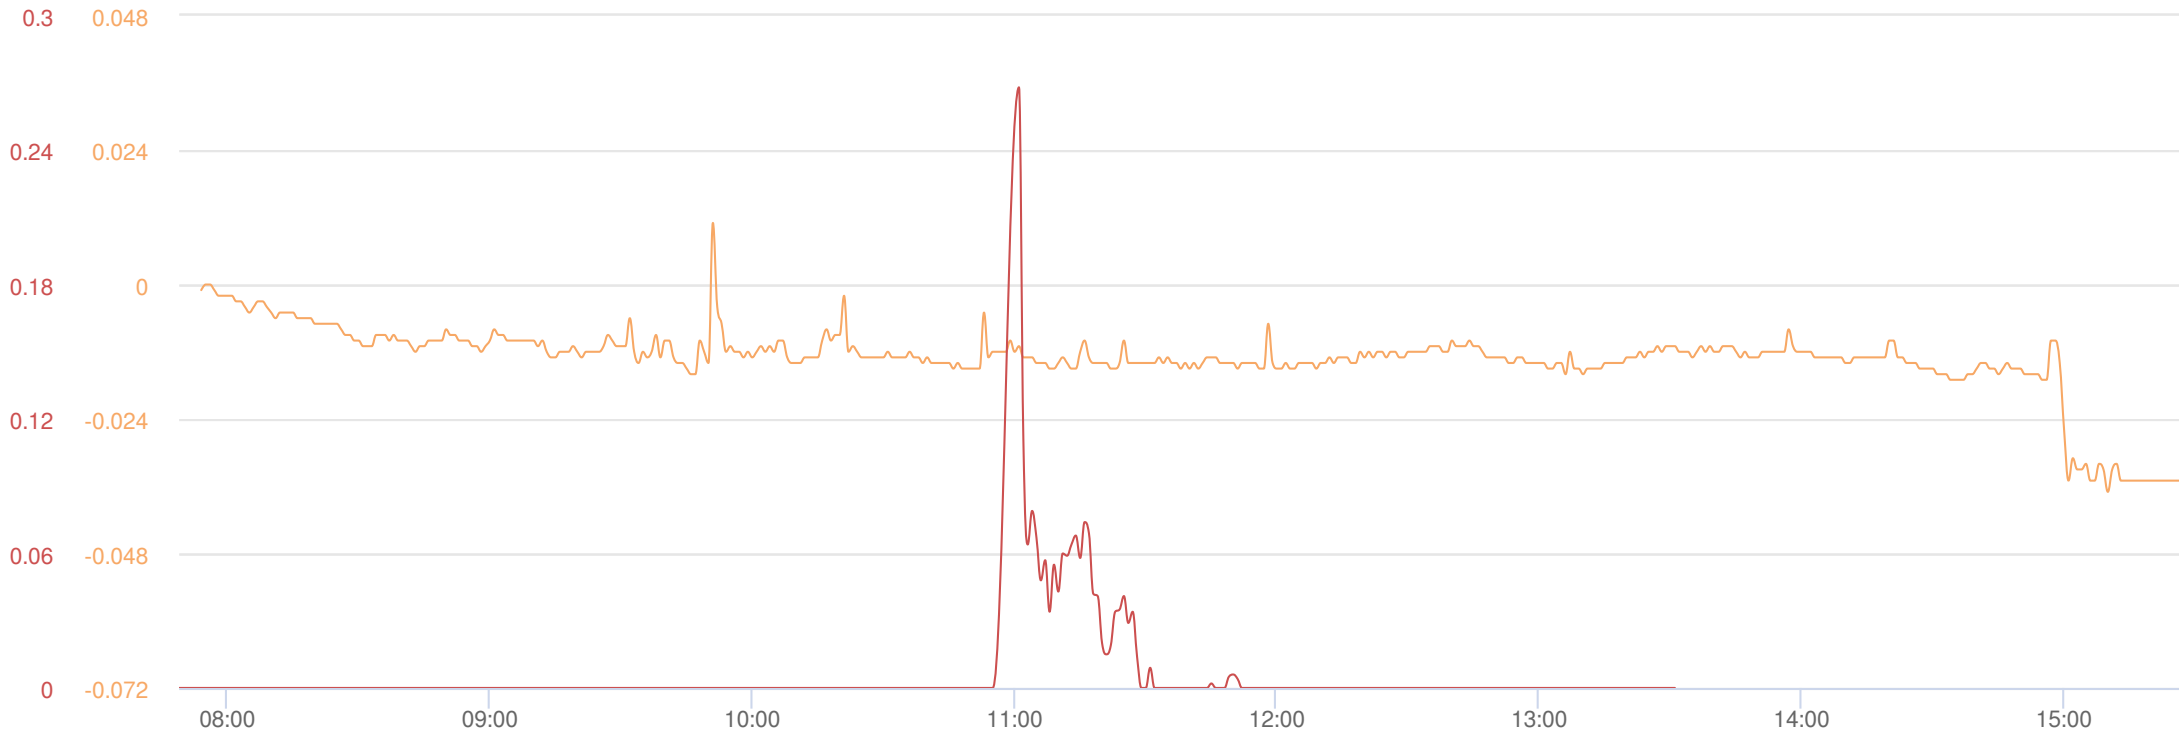
Tue, 23rd of Jun 2020, 0:00:00 – 22:20:39  
 (GMT-05:00) Eastern Time (US & Canada)

MIN	AVG	MAX
-0.037	-0.013	0.011

MIN	AVG	MAX
0	0.005	0.268

- Particulates (DustTrak reading, shown as orange line and orange y-axis scale): 0.1 mg/m<sup>3</sup> (15-minute average)
- TVOCs (miniRAE PID reading, shown as red line and red y-axis scale): 5 ppm (15-minute average)

Short-term peaks of DustTrak and miniRAE readings are common during instrument setup at the beginning of the workday, and during manual calibration/detection checks throughout the day.

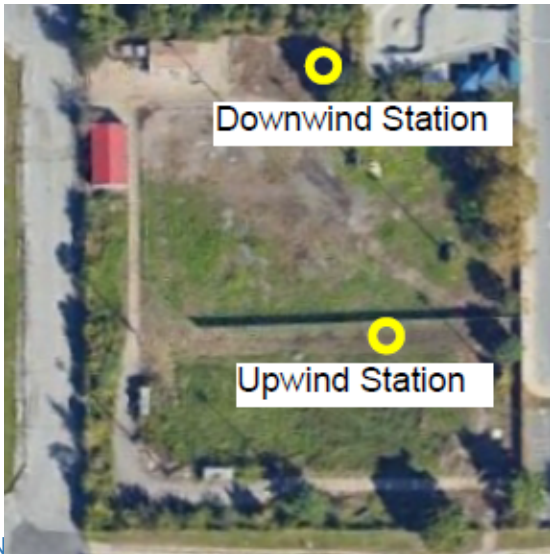
**Name** 41147 - Upwind  
**S/N** 0B357066  
**Location** 901 Stewart Ave,  
 Bethpage, NY 11714,  
 USA

**Mass Conc. Total** mg/m<sup>3</sup>

DustTrak-8530  
RS232(C)

**VOC** ppm

miniRAE 3000  
RS232(A)

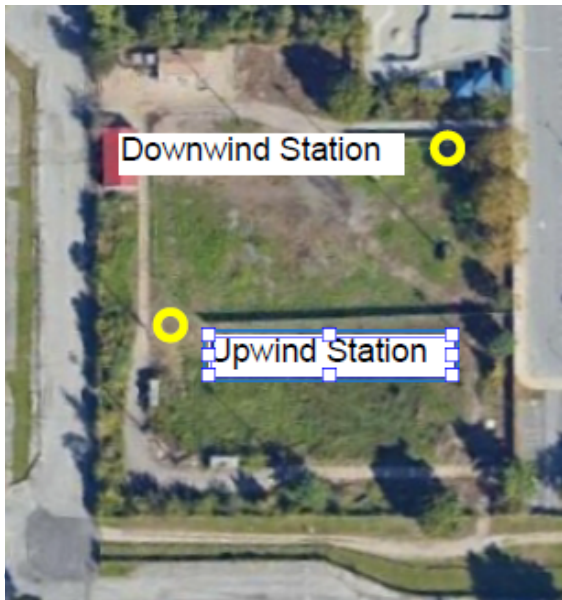
**Name** 39875 - Downwind  
**S/N** 0B333738  
**Location** Bethpage Community Park, 1001 Stewart Ave, Bethpage, NY 11714, USA

Mass Conc. Total mg/m <sup>3</sup> DustTrak-8530 RS232(C)			VOC ppm miniRAE 3000 RS232(A)		
MIN	AVG	MAX	MIN	AVG	MAX
0.003	0.011	0.051	0	0.771	179.76

NYSDEC DER-10 CAMP action levels:

- Particulates (DustTrak reading, shown as orange line and orange y-axis scale): 0.1 mg/m<sup>3</sup> (15-minute average)
- TVOCs (miniRAE PID reading, shown as red line and red y-axis scale): 5 ppm (15-minute average)

Short-term peaks of DustTrak and miniRAE readings are common during instrument setup at the beginning of the workday, and during manual calibration/detection checks throughout the day.

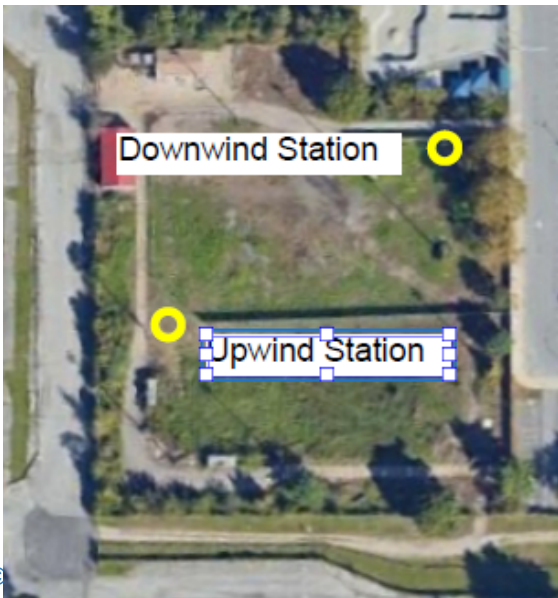
**Name** 41147 - Upwind  
**S/N** 0B357066  
**Location** Bethpage Community Park, 1001 Stewart Ave, Bethpage, NY 11714, USA

Mass Conc. Total mg/m <sup>3</sup> DustTrak-8530 RS232(C)			VOC ppm miniRAE 3000 RS232(A)		
MIN	AVG	MAX	MIN	AVG	MAX
0.009	0.015	0.146	0	0	0

NYSDEC DER-10 CAMP action levels:

- Particulates (DustTrak reading, shown as orange line and orange y-axis scale): 0.1 mg/m<sup>3</sup> (15-minute average)
- TVOCs (miniRAE PID reading, shown as red line and red y-axis scale): 5 ppm (15-minute average)

Short-term peaks of DustTrak and miniRAE readings are common during instrument setup at the beginning of the workday, and during manual calibration/detection checks throughout the day.

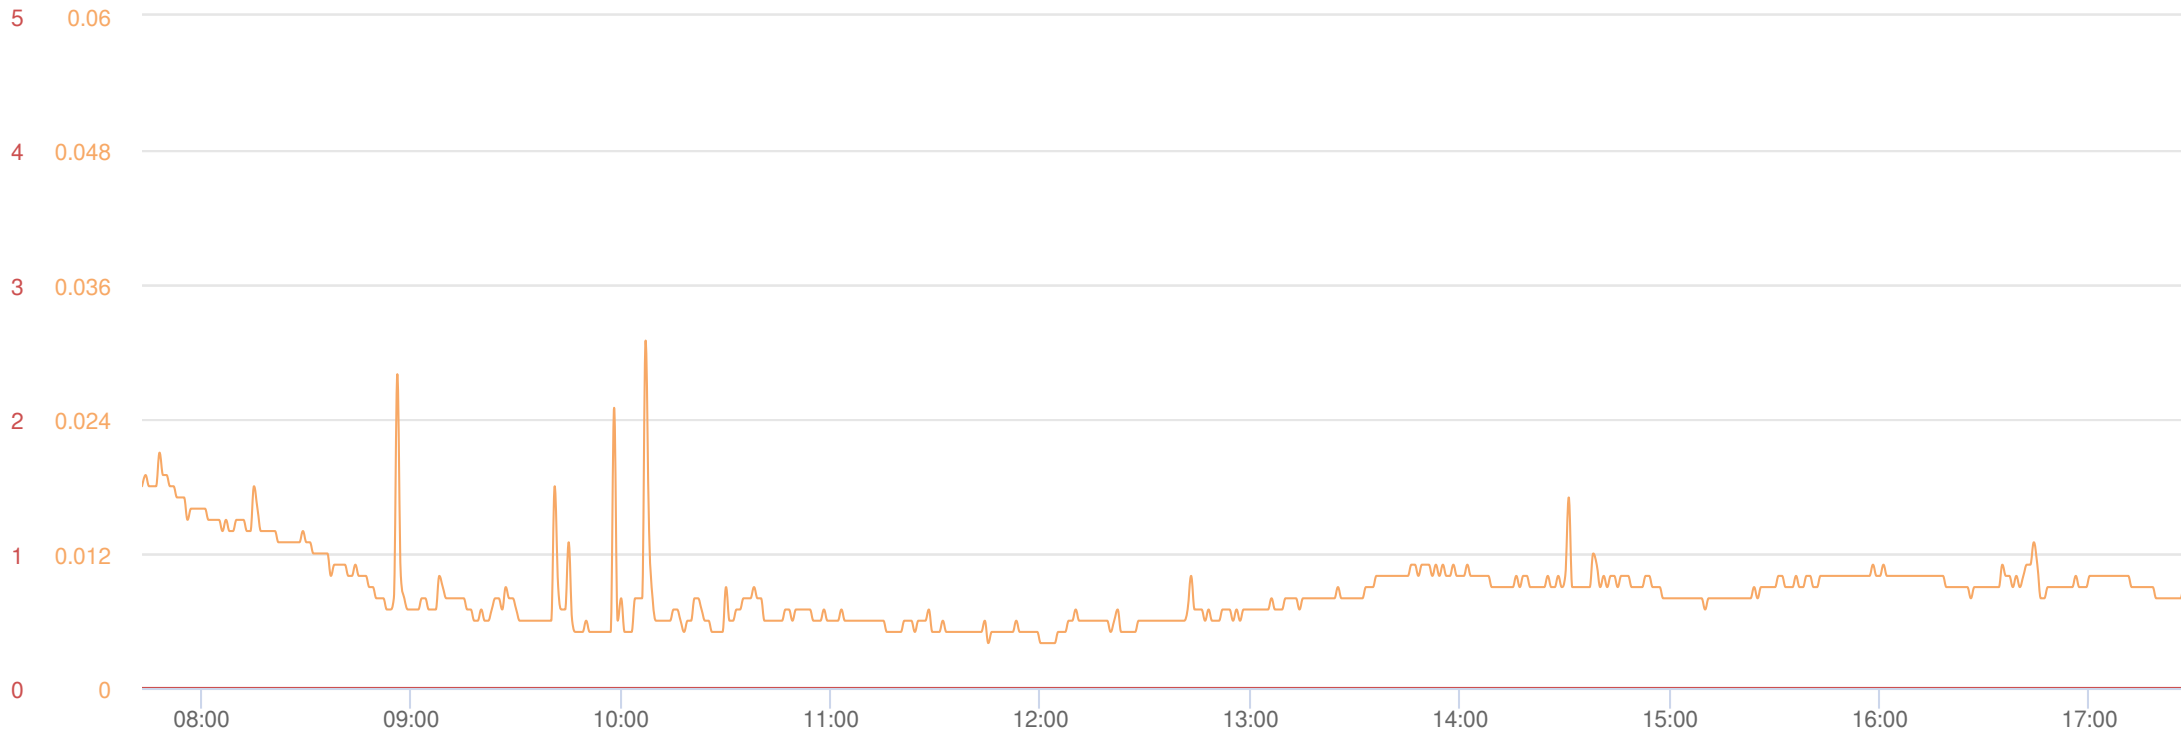
Thu, 25th of Jun 2020, 0:00:00 – 23:59:00  
 (GMT-05:00) Eastern Time (US & Canada)

Mass Conc. Total mg/m <sup>3</sup> DustTrak-8530 RS232(C)			VOC ppm miniRAE 3000 RS232(A)		
MIN	AVG	MAX	MIN	AVG	MAX
0.004	0.009	0.031	0	0	0

- Particulates (DustTrak reading, shown as orange line and orange y-axis scale): 0.1 mg/m<sup>3</sup> (15-minute average)
- TVOCs (miniRAE PID reading, shown as red line and red y-axis scale): 5 ppm (15-minute average)

Short-term peaks of DustTrak and miniRAE readings are common during instrument setup at the beginning of the workday, and during manual calibration/detection checks throughout the day.

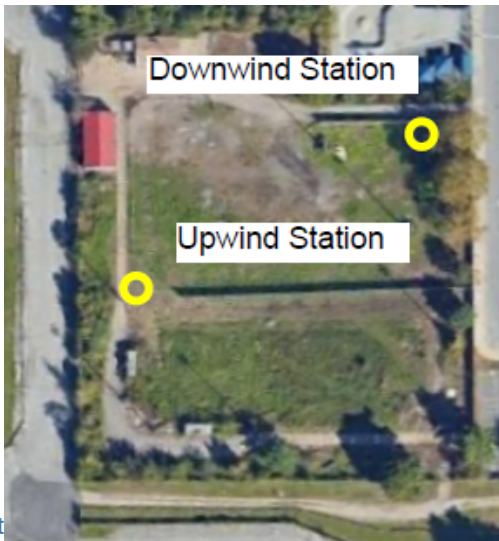
<b>Name</b>	41147 - Upwind
<b>S/N</b>	0B357066
<b>Location</b>	Bethpage Community Park, 1001 Stewart Ave, Bethpage, NY 11714, USA

Mass Conc. Total mg/m <sup>3</sup> DustTrak-8530 RS232(C)			VOC ppm miniRAE 3000 RS232(A)		
MIN	AVG	MAX	MIN	AVG	MAX
-0.006	-0.002	0.014	0	0.001	0.455

NYSDEC DER-10 CAMP action levels:
