**Weekly Progress Summary for ISTR Construction
Northrop Grumman Systems, Corp.
Operable Unit 3, Bethpage, NY
Reporting Period: July 20 – July 25, 2020**

PHOTOGRAPH LOG – July 20, 2020

Northrop Grumman
OU3 VOC Source Area Remedy
Bethpage Community Park

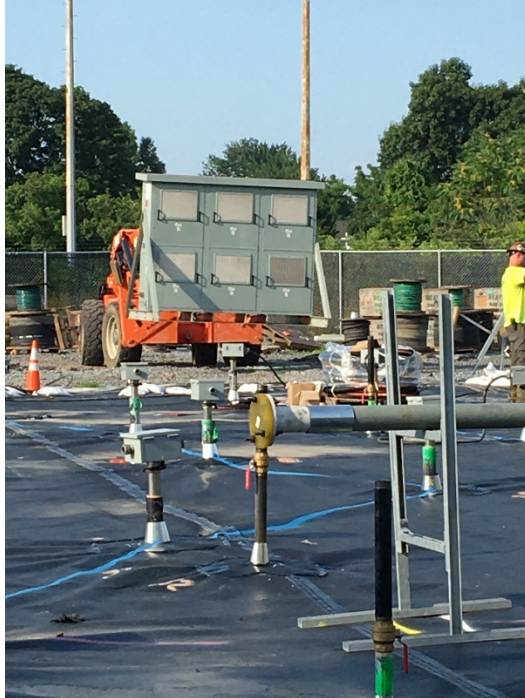
Photograph: 1

Description: Repositioning SCR cabinet

Location:
Wellfield

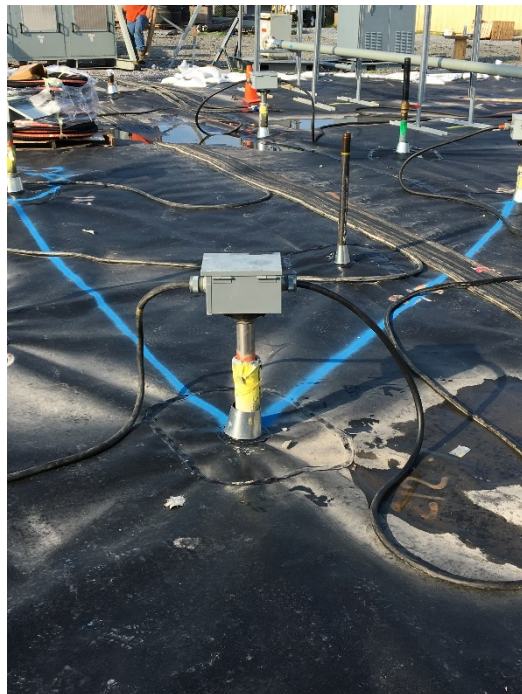
Photograph: 2

Description: Fully assembled heater wellhead

Location:
Wellfield

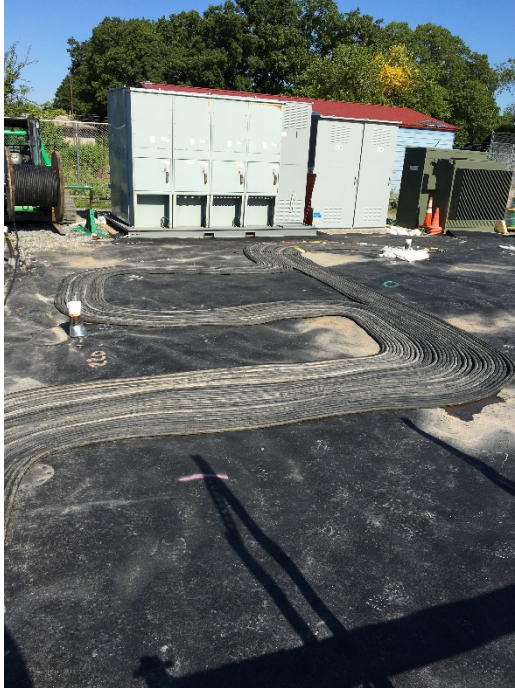
Photograph: 1

Description: Electrical cable and
SCR cabinet

Location:
Wellfield

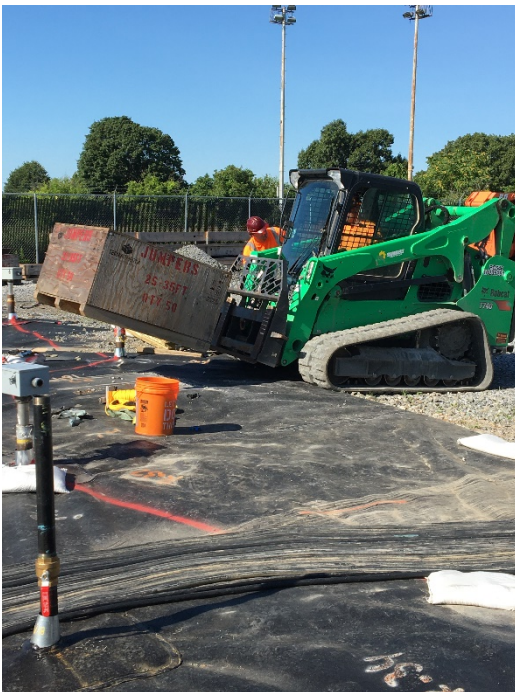
Photograph: 2

Description: Staging heater well
jumping cables for installation

Location:
Wellfield

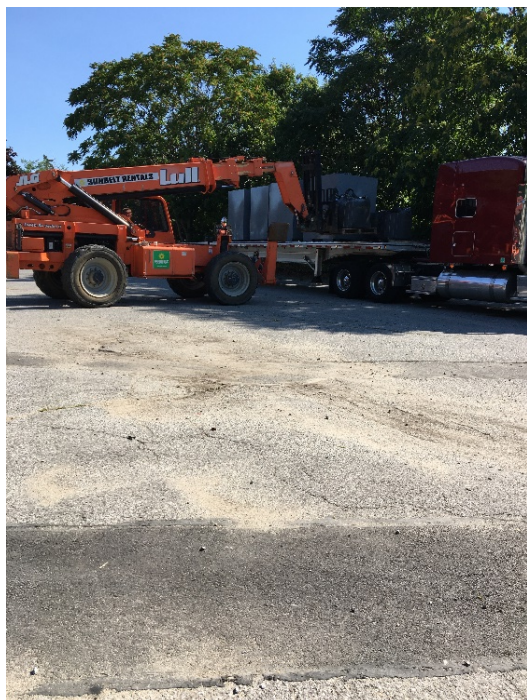
Photograph: 3

Description: Offloading vapor phase carbon and potassium permanganate vessels

Location:
McKay Road

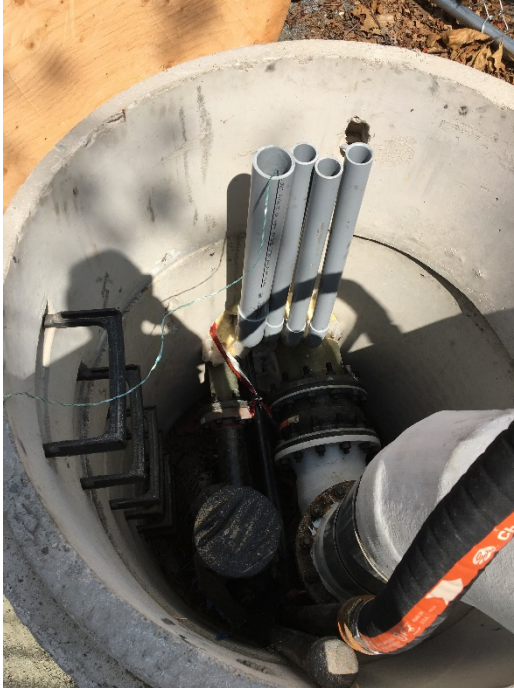
Photograph: 1

Description: Process piping within vault

Location:
East side of McKay Road

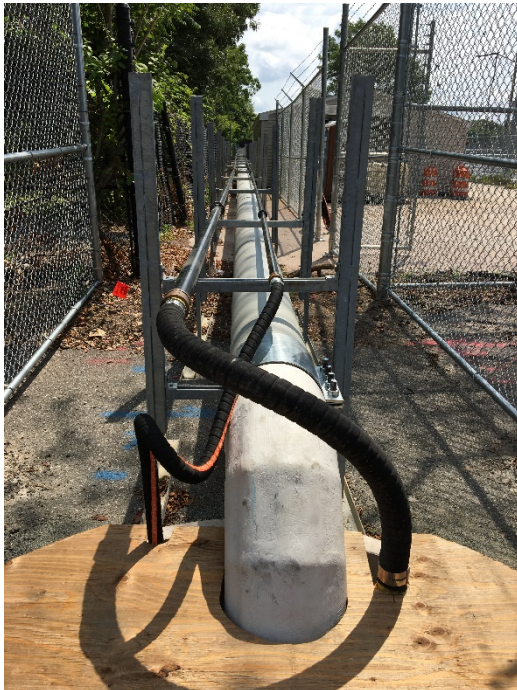
Photograph: 2

Description: Process piping into vault on McKay Field Road and locking swing gate (upper right)

Location:
McKay Field Access Road, looking east

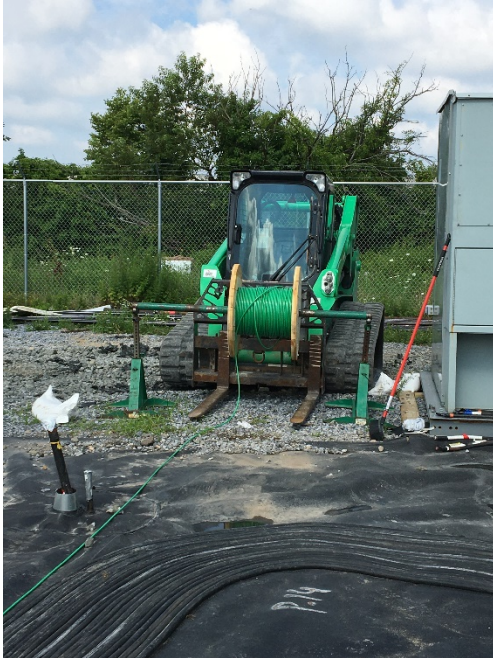
Photograph: 3

Description: Laying out ground wire for the heater wells

Location:
Wellfield

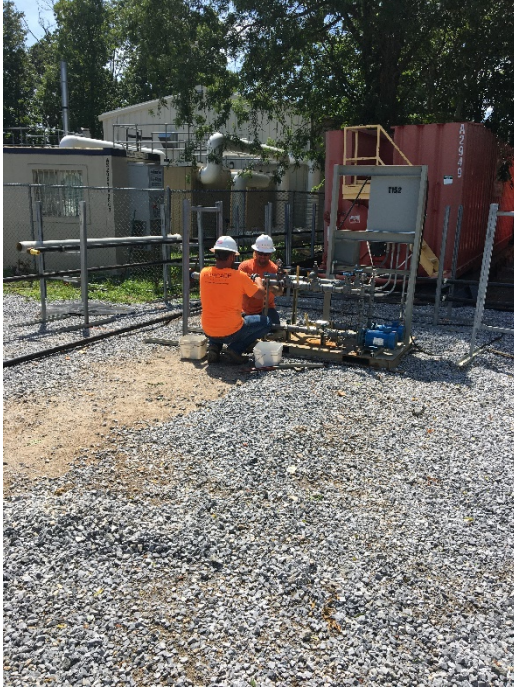
Photograph: 1

Description: Installing the ISTR
liquid effluent discharge pump skid

Location:
McKay Field

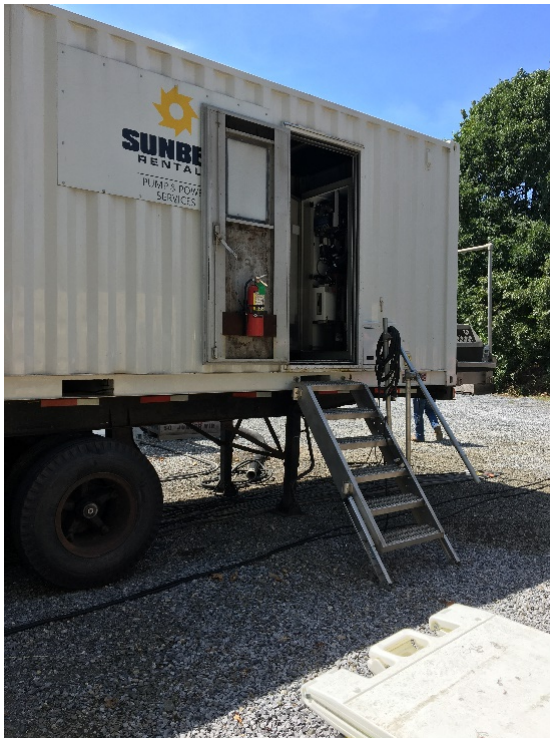
Photograph: 2

Description: Emergency
generator

Location:
McKay Field

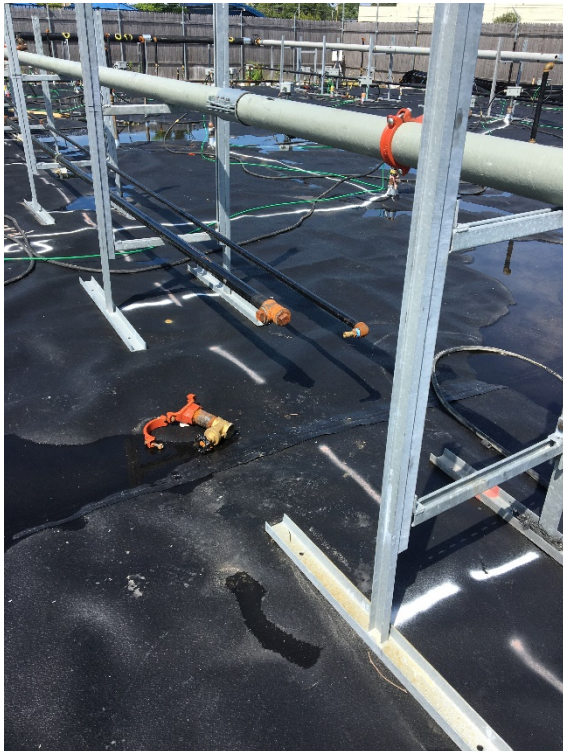
Photograph: 3

Description: Prepared 2-inch carbon steel water piping for leak and pressure testing

Location:
McKay Field

- Completed leak and pressure testing of the 2-inch carbon steel water piping using compressed air.
- Completed liquid effluent manifold between the Tier 1 treatment system, the three frac tanks, and the pump skid.

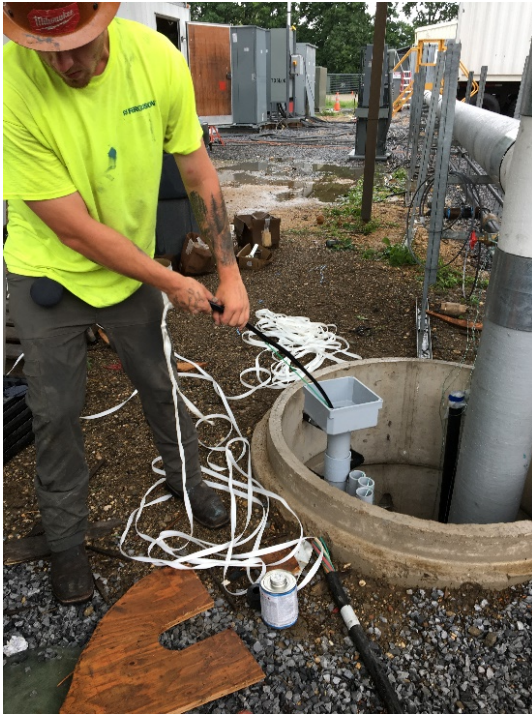
Photograph: 1

Description: Pulling electrical cable through existing conduit beneath McKay Field Access Road

Location:
McKay Field

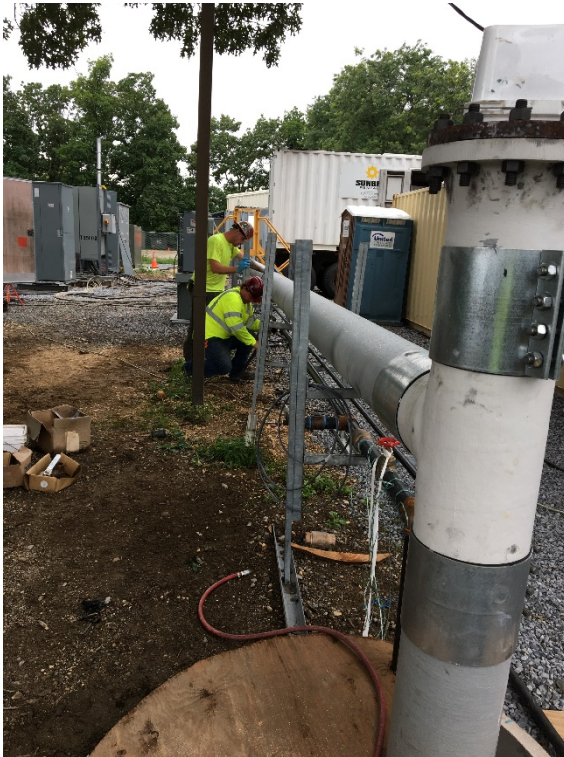
Photograph: 2

Description: Pressure testing 2-inch steel water line

Location:
McKay Field

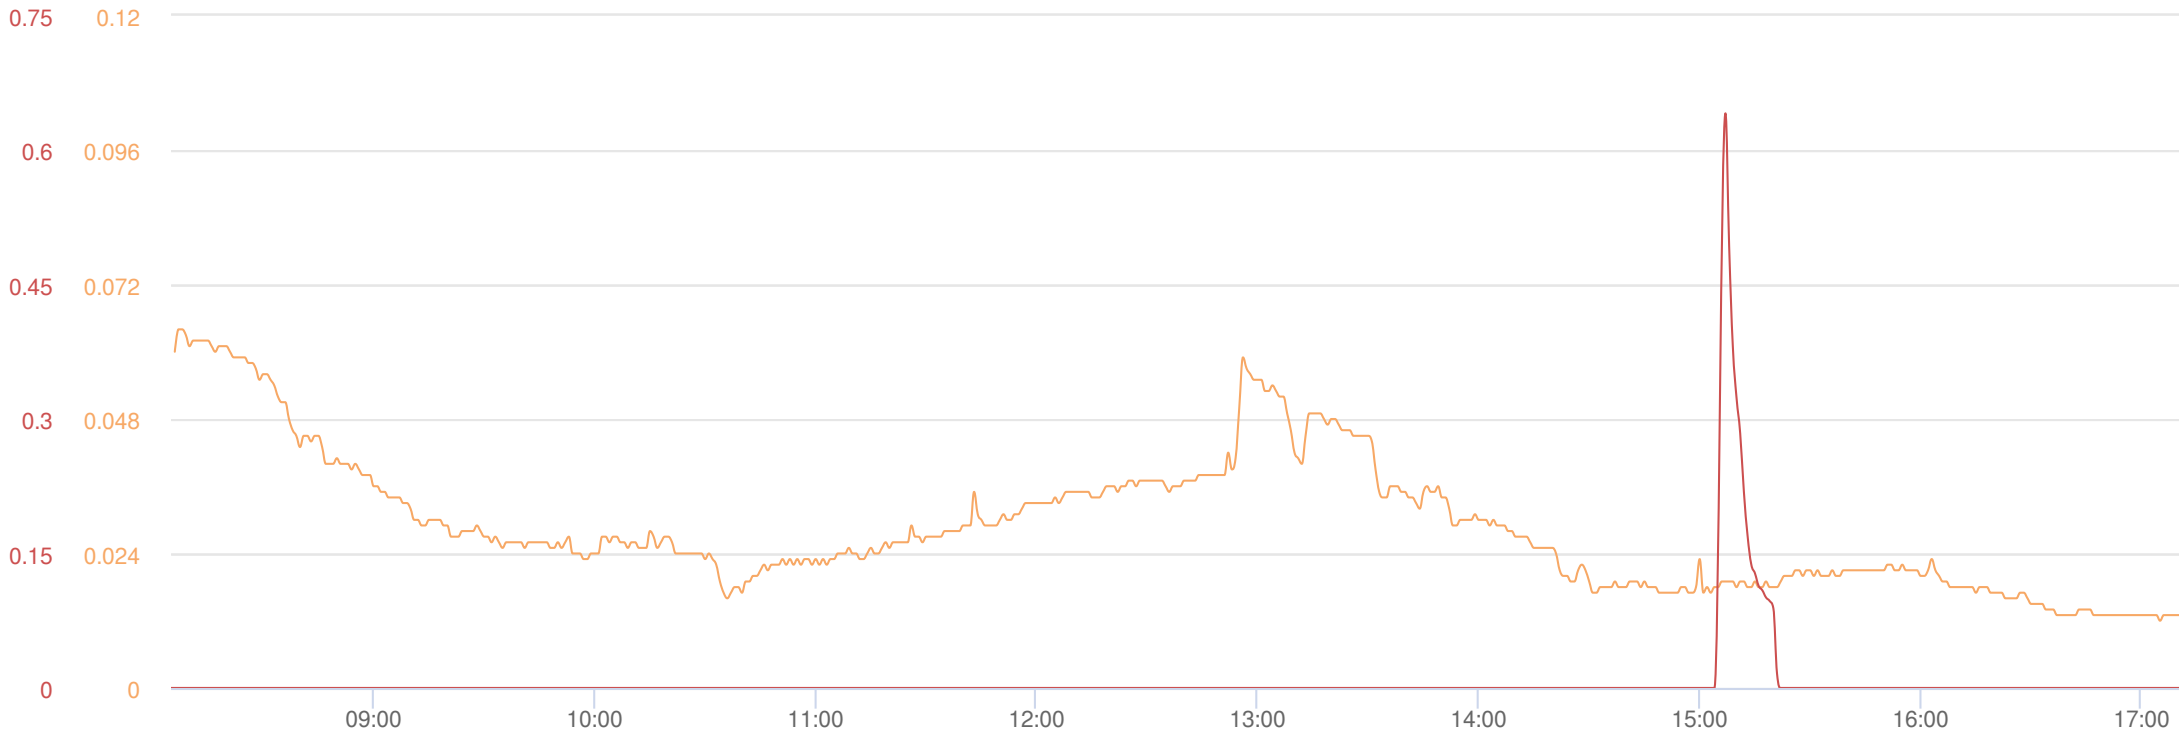
Name 41147 - Upwind
S/N 0B357066
Location 947 Stewart Ave,
 Bethpage, NY 11714,
 USA

Mass Conc. Total mg/m ³ DustTrak-8530 RS232(C)			VOC ppm miniRAE 3000 RS232(A)		
MIN	AVG	MAX	MIN	AVG	MAX
0.012	0.029	0.064	0	0.006	0.641

- Particulates (DustTrak reading, shown as orange line and orange y-axis scale): 0.1 mg/m³ (15-minute average)
- TVOCs (miniRAE PID reading, shown as red line and red y-axis scale): 5 ppm (15-minute average)

Short-term peaks of DustTrak and miniRAE readings are common during instrument setup at the beginning of the workday, and during manual calibration/detection checks throughout the day.

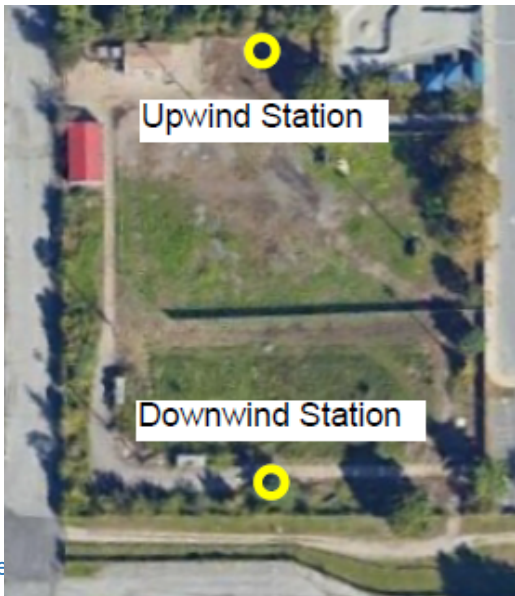
Name 39875 - Downwind
S/N 0B333738
Location 268 N 7th St, Bethpage, NY 11714, USA

Mass Conc. Total mg/m ³ DustTrak-8530 RS232(C)			VOC ppm miniRAE 3000 RS232(A)		
MIN	AVG	MAX	MIN	AVG	MAX
0.017	0.03	0.055	0	0	0

- Particulates (DustTrak reading, shown as orange line and orange y-axis scale): 0.1 mg/m³ (15-minute average)
- TVOCs (miniRAE PID reading, shown as red line and red y-axis scale): 5 ppm (15-minute average)

Short-term peaks of DustTrak and miniRAE readings are common during instrument setup at the beginning of the workday, and during manual calibration/detection checks throughout the day.

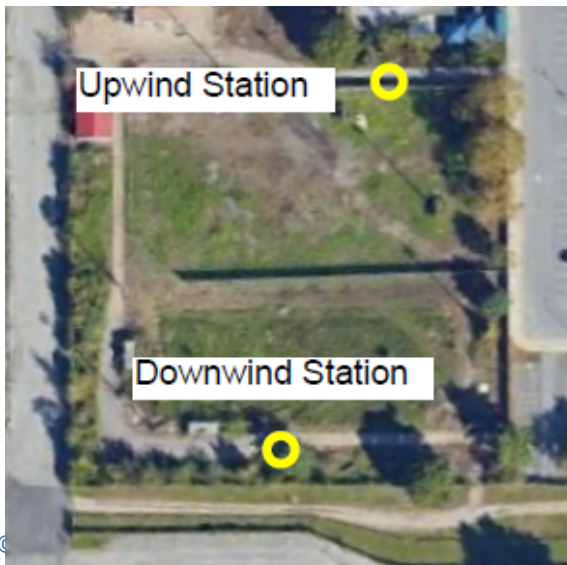
Name	41147 - Upwind
S/N	0B357066
Location	Bethpage Community Park, 1001 Stewart Ave, Bethpage, NY 11714, USA

Mass Conc. Total mg/m ³ DustTrak-8530 RS232(C)			VOC ppm miniRAE 3000 RS232(A)		
MIN	AVG	MAX	MIN	AVG	MAX
0.004	0.008	0.018	0	0	0

- Particulates (DustTrak reading, shown as orange line and orange y-axis scale): 0.1 mg/m³ (15-minute average)
- TVOCs (miniRAE PID reading, shown as red line and red y-axis scale): 5 ppm (15-minute average)

Short-term peaks of DustTrak and miniRAE readings are common during instrument setup at the beginning of the workday, and during manual calibration/detection checks throughout the day.

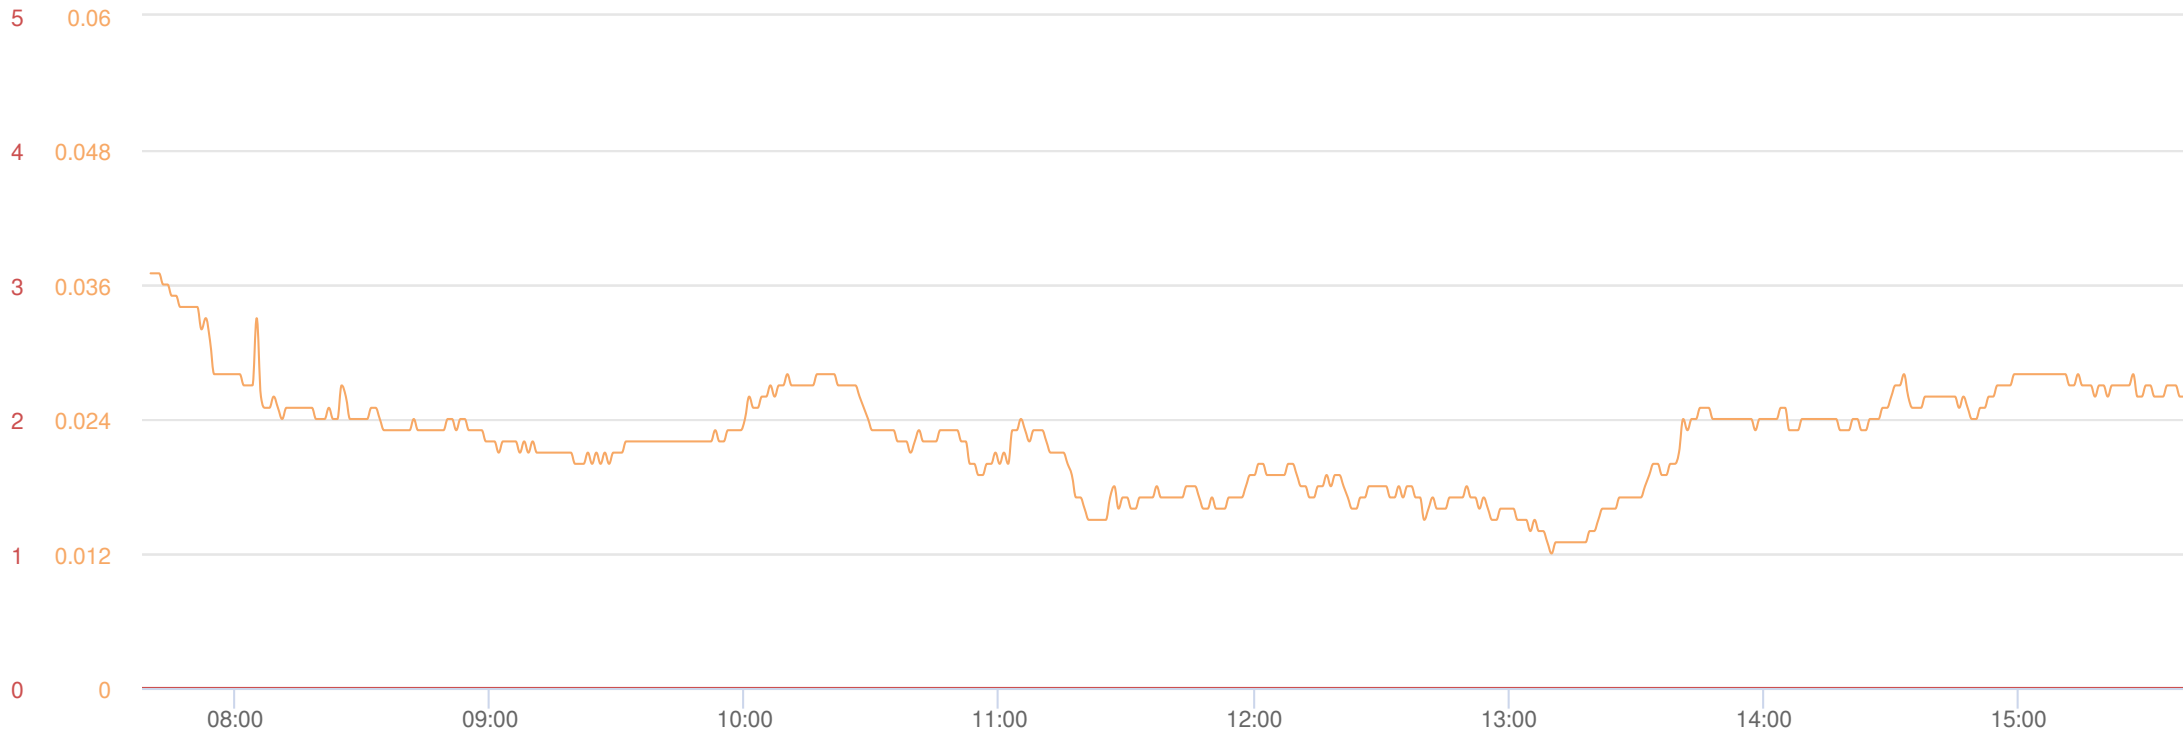
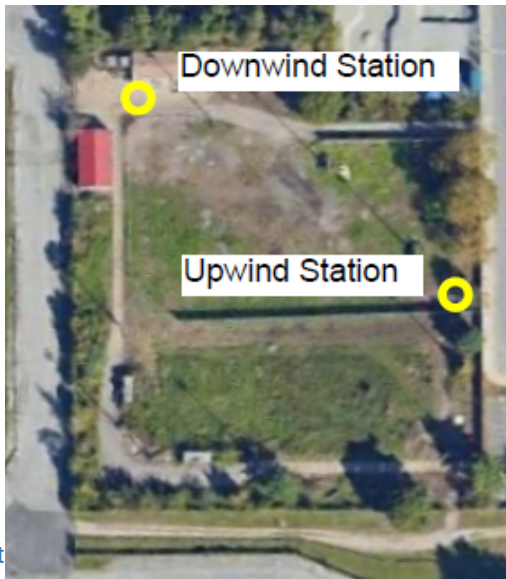
Name 41147 - Upwind
S/N 0B357066
Location Bethpage Community Park, 1001 Stewart Ave, Bethpage, NY 11714, USA

Mass Conc. Total mg/m ³ DustTrak-8530 RS232(C)			VOC ppm miniRAE 3000 RS232(A)		
MIN	AVG	MAX	MIN	AVG	MAX
0.012	0.022	0.037	0	0	0

- Particulates (DustTrak reading, shown as orange line and orange y-axis scale): 0.1 mg/m³ (15-minute average)
- TVOCs (miniRAE PID reading, shown as red line and red y-axis scale): 5 ppm (15-minute average)

Short-term peaks of DustTrak and miniRAE readings are common during instrument setup at the beginning of the workday, and during manual calibration/detection checks throughout the day.

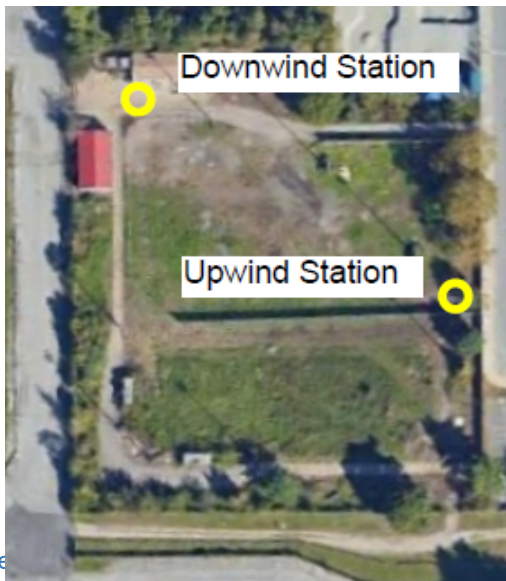
Name 39875 - Downwind
S/N 0B333738
Location Bethpage Community Park, 1001 Stewart Ave, Bethpage, NY 11714, USA

Mass Conc. Total mg/m ³ DustTrak-8530 RS232(C)			VOC ppm miniRAE 3000 RS232(A)		
MIN	AVG	MAX	MIN	AVG	MAX
0.014	0.023	0.035	0	0.035	0.074

- Particulates (DustTrak reading, shown as orange line and orange y-axis scale): 0.1 mg/m³ (15-minute average)
- TVOCs (miniRAE PID reading, shown as red line and red y-axis scale): 5 ppm (15-minute average)

Short-term peaks of DustTrak and miniRAE readings are common during instrument setup at the beginning of the workday, and during manual calibration/detection checks throughout the day.

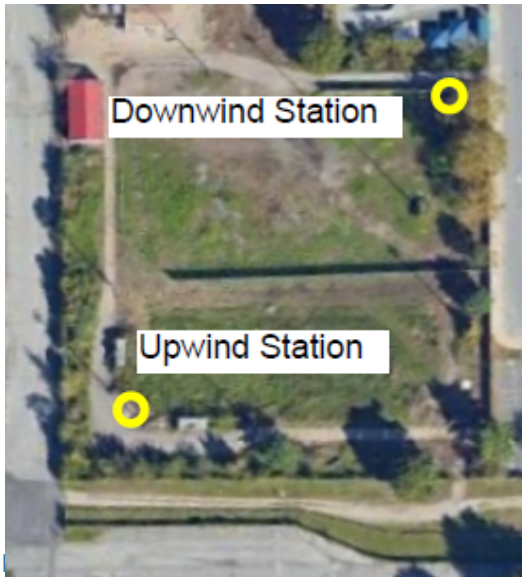
Name 41147 - Upwind
S/N 0B357066
Location Bethpage Community Park, 1001 Stewart Ave, Bethpage, NY 11714, USA

Mass Conc. Total mg/m ³ DustTrak-8530 RS232(C)			VOC ppm miniRAE 3000 RS232(A)		
MIN	AVG	MAX	MIN	AVG	MAX
0.006	0.015	0.035	0	0.041	2.397

- Particulates (DustTrak reading, shown as orange line and orange y-axis scale): 0.1 mg/m³ (15-minute average)
- TVOCs (miniRAE PID reading, shown as red line and red y-axis scale): 5 ppm (15-minute average)

Short-term peaks of DustTrak and miniRAE readings are common during instrument setup at the beginning of the workday, and during manual calibration/detection checks throughout the day.
