Subject: **Well Inventory Memorandum – Navy Owned Wells, NWIRP Bethpage**

Date: July 2015

Introduction

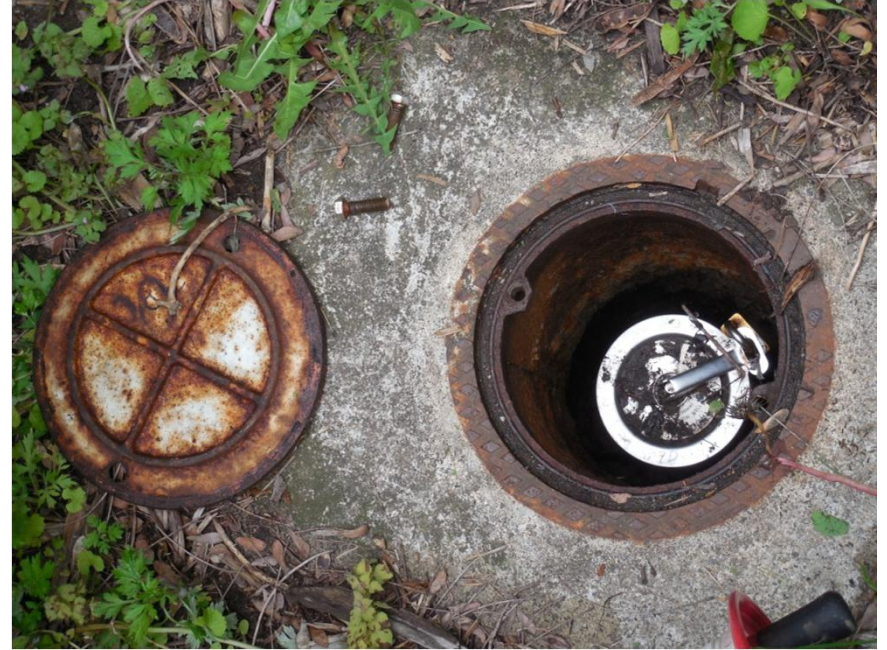
6A.DSCN0200-HN-29D

HN-29I	BPHNMW29I	130	120	130	5/20/2014	44.95	129.6	Fair	R	pad cracked	1124698.062	213999.3849	NWIRP - North of south warehouse buildings
6A	HN-29D	BPHNMW29D	220	210	220	5/20/2014	45.18	225.2	Good			1124717.151	214004.8275	NWIRP - North of south warehouse buildings
6B	HN-40S	BPHNMW40S	NA	49	59	5/22/2014	47.7	58.8	Good			1126042.82	212474.1604	Meade Ct @ N 7th St
7	HN-40I	BPHNMW40I	NA	108	118	5/22/2014	47.6	121.4	Good			1126027.474	212469.4837	Meade Ct @ N 7th St
8	HN-42S	BPHNMW42I	60	50	60	5/22/2014	48.85	61.5	Good			1126067.16	213790.77	Maple Ave @N 7th St
9	HN-42I	BPHNMW42S	110	100	110	5/22/2014	49.21	112.5	Good			1126065.736	213879.1202	Maple Ave @N 7th St
10	TT-309D	BPS1-TT-MW-309D	262	252	262	5/20/2014	59.38	267	Good			1125028.364	215208.337	NWIRP - Site 2 north of former sludge dry beds northwest side
11	TT-309I	BPS1-TT-MW-309I	170	160	170	5/20/2014	59.32	174	Good			1125016.064	215209.976	NWIRP - Site 2 north of former sludge dry beds northwest side

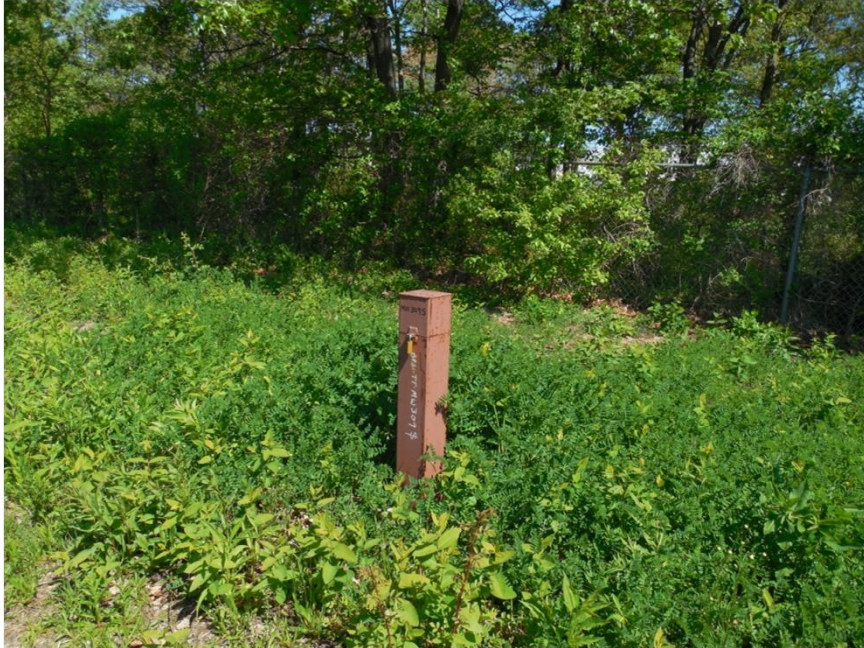
12.DSCN0056-BPS1-TT-MW309S

12	TT-309S	BPS1-TT-MW-309S	63	40.5	50.5	5/20/2014	58.19	58.5	Good			1124997.76	215211.896	NWIRP - Site 2 north of former sludge dry beds northwest side
13	TT-313S	BPS1-TT-MW-313S	63	NA	NA	5/20/2014	56.6	65.8	Good			1125592.409	215155.071	NWIRP - Site 2 northeast side
14	TT-312S	BPS1-TT-MW-312S	163	NA	NA	5/23/2014	56.7	167	Good		Felt like interface probe was stuck; covered in silt	1125165.414	215322.487	NWIRP - Site 2 north west of northern recharge basin
	TT-312I	BPS1-TT-MW-312I	170	NA	NA	5/23/2014	56.4	173.5	Good			1125165.88	215327.826	NWIRP - Site 2 north west of northern recharge basin
16	TT-314I	BPS1-TT-MW-314I	154	NA	NA	5/20/2014	57.6	158	Good			1125572.919	214550.204	NWIRP - Site 2 southeast side
17	TT-314S	BPS1-TT-MW-314S	165	NA	NA	5/20/2014	57.15	168	Good			1125571.342	214555.397	NWIRP - Site 2 southeast side
18	TT-308D	BPS1-TT-MW-308D	260	NA	NA	5/20/2014	59.2	266.2	Good			1124935.523	214965.058	NWIRP - Site 2 north of southwestern pond

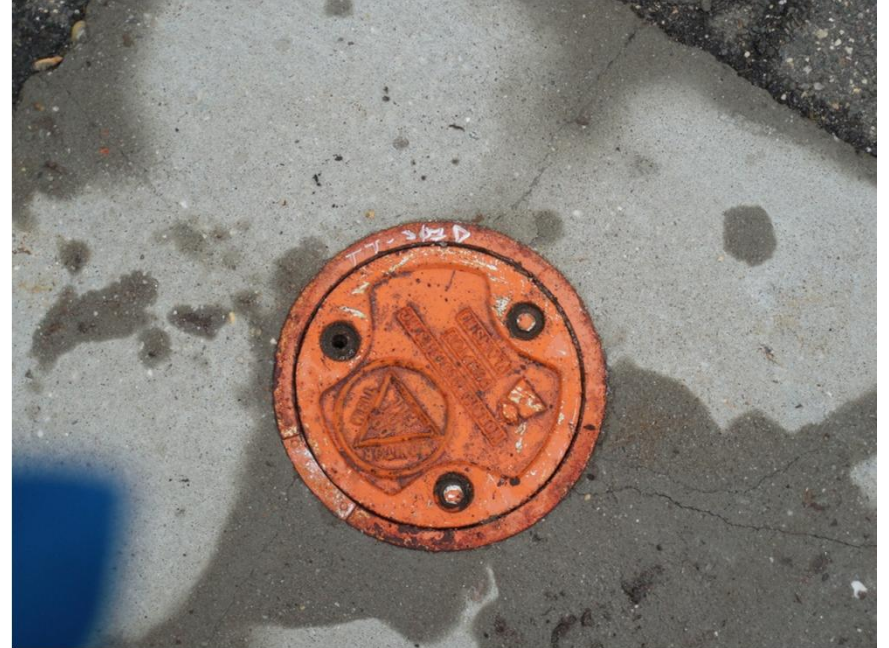
26.DSCN0173-BPS1-TT-MW307D

26	TT-307D	BPS1-TT-MW307D	286	276	286	5/22/2014	45.5	285.38	Fair	R	Pad cracked; needs bolts	1124926.585	213357.39	NWIRP - Southeast of south warehouse buildings
27	TT-304D	BPS1-TT-MW304D	191	180	190	5/20/2014	46.9	191	Good			1124994.61	213691.8	NWIRP - East of south warehouse buildings, stick ups cut off

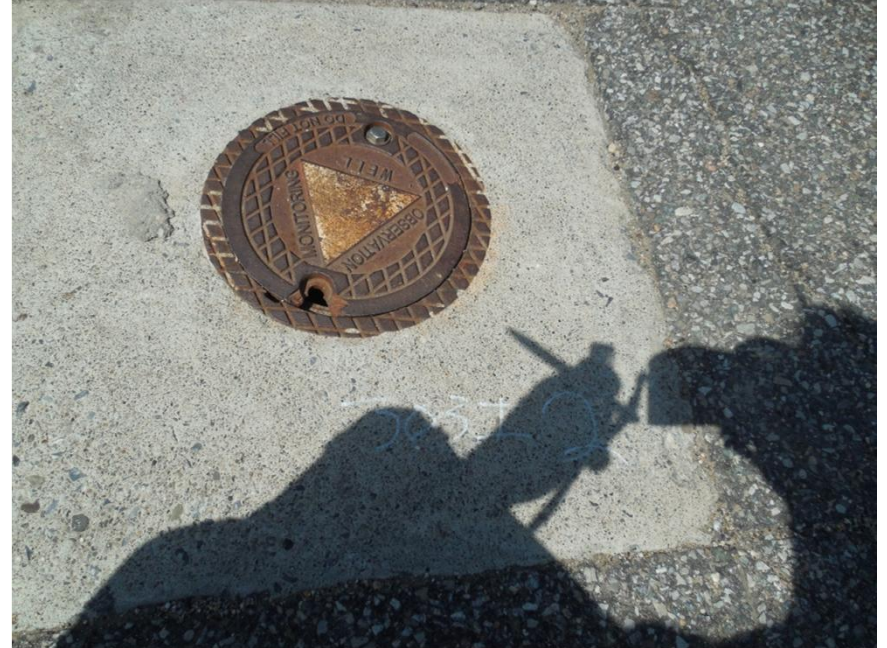
36.DSCN0123-BPS1-TT-MW303I2

36	TT-30312	BPS1-TT-MW30312	156	146	156	5/20/2014	45.5	151	Good			1124562.054	213779.054	NWIRP - Between south warehouse buildings on northeast corner
37	TT-303S	BPS1-TT-MW303S	56	46	56	5/20/2014	45.3	51	Fair	R	Pad cracked	1124583.496	213778.188	NWIRP - Between south warehouse buildings on northeast corner
	MW-01	BPTTAOC22MW01	68	48	68	5/20/2014	51.93	57.15	Fair	R, S	OLM; needs bolts, locks, jplug	1123685.101	214049.1047	NWIRP - 39.4' from Al's trailer, 22.4' from fence
	MW-02	BPTTAOC22MW02	66	46	66	5/20/2014	52.6	52.6	Fair	R, S	needs bolts & locks	1123715.055	214058.1533	NWIRP - Site 2, beware OLM
38	MW-03	BPTTAOC22MW03	65.5	45.5	65.5	5/20/2014	59.1	66.4	Good	S		1123680.109	214136.7829	NWIRP - Site 2, northern side
39	MW-04	BPTTAOC22MW04	66	46	66	5/21/2014	51.57	68	Good	S		1123645.162	214018.5265	NWIRP - Site 2 on northwestern corner of office building
	MW-05	BPTTAOC22MW05	67	47	67	5/20/2014	NA	NA	decommissioned			1123702.574	214173.9136	NWIRP decommissioned

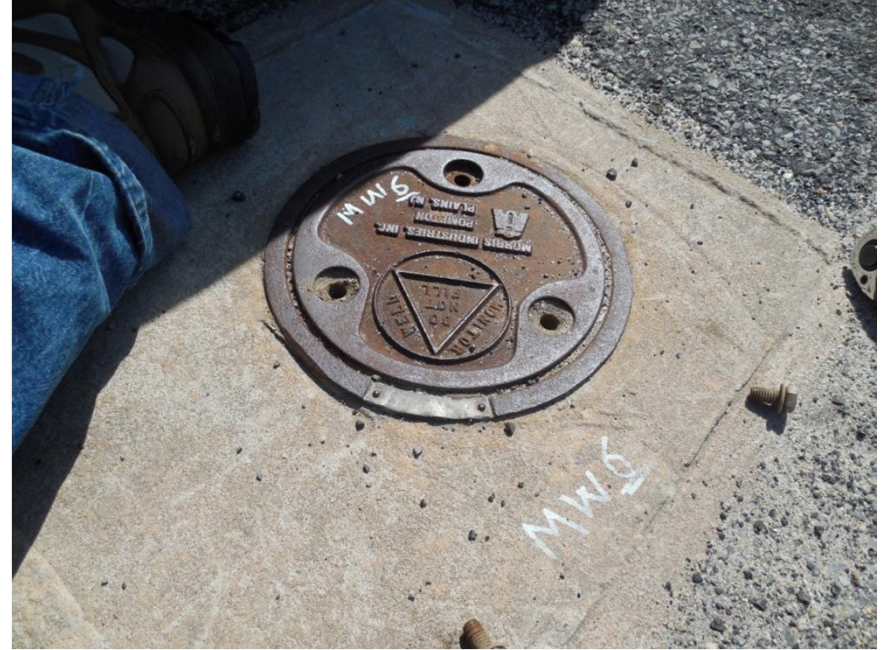
40.DSCN0127-BPTTAOC22MW06

40	MW-06	BPTTAOC22MW06	62	52	62	5/20/2014	47.2	63.1	Fair	R	needs bolts	1123745.67	213898.45	NWIRP - In lot behind SVE building
41	MW-07	BPTTAOC22MW07	62	52	62	5/20/2014	47	63.4	Good			1123660.55	213883.97	NWIRP - In lot behind SVE building
42	MW-08	BPTTAOC22MW08	62	52	62	5/20/2014	47	62.9	Fair	R	needs bolts	1123576.06	213932.1	NWIRP - In lot behind SVE building
43	MW-09	BPTTAOC22MW09	62	52	62	5/20/2014	48.27	63.3	Fair	R	needs bolts, pad cracked	1123539.24	214008.07	NWIRP - In lot behind SVE building
44	MW-10	BPTTAOC22MW10	60	49	59	5/20/2014	45.56	60	Fair	R	Pad cracked	1123833.4	213950.8	NWIRP - Northwest corner of south warehouse buildings
45	MW-11	BPTTAOC22MW11	64	53	63	5/20/2014	49.35	65.1	Fair	R	needs bolts	1123547.95	214145.5	NWIRP - In road just west of Site 4
46	BPOW 5-1	BPOW 5-1	527	480	510	5/21/2014	21.6	528	Fair	R	needs bolts & locks	1127145.842	198399.79	Kildare Crescent in cul-de-sac

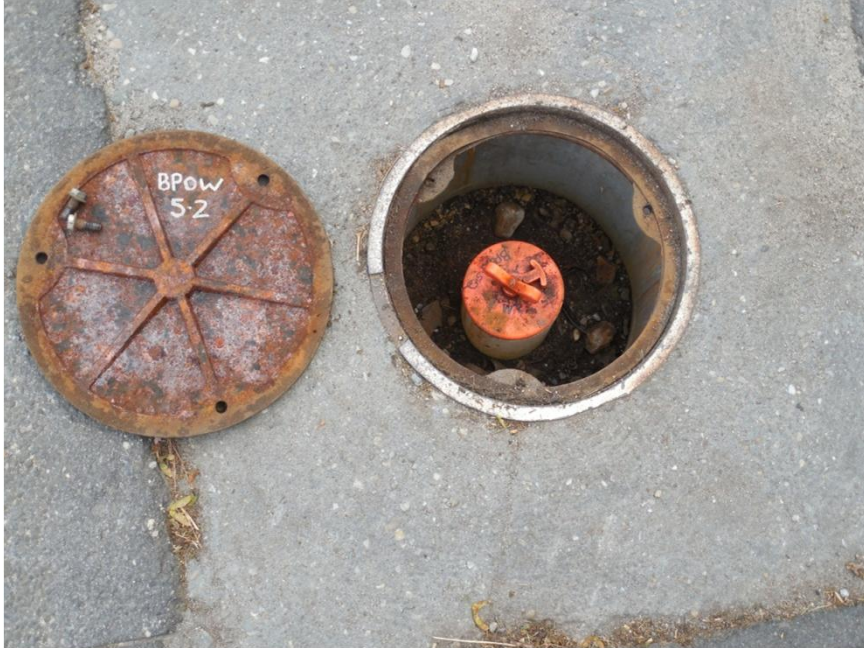
47.DSCN0136-BPOW-5-2

47	BPOW 5-2	BPOW 5-2	598	540	580	5/21/2014	24.7	599.4	Fair	R	needs bolts & locks	1127152.768	198410.857	Kildare Crescent in cul-de-sac
48	BPOW 5-3	BPOW 5-3	680	620	660	5/21/2014	21.57	683	Fair	R	needs bolts & locks	1127156.801	198389.891	Kildare Crescent in cul-de-sac
49	TT-101D		363	325	345	5/21/2014	31.25	355	Fair	R, S	needs locks	1125462.038	203545.488	Emerson Ave
50	TT-101D1		603	570	590	5/21/2014	33.1	609	Fair	R, S	needs locks	1125484.11	203545.086	Emerson Ave
51	TT-101D2		777	740	760	5/21/2014	33.65	784	Fair	R, S	needs locks	1125454.308	203545.377	Emerson Ave
52	TT-102D		618	560	600	5/21/2014	19.45	623.4	Fair	R	needs locks; ARCADIS on site having bladder pump issues	1127148.911	195341.937	Between Alken Ave & Southern State Pkwy inside sump

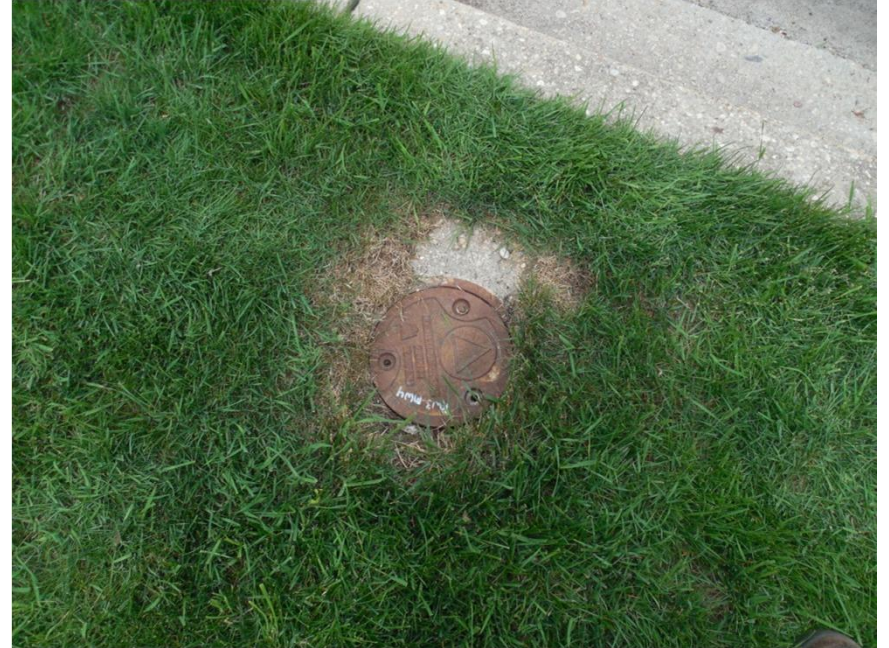
58.DSCN0147-RW3-MW4

58	RW3-MW4		NA	475	495	5/21/2014	40	511.1	Fair	R, S	needs bolts & locks; riser pipe has no sand pack	1128979.551	206773.751	Between Broadway and Sophia St
59	MW-75D2	MW-75D2	NA	230	240	5/21/2014	NA	NA	Good		Inaccessible; possibly transducers-most likely packer	1121671.241	213996.6831	Mulberry St between Jefry Ln & Washington Pkwy
60	RE-103D1	RE103D1	645	625	640	5/21/2014	38.31	668.5	Fair	R, S	needs locks	1125111.764	206694.59	By Avoca Ave & Martin Pl
61	RE-103D2	RE103D2	673	653	673	5/21/2014	38	691	Fair	R, S	needs locks	1125160.339	206692.993	By Avoca Ave & Martin Pl
62	RE-103D3	RE103D3	735	715	730	5/21/2014	38.81	761	Fair	R, S	needs locks	1125144.905	206693.459	By Avoca Ave & Martin Pl
	RE-104D1	RE104D1	375	350	370	5/21/2014	34.74	387.2	Fair	R, S	needs locks	1127745.611	207036.9997	Turn of Hilltop Ave
63	RE-104D2	RE104D2	735	710	730	5/21/2014	39.43	756.3	Fair	R, S	needs locks	1127708.991	207000.0361	Turn of Hilltop Ave

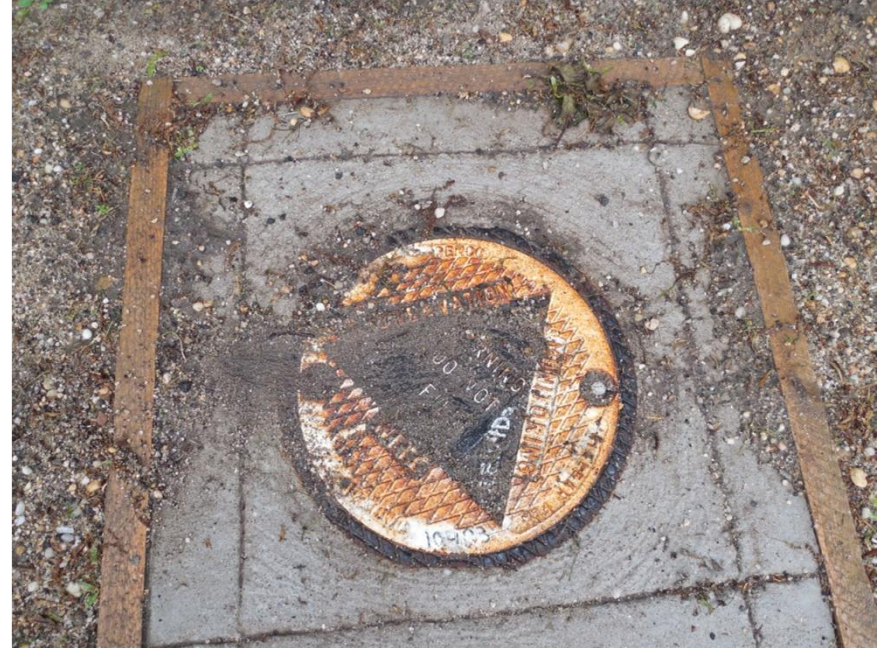
64.DSCN0162-RE-104D3

64	RE-104D3	RE104D3	785	760	780	5/21/2014	40.01	808.3	Fair	R, S	needs locks	1127695.554	206993.5018	Turn of Hilltop Ave
65	RE-105D1	RE105D1	555	530	550	5/21/2014	36.72	572.1	Fair	R, S	needs locks	1126664.427	205072.866	Lincoln Blvd between Roosevelt & Balfour Drives
66	RE-105D2	RE105D2	755	730	730	5/21/2014	38.15	780	Fair	R, S	needs locks	1126652.418	205064.024	Lincoln Blvd between Roosevelt & Balfour Drives
67	TT-302S	BPS1-TT-MW302S	52	41	51	5/22/2014	45.02	52	Good		Something blocking interface probe.	1124261.772	213812.671	NWIRP - Between south warehouse buildings on northern side
68	TT-302I1	BPS1-TT-MW302I1	120	110	120	5/22/2014	45.07	127.3	Good	S		1124251.046	213812.87	NWIRP - Between south warehouse buildings on northern side
	TT-302I2	BPS1-TT-MW302I2	150	140	150	5/22/2014	49.31	151.5	Fair	R, S	pad cracked	1124241.215	213813.43	NWIRP - Between south warehouse buildings on northern side
69	TT-302D	BPS1-TT-MW302D	213	203	213	5/22/2014	49.5	272.2	Good	S		1124230.805	213814.24	NWIRP - Between south warehouse buildings on northern side
