Bayer MaterialScience LLC
125 New South Road
Hicksville, New York
USEPA ID#: NYD002920312
Soil Vapor Intrusion Background Information Search Summary

FREEDOM OF INFORMATION LAW REQUEST
VOC INFORMATION AT SELECT PROPERTIES
HICKSVILLE, NEW YORK

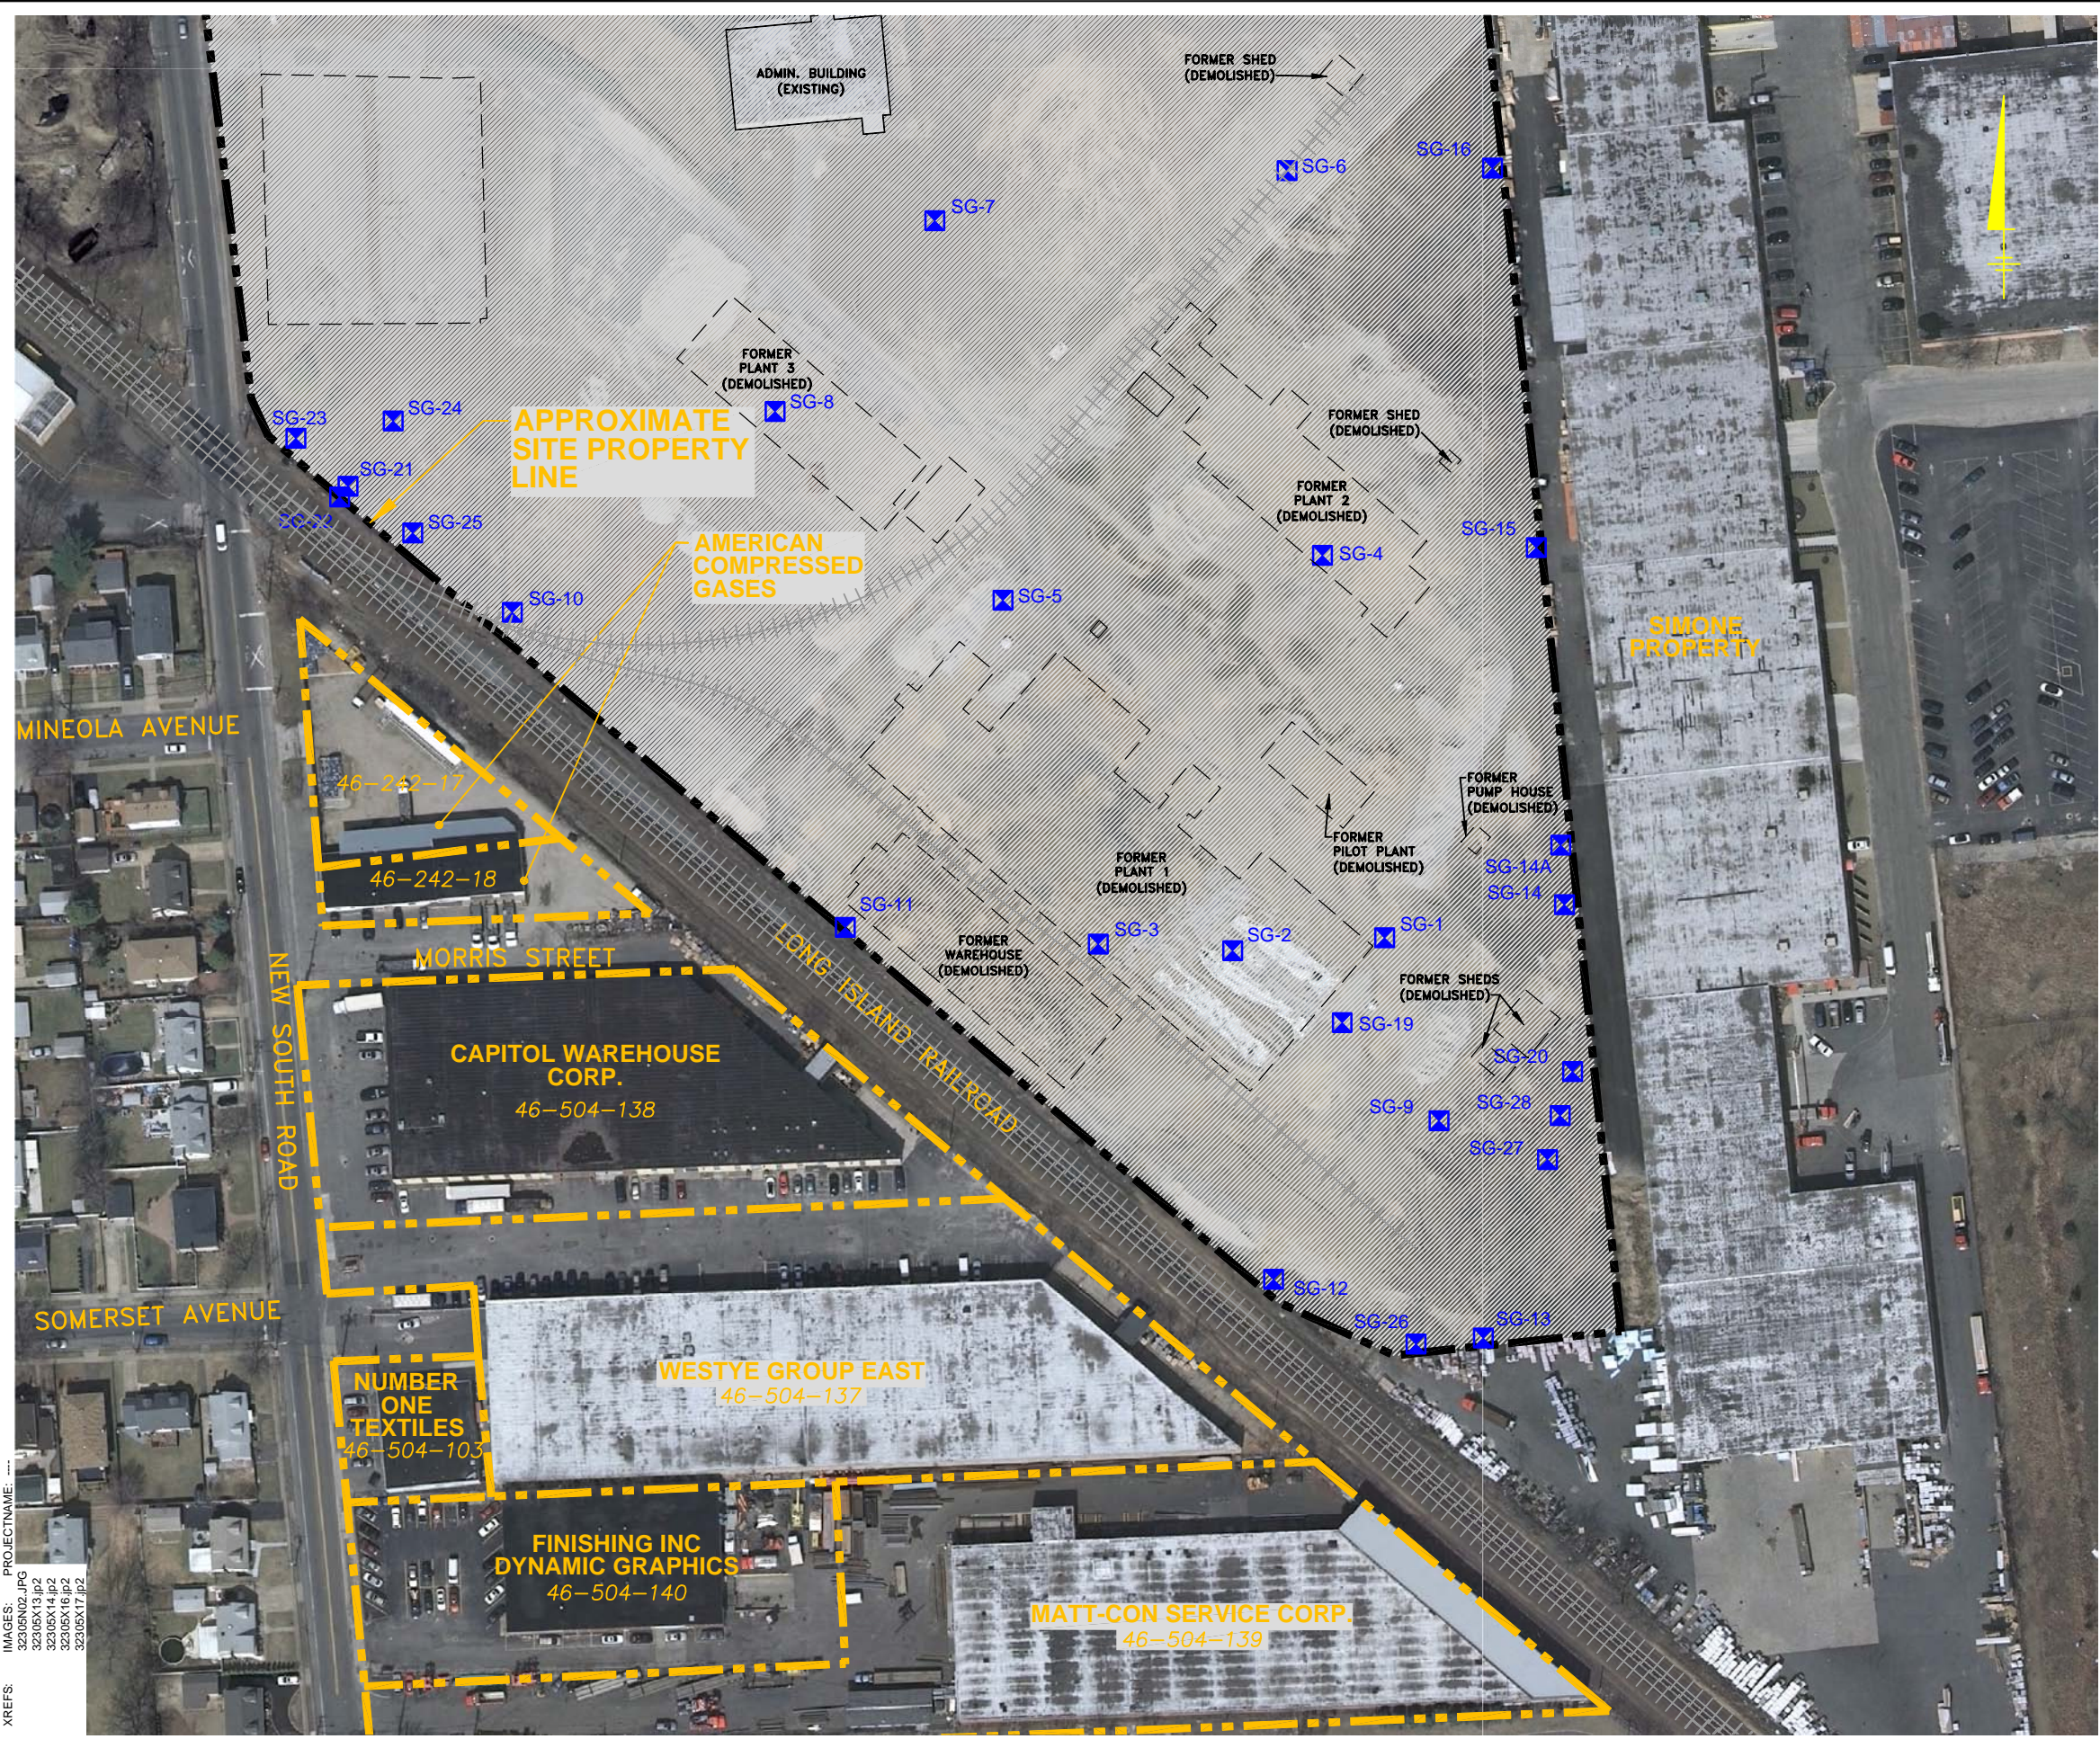
Figure

- NOTES:**
- AERIAL PHOTOGRAPH OBTAINED FROM NEW YORK STATE GEOGRAPHIC INFORMATION SYSTEM (NYS GIS) DATABASE. PHOTO DATE: 2007.
 - PROPERTY LINES APPROXIMATE USING NASSAU COUNTY DEPARTMENT OF ASSESSMENT MAP TITLED "LAND & TAX MAPS" FOR SECTION 46, BLOCK 240, BLOCK 504 AND BLOCK N.
 - BASEMAP, INCLUDING PROPERTY LINES FOR INDIVIDUAL PARCELS, WAS DEVELOPED BY COMBINING NASSAU COUNTY DEPARTMENT OF ASSESSMENT MAPS TITLED "LAND & TAX MAPS" FOR THE FOLLOWING BLOCKS WITHIN SECTION 46:
 - BLOCK 240 (MAP LAST REVISED DECEMBER 19, 2002).
 - BLOCK 504 (MAP LAST REVISED JANUARY 2, 2003).
 - BLOCK N (MAP LAST REVISED ON JANUARY 12, 2009).
 - CURRENT BUSINESS NAMES WERE ACQUIRED FROM TOWN OF OYSTER BAY TAX OFFICE AND A MARCH 2010 INTERNET SEARCH.
 - SVI = SOIL VAPOR INVESTIGATION
