Remedial Investigation Report

Operable Unit 5

RUCO Polymer Corporation Site, Hicksville, NY (Site #130004)

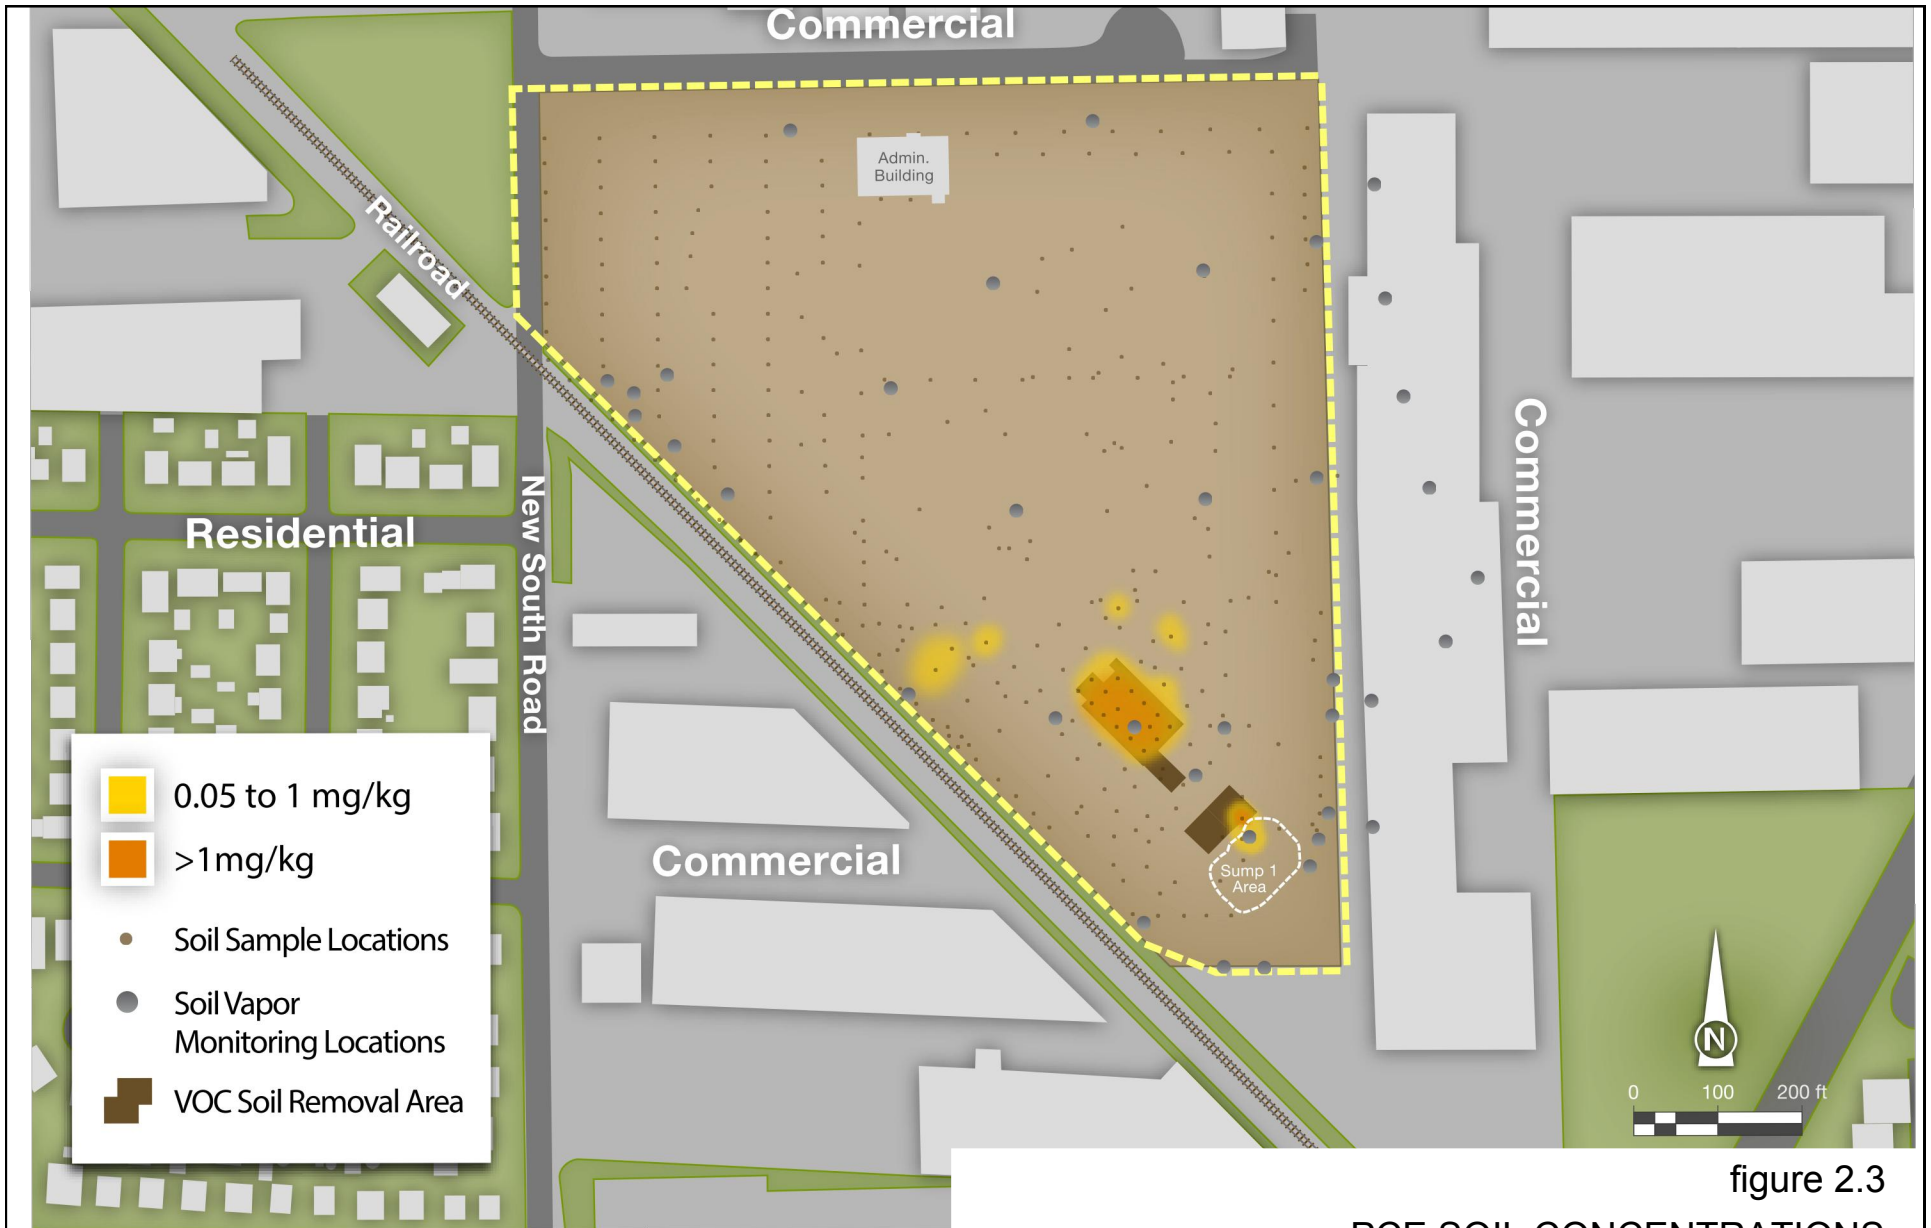
figure 2.3
 PCE SOIL CONCENTRATIONS
 OU-5 REMEDIAL INVESTIGATION REPORT
Ruco Polymer Corporation Site, Hicksville, New York

Under NYSDEC's RCRA program and the remedial actions undertaken due to designation as an Inactive Hazardous Waste Site, the vadose zone soils across the Site were extensively investigated through a series of comprehensive assessments completed between 2004 and 2009. Other than five locations in the vicinity of former Plant 1 where PCE concentrations ranged from 0.05 to 1 mg/kg, the total VOC concentrations were either less than 0.05 mg/kg or were non-detect across the remainder of the Site. Given that more than 450 sample locations have been tested, it is not expected that there are any residual sources of VOCs that remain in soil on the Site. The localized areas of elevated concentrations of PCE and TCE, shown on Figures 2.3 and 2.4 respectively, were removed in 2009.
