# Remedial Investigation Report

Operable Unit 5

RUCO Polymer Corporation Site, Hicksville, NY (Site #130004)

081618 | D22102 | 403 | Report No 1 rev1 | April 14 2016

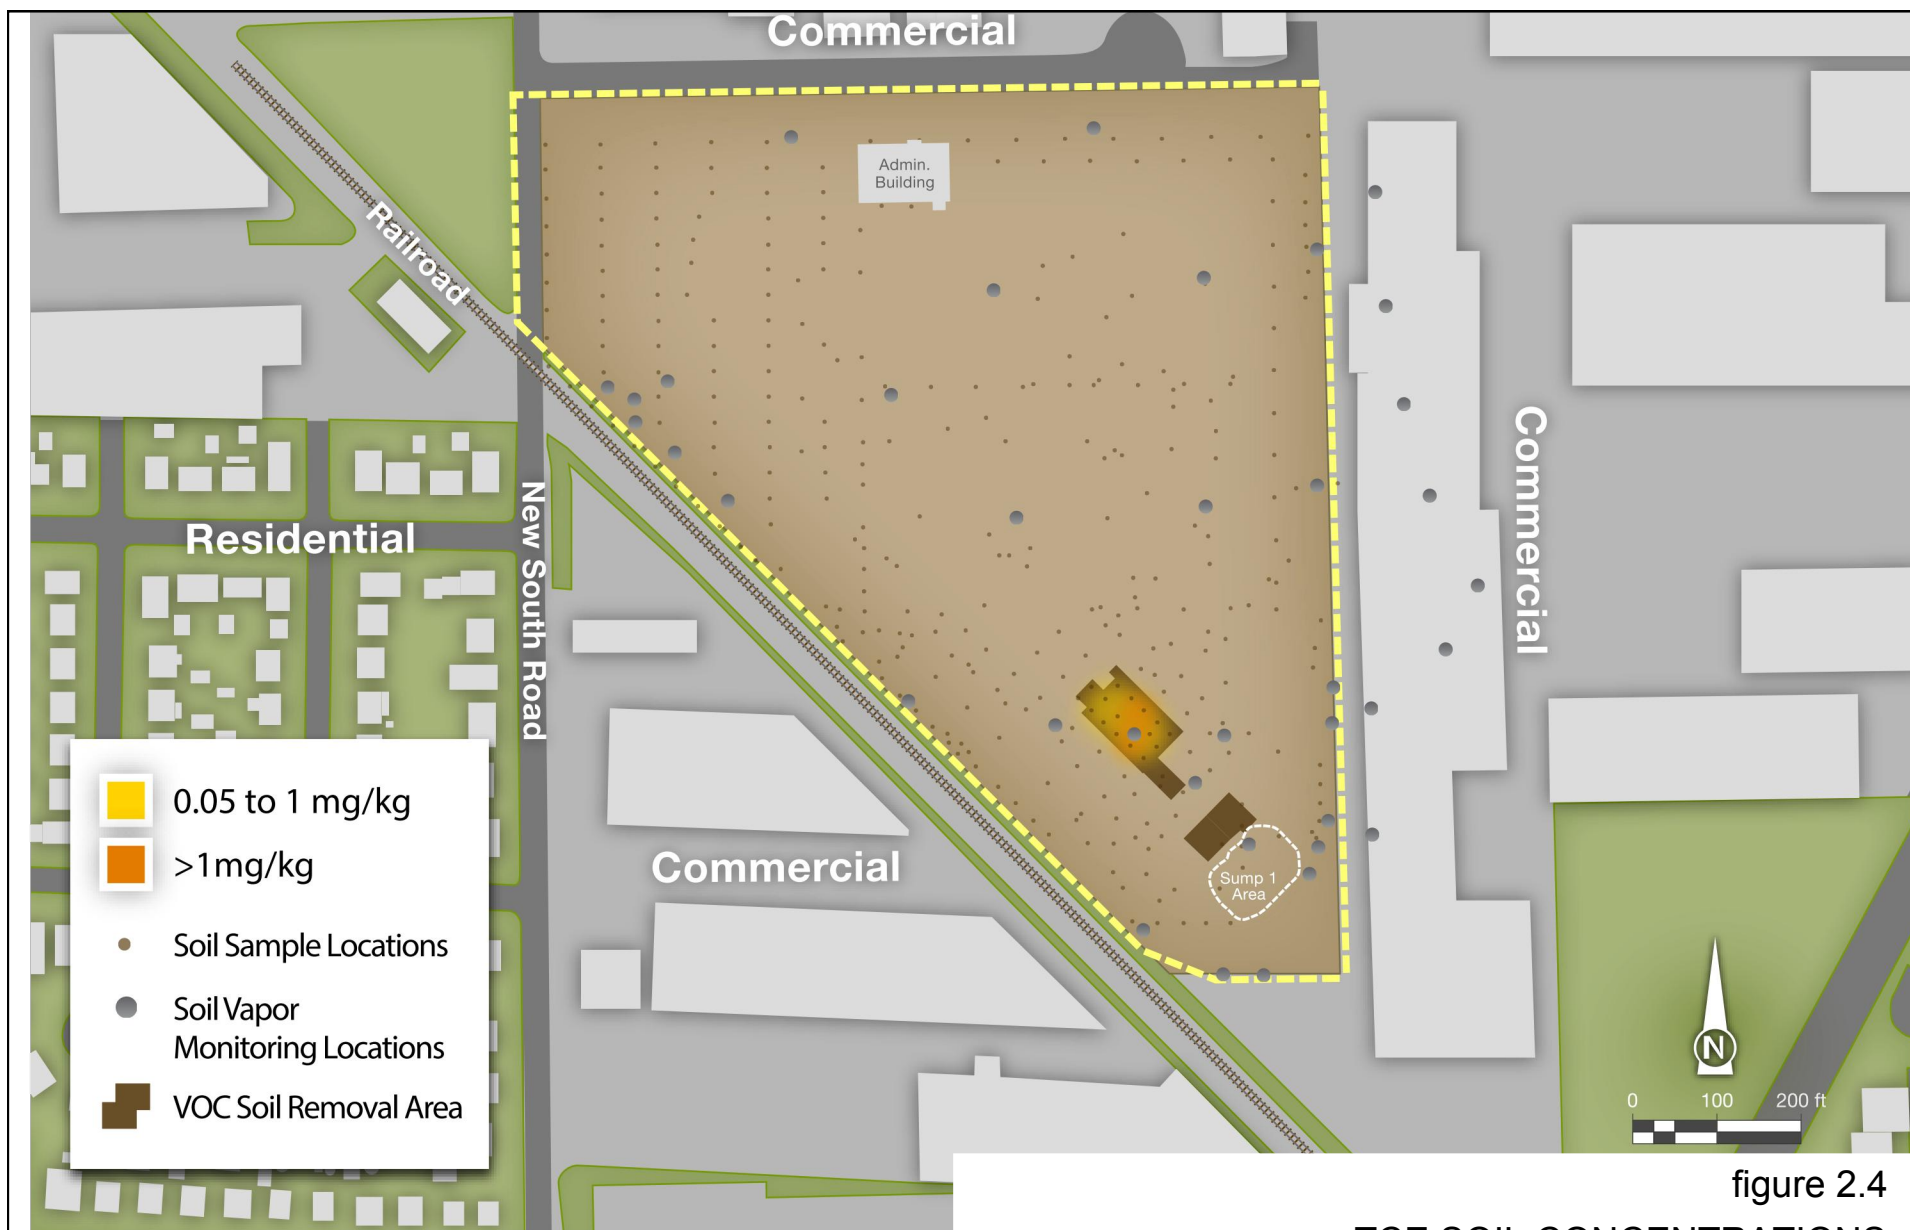
figure 2.4

TCE SOIL CONCENTRATIONS  
 OU-5 REMEDIAL INVESTIGATION REPORT  
*Ruco Polymer Corporation Site, Hicksville, New York*

Under NYSDEC's RCRA program and the remedial actions undertaken due to designation as an Inactive Hazardous Waste Site, the vadose zone soils across the Site were extensively investigated through a series of comprehensive assessments completed between 2004 and 2009. Other than five locations in the vicinity of former Plant 1 where PCE concentrations ranged from 0.05 to 1 mg/kg, the total VOC concentrations were either less than 0.05 mg/kg or were non-detect across the remainder of the Site. Given that more than 450 sample locations have been tested, it is not expected that there are any residual sources of VOCs that remain in soil on the Site. The localized areas of elevated concentrations of PCE and TCE, shown on Figures 2.3 and 2.4 respectively, were removed in 2009.
