REMEDIAL SYSTEM OPTIMIZATION REPORT

SHORE REALTY CORPORATION (AES)
1 SHORE ROAD, GLENWOOD LANDING, NEW YORK 11547
NYSDEC Site No. 130006
Work Assignment No. D009812-01

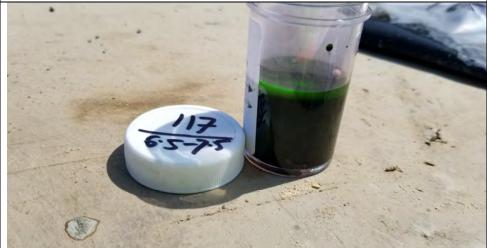
Photo 7: Side view of Oil-In-Soil test on sample collected from 6.5 to 7.5 feet bgs at SB-117.

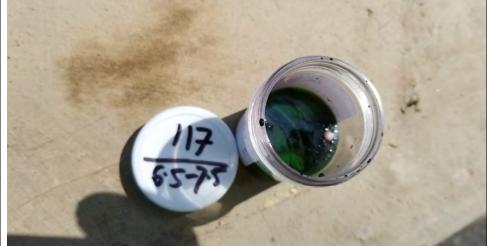
Photo 8: Top view of Oil-In-Soil test on sample collected from 6.5 to 7.5 feet bgs at SB-117.

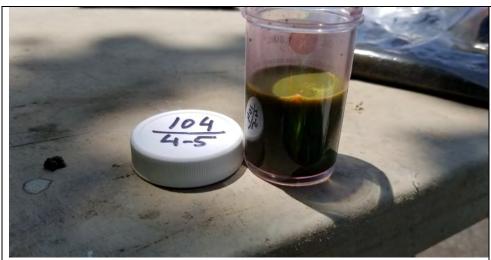
Photo 9: Side view of Oil-In-Soil test on sample collected from 4 to 5 feet bgs at SB-104.

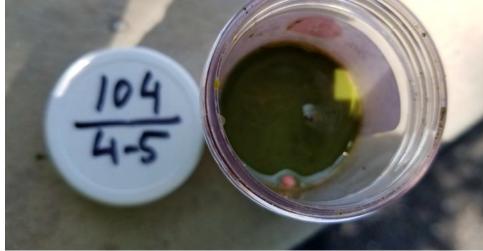
Photo 10: Top view of Oil-In-Soil test on sample collected from 4 to 5 feet bgs at SB-104.

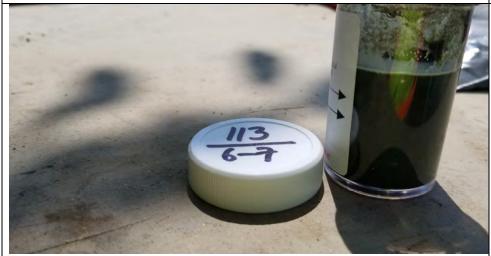
Photo 11: Side view of Oil-In-Soil test on sample collected from 6 to 7 feet bgs at SB-113.

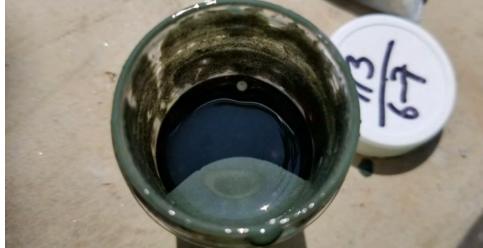
Photo 12: Top view of Oil-In-Soil test on sample collected from 6 to 7 feet bgs at SB-113.

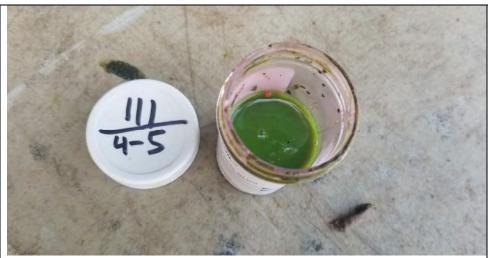
Photo 1: Top view of Oil-In-Soil test on sample collected from 4 to 5 feet bgs at SB-111.

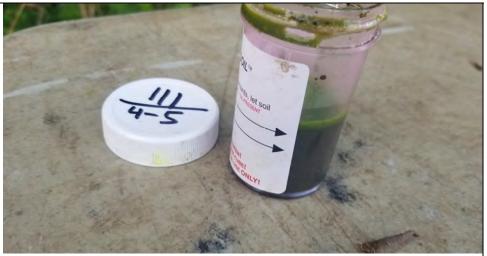
Photo 2: Side view of Oil-In-Soil test on sample collected from 4 to 5 feet bgs at SB-111.

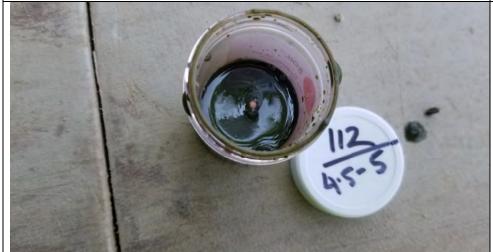
Photo 3: Top view of Oil-In-Soil test on sample collected from 4.5 to 5 feet bgs at SB-112.

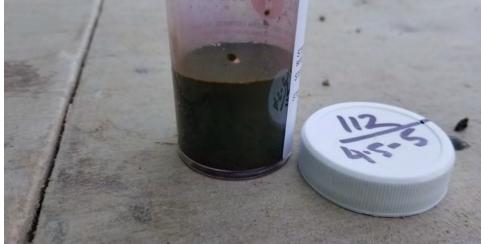
Photo 4: Side view of Oil-In-Soil test on sample collected from 4.5 to 5 feet bgs at SB-112.

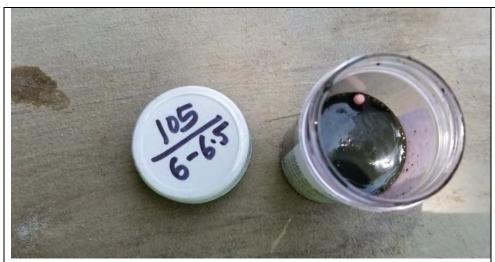
Photo 5: Top view of Oil-In-Soil test on sample collected from 6 to 6.5 feet bgs at SB-105.

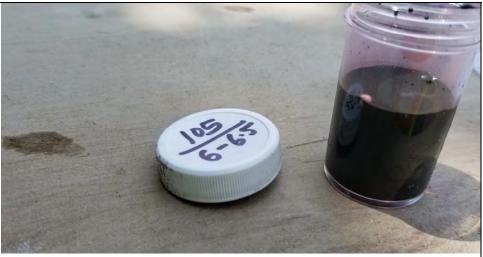
Photo 6: Side view of Oil-In-Soil test on sample collected from 6 to 6.5 feet bgs at SB-105.

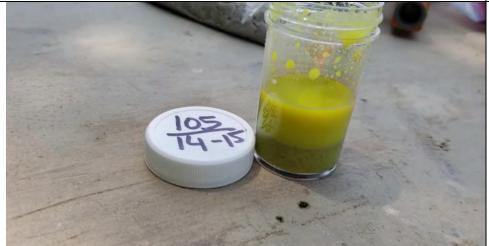
Photo 7: Side view of Oil-In-Soil test on sample collected from 14 to 15 feet bgs at SB-105.

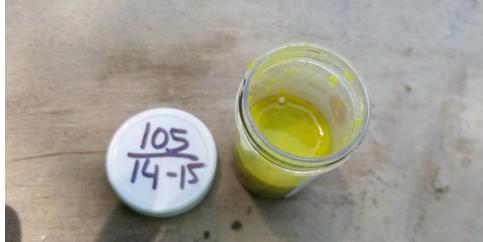
Photo 8: Top view of Oil-In-Soil test on sample collected from 14 to 15 feet bgs at SB-105.

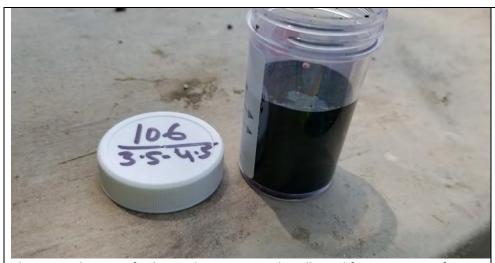
Photo 9: Side view of Oil-In-Soil test on sample collected from 3.5 to 4.5 feet bgs at SB-106.

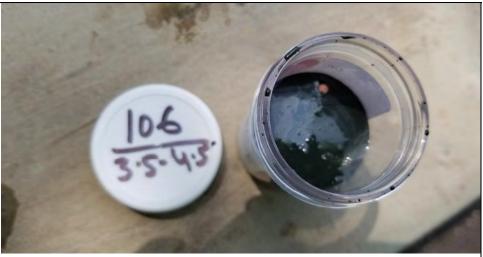
Photo 10: Top view of Oil-In-Soil test on sample collected from 3.5 to 4.5 feet bgs at SB-106.

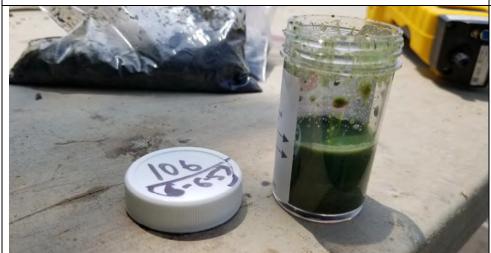
Photo 11: Side view of Oil-In-Soil test on sample collected from 6 to 6.5 feet bgs at SB-106.

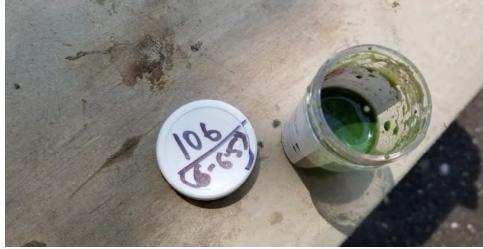
Photo 12: Top view of Oil-In-Soil test on sample collected from 6 to 6.5 feet bgs at SB-106.

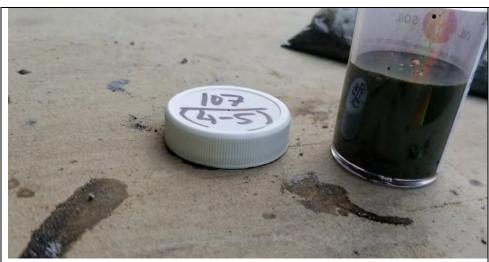
Photo 13: Side view of Oil-In-Soil test on sample collected from 4 to 5 feet bgs at SB-107.

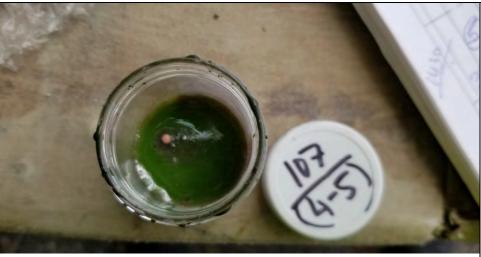
Photo 14: Top view of Oil-In-Soil test on sample collected from 4 to 5 feet bgs at SB-107.

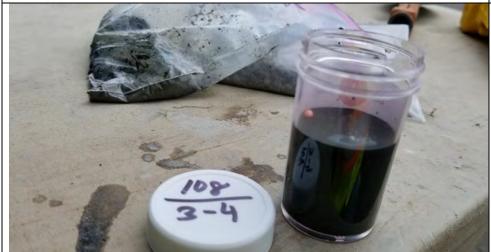
Photo 15: Side view of Oil-In-Soil test on sample collected from 3 to 4 feet bgs at SB-108.

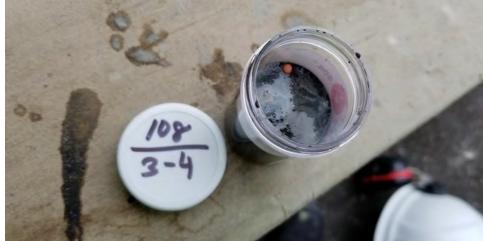
Photo 16: Top view of Oil-In-Soil test on sample collected from 3 to 4 feet bgs at SB-108.

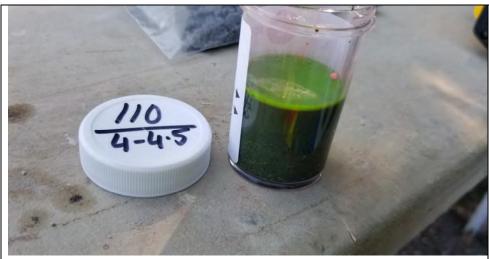
Photo 1: Side view of Oil-In-Soil test on sample collected from 4 to 4.5 feet bgs at SB-110.

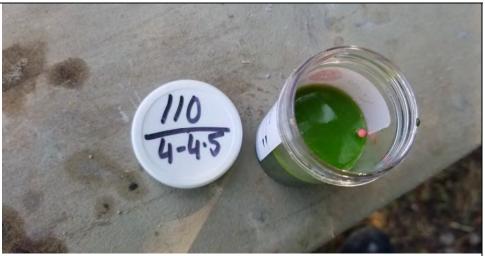
Photo 2: Top view of Oil-In-Soil test on sample collected from 4 to 4.5 feet bgs at SB-110.
